Scour And Erosion Alongside Bank Protection Work: Case Studies From Bangladesh

SCOUR AND EROSION ALONGSIDE BANK PROTECTION WORK: CASE STUDIES FROM BANGLADESH

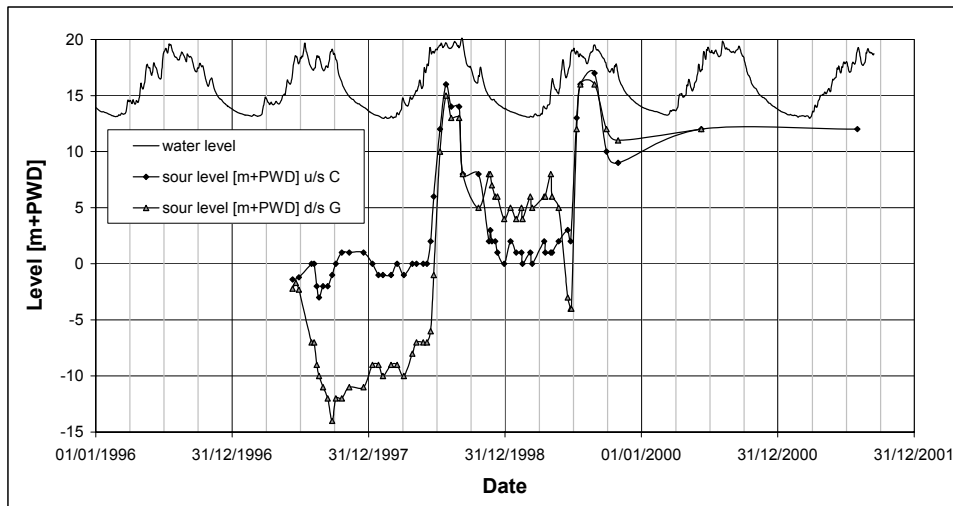
The 100-year flood level at Bahadurabad is 21 m+PWD. The deepest observed scour was at -14 m+PWD, which results in a maximum water depth of 35 m below 100-year flood level (Figure 7).

Figure 7. Development of river depth at upstream and downstream end of Bahadurabad.

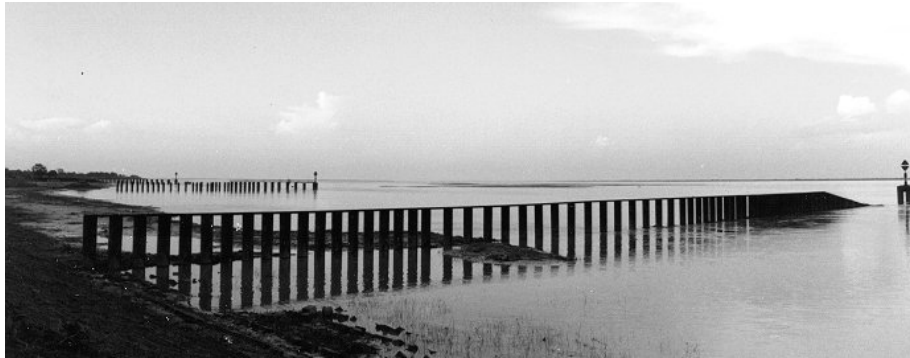
Figure 8. Permeable spurs at Kamarjani.

Scour data from different types of spurs are available from two locations along the Brahmaputra / Jamuna River: at the permeable spur field at Kamarjani and at Sariakandi at three hard points, both at the right bank. The permeable spurs at Kamarjani are shown in Figure 8, the measurements in Figure 9.
