The Eider Estuary

By KLAUS BEDNARCZYK, DETLEF SCHALLER and ULRICH VIERFUSS

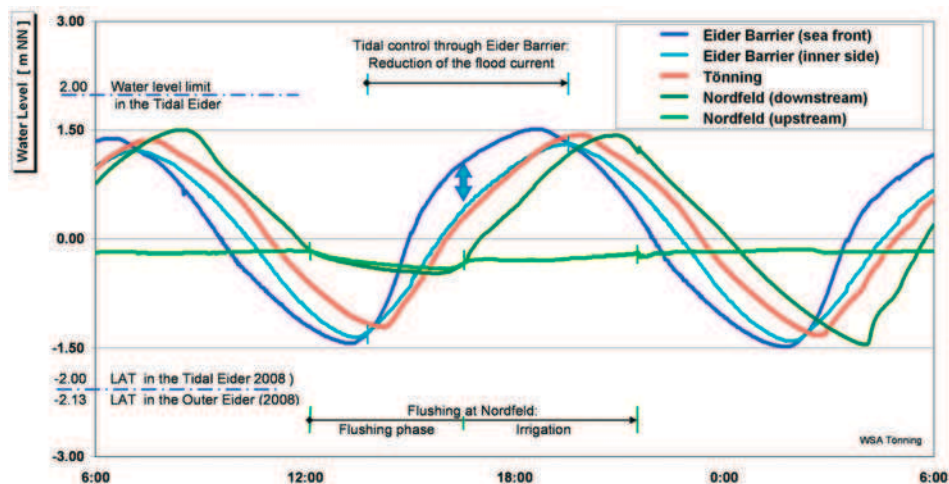
Fig. 3: Time series of tidal elevations in the Eider (August 7th and 8th, 2000)

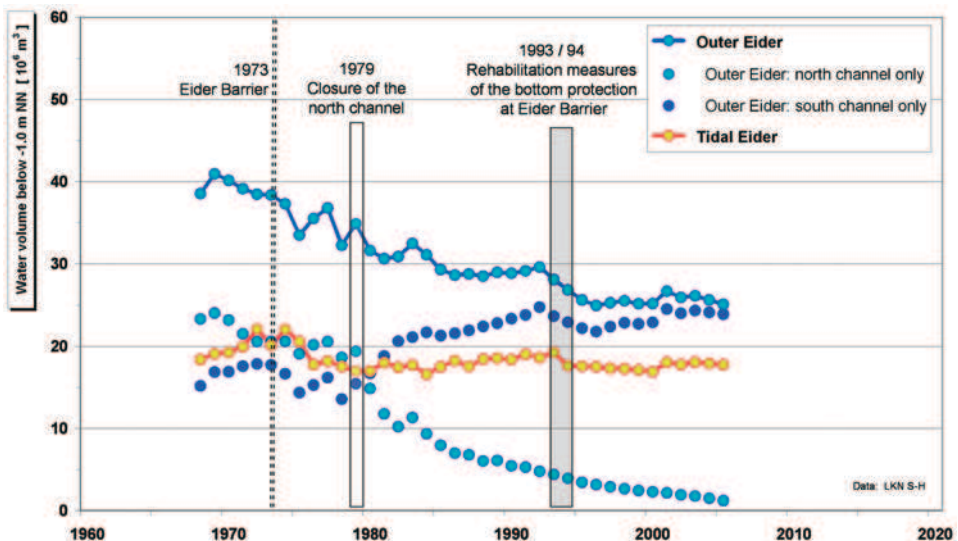
Fig. 4: Historical development of the water volumes of the Outer Eider (to 8 km from the barrage) and the Tidal Eider

The enclosure of “Katinger Watt” by a dike and forcing the river through the barrage with a considerably reduced tidal volume completely changed the morphological processes in the Tidal Eider (Fig. 4). Already after a few years, a channel migration was established in the remaining tidal flat area which has been stable up to the present. There was a noticeable decrease in the intensity of aggradation of the Eider; in the meantime, the process seems to be limited to the relocation of sediment. This evaluation, however, does not apply to the area between $+1$ m NN and the limiting level of $+2$ m NN which has been hardly sur-
