# Comparative study of the repair of cracked plates with two different composite patches

**ABSTRACT.** The aim of this study is to analyze the behavior of a crack with and without reinforcement by a composite patch of an aluminum plate in mode I using the finite element method. The repair patch is boron / epoxy and Carbon / epoxy, which are used with great success by many researchers. For the distribution of the stresses according to the various loadings, we can conclude that the effect of repair by patch in composite is very distinct, considering the intensities of stresses which decrease for each repair corresponding to the plate not repaired, therefore, the patch in composite dampens the stress field induced at the crack tip and causes a reduction in stresses. The repair with the Bore / epoxy composite patch is more effective than the Carbon/Epoxy patch, this is due to the mechanical properties and the various characteristics specific to boron/Epoxy which gives very significant and very effective results for the repair.

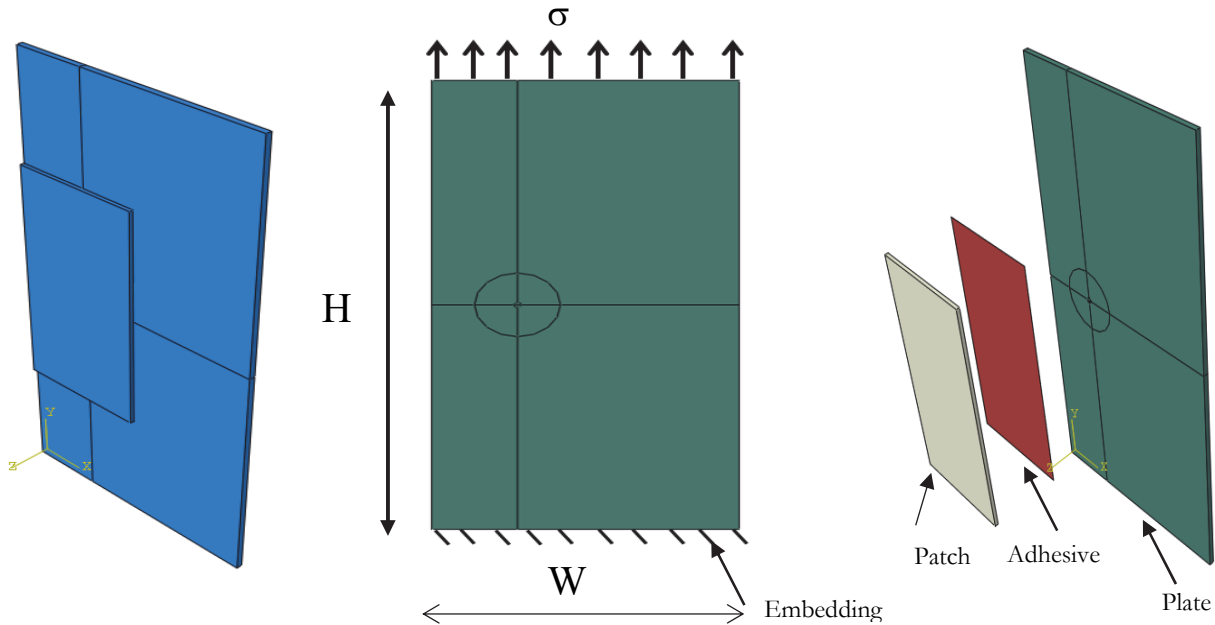
Figure 1: Geometrical model of the repaired plate.

The mechanical characteristics of the assembly materials (plate, patch and the adhesive layer) are shown in the Tab. 2 and 3, the Fig.1 shows the geometric model of the structure used.

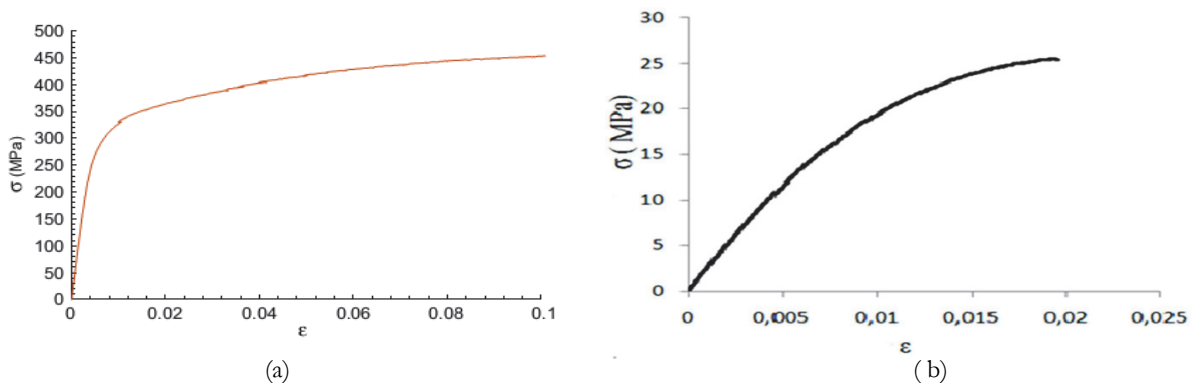
Figure 2: Stress-strain curve: a) - Aluminum plate 2024 T3 b) -Adekit A140 adhesive [29]

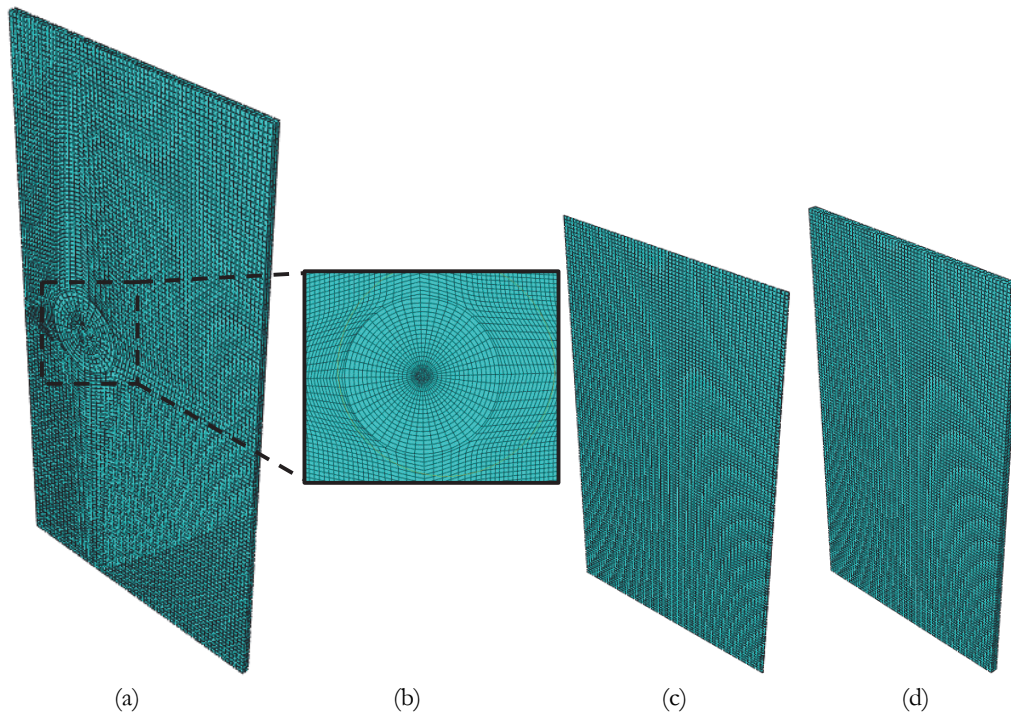
Figure 3: Geometrical model and mesh of the structure: a) Plate, b) Head of crack, c) Adhesive and d) patch.

The finite element analysis of the configuration of the repaired plate (shown in Fig. 3) is done using the calculation code ABAQUS [30]. The structure of the layers of the laminate (patch) is in fact a three-dimensional structure. A three-dimensional finite element model of such a structure has several degrees of complexity. A refined mesh is presented at the adhesive layer and plates to determine the maximum stresses.

The adhesive is modeled as a third layer. In the finite element model, the nodes are common between each three-dimensional structure so that there is a continuity of the strain and the stress. The elements used in the modeling of the set are C3D20R, A 20-node quadratic brick. A fine mesh was adopted in the area around the crack. The number of elements used in this study are 85062 elements in the Aluminum plate, 16256 elements in the composites patch and 8128 elements in the adhesive layer.

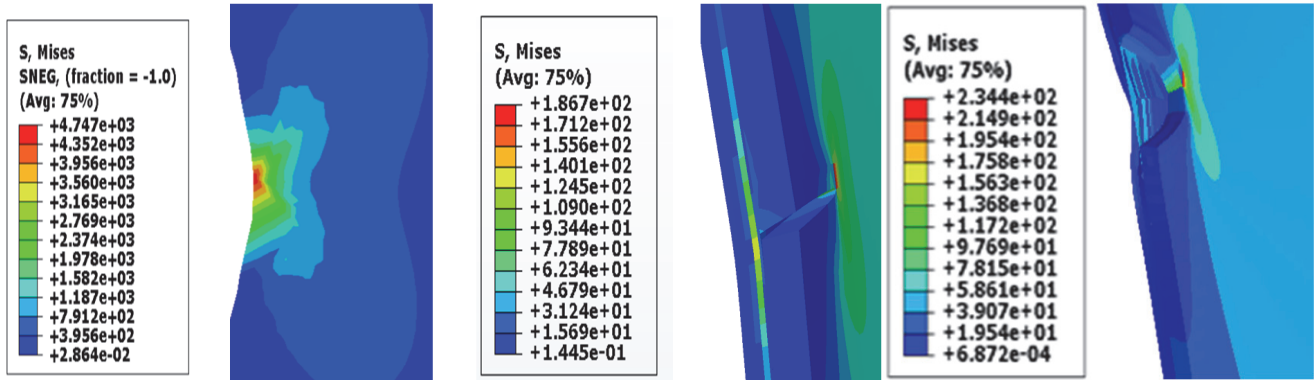
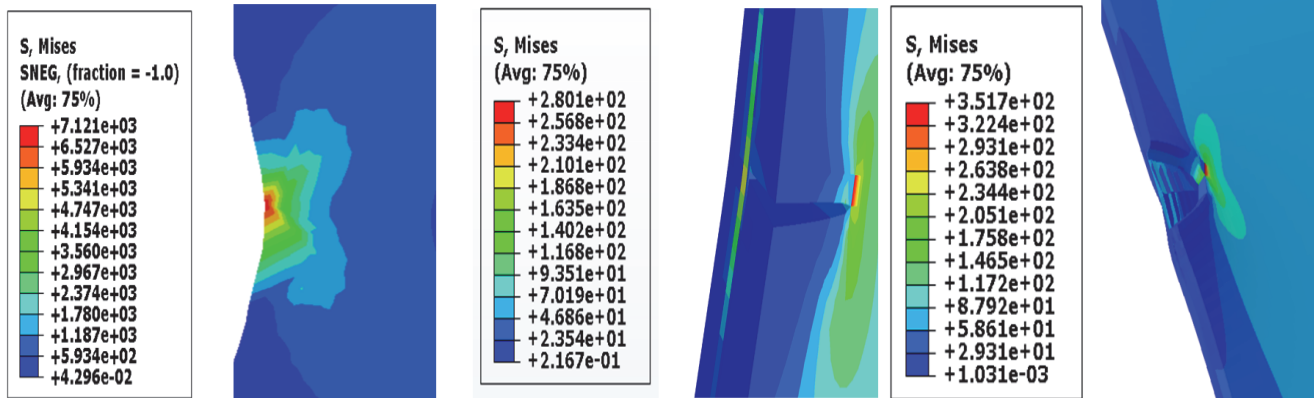
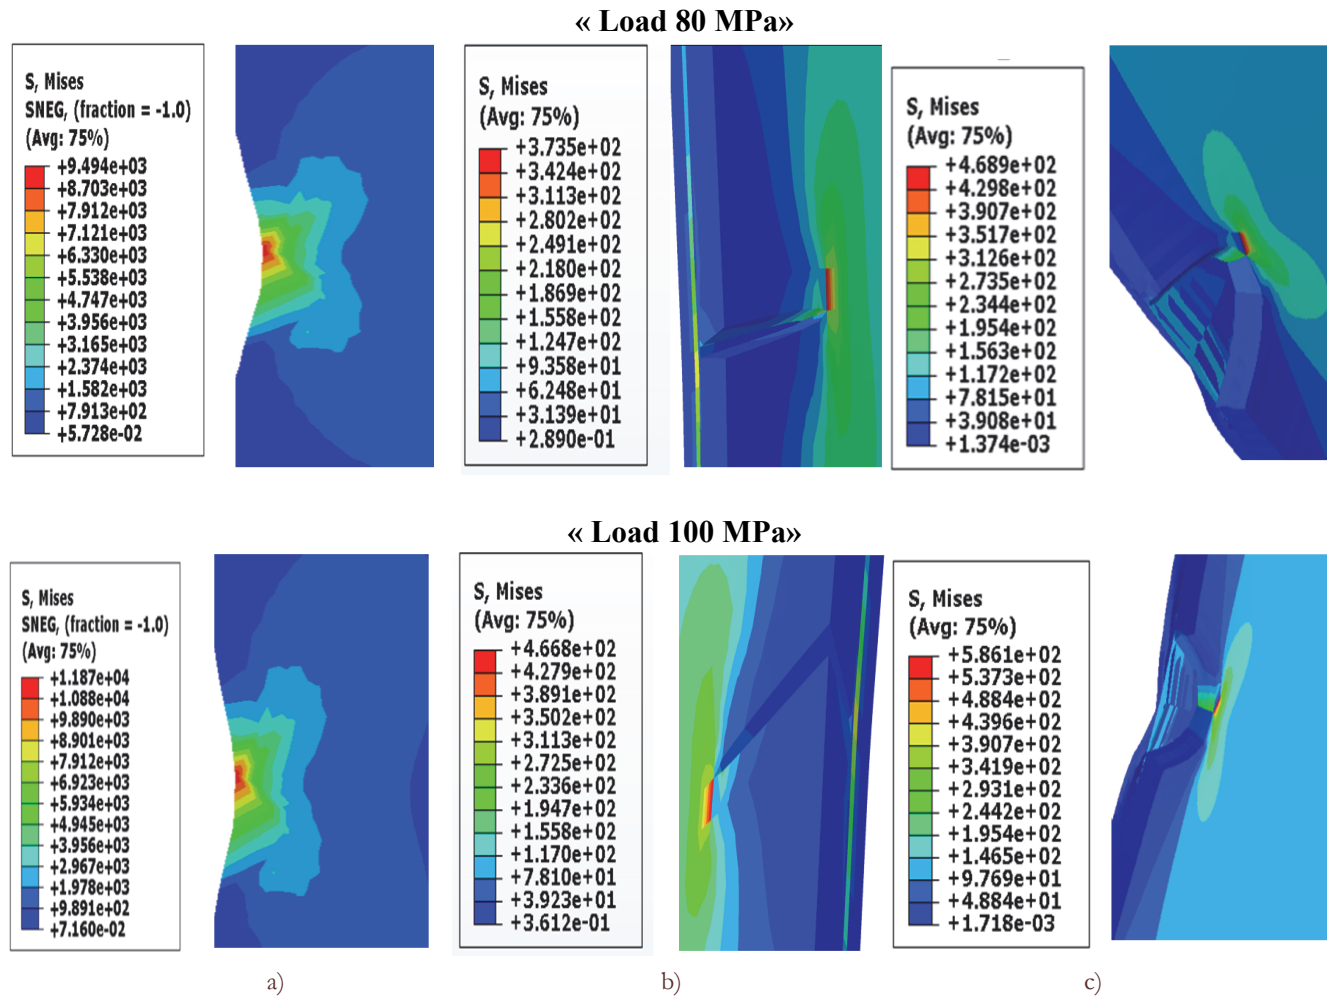
Figure 4: Distribution of the Von Mises equivalent stresses: a) Plate not repaired b) Plate repaired Boron epoxy c) Plate repaired Carbon epoxy.

The first remarks drawn by these stress distributions leads us to conclude that the unrepaired plate is stressed by very significant stresses especially at the crack tip and the affected area is very large, namely this confined plastic area, while, in the presence of the composite which is a very stress-absorbing element, and after the repair of this plate, these equivalent stresses of Von Mises have a very distinct reduction in its intensity, hence the importance of this repair by this boron / epoxy composite, and by carbon /epoxy, therefore, there is a relaxation of the stresses.

The reduction of the stress intensities in the event of repair is very remarkable relative to the unrepaired plate for the equivalent stresses of Von Mises, this proves that the composite patch absorbs and dampens all the stresses at the same time by slowing the crack propagation and make the stress field lower, for a confined area in the vicinity of the crack head and to avoid its initiation, this repair in composite patch prevents the propagation of the crack and allows the longevity of life for crack.

The gain in repair is very distinct by the two composites due to their effectiveness, hence, the most effective and efficient composite is boron/epoxy by its important mechanical properties, which leaves all the stresses to be reduced and to be absorbed, then the carbon/epoxy, which in turn has interesting properties and leaves the stresses to be reduced.

For the cases of repair by these two patches, the maximum stress reached does not even exceed 600 MPa for a loading of 100MPa, while for the not repaired plate, this stresses reaches around 11870 MPa, and this proves the absorption of these stresses by repair.

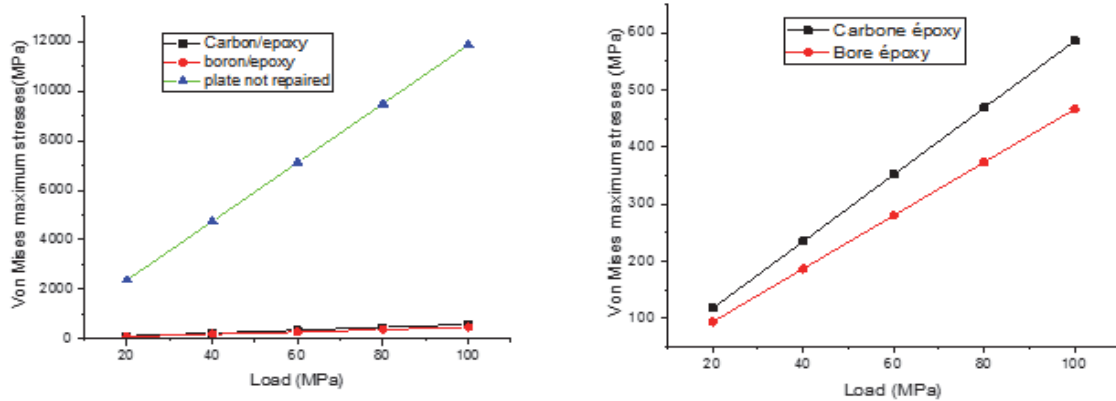
Figure 5: Variation of the maximum equivalent stresses of Von Mises according to the various loadings.

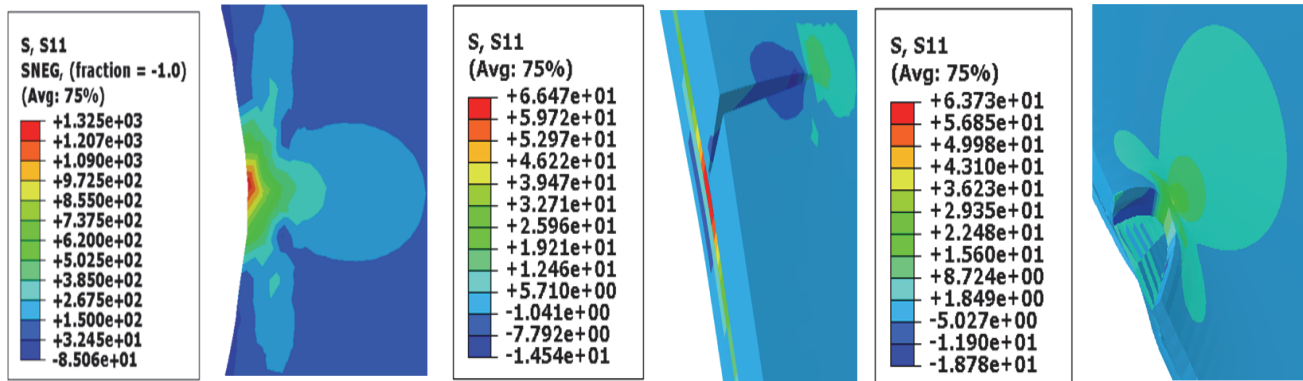
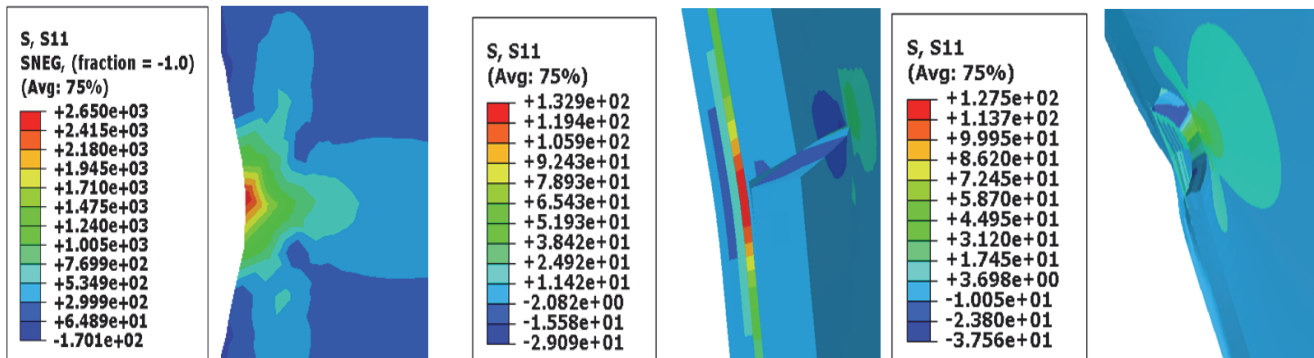
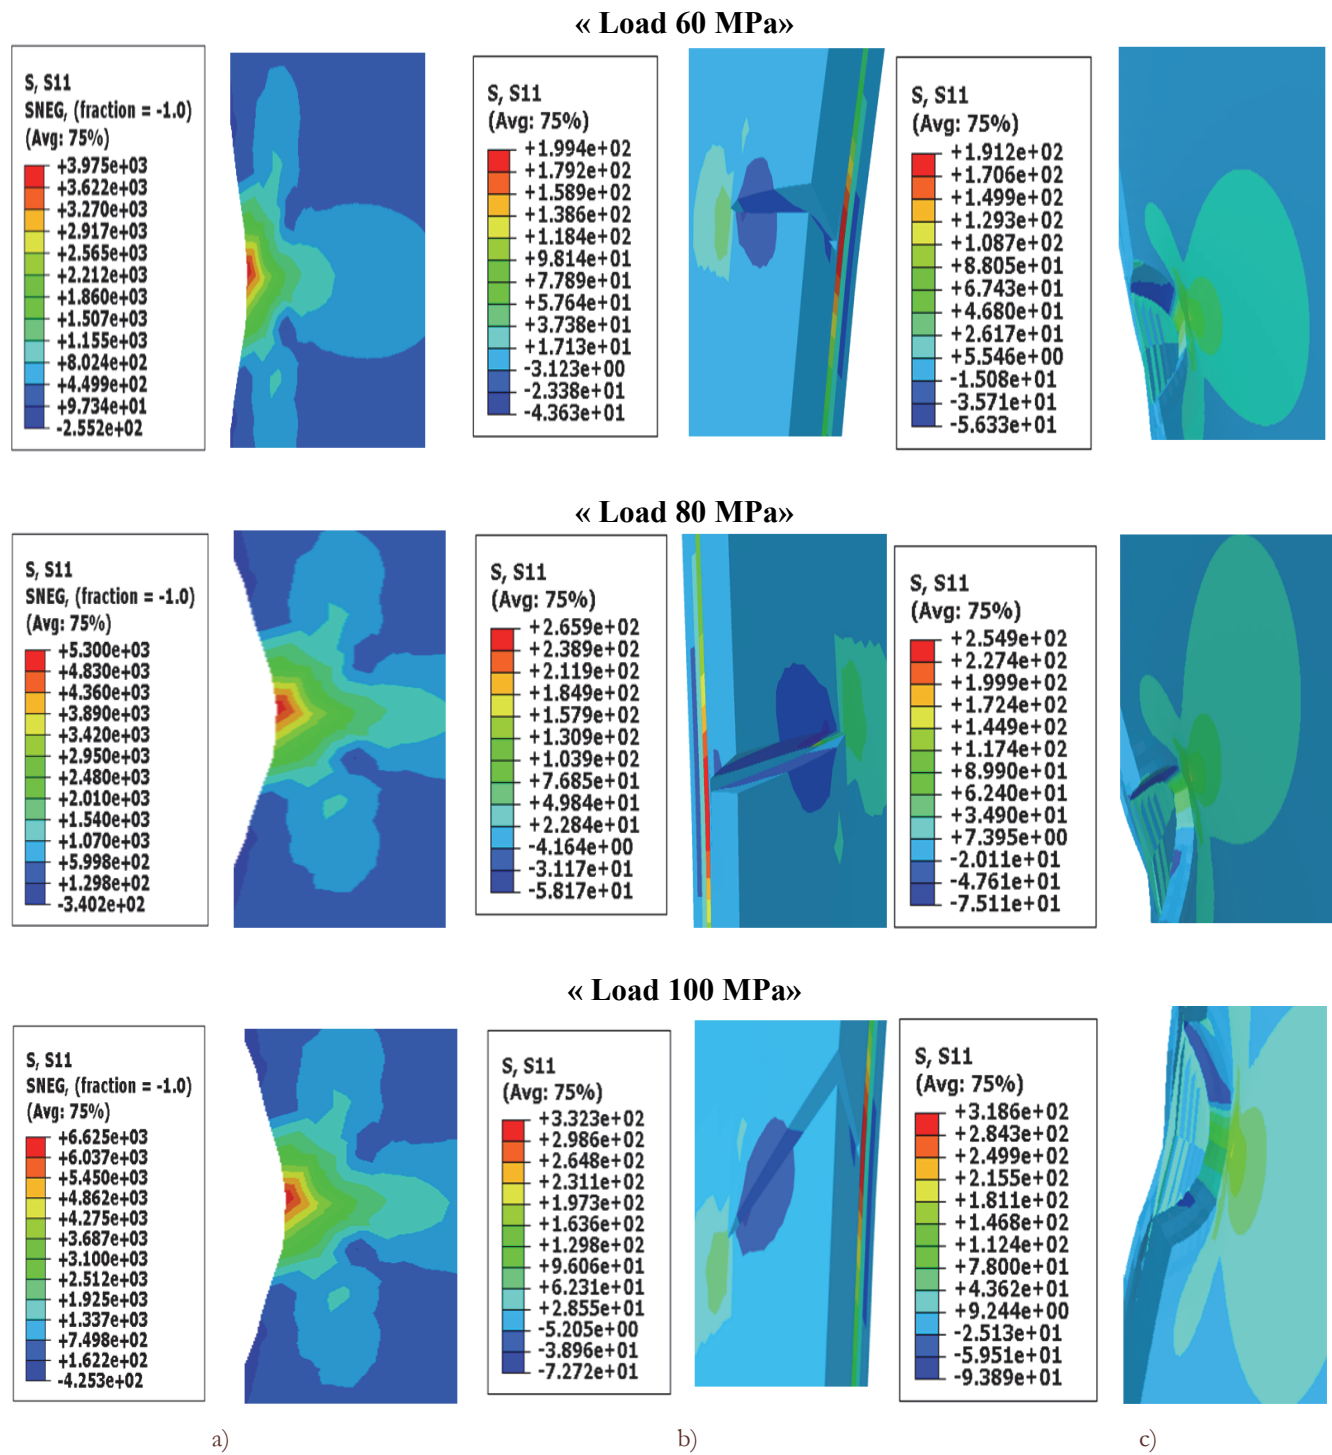
Figure 6: Distribution of normal stresses  $\sigma_{xx}$ ; a) Plate not repaired b) Plate repaired Boron epoxy c) Plate repaired Carbon epoxy.

We note that the area of the repaired plate is strongly affected by very important stresses compared to that repaired, we conclude that there is a very remarkable reduction for this repaired plate, for that, and for fairly low load, such as 20MPa and 40MPa, their effects on the repaired plaque are almost weak. It is noted that the reduction of the normal stresses is less important unlike the boron/epoxy patch, since approximately the crack head, which knows an opening of its lips, and creates a stress field around its head proves a gain quite significant by this repair, hence the effectiveness of the Bore / epoxy patch compared to the carbon / epoxy patch, by its very important mechanical properties which make it possible to reduce the stresses induced at the crack head and give the plate a certain rigidity in order to be able to withstand different stresses and increase its lifespan.

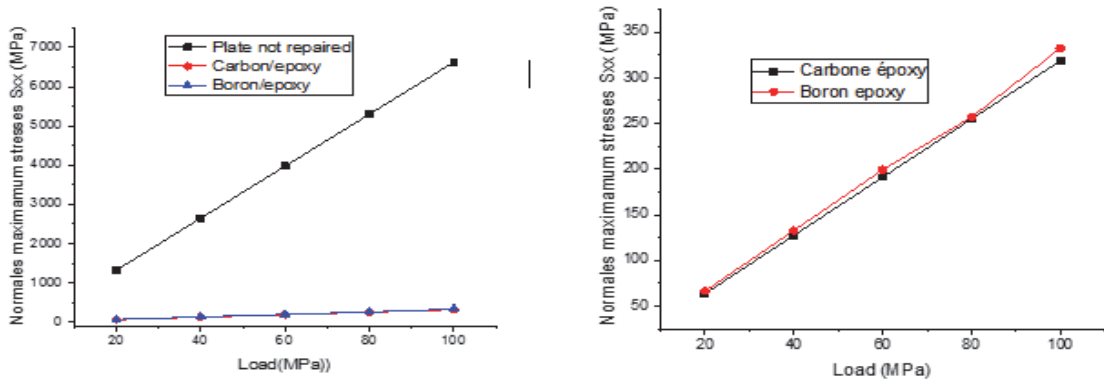
Figure 7: Variation of the maximum normal stresses  $\sigma_{xx}$  according to the various loadings

To change the normal maximum stresses  $\sigma_{xx}$  according to different loads, we note that the repair patch composite provides a significant gain compared to the unrepaired plate and that depending on the corresponding patch, hence the effectiveness repair that extends the life of the cracked plate. The repair by these two composite patches is almost similar considering the two boron / epoxy and carbon / epoxy curves are almost combined and do not exceed 320MPa for a loading of 100MPa.

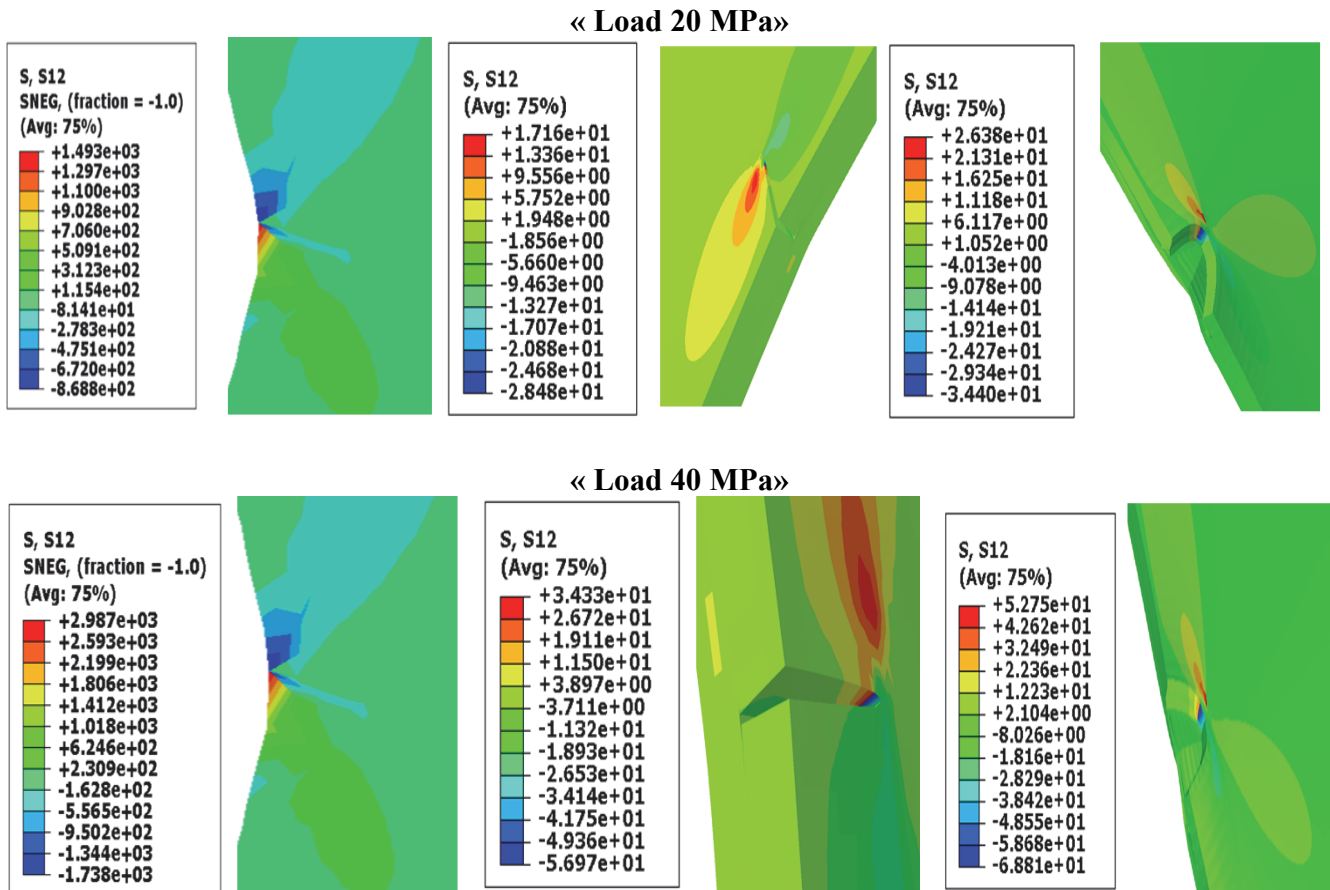
For the different loads, we compare the different tangential stresses for the unrepaired plate and after its repair by composite patch, which is Boron/Epoxy and Carbon/Epoxy; we have obtained the following results:

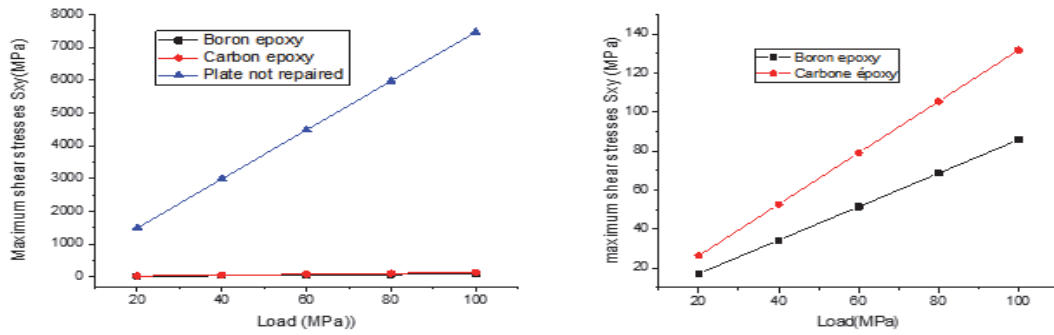
Figure 9: Variation of the maximum tangential stresses  $\tau_{xy}$  according to the various loadings.

For the cases of the curves representing the variation of the maximum shear stresses  $\tau_{xy}$  as a function of the different loadings, the gain in stresses going progressively from the unrepaired plate towards the plate repaired by the Carbon / epoxy patch, until the plate repaired by the most effective boron / epoxy composite, because the patch in boron / epoxy composite absorbs stress concentrations at the crack head well than the carbon/epoxy composite and consequently good stress absorption in the vicinity of the crack head.

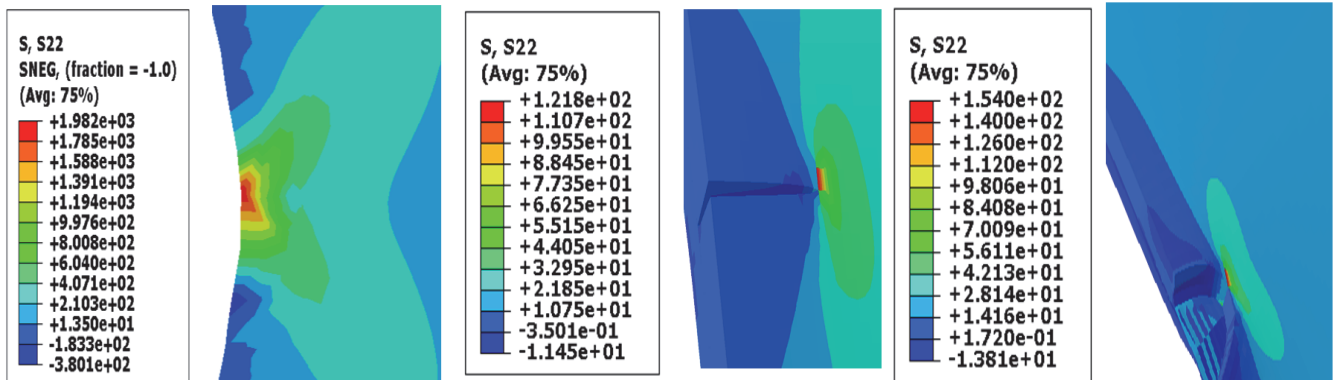
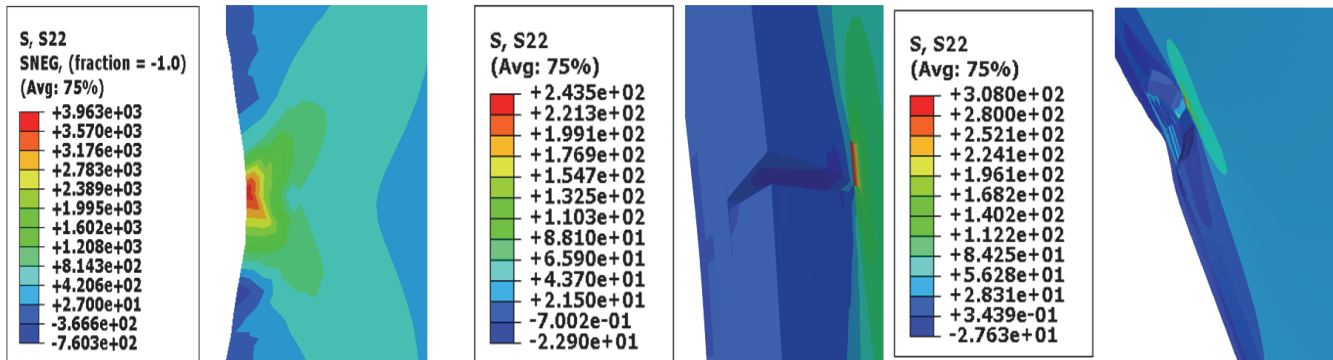
To be able to distinguish and see the effect of the patch on a cracked plate laterally stressed at tensile stresses of its two ends, that is to say, in the direction of the opening of the lips of the crack, we expose these normal constraints  $\sigma_{yy}$  for the two cases.

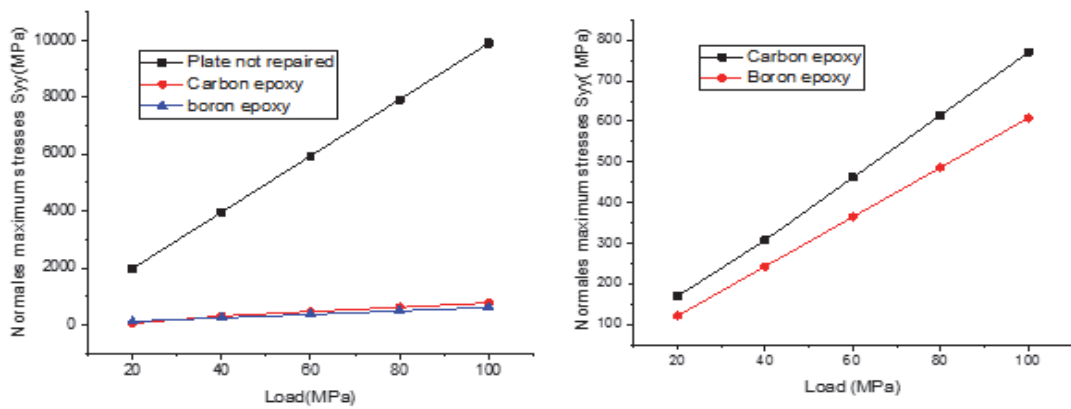
Figure 11: Variation of the maximum normal stresses  $\sigma_{yy}$  according to the various loadings

This figure shows that the effect of the repair by composite patch is very distinct; given the gain in the stresses, which experienced fairly low values relative to those found for the cracked plate without repair, therefore the composite patch is a damper or a stress absorber. The reduction of the stresses is very distinct for this not repaired plate by the effect of the repair by the two patches and it is very remarkable and more effective for the boron/epoxy, which presents better results for the reduction of the stresses and to prolong the service life of repaired materials.

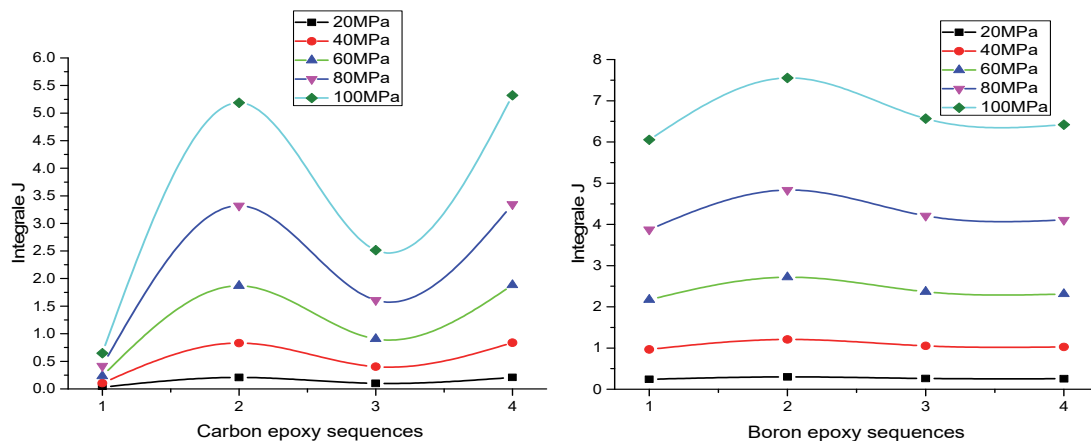
Figure 12: Representation of the integral (J) for different loading.

For the variation of the integral J as a function of each sequence (Plaice) for different loading for the plate repaired by patch in composite which is (Carbon / epoxy), we notice that as the load increases, the corresponding integral J also increases, and this integral reaches its maximum at sequence No. 2, that is to say for the orientation of the fibers at 45 °, and this maximum value is of the order 5.3mj / mm<sup>2</sup>.

For the plate repaired by patch in composite (Boron epoxy), the variation of the integral J for different loads for the four stacking sequences is almost proportional to the loading, since for low loads such for 20MPa and 40MPa, this integral does not exceed 2.7mj / mm<sup>2</sup>, and reaches its peak which is of the order of 7.5 mj/mm<sup>2</sup> for the same sequence with the orientation of the fibers at 45 °, which corresponds to the second fold of the boron epoxy composite. in the close vicinity of the adhesive, the energy due to crack propagation, induces a greater intensity and for progressive loads and decreases towards the last stacking sequences of the patch, according to shows that the patch absorbs a very large amount of energy that passes through it, and consequently, increase the lifetime of the structure.
