Article

Impact Damage Resistance and Post-Impact Tolerance of Optimum Banana-Pseudo-Stem-Fiber-Reinforced Epoxy Sandwich Structures

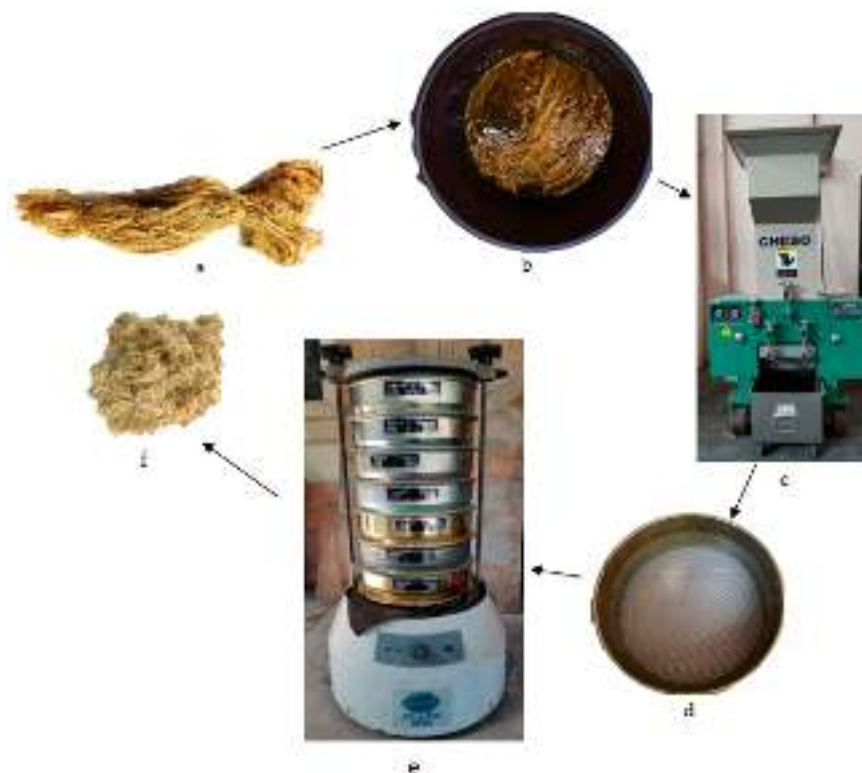
Figure 1. Photos of (a) long banana fibers, (b) chemically retted fibers, (c) fiber chopping machine, (d) 3.35-mm brass frame sieve, (e) rotational shaker, and (f) short banana fibers.

Initially, to eliminate any surface impurities, a long banana fiber, as shown in Figure 1a, was washed with deionized water and dried in a circulation oven Model H750CLAB200D16 (CMH Ltd., Lancing, UK) at 70 °C for 9 h. Then, the fibers were soaked in 5.45 wt.% sodium hydroxide (Figure 1b) for 5 h according to the optimal conditions suggested by the Box–Behnken design [25]. These fibers were ground down using a Cheso Model N3, (Cheso Machinery Pte. Ltd., Loyang Way, Singapore) crusher machine (Figure 1c). In order to obtain the 3.35-mm fiber length, a multi-stage sieve (Figure 1d)—model BS410/1986 (Endecots Ltd., London, UK)—fixed to a rotational shaker (Endecots Ltd., London, UK) (Figure 1e) was used. The speed of this shaker was maintained at 275 rpm for 45 min. The short banana pseudo-stem fibers were utilized as the reinforcement, as illustrated in Figure 1f. Similar processes were repeated for the Kevlar, carbon, and glass fiber tows, except for the alkaline treatment. These synthetic fibers were chopped using a carbon fiber shear cutter Model 3670C-8 (EasyComposite Ltd., Stoke-on-Trent, UK) and sieved using a rotational shaker. Then, the epoxy-resin matrix with fibers was gradually mixed at 29.86 wt.% of the fiber loading.

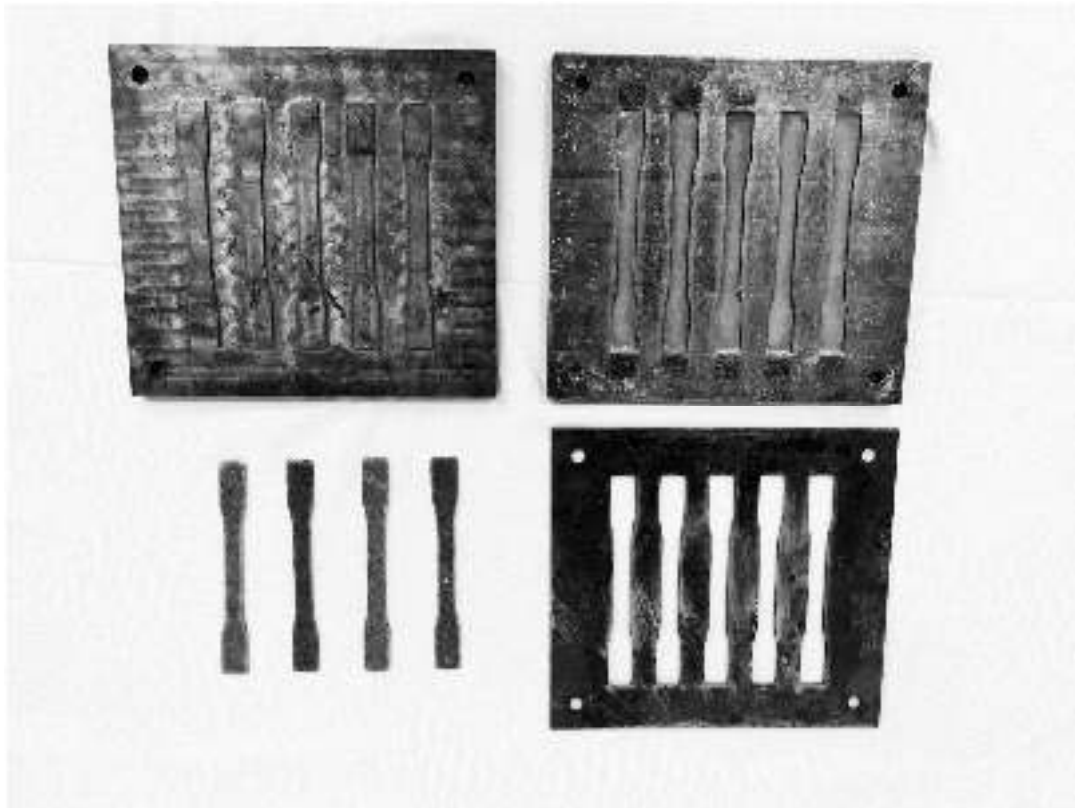
Figure 2. Photo of tensile specimen fabrication.

The tensile test specimens of banana epoxy composites were fabricated using the mold shown in Figure 2. A dog bone specimen was manufactured following ASTM D638 [29].

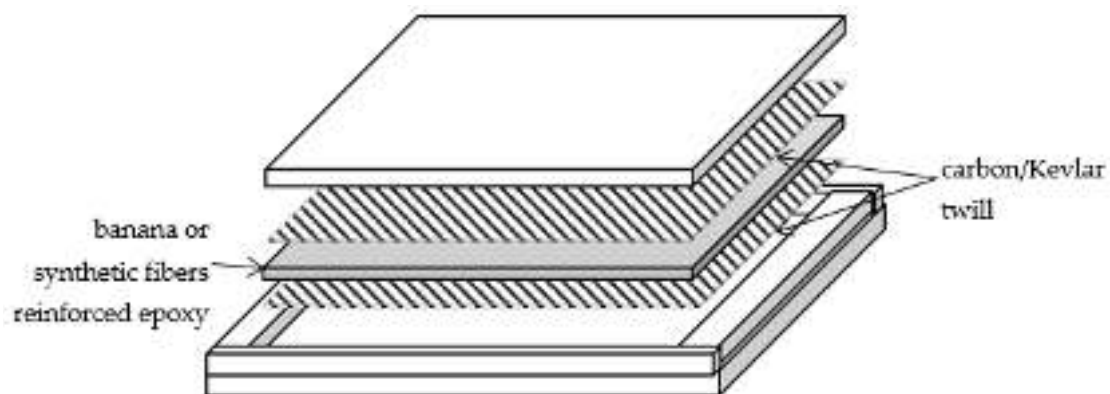
Figure 3. Schematic of the fiber-reinforced epoxy sandwich structure fabrication.

In order to fabricate the sandwich structure, a banana and synthetic fiber epoxy composite was layered with carbon/Kevlar plies. Here, these 2/2 woven hybrid skins were initially cut to a size of 300×300 mm before being placed into picture frame molds. Prior to that, those fibers were gradually mixed with epoxy-resin paste. Further, the sandwich structures were prepared using a hot press machine. The specimens were then heated to 70 °C for one hour under a pressure of 1 bar before leaving them to cure overnight. The samples were inspected visually before being sectioned into 150×100 mm samples. In this study, at least five samples for each configuration were examined. The configuration of this structure is shown in Figure 3.

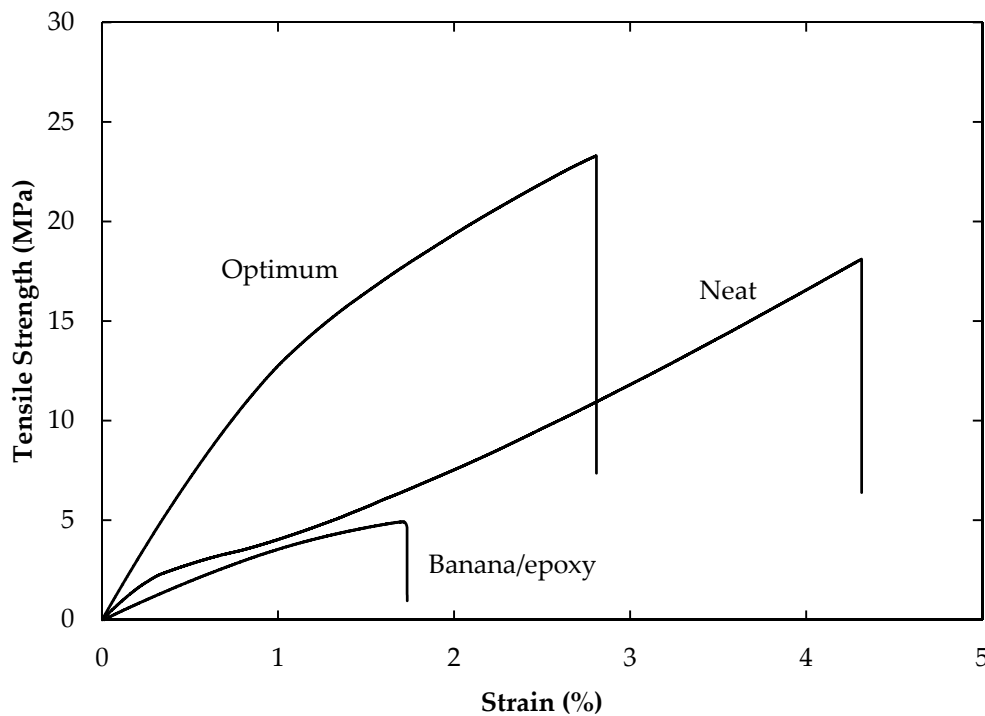
Figure 4. Typical stress–strain curve for neat, optimal banana/epoxy composite, and banana/epoxy composite.

Figure 4 illustrates the stress–strain curves of the neat epoxy system, banana fiber composite, and optimal banana reinforced epoxy composites. It can be seen that the maximum stress and tensile modulus of the optimal banana fiber reinforced epoxy composite were increased by 66% and 22%,

respectively, compared to the neat epoxy resin. It is suggested that the properly optimized the fiber blending condition improved the load-bearing capabilities between the fibers and matrixes. A similar finding was also reported by Yaghoobi and Fereidoon [23]. In this figure, the untreated, 0.25-mm length, and mixed at 50 wt.% fiber loading of a banana-fiber-reinforced epoxy composite was also included for comparison. Interestingly, these composites unfolded at lower tensile strength and modulus values than the virgin epoxy-resin. In addition, the tensile modulus of this unoptimized composite was found to be 792 MPa, which was lower than that of the optimal banana epoxy composite with 1628 MPa. It was demonstrated that adding inappropriate natural fiber “debris” in the polymeric matrixes decreased the material properties of the structure.

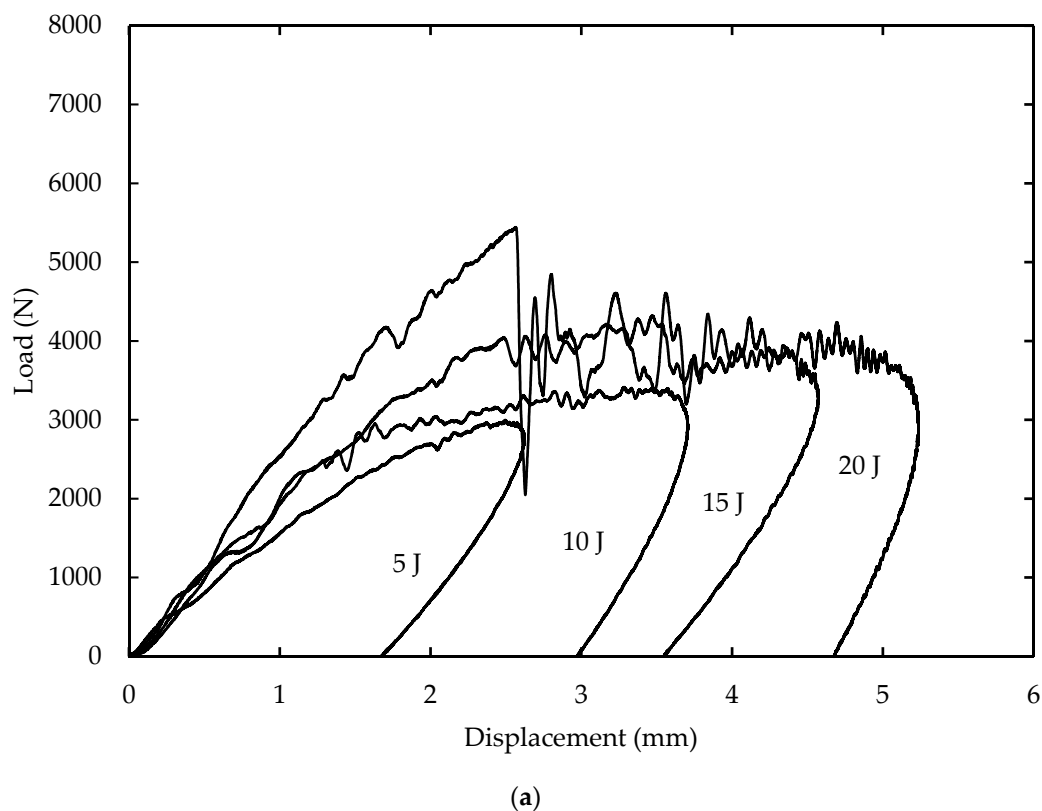
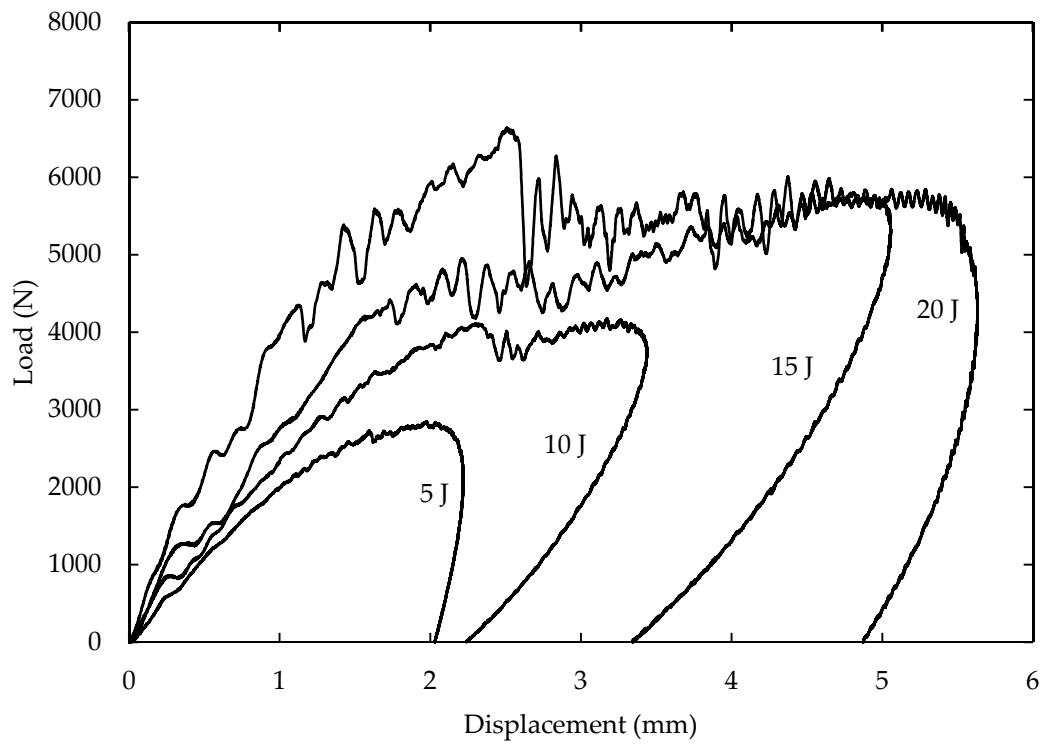
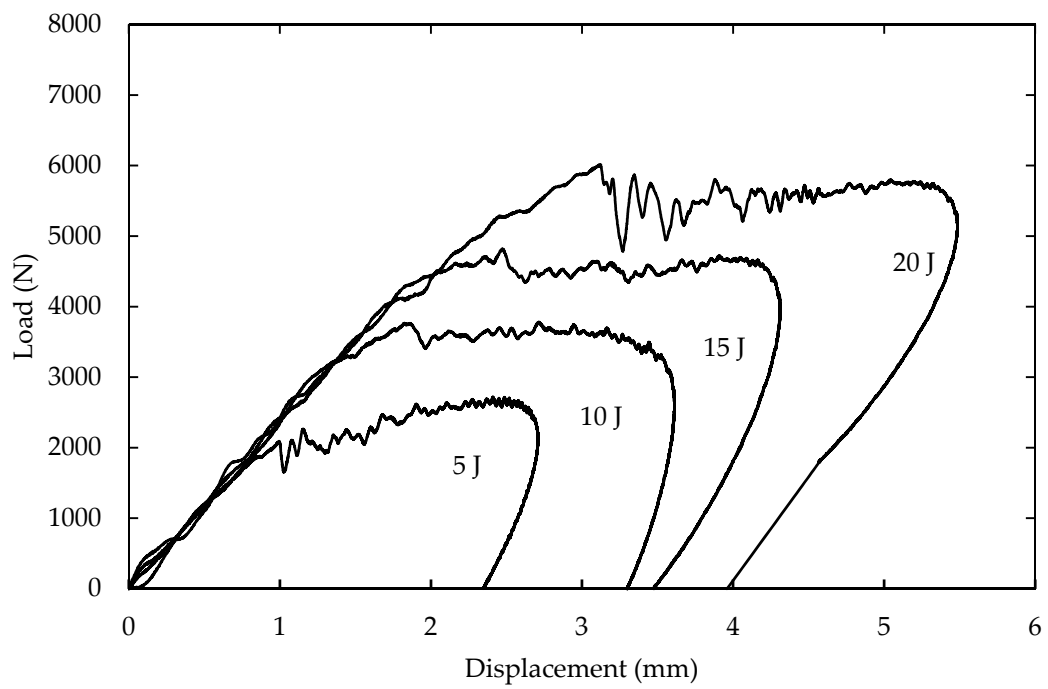
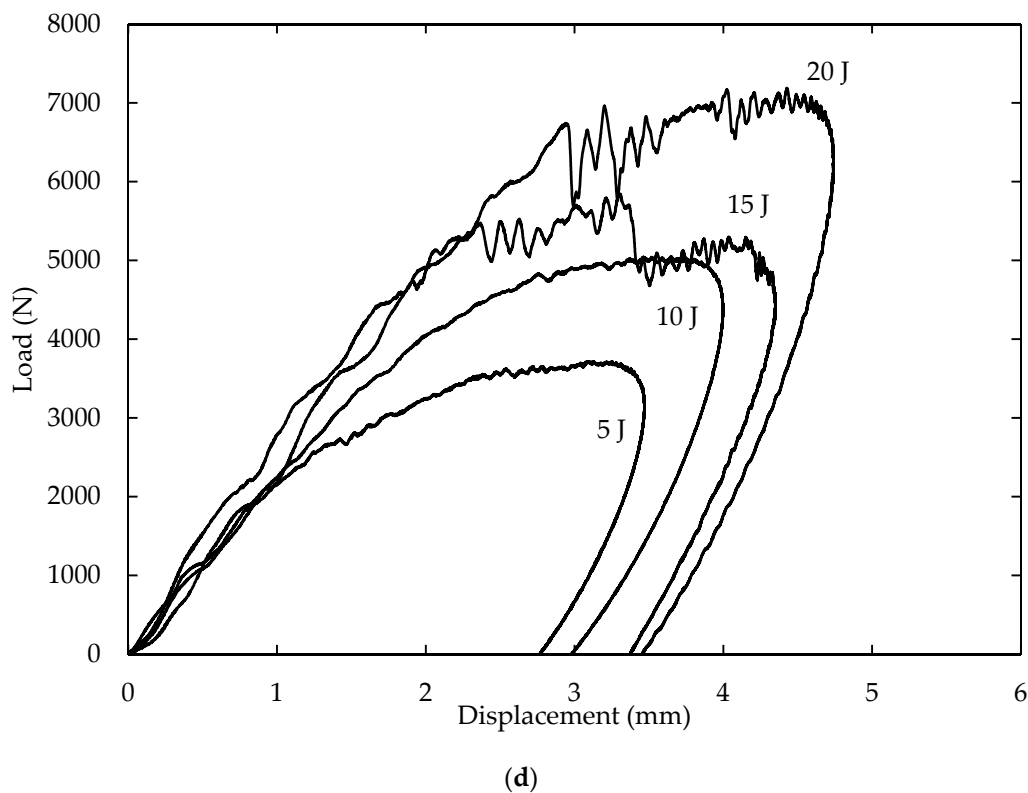
Figure 5. Typical load–displacement traces of (a) banana, (b) Kevlar, (c) glass, and (d) carbon/epoxy sandwich structures.

Figure 5 illustrates typical load–displacement traces for the low-velocity impact response at four different impact energy levels correspond to the optimal banana, Kevlar, glass, and carbon epoxy sandwich structures. All traces initially exhibited a similar pattern with the force increasing in an

almost linear manner before reaching a peak load. This was associated with the plastic deformation of the sandwich structures directly beneath the hemispherical impactor. Figure 5a presents typical load versus displacement traces for the impact loading of the optimal banana epoxy sandwich structures. It can be seen from the figure that increasing the incident impact energy increased the effective slope of the curve up to 3 mm of displacement, suggesting a rise in the contact stiffness of the system. Beyond this point, a non-linear trace pattern was observed, resulting in the initiation of unstable crack propagation and fiber fracturing. A very drastic fall in the contact load was apparent in the trace for the 20 J impact energy level due to sub-critical propagation and brittle failure of the core. Continued loading often resulted in microcracking and instabilities, with this being most evident in the 15 J impact energy trace where very small load jumps were apparent in the trace at displacements above 3 mm. In addition, the enclosed area within the loading and unloading curves was a measure of the energy absorbed due to the damage in the laminates. Then, the impactor was rebounding since the force and deflection values decreased in the unloading phase. At all the energy levels used in this study, the impactor did not fully perforate the sandwich structures and a portion of the impact energy was conserved as elastic energy. This energy was then transferred back to the steel impactor, causing it to rebound. He et al. [33] suggested that if the core structure was a highly brittle material, the rapid rebound of the skin under impact can result in debonding at the interface between the adjacent layers of the face sheet and the core. Figure 5b–d reveals the typical load displacement traces for Kevlar, glass, and carbon epoxy sandwich structures after being subjected to 5, 10, 15, and 20 J impact energies. From the figure, it is evident that the Kevlar/epoxy composite has a characteristically higher contact stiffness than that of the other composite structures; however, the carbon/epoxy structure offered less “resting” displacement during the unloading phase. It can be suggested that this has resulted in less of a dent depth for the carbon epoxy structures.

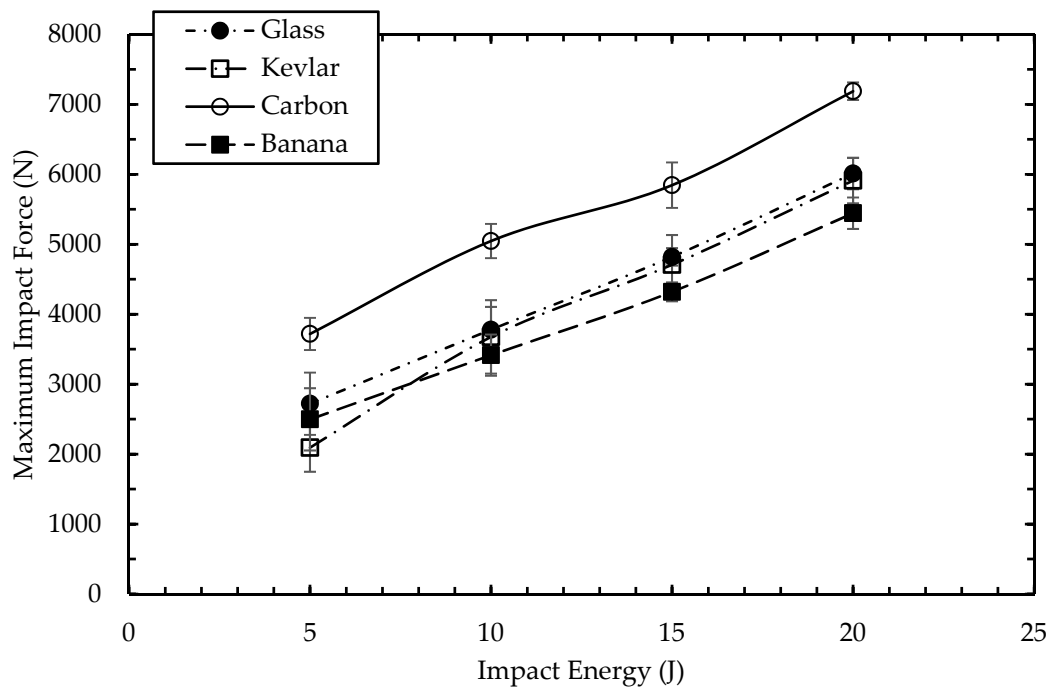
Figure 6. The variation of the maximum impact force at different impact energy levels for composite structures.

The variations in the peak force at different impact energy levels for composite structures are shown in Figure 6. It can be observed that the peak impact force was increased with increases in the energy level. A similar observation was also reported by Olsson et al. [34]. In addition, the optimal banana/epoxy composite offered a lower peak force than those of the synthetic/epoxy structures. Joseph et al. [35] claimed that fiber pullout and fiber compatibility were the major contributors to the toughness of the composite. Thus, synthetic fibers offered a significantly higher peak load, suggesting higher bonding capabilities with the matrix due to the surface smoothness and consistency of the cross-section. In the case of natural fibers, such a mechanism was not favored due to the mechanical interlocking between fibers and the matrices. In this study, to increase the compatibility between the banana fiber and the matrix, the chemical treatment was promoted; however, the peak force still remained unimpressive.

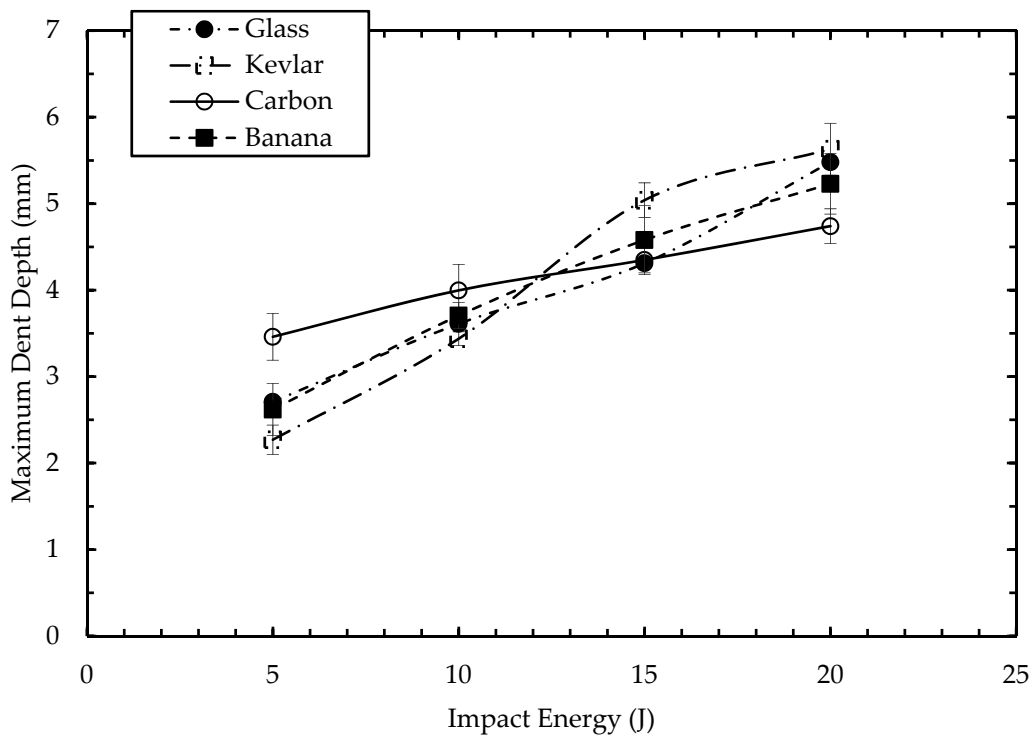
Figure 7. Variation of the maximum dent depth against energy level traces for composite structures.

The peak displacement indicates the maximum deformation of the sandwich panels, which results in a significant area of damage after subjection to different energy levels. Figure 7 shows representative maximum dent depth against energy level traces for different core composites. In general, the maximum displacement steadily increased with rising impact energy. It can be seen that carbon fiber had the highest dent depth at low energy levels and it was the lowest at higher impact energies. This was in part due to the high in-plane tensile properties of the material. Properties of the core, including rigidity and brittleness, also influenced this behavior. In a recent study by Chen and Hodgkinson [36], it was found that at high peak displacement, the uppermost skins of the specimens exhibited more evidence of splitting and delamination of the surface ply. Further, comparing the maximum displacement values for optimum banana and synthetic structures, it can be seen that the values vary between those structures. This helps to explain why the differences between the behavior of core structures were within the scattering; as a result, peak displacement is another independent parameter of sandwich panels.

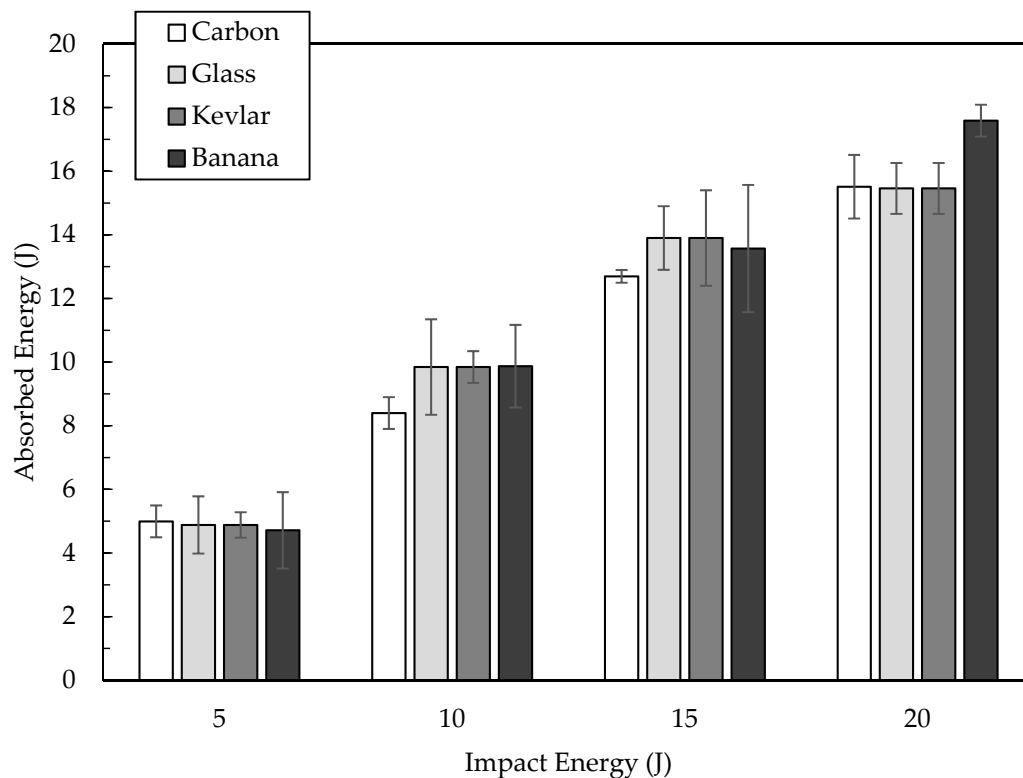
Figure 8. Typical absorbed energies at various incident energy levels.

The total impact energy is a combination of the energy absorbed and the elastic energy loss of the impacted structures [37]. If the percentage of the energy absorbed is high, the energy converted to elastic energy lost by the impactor is low. As a result, the impact energy is fully transferred to the structures at the point of maximum displacement [38]. In order to evaluate the impact response and resistance of the composite structures, the energy absorbed against impact energy traces are shown in Figure 8. The absorbed energy was measured by calculating the area under the force–displacement

traces. An observation of the figure suggests that the absorbed energy tended to increase with the incident impact energy, although there did appear to be scattering in the findings, particularly between the optimal banana/epoxy and carbon/epoxy composites. The lower energy absorption means that there was not much energy lost due to failure. Thus, each failure mechanism, including matrix cracks, interlayer failures, delamination, and fiber breakage, absorbed a fraction of the impact energy. The variation of energy absorbed depends on the skin thickness [39], the mechanical properties of fibers and matrices [40], the density of the core [41], and the impactor head [42].

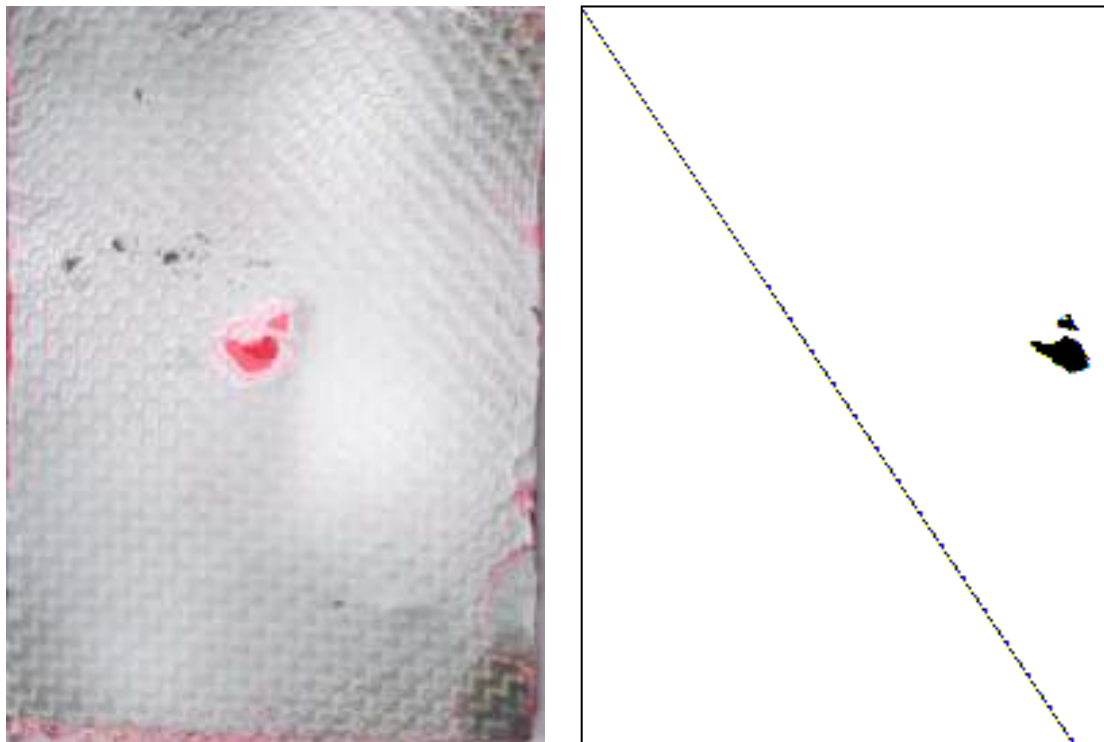
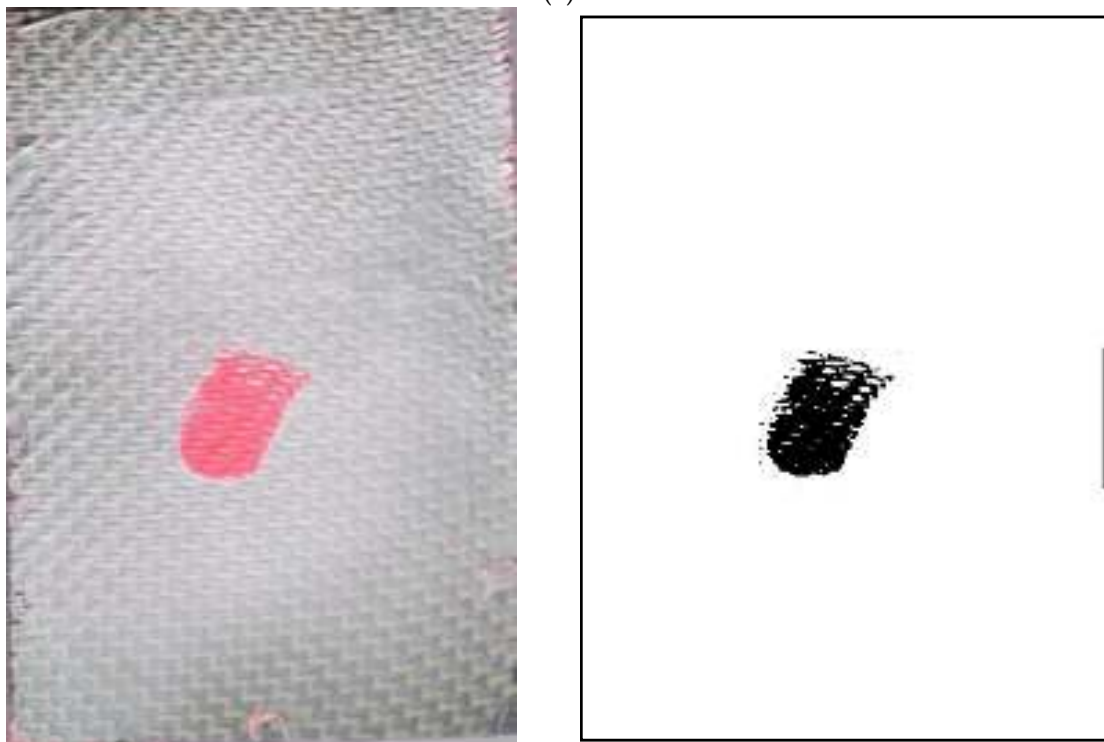
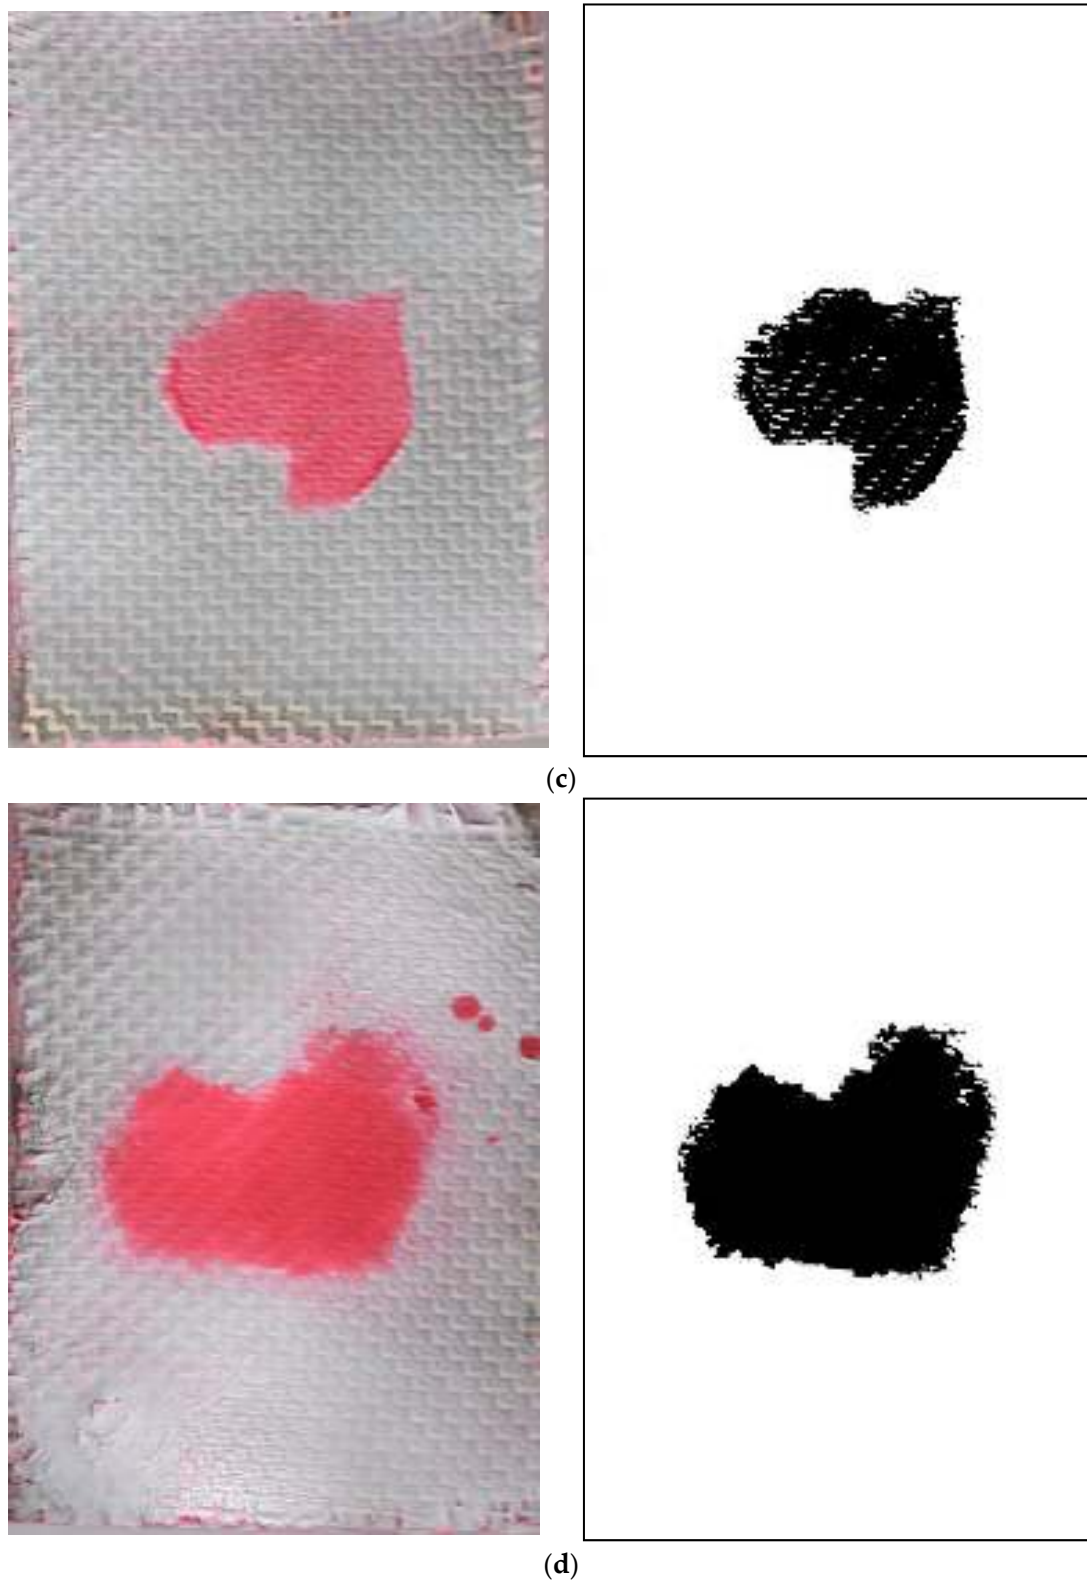
Figure 9. Damage area of impacted specimens of the banana/epoxy sandwich structure with respect to different impact energy levels: (a) 5 J, (b) 10 J, (c) 15 J, and (d) 20 J.

The evolution of the damage area with impact energy for the optimum banana/epoxy sandwich structure is presented in Figure 9. The sample data was elucidated using a dye penetrant inspection beginning at the uppermost impacted face and followed by measurement of the area using ImageJ software. According to the load–displacement curves (Figure 5), the onset of damage, essentially matrix cracking, was at approximately 3000 N. As the impact energy increased, greater propagation of the damage area in the transverse direction of the specimen was obtained. As can be seen from Figure 9a, a closely peanut shape of visible marks, just like in plain laminates [43], was observed, which was dominated by matrix cracking of the skin. Further loading often resulted in delamination and fiber breakage, which was revealed by the changes of dye color, as shown in Figure 9b–d, which illustrate a similar shape for the dented areas. It can be suggested that this damage mainly corresponds to delamination of the skin and brittle fracture of the core. Here, a small permanent indentation (residual indentation) was created on the uppermost skin, which added to the fracture resulting from the composite core around the impact site. If the core layer is a brittle material, the fast rebound of the face sheet under the impact will result in debonding at the interface between the face sheet and the core. Selver et al. [44] mentioned that larger dent depths in the structure may be attributed to impact energy that was absorbed by a smaller area, which generates a greater plasticity of the composite, stiffness degradation, and more localized damage under the hemispherical steel impactor.

Figure 10 shows the front- and back-face damaged areas versus the nominal impact energies. The areas were calculated by post-processing the results of the dye penetrant test, as shown in Figure 9. Many works [45,46] reported that the relationship between the in-plane damaged area and the incident

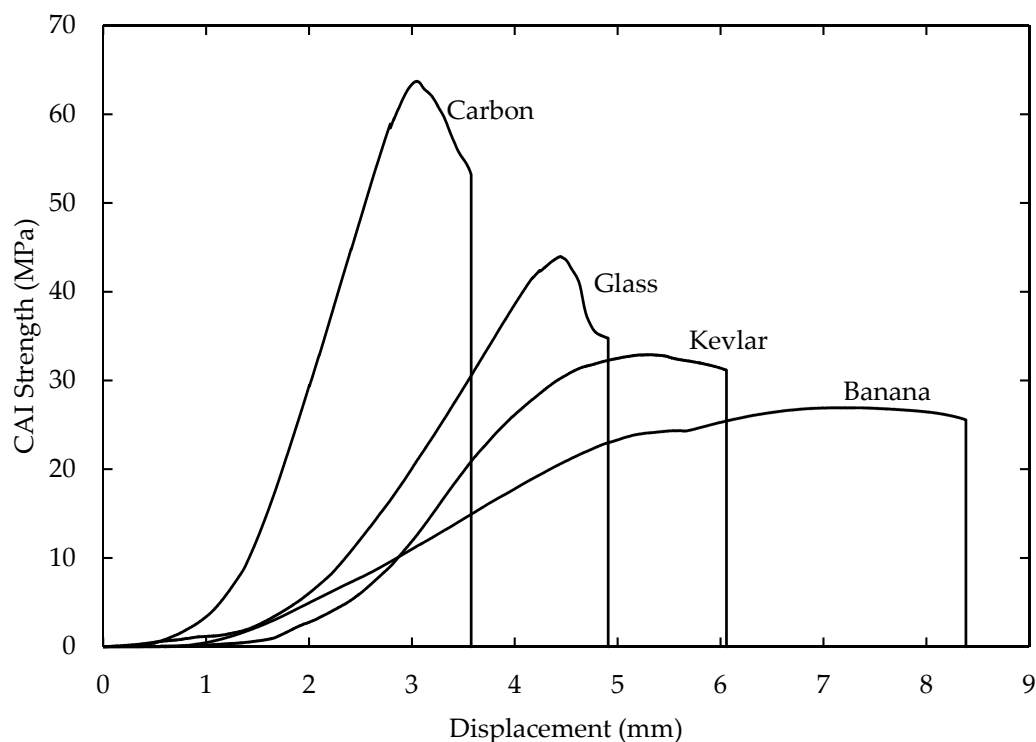
Figure 11. The variation of compression after impact (CAI) strength with the displacement for four different sandwich structures subjected to an energy impact of 10 J.

Figure 11 shows the variations of CAI strength performance with the displacement for the optimal banana, carbon, Kevlar, and glass sandwich structures following an impact energy of 10 J. For all sandwich panels, the structures exhibited an initial linear CAI strength before reaching a maximum value, following which the strength gradually fell, an effect that was also reported previously [47]. The figure shows that an increase in peak stress resulted in a decrease in the displacement, highlighting the presence of the stronger and stiffer core structures. The carbon/epoxy based sandwich structure was seen to offer a greater residual strength than those of other systems. Furthermore, the findings also show that the CAI strength of the natural-fiber-reinforced epoxy was still lower than its synthetic fiber counterparts. The differences in residual stress were recorded at 22%, 63%, and 136% between banana and Kevlar, glass, and carbon respectively.

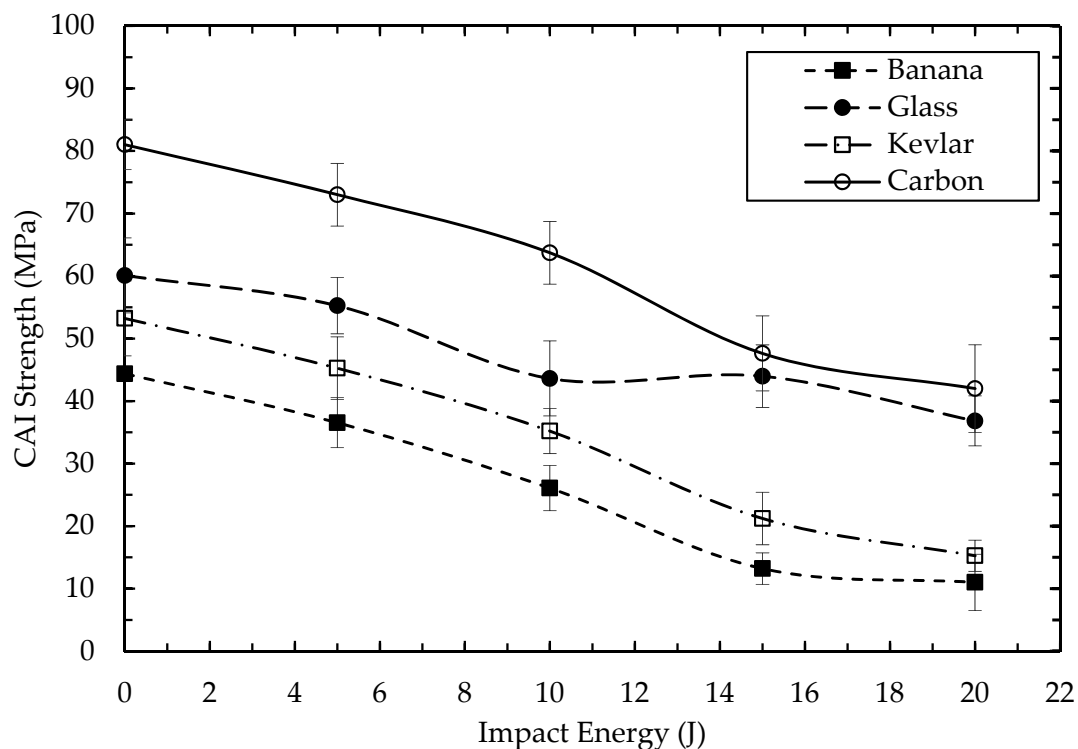
Figure 12. The average CAI strength versus impact energy traces of the sandwich structures.

Figure 12 illustrates the average CAI strength versus impact energy traces of the sandwich structures, including those of unimpacted specimens. As observed, the compression strengths decreased with the increase in impact energy. The carbon fiber sandwich structure exhibited a massive residual strength under all impact energies with the optimal banana composite system providing the least. The outstanding residual strength performance of the carbon/epoxy sandwich structure was due to the high resistance to shear cracking between the carbon and epoxy of the core. The use of the surface treatment and fiber conditions of the banana pseudo-stem fiber in order to increase the surface bonding between the fiber and matrix was still insufficient and failed to offer high resistance to CAI strength compared to synthetic fibers. With respect to CAI behavior in the sandwich structures experiments, core breaking and skin buckling were identified as the major failure modes of the sandwich structures [48]. Castanié et al. [49] mentioned that matrix cracking and delamination between the face sheet and the core were found to be the most common damage mechanisms of the sandwich structure under residual compression strength.

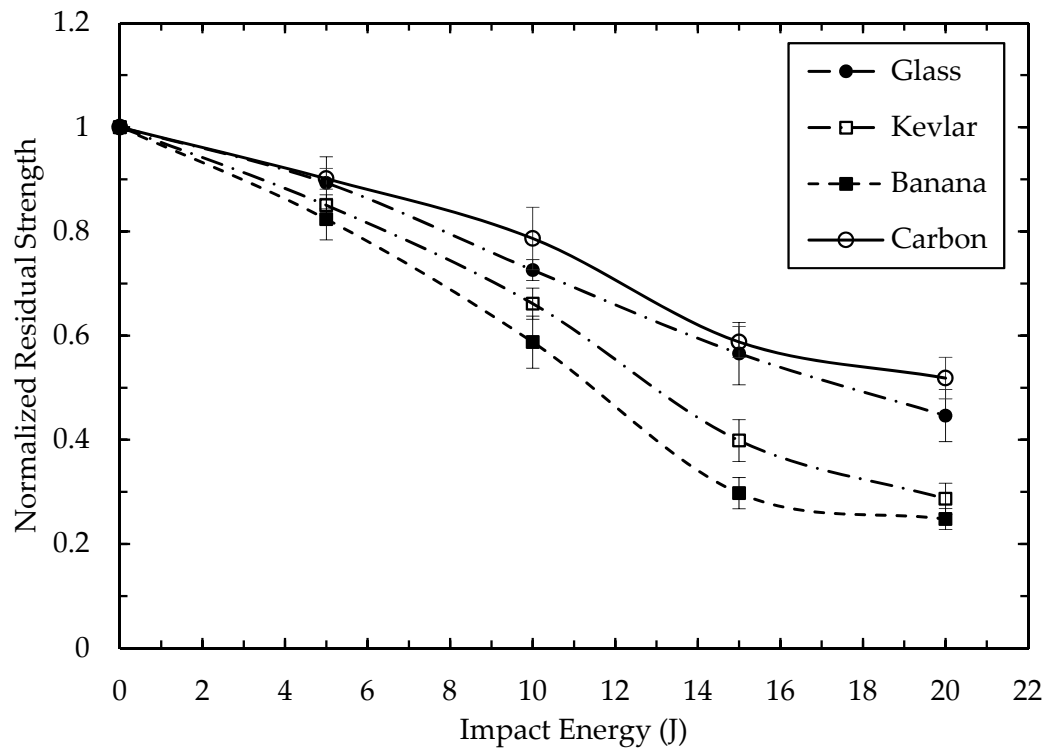
Figure 13. Normalized residual strength as a function of incident impact energy.

In order to compare the properties of impact damage on the strength of the material, the ratio between the CAI strength of the specimens damaged by a given impact and the unimpacted sample was measured. Figure 13 presents the normalized residual strength as a function of the incident impact energy. The optimal banana/epoxy sandwich structure showed the greatest reduction in normalized strength; however, the lowest drop in the normalized residual strength was obtained in the carbon/epoxy core structures. In addition, the normalized CAI strength gradually decreased with the increasing incident impact energies. Similar findings were reported by Wang et al. [50]. At an impact energy of 15 J, the normalized reductions of this strength were: 41% in the carbon/epoxy structure, 43% in the glass/epoxy structure, 60% in the Kevlar/epoxy structure, and 70% in the optimum banana/epoxy structure. The lowest reduction in normalized value, especially of the synthetic fiber structure, may be due to the stiffer core, making the structure more stable and with a high resistance to impact. As a result, synthetic fiber/epoxy systems were more prone to buckling during CAI testing.

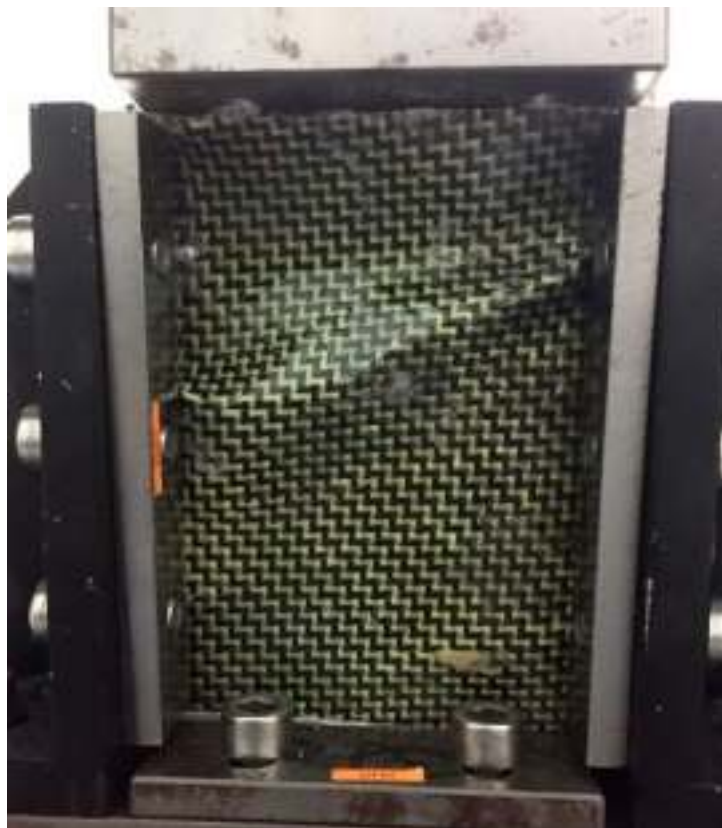
Figure 14. The CAI testing condition of the banana-epoxy sandwich structures subjected to an impact energy of 15 J.

Figure 14 shows the CAI setup conditions of the optimum banana/epoxy sandwich structures subjected to a 15 J impact energy. The major delamination face was observed perpendicular to the loading direction. As can be seen in the figure, the failure form of the outer skin was more severe at the point of impact. In addition, the debonding phenomenon occurred between the core and the outer surface extended rapidly from the middle of the damaged area to both sides of the edge. All failure modes for the testing sample were similarly observed and were associated with the compression shear failure and local buckling at the point of impact [51].

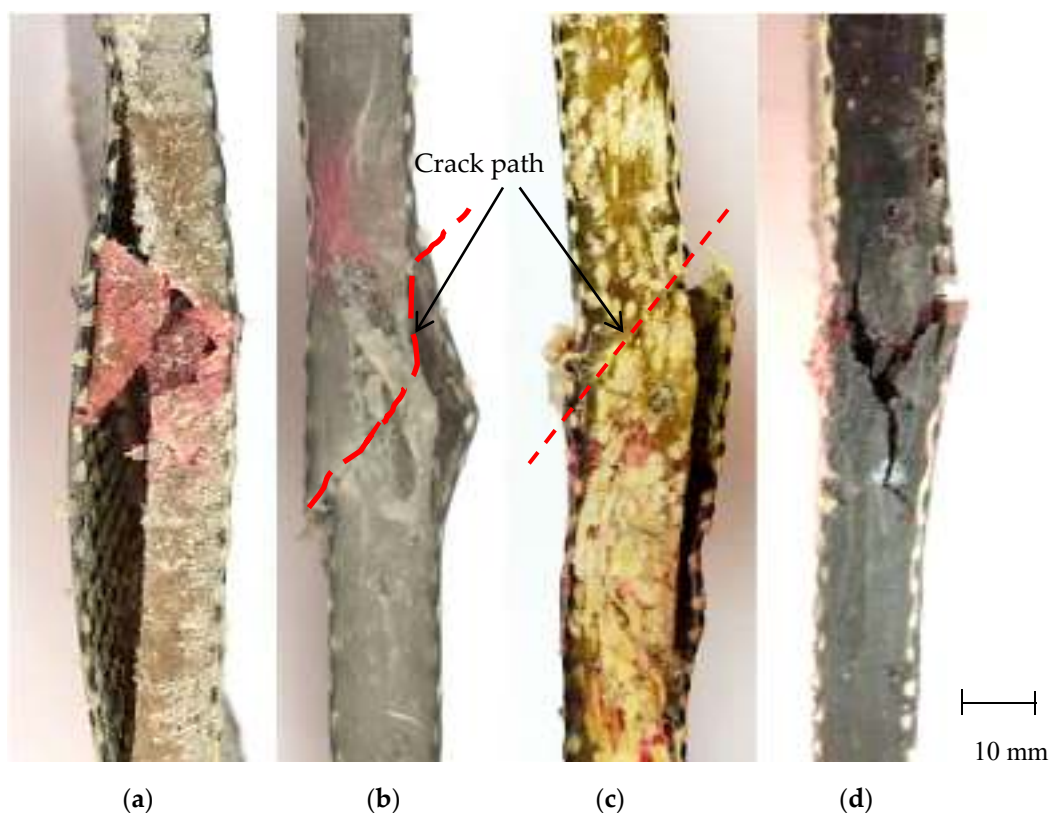
Figure 15. Cross-section of failure modes for the CAI testing of the (a) banana, (b) glass, (c) carbon, and (d) Kevlar epoxy sandwich structures.

Typical failure modes of the optimal banana, glass, carbon, and Kevlar epoxy sandwich structures subjected to compression loading are illustrated in Figure 15. It can be seen that the optimal banana epoxy core largely fractured from the middle position and the uppermost skin was folded (Figure 15a). From the side view of the failure specimen, compression shear cracks located at the impacted zone and delamination of the outer face sheet were extensively observed for the glass/epoxy system (Figure 15b). In addition, shear matrix cracking toward the direction of CAI loading was also obtained for the Kevlar structure, as shown in Figure 15c. This damage occurred due to stress concentration at the impact point of loading and the failure mode propagating throughout the area. The difference in the material properties between the high stiffness of the skin and the soft core contributed to the catastrophic failure of the sandwich structure during CAI testing [52]. Less core buckling and face sheet microbuckling of the carbon/epoxy structures was observed (Figure 15d), suggesting a high stiffness of the core and resistance to the axial compressive stress within the face sheets. V-shaped shear cracking was clearly apparent in this sandwich panel.
