Mechanical behaviour of composite laminates repaired with a stitched scarf patch

C. Sun, W. Zhao, J. Zhou, M. Altenaiji, W.J. Cantwell, Q.Y. Wang, Z.W. Guan

To appear in: *Composite Structures*

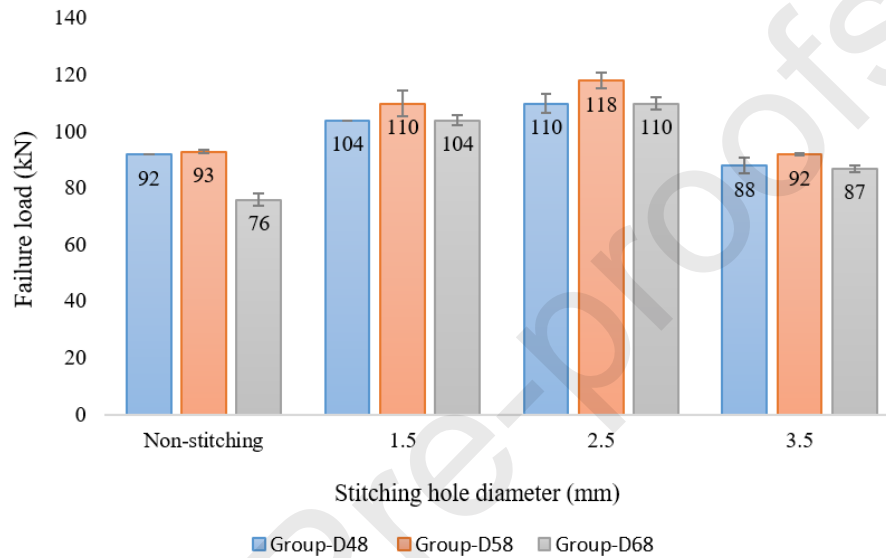
211
 212 Fig. 4. Failure load comparison between different groups

187 Fig. 4 compares the failure loads of the range of test samples presented in Table 1. It can be seen that for all
188 sample groups, the failure load increases with increasing stitching hole size up to a value of 2.5 mm. This
189 improvement in strength is due to the fact that the integrated carbon fibre threads share the load with the bonded
190 area of the scarf joint. Clearly, there are greater numbers of fibres in samples with larger hole sizes, increasing the
191 load-carrying capability of the joint. However, when the hole diameter reaches 3.5 mm, the failure load decreases
192 quite significantly. Although the larger hole size has a greater number of fibres passing through it, the introduction
193 of such a relatively large hole reduces the strength to values close to that of the unstitched laminate. There is clearly
194 a balance between the benefits of incorporating greater numbers of fibres into the joint via larger holes and

196 From Fig. 4, it can be seen that for the unstitched laminates, increasing the scarf ratio has little effect on the
197 failure load over the scarf ratios of 1:8 and 1:10, with the exception being a small scarf ratio of 1:12, where the
198 sample exhibited a 18 % reduction in failure load. Several observations have been made following the experimental
199 investigations by Baig et al. [13] and Cheng et al. [17]. Baig et al. [13] noted that the sensitivity to the scarf ratio
200 in a repaired laminate is linked to the manufacturing process used to produce the patch (pre-formed patch or
201 prepreg patch) as well as the properties of the interface between the patch and the repaired area. It is evident in
202 Fig. 4 that samples with a scarf ratio of 1:10 (Group-D58) exhibit the highest load-carrying capacity, whereas the
203 failure loads for stitched samples with scarf ratios of 1:8 (Group-D48) and 1:12 (Group-D68) are similar. Cheng

207 fixed at 100 mm, the influence of decreasing scarf ratio on the ultimate load is not significant, in general. However,
 208 in most cases, the effect of carbon fibre stitching is significant. For example, relative to the unstitched laminates, the
 209 ultimate failure loads of the 2.5 mm stitched laminates increased by approximately 20, 27 and 45 % for scarf ratios
 210 of 1:8, 1:10 and 1:12, respectively.

214 From Fig. 4, it is clear sample D58H2.5 offers the highest ultimate tensile strength of all of the samples considered
 215 and this panel was selected for further investigation. Fig. 5(a) shows the longitudinal strain ϵ_{yy} distribution (i.e.
 216 the strain in the loading direction) at loads corresponding to 35, 70 and 99 % of the ultimate value. Under these
 217 loading conditions, high strain regions can be seen at the tips of the stitching boundary. However, with increasing
 218 load, it is evident that while the strain values increase, the strain field patterns remain the same. Fig. 2(b) shows
 219 that the ends of stitching threads are bonded on the surface of laminate, and therefore high strains were detected
 220 there (Fig. 5a). From Fig. 5a, it can be clearly seen that relatively large strains occur at the stitch hole locations
 221 and around the top and bottom edges of the patch. The reason for this is that in these high strain areas, most of the

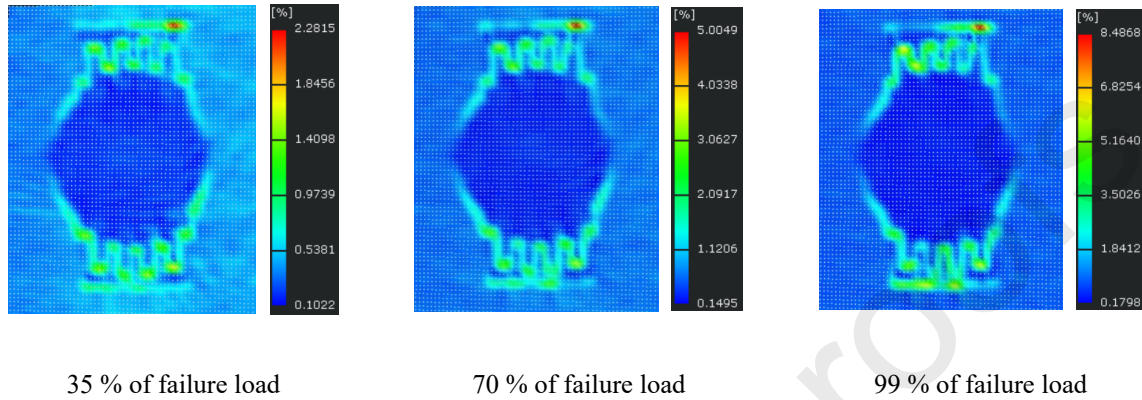
(a) Development of ϵ_{yy} at different loading levels

248 Fig. 5. DIC results and failure mode of D58H2.5

223 5(a) indicates that no significant change in strain is apparent in the carbon fibre threads away from the stitch hole,
224 with the strain remaining around 0.18 % until ultimate failure. This is due to the high strain areas mentioned above,
225 which support the loading-carrying capacity until final damage propagation, as shown in Fig. 5b. During the
226 loading process, any deformation along the loading direction of the repaired laminate region was constrained by
227 the carbon fibre threads. This evidence suggests that the ultimate strength is enhanced due to the stitches sharing
228 the load with the bonded patch.

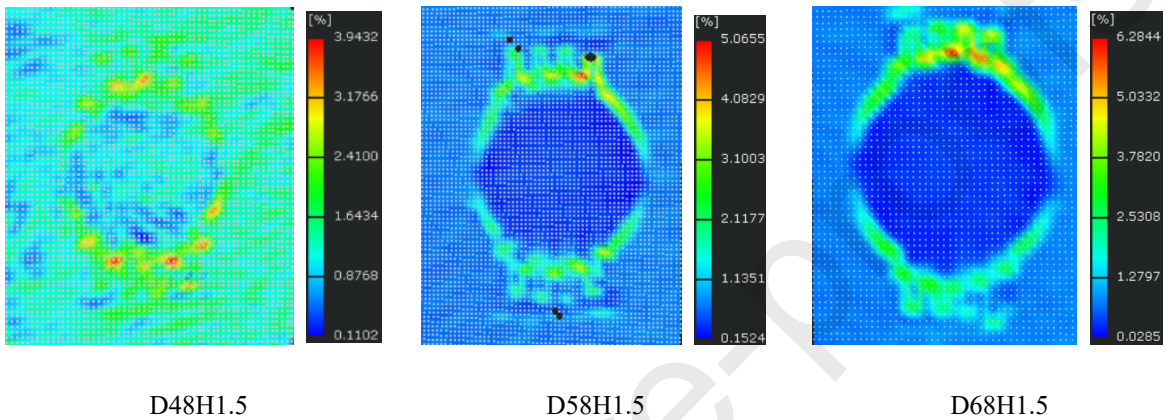
314 Fig. 8. ϵ_{yy} strain distribution in panels D48H1.5, D58H1.5 and D68H1.5 close to the failure load.

307 volume of residual parent material decreases, introducing regions of large deformation around the stitching holes
308 along the upper and lower patch boundaries (Fig. 8). In addition, when the stitch size remains constant in Fig. 8,

309 the carbon fibre tows apply less constraint in samples based on larger scarf patches. Figure 9 shows the failure
 310 modes in samples D58H1.5 and D68H1.5. As was the case in sample D48H1.5 shown in Fig. 7, damage initiates
 311 from the edge of the patch, outside the stitching area and propagates horizontally towards the edges of the laminate.
 312 This evidence suggests that the scarf ratio appears to have a limited effect on the failure modes in the stitched
 313 laminates.
