FULL-SCALE SHAKING TABLE TESTS ON DEFICIENT RC BUILDINGS STRENGTHENED WITH FRP COMPOSITES

Abstract

Keywords: seismic strengthening; shaking table tests; FRP composites; deficient RC buildings

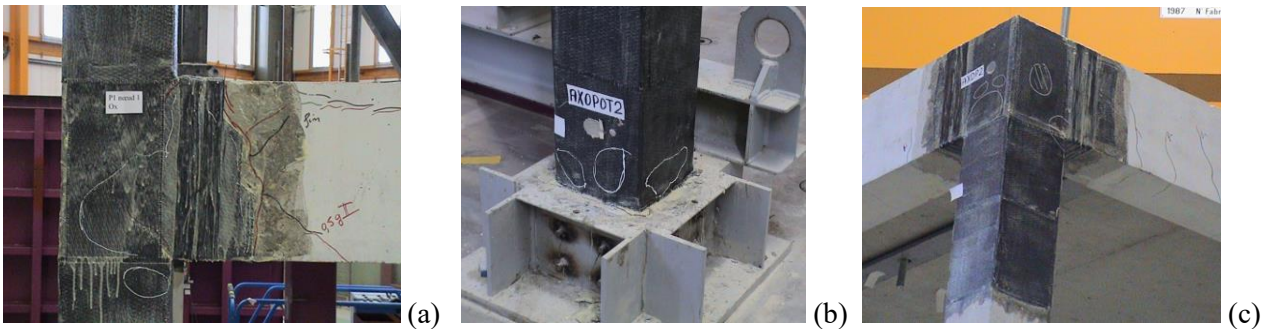
Fig. 5 - Damage after the test at PGA=0.5g on the CFRP strengthened frame: (a) beam end at 1st storey, (b) bottom of column 1st storey, (c) 2nd storey joint

Following the CFRP strengthening of the frame, a second series of shaking table tests were conducted with PGA levels ranging from 0.05g to 0.50g. No evident damage appeared during the test at PGA= 0.05g. The first damage to the CFRP sheets at the 2nd storey columns was observed after the test at PGA level of 0.20g. No further damage was noted at columns or CFRP sheets until after the final tests, although some fracture of the sheets occurred at beam-column joints. The adopted strengthening strategy was effective in preventing debonding of the CFRP sheets, as this type of failure was not observed during the tests. However, after the test at a PGA of 0.50g, significant concrete cracking occurred on the beams (Fig.5a), concrete cover spoiling under the CFRP confinement at the end of columns (Fig.5b) and at joints (Fig.5c). Fig.6 shows the deformed shape at maximum deformation for the bare and CFRP strengthened frame. It was noted that the use of CFRP strengthening resulted in a significant reduction in the inter-storey drift of 67% at the second

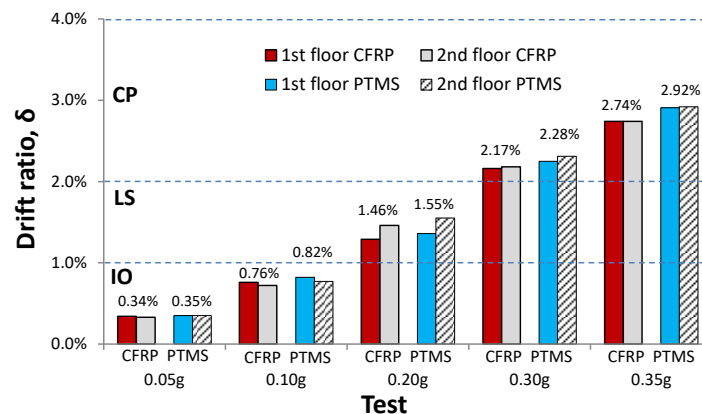
Fig. 11 - Interstorey drift ratio of 1st and 2nd floors during phase 4 (Y direction)

Existing guidelines for seismic assessment and retrofit of existing buildings such as ASCE/SEI 41-06 [18] establish limits on acceptable values of maximum interstorey drift ratios, implying that exceeding these limits is a violation of a performance objective. According to ASCE/SEI 41-06, maximum transient drift ratios of $\delta=1.0\%$, 2.0% and 4.0% correspond to Immediate Occupancy (IO), Life Safety (LS), and Collapse Prevention (CP) performance levels, respectively.

The maximum interstorey drift ratios of the 1st and 2nd floor of the CFRP and PTMS-strengthened frames are shown in Fig.11. This figure presents the results from two equidistant displacement transducers fixed on each exterior face of the slabs, labelled as “CFRP” and “PTMS” according to the strengthening technique used on the frame. It is shown that the 1st and 2nd floors of the strengthened frame had similar δ_s at all PGA levels. This implies that both CFRP/PTMS strengthening solutions led to a more uniform damage distribution over the building height, which allowed a better exploitation of the available capacity of members. The building remained safe within the CP performance level during the last test at PGA of $0.35g$ ($\delta=2.92\%$). Overall, maximum drift values of the “PTMS” frame were only 2-6% larger than those of the “CFRP” frame, thus indicating that some negligible in-plane torsion occurred during the tests.
