Rehabilitation of timber bridge piles using a wrapping system

R. Borzou & W. Lokuge

School of Civil Engineering and Surveying, University of Southern Queensland, Springfield, QLD4300

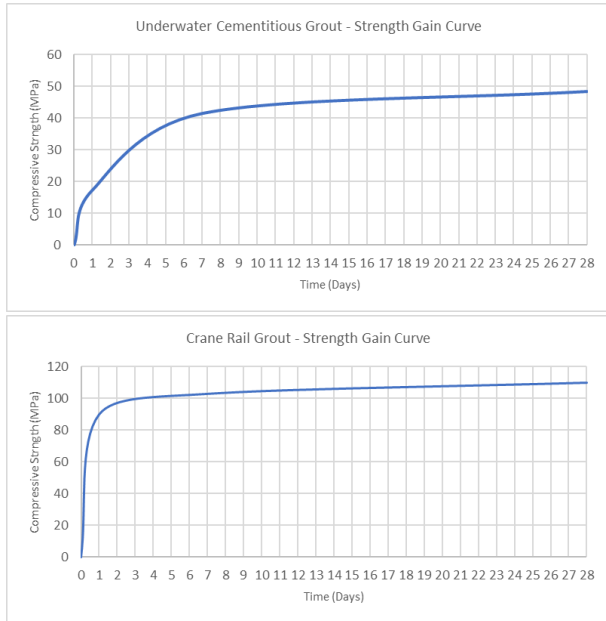
The two filler materials used were crane rail grout and underwater cementitious grout. Both filler materials will reach approximately 90% of its compressive strength after 7 days (Figure 1).

Figure 1. Strength development of filler

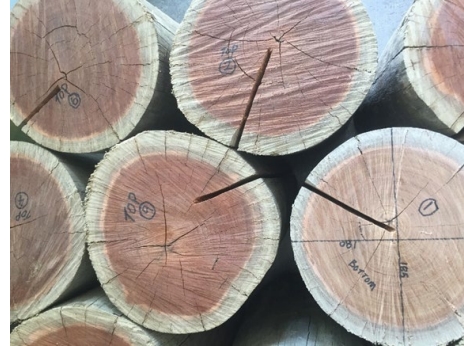
through inspection of deteriorated timber piles. The length of split gained from inspection extends greater than 1 m. Therefore, the split used in this research runs the entire length of the sample (≈ 300 mm). These two parameters will be maintained throughout experimental procedure. Split depth will be adopted at depths of full radius, $2/3$ radius and $1/3$ radius Figure 2.

Figure 2. Defect induced samples

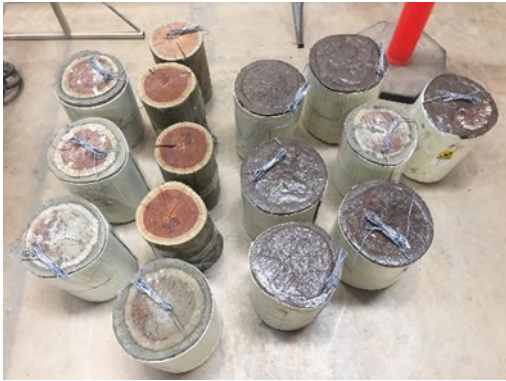
All the samples ready to be tested are shown in Figure 4 and they are to be tested using the SANS compression testing machine to find the maximum

Figure 4. Samples ready for testing

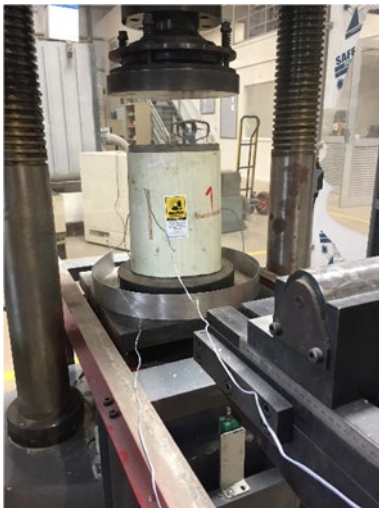
load/stress of the timber piles. Samples were attached with the strain gauges too to get the strain values in addition to the strains getting from the machine. A sample ready to be tested in the machine is shown in Figure 5.

Figure 5. Sample in the compression-testing machine

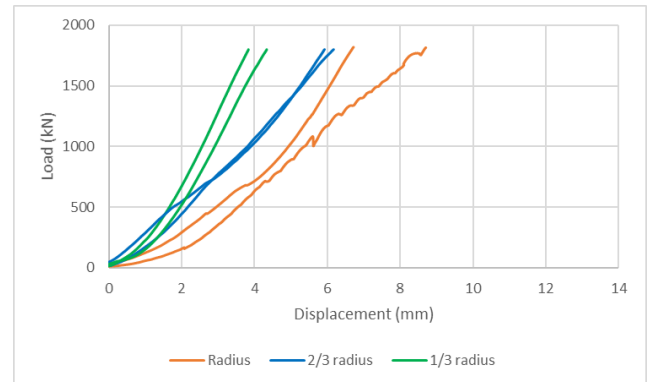
Figure 7 shows the load deformations curves for underwater cementitious grout (samples did not reach their capacity). However it is clear from Figures 6 and 7 that the deformation with FRP wrapping and cementitious filler is less than the deformation observed for unwrapped samples.

Figure 7. Load deformation curves for cementitious grout

Figure 8 shows the load deformation curves for the samples wrapped with FRP and crane rail grout as the filler. Comparing with Figure 7, it can be observed that samples with crane rail filler will reach a higher ultimate deformation than the samples with cementitious grout filler.
