Oxidation-induced Cu coating on steel surface

Oxidation-induced Cu Coating on Steel Surface

Keywords: Oxidation-induced; Cu coating; Copper-bearing steel; descaling

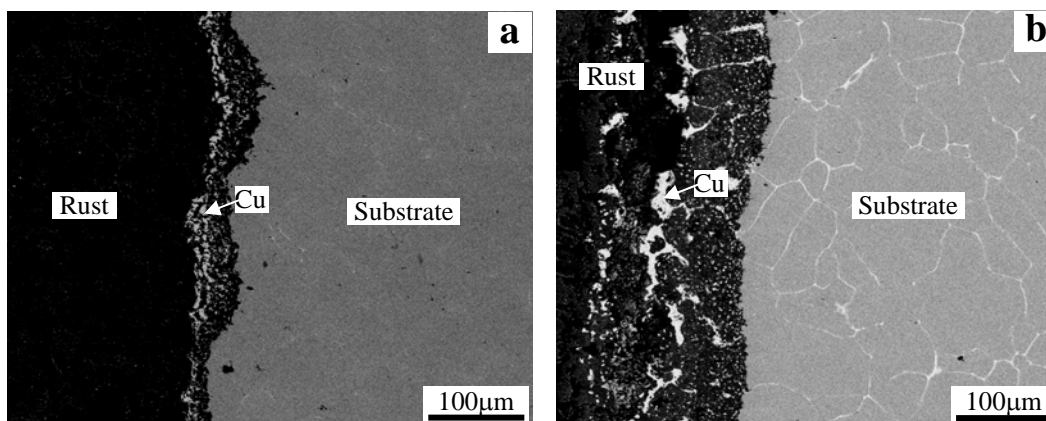
Fig.1 Back scattered electron images of the inclined cross sections of the steel samples with 6.8%Cu (a) and 12.6%Cu (b) after heating at 1000°C for 2h.

Thick rusts appeared on all the samples after being heated at high temperature, 1000°C and 1150°C in current work. Fig.1 shows the back scattered electron images of the inclined cross section of the test steels heated at 1000°C for 2h. Oxidation of iron happened rapidly during heating process, and the oxides appear in black in Fig.1. On the other hand, the oxidation of copper at these temperatures was slow comparing with iron. Both samples show that separately scattered copper particles, the brighter parts in back scattered electron images in Fig.1 with more than 95% copper according to EDX results, distributed near the substrate in the rusts. The copper in the rusts have little or nothing to do with the development of the oxidation. In other words, the rusts connect directly to the substrate and it can be deduced that if the sample heating continued, the rust would keep growing.

For the steels with 6.8% copper (Fig.1a), the copper particles in the rust are much finer than those in the steels with 12.6% copper (Fig.1b). For the latter, in the substrate, a copper-rich phase precipitated at the grain boundaries because of the rather high copper content. At the same time, it is likely that a certain amount of copper dissolved in the steel as solid solution uniformly, and no copper-rich precipitation appeared in the steel with 6.8% copper as shown in Fig.1a. Under the temperature of 1000°C, the copper particles in the rusts cannot connect with each other even though the copper content is high enough to form copper-rich phases.

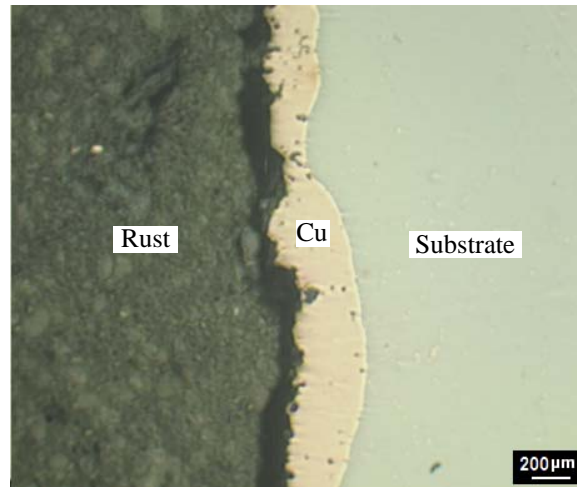
Fig.2 Optical microscope image of the inclined cross section of steel with 6.8%Cu after heating at 1150°C for 2h.

After heating at 1150°C, both steels show an integrated copper layer beneath the thick rusts. Fig.2 shows the morphology of the inclined cross section of steel with 6.8% copper after heating at 1150°C for 2h. The copper layer appears between rust and substrate, which was the perfect position of copper coating.

The thickness of copper coating changes from a few microns to tens of microns with some small oxide particles scattered in the layer. Major oxides were pushed away from the substrate and gathered at the outer layer as shown in Fig.2, and there were no copper particles scattered in the rusts either.

In Fig.2 and Fig.3, there is not any hole in the copper layer of the samples before descaling, so the holes in Fig.4 must be formed during the descaling process. From both Fig.2 and Fig.3, it can be observed that there are some dark particles with different sizes within the copper layer area, and they may have the same composition as spectrum 3 in Fig.3. In other words, there are some oxide particles in the copper, which were formed during heating and oxidation. These small oxide particles near the surface reacted with the descaling reagent and were dissolved in the solution, leaving small holes behind; then the solution reacted with other small oxide particles near these holes. These holes might become deeper or larger after the reaction, thus forming many holes with different depths and shapes. Therefore, further research should aim at achieving a clean surface without holes.

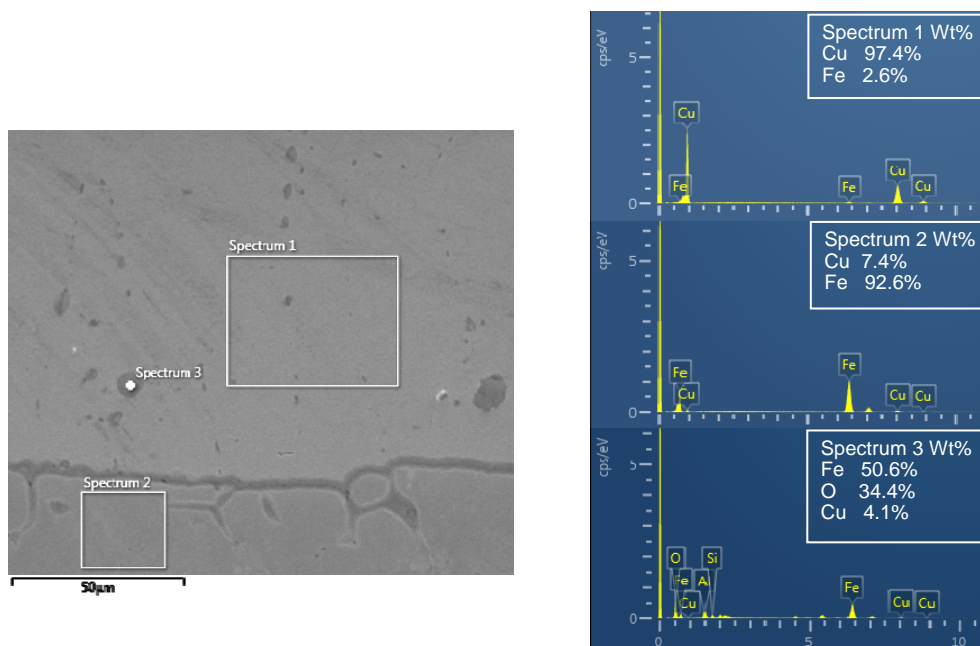
Fig.3 SEM morphology and EDX spectra of the substrate and Cu layer on the inclined cross section of steel with 6.8%Cu after heating at 1150°C for 2h.

By observing the interface between the copper layer and substrate, as shown in Fig.3, a fine line can be seen at the interface. The brighter part above the line in Fig.3 is copper layer with copper content of higher than 97% according to EDX results, and the less bright part under the line is substrate with the copper content of 7.4%, close to the copper content of the bulk steel. The dark particles in the copper layer are mainly oxides of iron with small amount of copper. The copper coating and substrate connected perfectly and there is not any slight void between them, which usually can be seen in other composite materials, even though the interface is not so straight.
