# ***Effects of anchorage deterioration on the shear behaviour of reinforced concrete half-joint beams***

Mak, M.W.T., Sheasby M.P. and Lees, J.M. (2020). Effects of anchorage deterioration on the shear behaviour of reinforced concrete half-joint beams. *Proceedings of the fib Symposium 2020 on Concrete Structures for Resilient Society. 22-24 Nov 2020, Shanghai, China.*

# EFFECTS OF ANCHORAGE DETERIORATION ON THE SHEAR BEHAVIOUR OF REINFORCED CONCRETE HALF-JOINT BEAMS

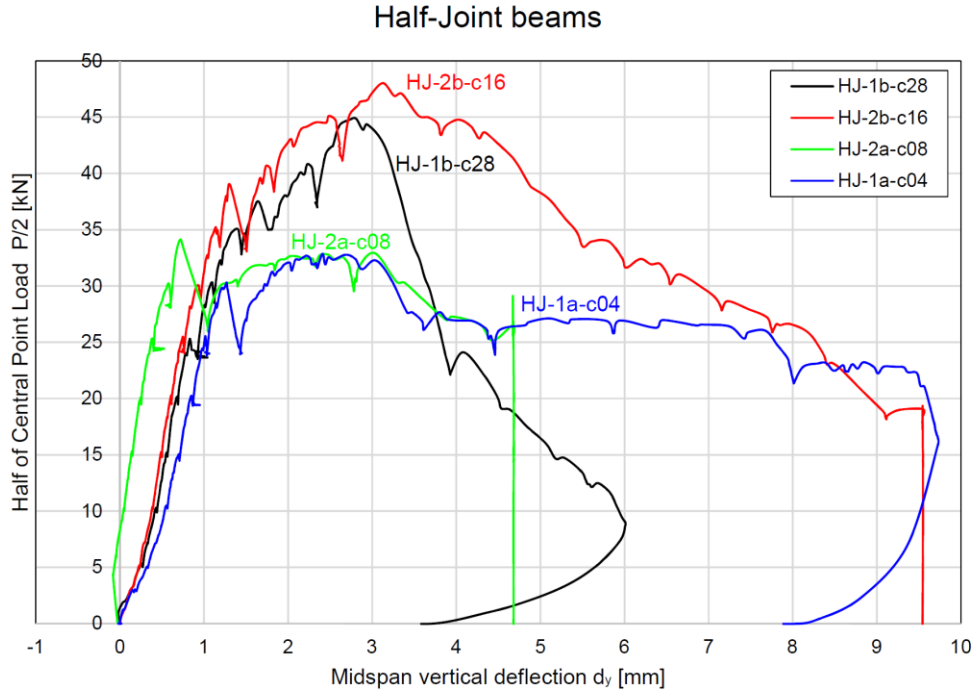
Figure 4. Comparison of load-deflection curves at the point of application of the central force.

The load-deflection curves for all the tests are compared in Figure 4. The load values correspond to the vertical reaction under the half-joint nib. The value of the reaction was calculated as half of the central point load measured with the load-cell. The displacement was measured with a Linear Potentiometric Displacement Transducer (LPDT) at the top of the beam at the mid-span. All the specimens were tested up to failure.

Within the initial elastic range, the specimens exhibited slightly different initial stiffnesses, but no trend was identified. In terms of ultimate peak strength, HJ-1b-c28 failed at a load of 44.9 kN and HJ-2b-c16 failed at a slightly higher load of 48.0 kN. The half-joint HJ-2a-c08 and HJ-1a-c04 had peak loads of 34.1 kN and 32.9 kN respectively. The readings from the strain gauges located within the 70 mm unbonded length of the main longitudinal bars indicated that at peak loads, the bars reached average strains between  $145 \mu\epsilon$  and  $172 \mu\epsilon$ , suggesting that the stresses in the steel remained well below the yield limit of the material. The cracking pattern of each half-joint after failure is shown in Figure 5. The cracks indicate that greater cover distances led to failure of the half-joint away from the anchorage region. Lower cover values led to anchorage failure of the longitudinal bars. The resulting slip of the bars induced the development of a diagonal crack originating at the bottom corner of the full-depth section (HJ-1a-c04, HJ-2a-c08, HJ-2b-c16). This was followed by multiple inclined cracks in the concrete compression zone, at the transition between the nib and the full-depth section.
