EVALUATION OF A VISUAL ASSISTANCE SYSTEM TO SUPPORT MANUAL SCARF REPAIRS FOR A DIGITALIZED AIRCRAFT MAINTENANCE

Abstract

2 SYSTEMS AND TOOLS FOR COMPOSITE SCARF REPAIR

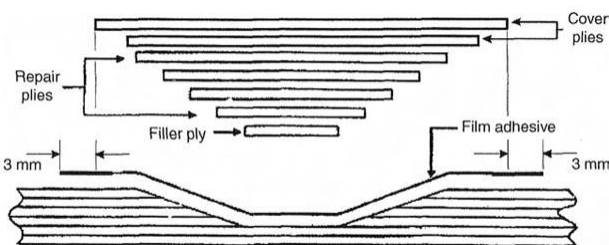
If a damage occurs, the structure is mostly repaired based on the manual tapered method, depending on how extensive the damage is, where is it located on the structure and it is still classified as repairable after the structural repair manual (SRM). [3] In this process, the individual material layers around the centre of the damaged area are removed from the technician with a hand-grinder and then rebuilt by inserting several fibre layers, see FIG. 1. [2]

FIG. 1 Structure of a tapered scarf repair [3]

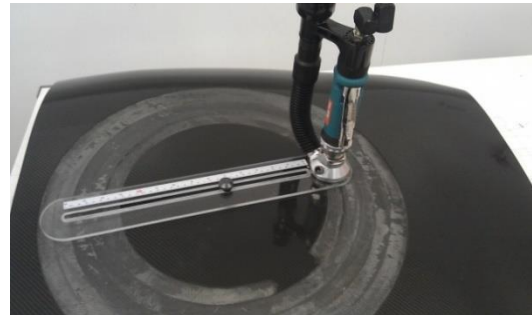
Mechanical devices can be used to support the hand-guided process, see FIG. 2, here in the form of

a toolkit for a stepped scarf repair, which guides the grinder for increased accuracy during the grinding process. [4]

FIG. 2 Toolkit for stepped scarf repairs [4]

In contrast to the tool kit from FIG. 2, various systems have been developed in recent years in the area of research for a partially or fully automated scarf procedure. At this point a short overview of two selected systems follows.

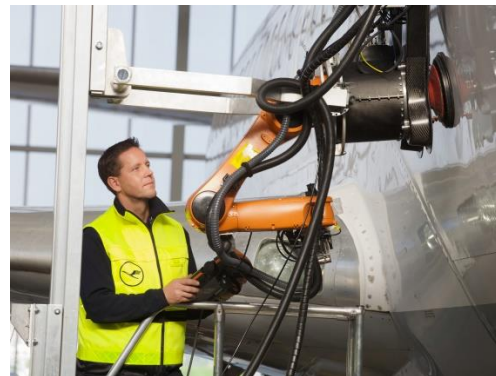
The system in FIG. 3 is build up within the *LuFo* projekt "CAIRe" (FKZ 20W1101A) and consists of a portable robot arm which is mounted directly on the damaged structure via suction cups and is equipped with a milling unit. A laser scanning system allows to scan the surface and based on this data the software calculates the travel path for the implemented milling unit which creates the scarf geometry automatically. [5]

FIG. 3 Automated scarfing with CAIRE System [12]

Fully automated systems such as *CAIRe* are particularly suitable for the repair of major damage to large fuselage or wing segments which either cannot be disassembled or at least not without increased workload. The system from the *Supcrafted* project is also specially designed for on-wing repairs, but initially for slightly curved structures.

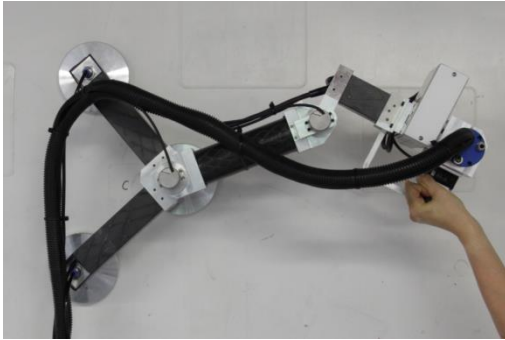
In contrast to the fully automated scarf unit in FIG. 3, a hand-guided milling unit was developed by the TU Hamburg within the project *Supcrafted*. The user is supported during the grinding process and can intervene directly in the process and make corrections in case of problems. The design is based on a three-axis system, whereby the X and Y axes are guided manually and the Z axis with integrated

milling unit automatically feeds the milling depth depending on the position in the X, Y - plane. [6]

FIG. 4 Mobile hand-guided scarf unit [7]

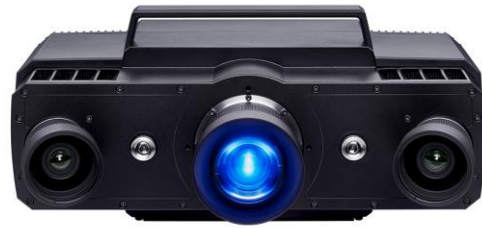
FIG. 5 GOM Atos 5 system [9]

The *ATOS 5* [9] system, see FIG. 5, from *GOM* provides the best results, not at least because of its encapsulated housing [9] whereby the system has a significant advantage which allows its usage under real industrial conditions. Thus the system is safe from CFRP dust which occurs during grinding. The dust can be electrically conductive and can lead to short circuits of exposed electrical components. [10] After the surface is scanned by the structured light projector, the software interface allows to programm various application for calculating geometric bodies or contours. So the scanned surface and the calculated bodies/contours can be combined or compared within a deviation analysis for example. It's also possible to reproject these geometric contours and visualizes them on the component surface, see the example in FIG. 15 in chapter 7.1. It is one of the important functions to realize visual support during the scarfing process.

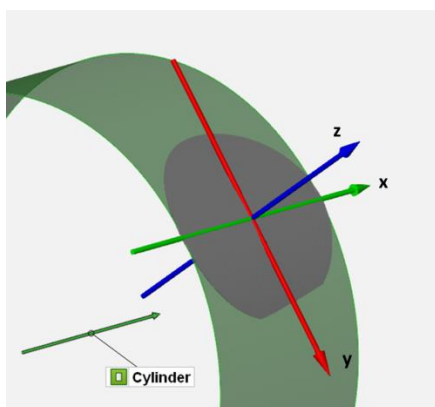
First of all the original surface is scanned. It needs to have some glued on reference points around the assumed outer contour of the scarf. These are necessary to calculate the relative orientation between object and scanner in all coming steps. Furthermore a coded reference point has to be in the middle of the damage, another on the outside of the maximum scarfing distance. Based on the coded points the surrounding area is deleted and the initial surface is calculated. The coordinate system is centered in the middle of the damage and is orientated by using a fitting cylinder. The x-axis is orientated towards the non-curved direction, the y-axis towards the curved direction and the z-axis is perpendicular to the surface, see FIG. 7

FIG. 7 Scanned surface (grey) with reference points and coordinate system oriented by a fitting cylinder (green)

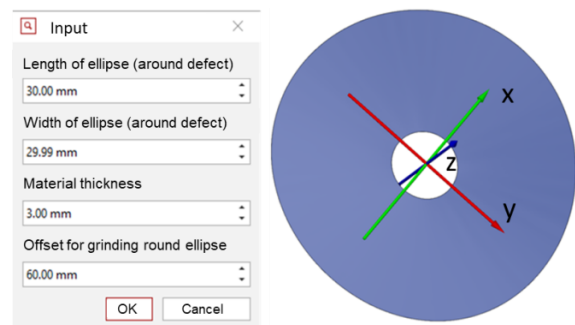
Secondly, a user input window asks for the scarfing parameters. Based on this, the inner and outer ellipse (or circle) are generated. The inner contour has a constant offset in the negative z – direction in the amount of the material thickness. Then the outer and inner curves are connected to create a taper geometry (in the first test series outer and inner contour are linear connected as simplification). Based on this a point-cloud for the nominal scarf geometry is generated. In the subsequent step this point-cloud is meshed and smoothed to become the nominal scarf structure. It contains the information of the reference points and the coordinate system.

FIG. 8 User input window (left) and nominal scarf contour (right)

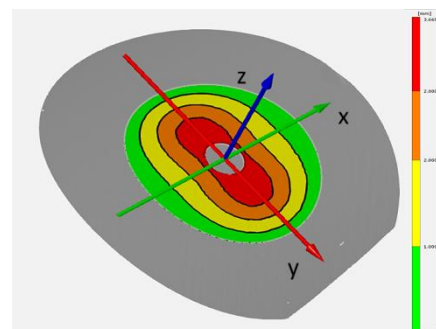
The next step is to compare the nominal contour to the actual scanned surface. The result is then displayed as a color plot with level lines. The calculated level lines can be reprojected with ATOS 5, shown later in FIG. 15. [9] The software automatically corrects the distortion, as long as at least three reference points are located in the projection area.

FIG. 9 Deviation between scanned and nominal surface, max. grinding depth = 3.6 mm (red area)

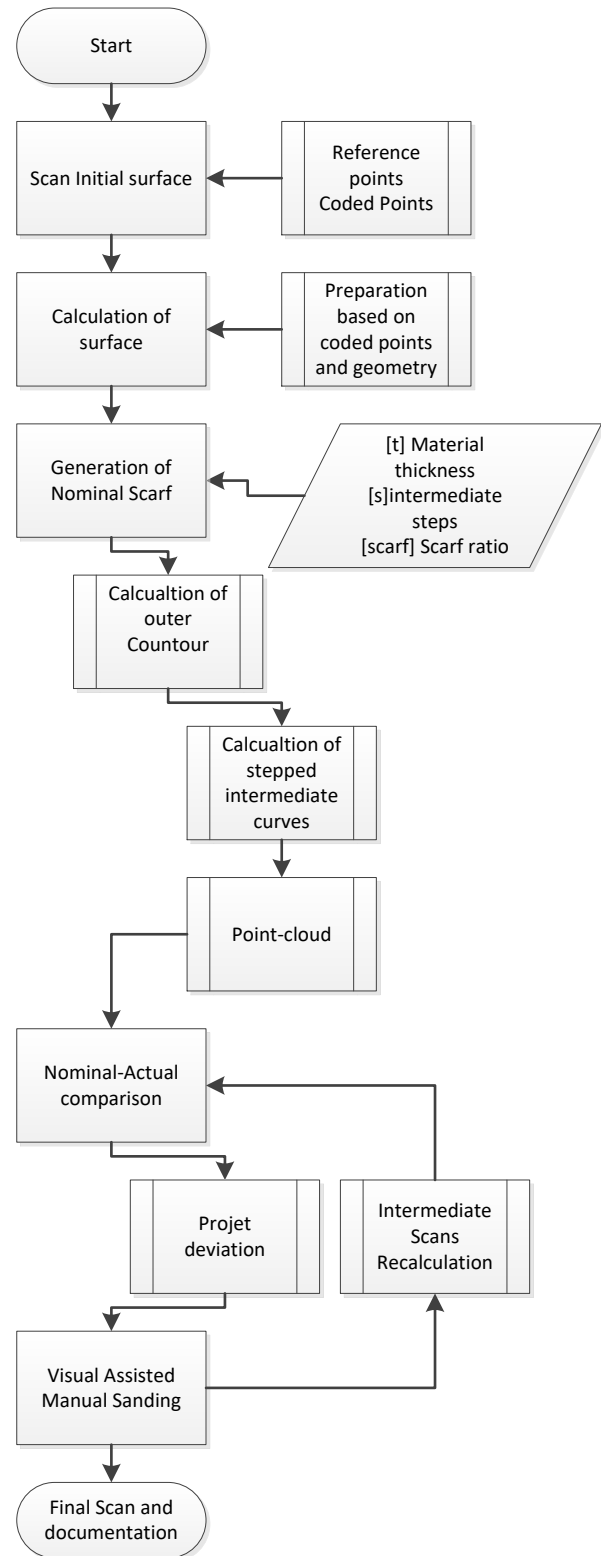
FIG. 10 shows the complete workflow within the calculation program for the assisted grinding process.

FIG. 10 Workflow of the calculation program for assisted scarf repairs

To be more flexible by generating individual scarf geometries, the program was adapted so that the inner scarf contour can be additionally set with manual input depending on the damaged area. The outer contour is creating by an offset parameter around the inner contour. The process step "Calculation of stepped intermediate curves" in FIG. 10 signals the adapted method to connect the outer with the inner contour to create a smoother tapered geometry. So now the user can set intermediate steps between the single scarf contours to adjust the tapered scarf geometry to curved structures, see FIG. 17 in chapter 7.3.

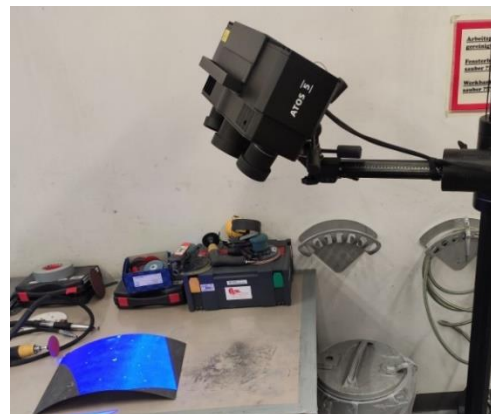
FIG. 12 shows the test setup for assisted scarfing with the *GOM ATOS 5*. The tests were carried out in a separate workshop area of Lufthansa Technik (Hamburg) with the room lighting switched on in order to evaluate the visibility of the projections on the surface under realistic conditions.

FIG. 12 Test setup for assisted scarfing process at Lufthansa Technik (Hamburg) on single curved CFRP samples [12]

The measuring system requires an additional computer with a corresponding software package, which is connected to the scanner via a control unit. After the damage location has been defined on the CFRP sample, it has to be prepared with optical markers which are glued on around the damaged area.

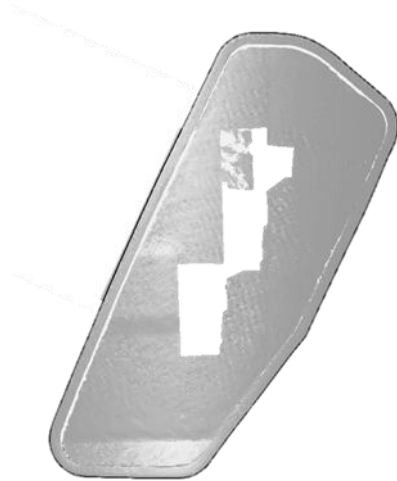
this time, due to the limited field of view of the assistance system, the overall scan surface has to be composed from several partial scans using glued markers. In addition, the further development of the software application within the individual manual curve generation method, see the end of chapter 5, is tested. The following FIG. 13 shows the complete scarf contour within the software interface from GOM. In the end, the findings during the test are discussed with the experts from Lufthansa Technik.

FIG. 13 Complete scarf contour of second pilot test in GOM Software

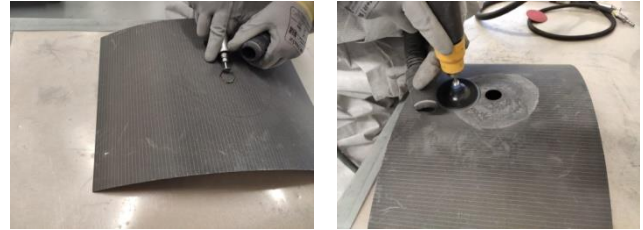
In the conventional scarfing process, the technician uses a marker to transfer the nominal contour to the structure, with using a circular template for the outer radius of the scarf contour. A compressed air grinder is used for the implementation.

During grinding, the technician orientates himself on the light reflection of the fibre layers which signals the different fibre orientation and checks the

intermediate status by touching along the grinded contour combined with a visual inspection. Cause experienced and well-trained technicians are able to assess the quality of their work very well themselves and thus meet the requirements for repair.

FIG. 14 View during the unassisted scarfing process [12]

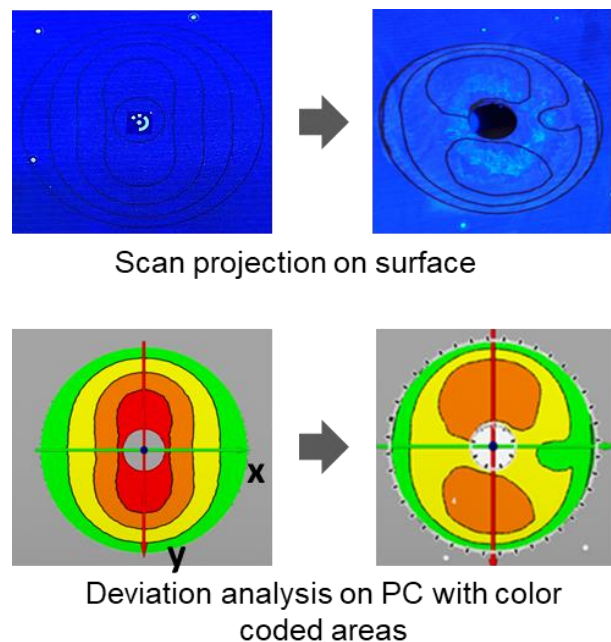
FIG. 15 shows intermediate statuses during the assisted scarfing, with the first figure showing the initial situation before the grinding process begins. By means of the coded marker in the centre of the damaged area, the software detects for which area of the previously measured component surface the nominal scarf geometry should be calculated. Due to the hardware limitation of the GOM ATOS 5, the reprojection of the calculated nominal geometry is realized with two colors. The colored deviation analysis is shown on the computer display within the ATOS software [11].

FIG. 15 Initial and intermediate status of the assisted scarfing process

The number of scans for the analysis of the current status was freely chosen by the technician. The contours adapt to the respective status of the scarf and indicate the current deviation from the nominal geometry in mm via the colored scaling.

geometry results in an elliptical formation of the contour lines in the direction of Y, see FIG. 15 (lower left). The contour should correctly be circular. This has the effect that too much material is removed in the marked area (FIG. 17) due to an incorrect deviation analysis between nominal and as-is status.

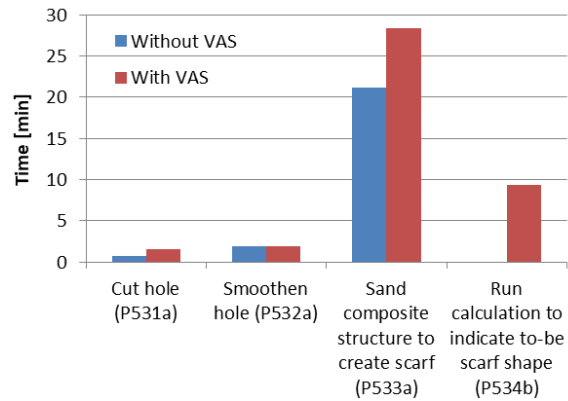
As mentioned in chapter 6.1, the individual process times were recorded during the first test series. FIG. 16 shows the time intervals for the scarf process. The time for evaluating the intermediate status during the unassisted scarfing is included in process step P533a, since the technician carries out his evaluation within a few seconds and resumes the grinding process immediately.

The time required to cut out the center of the damaged area differs only marginally, whereas the grinding process P533a with the assistance system increased by 34% to 28 minutes compared to the unassisted process.

FIG. 16 Comparison of time values between unassisted and assisted grinding

In addition, the technician needs 7 minutes for the first initialization and projection of the scarf geometry compared to the 2 minutes required for marking with a color marker. Due to the recording and calculation of the intermediate statuses, the entire process is extended by a further 10 min (P534b) to a total of 50 min. This increases the time for scarfing within this test series from 27 min (unassisted) to 50 min (assisted). A part of the additional time required can be explained by the fact that the technician was using the system for the first time for scarfing and wanted to work as accurately as possible with the help of the system. Currently some manual process steps must be performed by the technician which could be reduced to a minimum by a better workflow within the program, remind FIG. 10. So together with the system set-up at the beginning, the increased time expenditure can be explained. But it is therefore assumed that once a technician is fully familiar with the system, the time differences could be decrease.

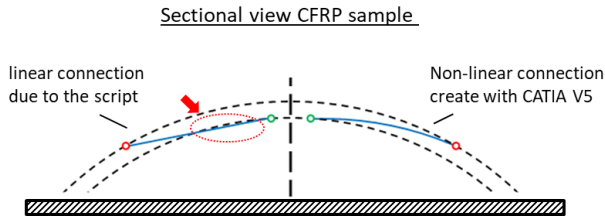
First of all, an effect from the calculated nominal geometry by the programmed script has to be explained. The calculated nominal geometry for the assisted repair was generated with a simplification, see 5 (2). The following sketch in FIG. 17 shows the difference between the calculated nominal geometry by the programmed script and the designed nominal geometry with *CATIA V5*. Because the inner and outer contours are linearly connected in the script to create a tapered scarf geometry (initial simplification), the curvature of the nominal

FIG. 17 Sketched section view of the nominal geometry from the script (left) and designed with CATIA (right)

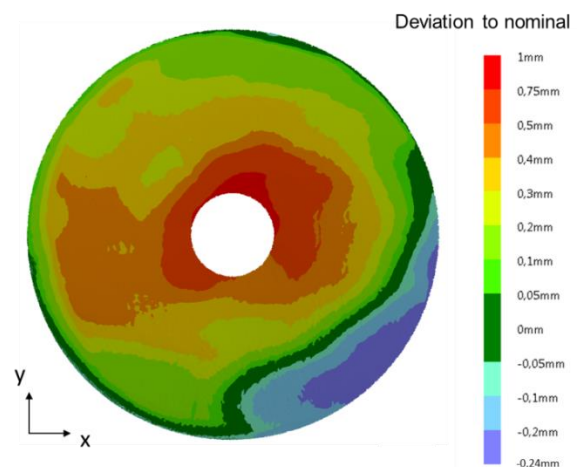
For a DA, the reference surface has to be positioned correctly into the point cloud of the scanned as-is surface. While the nominal geometry of the assisted scarf is positioned by the script, the nominal geometry of the unassisted scarf has to be positioned by a best-fit procedure. Furthermore the nominal geometry for the unassisted grinding has to be designed afterwards, because it wasn't intended to use the assistance system. Therefore only the final geometry was scanned and thus only the outer tapered contour of the final geometry is used for designing and positioning the nominal geometry for a deviation analysis. The results can be seen in FIG. 18 and FIG. 19.

Both analyses show the final deviation in mm from the required nominal geometry. The deviations from the nominal geometry can be derived from the resolution of the color scales. Light green – dark green areas indicate that the nominal geometry has been reached, orange – red indicates that material has yet to be removed and blue – purple indicates that too much material has already been removed. The DA in FIG. 18 shows quite good results, especially in the outer areas. This might be caused by the fact, that the technician has many years of experience, however it also becomes obvious that

FIG. 18 DA No.1, unassisted scarf vs. designed nominal geometry (non-linear connected, compare FIG. 17)

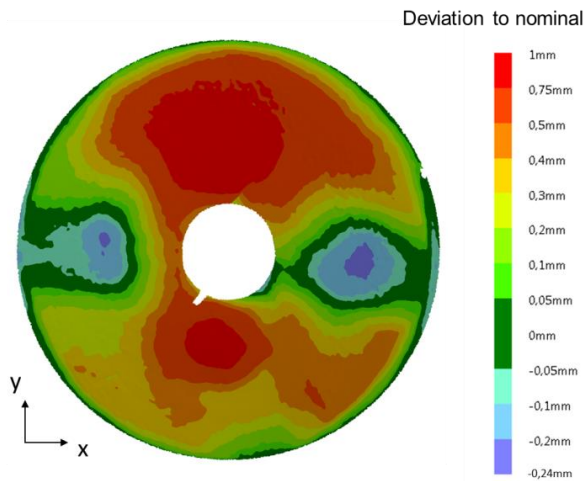
It is noticeable that the color pattern of the second deviation analysis in FIG. 19 shows an irregularity. The red colored areas in y - direction can be explained by the order, not to grind further material away. At this point the negative effect of the simplified geometry as described before became apparent. According to the assistance system, the technician should have partially grinded away the last layer of CFRP at these areas. Nevertheless the maximum deviation is also up to 1 mm, just as with the unassisted scarf geometry.

Due to the minimal curvature in x – direction, the deviation analysis is evaluable in these areas and shows deviations around ± 0.2 mm to the nominal geometry. Important at this point is that the technician can hardly estimate when, for example, 0.2 mm of material has been removed. Due to the usual mechanical vibrations during grinding, it is difficult to recognize if a material thickness of 0.2 mm has been removed, according to the expert. However, in order to make an exact statement about the tolerances to be achieved with the assistance system, further test series would have to be carried out in the future.

FIG. 19 DA No.2, assisted scarf vs. calculated nominal geometry (linear connected, compare FIG. 17)

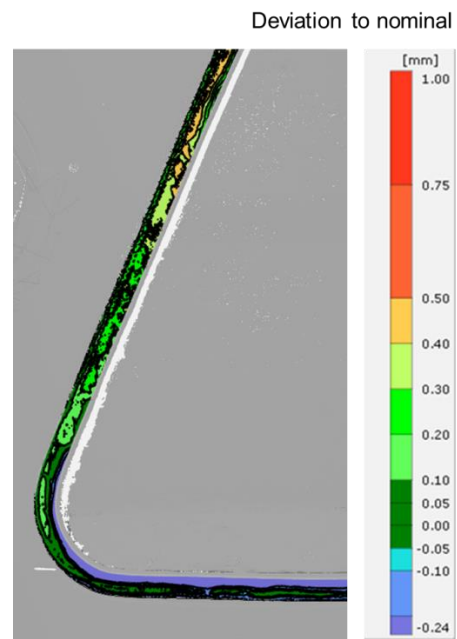
The second test series essentially showed that a large scale support requires significantly more time for the initialization of the complete surface. But the implemented method to generate an individual scarf contour has worked well, so the system can be used more flexible for different damage scenarios in the future. During the grinding process, the feedback from the technician regarding the presentation of a deviation analysis was very positive. Due to the complex and large CFRP structure, it is a quite difficult tasks for the technician and requires a high level of concentration for a long time period, so he was glad to be able to check his work status via the assistance system. The DA in FIG. 20 shows a part of the lower left corner of the complete scarf contour during the grinding process. As in the DA's from FIG. 18 and FIG. 19, the light green to dark green areas indicate similarly good results of the deviation from the nominal scarf contour about only 0 - 0.2 mm. But in contrast to the first test series, the component in FIG. 13 has different material thicknesses around the calculated scarf contour. This thickness variation cannot be considered by the system so far, so that some areas such as the purple colored, show inaccuracies.

FIG. 20 In-Situ DA of assisted scarf vs. calculated geometry
