Vacuum

Surface density of growth defects in different PVD hard coatings prepared by sputtering

P. Panjan^{a,*}, M. Čekada^a, M. Panjan^a, D. Kek-Merl^a, F. Zupanič^b, L. Čurković^c, S. Paskvale^a

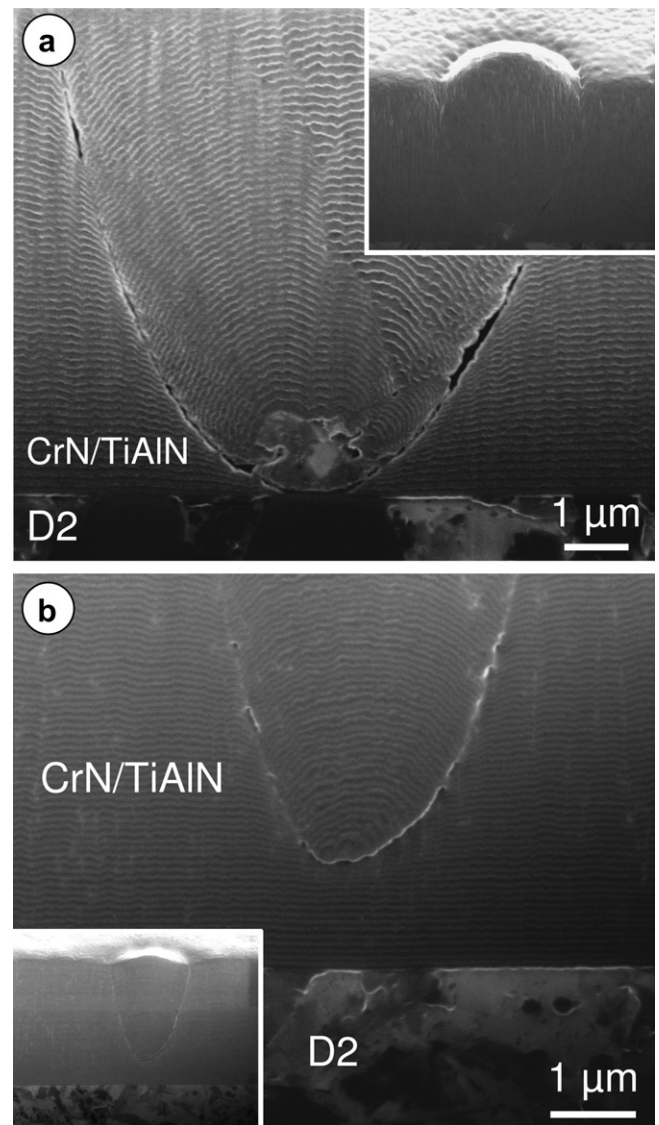
Fig. 1. SEM images of FIB cross-section of nodular defects in the TiAlN/CrN nanolayer coatings.

Figs. 1 and 2 show FIB and SEM images of typical growth defects found in the TiAlN, TiAlN/CrN and AlTiN/TiN nanolayered coatings. Nanolayered coatings are especially useful for investigating the defects because the layer structure reveals the origin of the defects and their influence on the coating growth. SEM images on FIB cross section (Fig. 1) show that nodules have the form of a cone protruding above the coating surface. Nodular defect shown on Fig. 1a started to grow on the substrate surface on a seed which remained on the substrate surface. Fig. 1b shows an example of a nodular defect which started to grow in the middle of the coating due to the incorporation of a foreign particle during the deposition process.

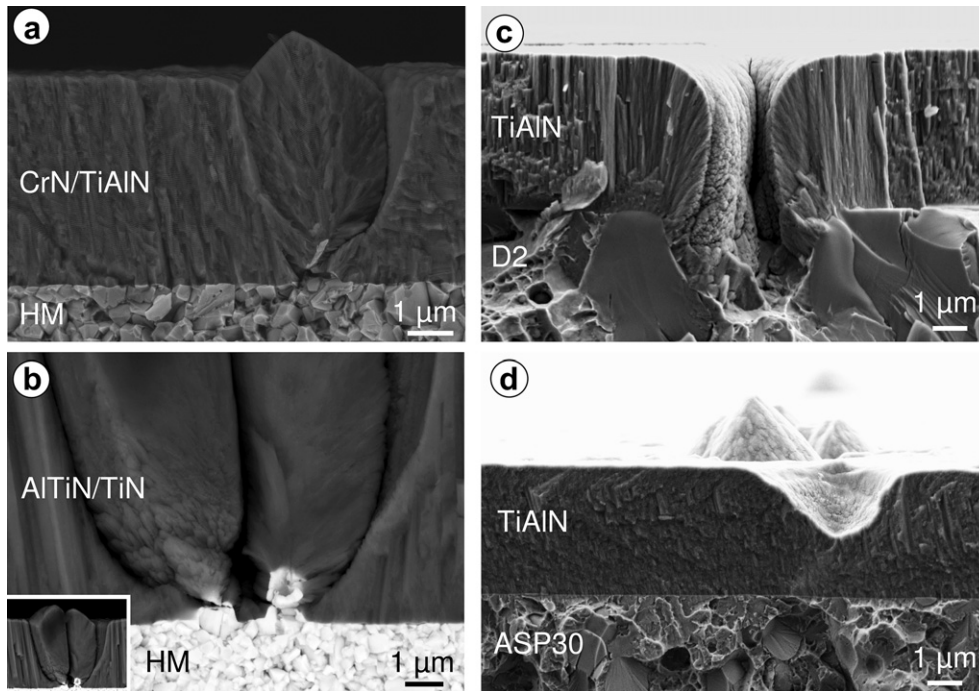
Fig. 2. SEM images of a nodular and pinhole defects in the TiAlN, TiAlN/CrN and AlTiN/TiN nanolayer coatings.

Fig. 2a shows cross-sectional backscattering electron micrographs of the TiAlN/CrN nanolayer deposited on cemented carbide. The seed which juts out from the substrate surface is clearly visible (in this case the seed is small part of tungsten carbide which

remained on the substrate surface after mechanical pretreatment). An example of a very interesting nodular defect is shown on Fig. 2b. Cross-sectional SEM micrograph of the TiAlN/TiN nanolayer coating on cemented carbide shows that the nodular defect nucleated on two seeds (very small surface asperities, which remain on the substrate surface after its mechanical pretreatment). A typical internal structure of the nodules is also visible. The microstructure of the coating in the nodule is substantially different in comparison with that of the surrounding matrix. It can also be seen that the boundary between the cone-shaped defect and the coating is highly porous. Fig. 2c shows defects in the form of pinholes generated at the substrate pit (cavity), formed during polishing. It is too large to be closed by the deposited hard coating. On Fig. 2d there is an example of a dish-like hole forming when a coated foreign particle flakes off due to high stress in the coating.

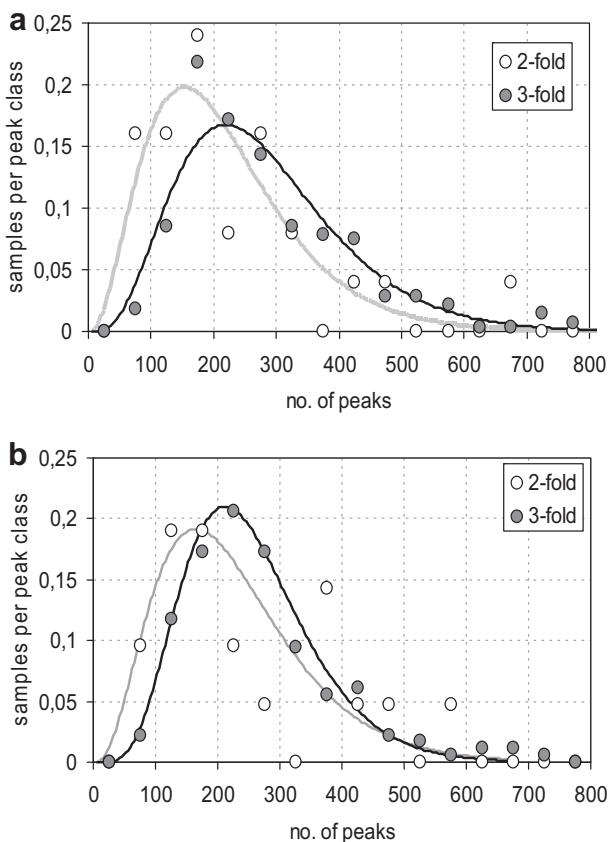
Fig. 3. Distribution of defect density for TiAlN (a) and AlTiN/TiN (b) nanolayer hard coatings deposited on cemented carbide substrates.

From a large number of measurements we performed an elementary statistical analysis in order to evaluate the defect surface density for a desired coating (Fig. 3). The number of measurements is quite large (500 in total) and the number of defects per area often scatters considerably in the same series of samples. Therefore a statistical analysis is necessary to extract the overall results. A suitable distribution has to be fitted to the acquired measurements rather than taking a simple average where isolated outliers can spoil the final value considerably.

Fig. 3a shows the distribution of all the samples coated with TiAlN, divided in two series based on the type of rotation. The 3-fold rotation gives a good fit, which is partly a consequence of a large number of samples. The peak of the distribution is located at $220\ \text{defects}/\text{mm}^2$. In 2-fold rotation there is more scattering but the overall form is still in good agreement with the Poisson

distribution. The peak is located at a significantly lower value, at $150\ \text{peaks}/\text{mm}^2$. The same analysis was performed also on AlTiN/TiN nanolayer coatings for samples prepared using 2- and 3-fold rotation. In comparison with TiAlN we did not find any significant difference in peak location. We also analyzed the samples mounted at the same position in the vacuum chamber on the holder which assured 1-, 2- and 3-fold rotations. We found (see Table 1) that the difference in defect density between all the three samples from the same batch was rather high (up to 200%). Samples from different batches were analyzed and the results are randomly distributed regarding the rotation type. There can also be a substantial difference (up to 50%) on the two faces of the same 3-fold rotated sample. The results of all these measurements show that the formation of significant share of the defects is spatially localized and sporadic.

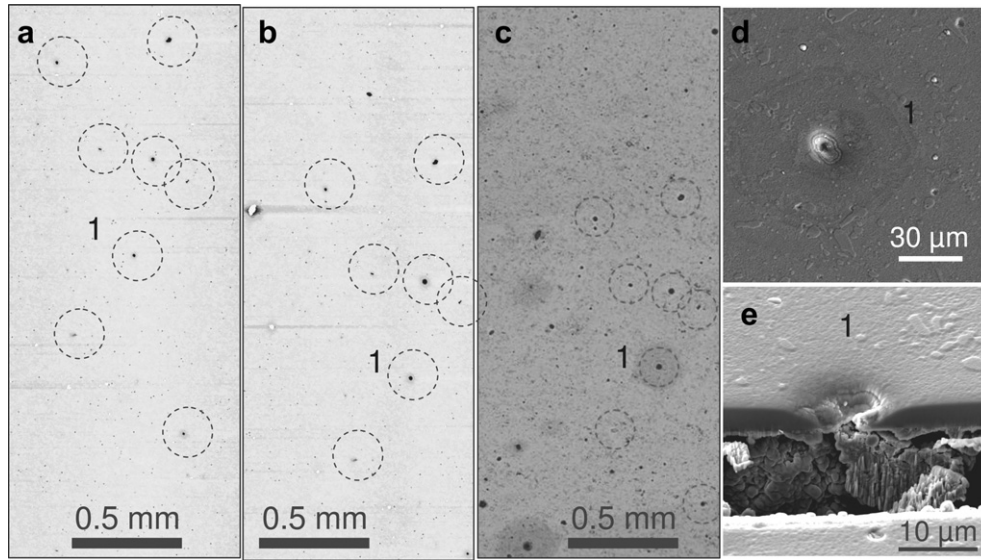
Fig. 4. 3D profilometry image of TiAlN coating on D2 tool steel before (a) and after corrosion test (b); optical image of the same area after corrosion test (c); SEM image of selected pinhole (number 1); FIB image of the pin-hole (number 1) cross-section after corrosion by backscattered electrons (e).

Due to the weak boundary between the nodular defects and the surrounding material some of them can become separated from the coating leaving a cavity. The ejection of a nodulus appeared when the coating is thick enough or if it is exposed to mechanical forces (e.g. sliding). A high concentration of such pinholes increases the coating porosity. The pinholes and the open structure between the nodulus and the surrounding coating are responsible for pitting corrosion (Fig. 4). A corrosion tests of PVD coatings, using

electrochemical methods (potentiodynamic data and with electrochemical impedance spectroscopy), were performed in chloride medium. Surface characterization was performed before and after corrosion test by 3D-profilometry, optical microscopy and FIB. After corrosion we performed profilometry over the same area as on the as-deposited sample, paying special attention to the position of the pinholes at which pitting corrosion occurred (e.g. pinhole 1 on Fig. 4). Then we also took optical images of the same area (Fig. 4c). By comparison of the 3D profiles and the optical image it is possible to identify the network of pinholes also on the optical image. We selected individual pits on the coating surface and made a slice-by-slice sectioning by FIB. The FIB image of pit (number 1) cross-sections after corrosion is presented on Fig. 4e.

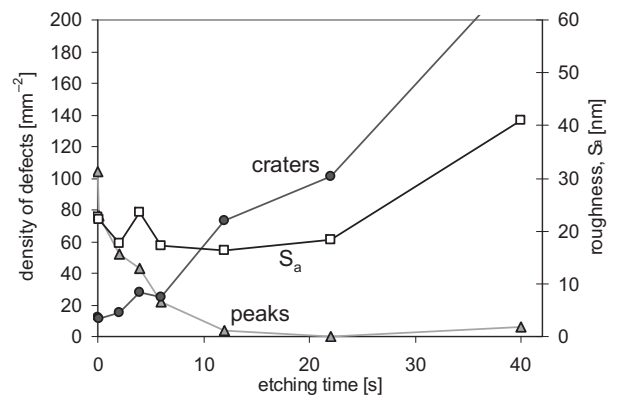
Fig. 5. Surface roughness, peak and crater density as a function of etching time during GDOES depth profiling of TiAlN hard coatings.

We performed compositional depth profiling of coatings using GDOES technique. The craters with different depths were prepared on selected coatings. The etching time was between 1 and 80 s. After GDOES experiment we evaluated the coating topography of the GDOES crater bottom using the 3D profilometer. We found that after short ion etching (a few seconds) all cones formed during coating deposition process transformed into holes. Fig. 5 shows the density of peaks and holes as well as surface roughness of the TiAlN coating deposited on tool steel as a function of etching time. Density of peaks rapidly decreases after a short etching time, while the density of holes increases simultaneously. This effect can be explained by the reduction of the cohesive force between the inclusion and the coating after removal of the top layer and by high thermal stresses which appear during ion etching between the cones and the bulk coating. Namely, the electric field density on the conical defects is much higher compared to that of a flat surface. Thus an ion current with higher density appears which is responsible for higher local temperature and thermal stress. Such stresses

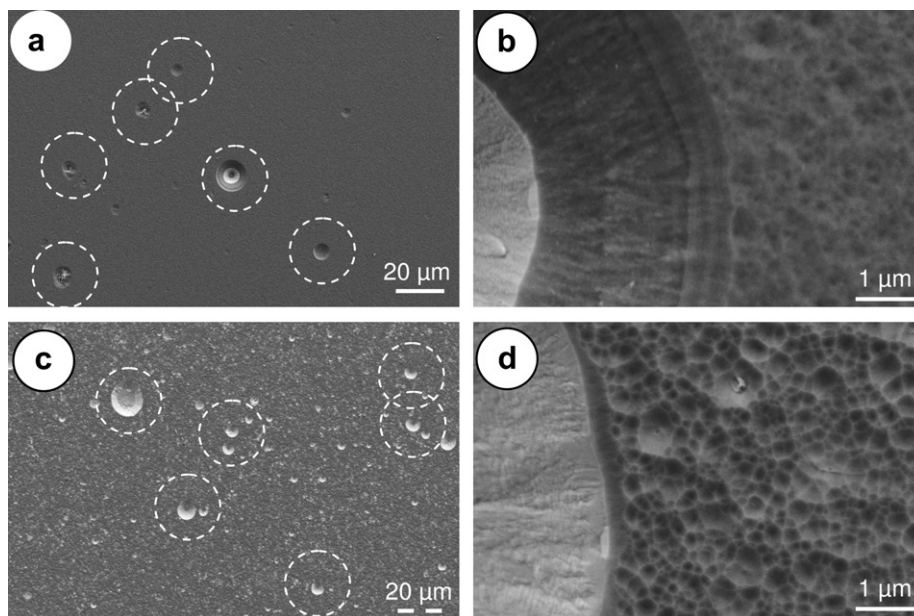
Fig. 6. SEM images of TiAlN hard coating in the GDOES crater after etching time of 6 s (a, b) and 45 s (c, d).

can cause the detachment of the coated particles (see craters on Fig. 6a,c). We found that the surface roughness is more or less constant during etching of fine-grained coating with homogeneous composition while it rapidly increases when the steel substrate starts to etch. The reason for roughness increase is the generation of surface features during ion bombardment of inhomogeneous tool steel material.
