73rd Symposium on Sustainable Humanosphere - RISH-LAPAN-LIPI International Symposium

Research and Developments for Enhancing Seismic Performance of Wooden Dwelling Houses in Recent Japan

Kohei Komatsu

Research Institute for Sustainable Humanosphere, Kyoto University

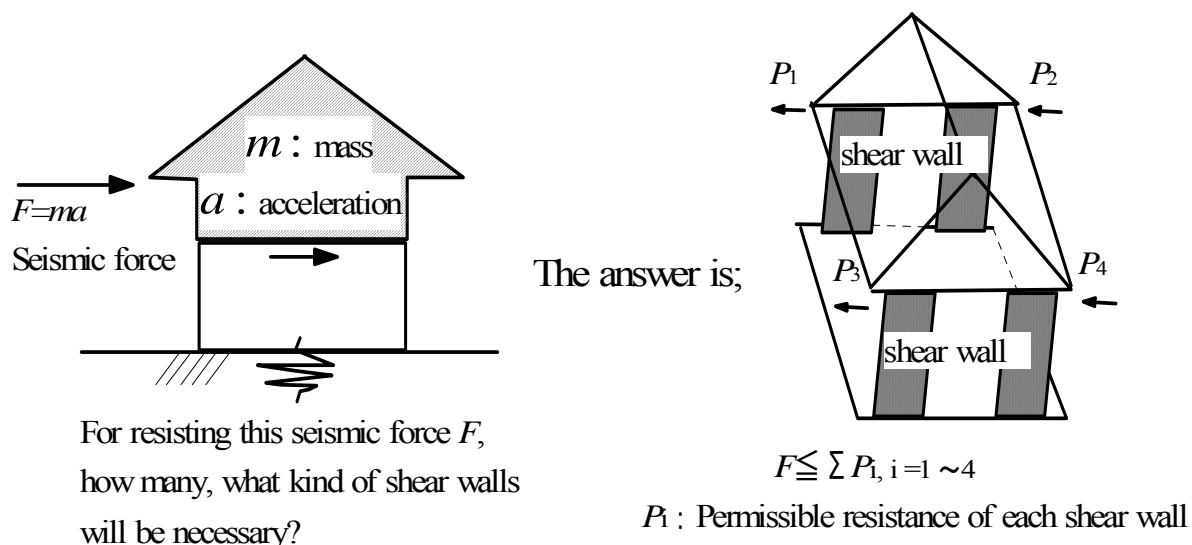
Fig.1 Schematic explanation for checking out the necessary shear wall quantity.

On the other hand, strategies for resisting earthquake or damage preventing technology have been investigated every time severe earthquake attacked wooden residential houses. The first important response to resist against earthquake strike was to establish the Building Standard Law in 1950. In this occasion, so-called “shear wall resistance factor: SWRF” was first introduced to calculate simply how much is the total resisting ability of wooden residential house against seismic force. Figure 1 explains simply how seismic force can be resisted by a group of shear walls.

First concept shown in Fig.1 introduced for estimating seismic force was called as “fixed seismic intensity method”, which implies that acceleration “ a ” in wooden house was assumed to be constant without respect to its height, i.e. the ground acceleration was believed to be held good up to any elevation. It is well-known fact that this concept is now incorrect, but until recently most constructions were designed based on this insufficient concept. **Figure 2** shows a never forgetting example caused by this insufficient design concept.

Most wooden dwelling houses built before 1980’s were constructed in accordance with old seismic resistance concept as shown in Fig.1. After experienced devastating attacks by a series of earthquake, however, effort for revising old seismic resisting concept into new one has been paid at first by research scientists in Building Research Institute in 1970’s, then a kind of task force combined with scientists in Forest Research Institute and Disaster Preventing Research Center in Tsukuba was set up for evaluating performance of various shear walls. Finally in 1980, a new seismic resisting design concept was proposed based on the latest earthquake engineering. In the new concept, acceleration in building induced by earthquake was expressed as a function of elevation, stiffness, natural period of the building, ground properties and so on, thus it should be no more constant along elevation of building as has been stated in the old concept. This new concept was also accepted in designing wooden residential houses, and required shear wall amount (length) for earthquake force was revised into right values. At the same time, shear resistance factors of various shear walls were newly admitted on the basis of a series of experimental and theoretical research results obtained by task force jobs^{5)~8)}.

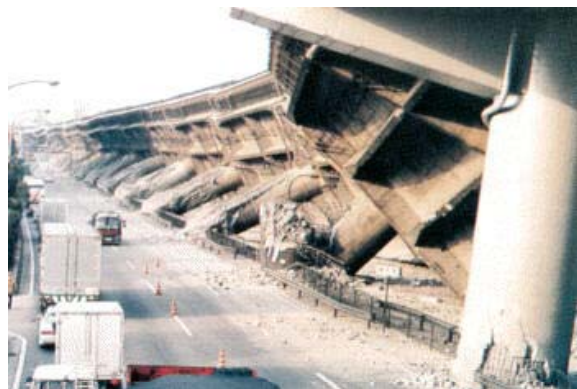
Figure2 Collapse of a 635m section of single-piered bridges (Photo is taken from records of the 1995 Great Hyougoken-nanbu Earthquake Disaster edited by Architectural Institute of Japan & Japan Society of Civil Engineers)¹⁾.

Note: It is said that this single-piered bridges was designed before new seismic design method was introduced in 1980.²⁾

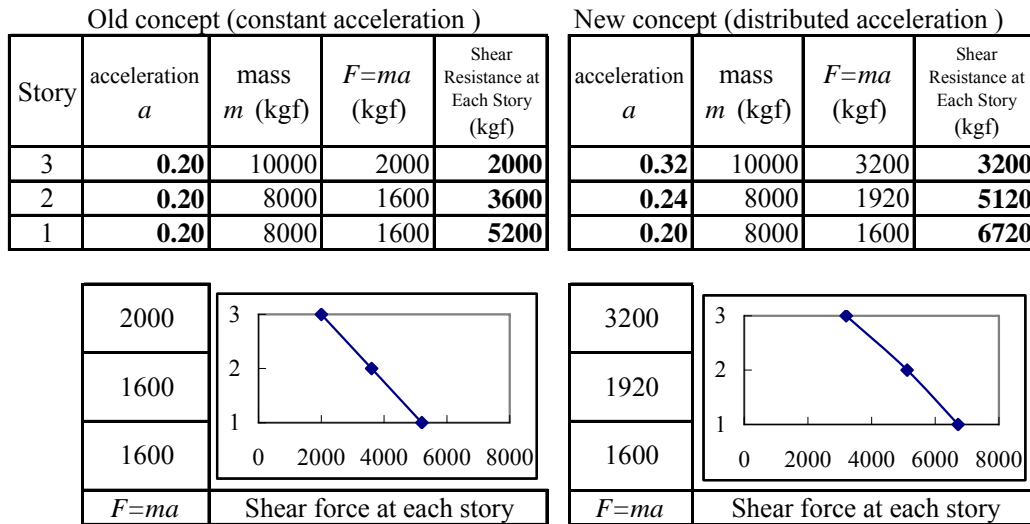
Fig.3 Comparison between old seismic resistance concept and new one.

Figure 3 shows simple comparisons between old concept and new concept for seismic resistance and how different the required shear resistance capacity for each story against seismic force. For example, let assume mass distribution of 3 story wooden house as shown in Fig.3. (This assumption is not realistic, of course). In the case of old seismic resistance concept, required total shear resistance capacity at 1st floor is 5200kgf. While in the case of new seismic

concept in which acceleration due to earthquake distributes along elevation, required total shear resistance capacity for 1st floor was estimated as 6720kgf. This means that 6720/5200=1.3 times shear wall amount is necessary for resisting against same intensity of earthquake. This also implies inversely that the wooden structures built before 1980's had insufficient amount of shear wall, thus they will have higher probability of collapse by any devastating earthquake attacks even if they had been constructed by keeping Building Standard Law rigorously at that time.

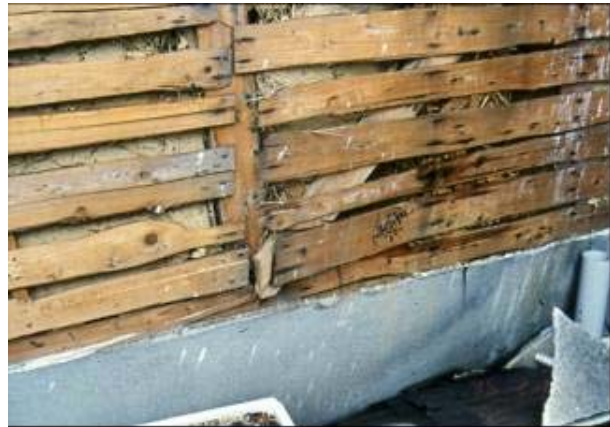
Fig.5 Poor connection between brace and sill or column observed in the 1955 Great Hyogoken-nanbu earthquake.

In the 1955 Great Hyogoken-nanbu earthquake, a lot of insufficient shear wall was observed everywhere. We presumed that at first this kind of insufficient connection was broken due to pullout motion then push down towards outside of sill as shown in Fig.5. Once the brace lost its structural function, story collapse was easily occurred..

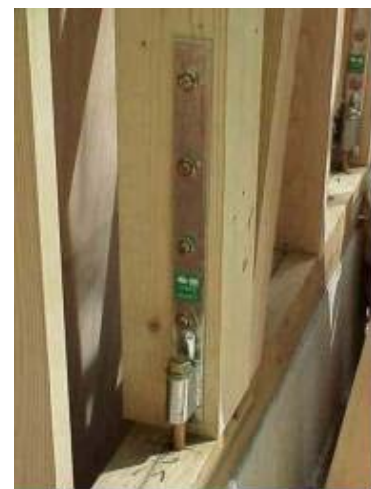
Fig.6 Example of “hold-down connector” set at column-sill joint in a wooden conventional post & beam structure. This connector, for example, can be used to sustain 20kN pullout force.

At present, in the case of newly constructed wooden post & beam structures, premature pullout failure at column-sill joint or brace-sill joint prior to yielding of shear wall itself should be rigorously avoided, hence those important joints must be connected using such a strong fastener called as “hold-down connector” as shown in Fig.6.

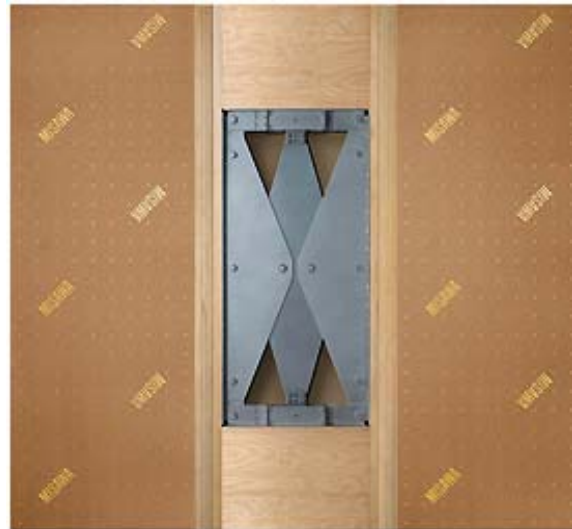
Fig.8 Seismic control equipment for wooden prefabricated house. (Photo by courtesy of Misawa home)

Fig.8 shows an example of seismic control equipment developed for wooden prefabricated house¹¹⁾. This equipment is hid in a shear wall so that usually cannot be seen from outside.
