Detection and localization of debonding damage in composite-masonry strengthening systems with the acoustic emission technique

E. Verstrynghe & K. Van Balen

KU Leuven, Department of Civil Engineering, Building Materials and Building Technology Division, Heverlee, Belgium

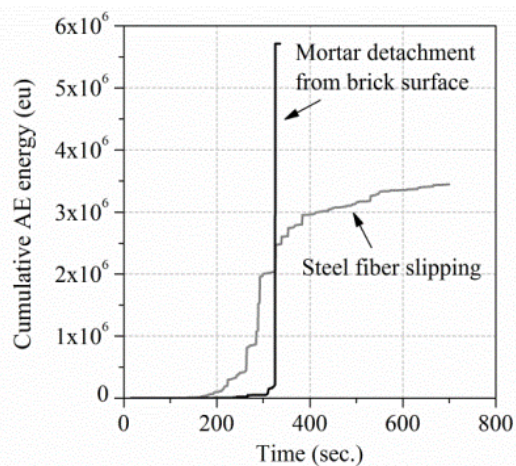
Figure 8. Comparison of AE output for different failure modes in SRG-strengthened bricks

In Figure 8, a comparison is made between two SRG-strengthened specimens with different failure modes, namely brick/mortar detachment and fibers slipping. A brittle behavior is observed in the specimen with brick/mortar detachment failure. The detected AE energy level in this specimen is very low during the test followed by a sudden release of energy at the moment of debonding. On the other hand, the fibers slipping failure mode produces a progressive release of energy during the test while the adhesive bond diminishes, followed by a reduction of the AE energy rate in the stage governed by frictional resistance. A more detailed analysis and characterization of debonding mechanisms based on AE results was presented in (Ghiassi et al., 2014).
