# Flow Angularity Investigations in an Automotive Slotted Wall Wind Tunnel

**Abstract:** The Volvo Cars aerodynamic wind tunnel has had a vortical flow angularity pattern in the test section since its original commissioning in 1986. The vortical flow nature persisted after an upgrade in 2006, when the fan was replaced and a moving ground system was introduced. It has been hypothesized that the cause for this flow angularity pattern was leakages around the heat exchanger installed in the settling chamber. The present paper tests this hypothesis by measuring the flow angularity in the test section before and after sealing the leakages. The findings show that the leakage path around the heat exchanger does not influence the flow angularity, and that the current pattern is different compared to the commissioning after the upgrade. This prompted an investigation of the influence from the turbulence screens, which were changed after the upgrade commissioning. These investigations indicate that the probable cause of the vortical flow angularity pattern is residual swirl from the fan. Force measurements on a reference car with and without extra induced flow angularity show that the flow a

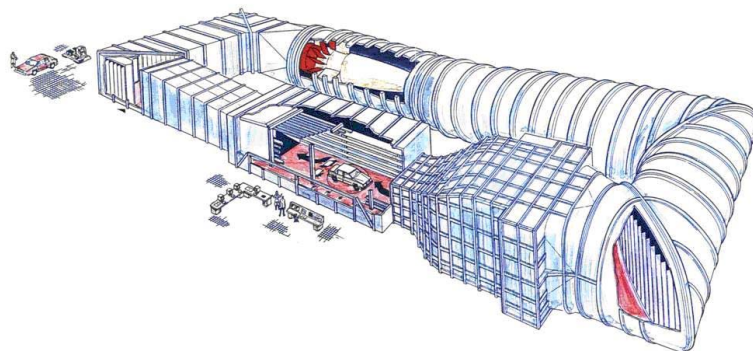
**Figure 1.** Overview of the Volvo Cars full scale aerodynamic wind tunnel (PVT).

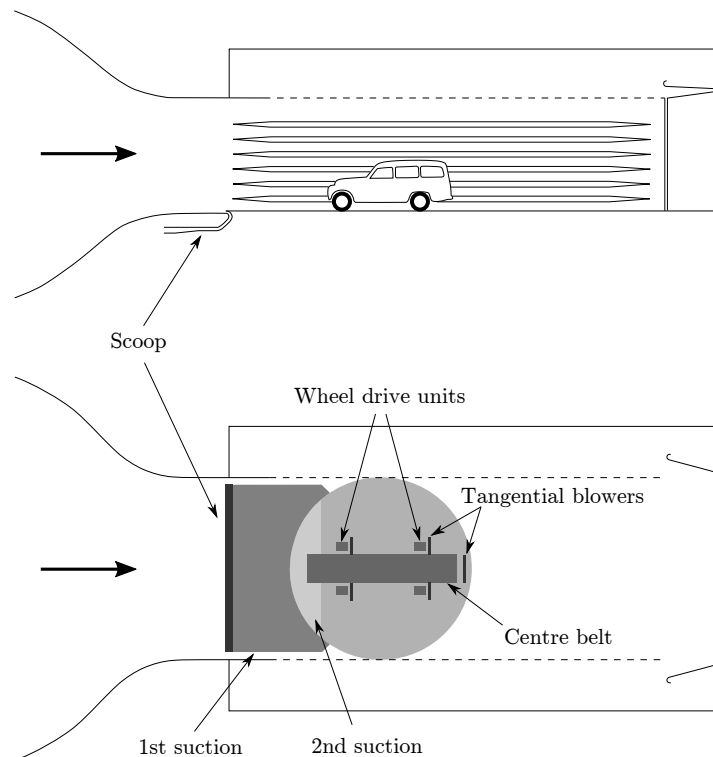
**Figure 2.** The moving ground and boundary layer control system in PVT [20].

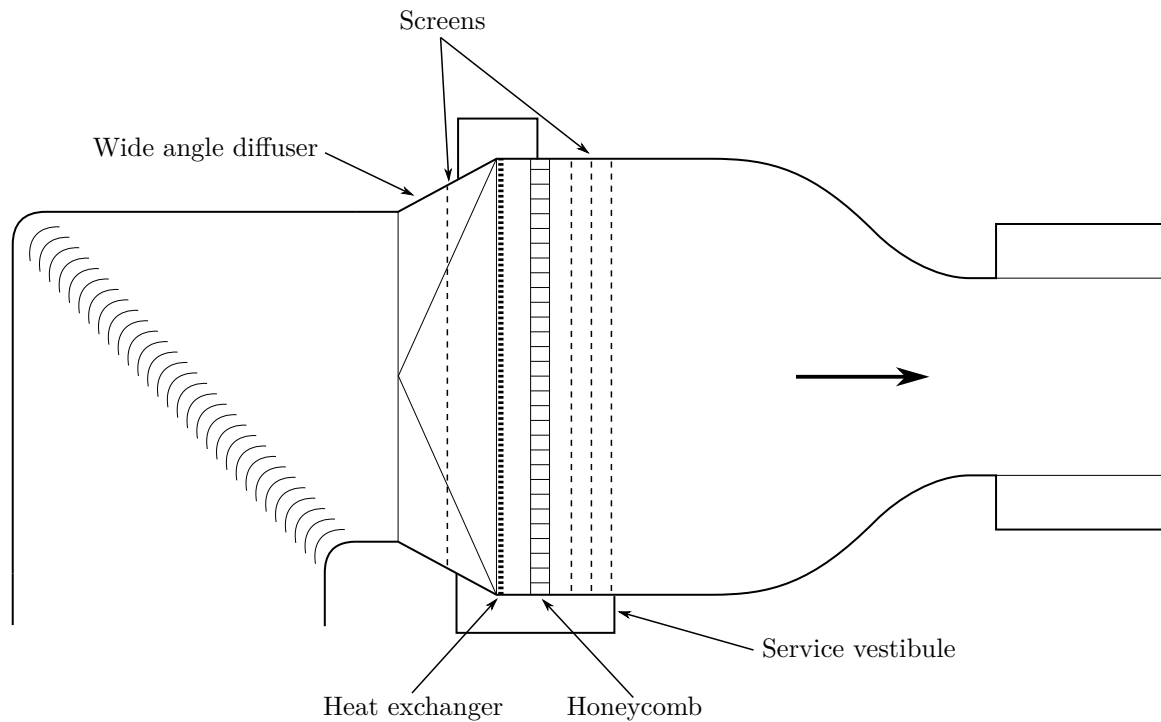
**Figure 3.** Sketch in top view showing the installation of the heat exchanger and other flow conditioning devices in the settling chamber.

In terms of flow conditioning, all corners are equipped with guide vanes to help the flow turn and reduce losses. The settling chamber is, as outlined in Figure 3, equipped with a total of four screens, a heat exchanger, and a honeycomb structure. One of the screens is mounted in the wide angle diffuser that connects the circular fourth corner and the rectangular settling chamber, and acts to suppress separation in the diffuser. The heat exchanger is mounted at the upstream end of the settling chamber, and makes the flow more uniform through its large loss. It is installed so that its core spans the full width and height of the settling chamber, which means that the pipes supplying the cooling (or heating in thermodynamic mode) water are mounted in small vestibules outside of the settling chamber. These vestibules are sealed towards the atmosphere, but not towards the settling chamber, which means that flow can escape from the upstream side of the heat exchanger core and reenter on the downstream side. After passing the heat exchanger, the flow is aligned by the 800 mm deep honeycomb, after which it passes through the remaining three screens. Due to the size of the settling chamber, each screen is made out of two halves welded together at the centerline. Finally, a 6:1 contraction ratio nozzle with chamfered edges to suppress corner vortices accelerates the flow into the test section.

The installation of the heat exchanger, schematically shown in Figure 3, resulted in a possible flow path around the heat exchanger core. The width of the slot through which the air leaked was not uniform along the height of the heat exchanger, ranging from about 10 mm to 40 mm, which has been hypothesized to have caused the swirling motion seen in both 1986 and 2006. The local effect of this leakage on the near wall flow between the heat exchanger and the honeycomb can be seen in Figure 6, where smoke is used to visualize the air reentering into the airline from the service vestibule. In order to quantify the effect from this leakage on the flow in the test section, the leakage was sealed using tubular pipe insulation and tape, and the flow angularity was then measured.

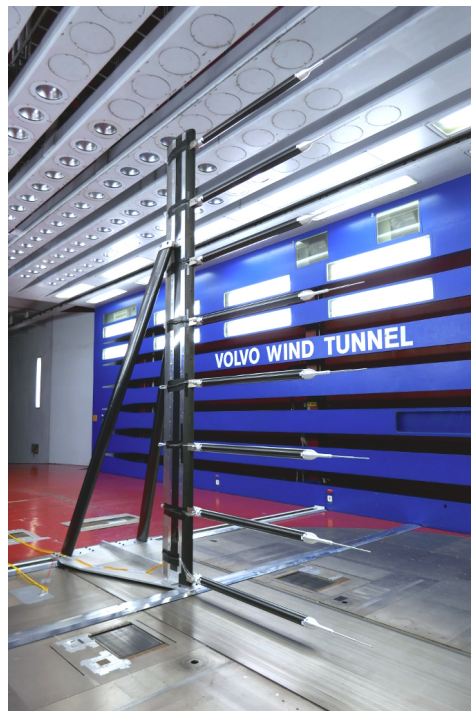
**Figure 5.** The Volvo PVT flow measurement rig (FMR).

The flow angularity measurements were performed using the purpose built flow measurement rig, which can be seen in Figure 5. It featured eight probe arms and measured flow angularity as well as static and total pressure simultaneously using five-hole Aeroprobe Air data probes connected to the pressure measurement system installed in the wind tunnel. Due to the design of the strut assembly, the flow interference from the strut at the probe locations was non-uniform and was corrected for using an approach combining numerical simulations and physical measurements of the interference. The total uncertainty of the full measurement chain was estimated according to the JCGM Guide to the expression of uncertainty in measurement [23], and included the uncertainty of all measured quantities and the interference correction. A more thorough description of the rig, the interference correction, and the quantification of measurement uncertainties was given by Ljungskog et al. [24]. Typical uncertainties for the flow angularity measurements are given in Table 1, where it can be seen that the uncertainties varied slightly over a plane, but had a weak velocity dependency. This is since the uncertainties are not dominated by the pressure measurements, but rather by the optical measurement of the offset angles of the probe arms [24]. Furthermore, it can be noted that the measurement uncertainties for the full measurement chain were significantly lower than the stated accuracy of a factory calibrated Air data probe ( $\pm 0.15^\circ$ ). This was achieved by calibrating the probes in situ for a narrow range of angles ( $\pm 2^\circ$ ) following the procedure outlined in the AIAA recommended practice on calibration of subsonic and transonic wind tunnels [25].

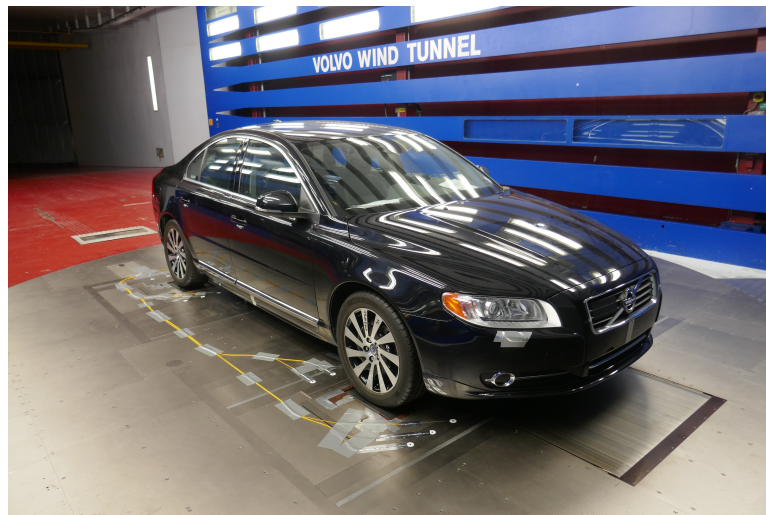
**Figure 9.** The reference vehicle mounted in the test section at zero yaw.

In order to quantify the influence from the flow angularity induced by the tape on the downstream screen onto the aerodynamic forces of interest during vehicle development, a reference vehicle that was used to perform regular checks of the wind tunnel repeatability was tested. The tests were run as yaw sweeps from  $-20^\circ$  to  $20^\circ$ , both in standard operating conditions and with the tape. The vehicle was a Volvo S80 of model year 2008, and can be seen in Figure 9. Forces were measured using the underfloor balance and averaged for 20 seconds for each of the yaw angles. The wind speed was 140 km/h and all ground simulation systems were activated, which is the standard test setup for aerodynamic development work. The specified repeatability of the force coefficients in this mode of operation are given in Table 2, where the test figures within refer to the repeatability for measurements performed with the vehicle mounted in the test section between the runs. Correspondingly, the between test numbers refer to the case when the vehicle has been removed and reinstalled between the measurements, on the same day or at a different time. It can be noted that the front- and rear axle lift coefficients had the same repeatability between tests, but differed within a test. This is because the within test repeatability was mostly determined by unsteady flow behavior around the car, and thereby the averaging time. Since the front of the vehicle was subjected to a steady oncoming flow, the time averaged force converged faster than for the rear lift, which was more affected by unsteady flow under the car and in the separated base wake. Hence, the within test repeatability could be improved by increasing the averaging time from the current standard, which was chosen as a tradeoff between repeatability and productivity for day to day vehicle development work. In contrast, the between test repeatability is mostly determined by the installation of the vehicle, which might differ slightly between tests.
