Finite Element analysis of the behavior of bonded composite patches repair in aircraft structures

ABSTRACT. This paper aims to analyze the multi-effects of the glass fiber reinforced polymer (GFRP) composite patch to repair the inclined cracked 2420-T3 aluminum plate. Three-dimensional finite element method (FEM) was used to study the effect of GFRP composite patch with different stacking composite laminate sequence, $[0^\circ]_4$, $[90^\circ]_4$, $[45^\circ]_4$, $[0^\circ/45^\circ]_{2s}$, and $[0^\circ/90^\circ]_{2s}$, on the crack driving force, *J-integral*, of inclined cracked 2420-T3 aluminum plate. Furthermore, the effects of patch geometry, number of layers, single or double side patch, and crack inclination angle are described.

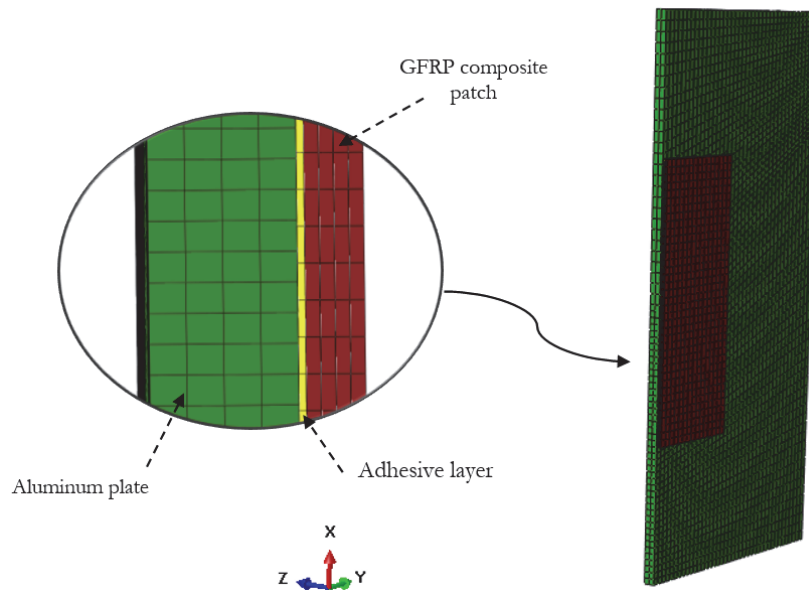
Figure 2: Typical mesh of the present model.

The Contour Integral method is used to compute the value of J -integral [17, 18]. In the present model, C3D8R: an eight-node linear brick was used to mesh each element of the main plate, adhesive, and the composite patch. The refining process of mesh was carried out to assure that results are not dependent upon the size of the element. A complete mesh of a composite repaired aluminum plate model is shown in Fig. 2.
