**EFFECTIVENESS OF FORESTRY RELATED
BEST MANAGEMENT PRACTICES
IN THE TROUT CREEK WATERSHED, COLORADO**

Completion Report No. 202

This report was accepted as Thesis
in partial fulfillment of the requirements
for the Masters of Science
for Nani Bay Teves in Spring 2005.

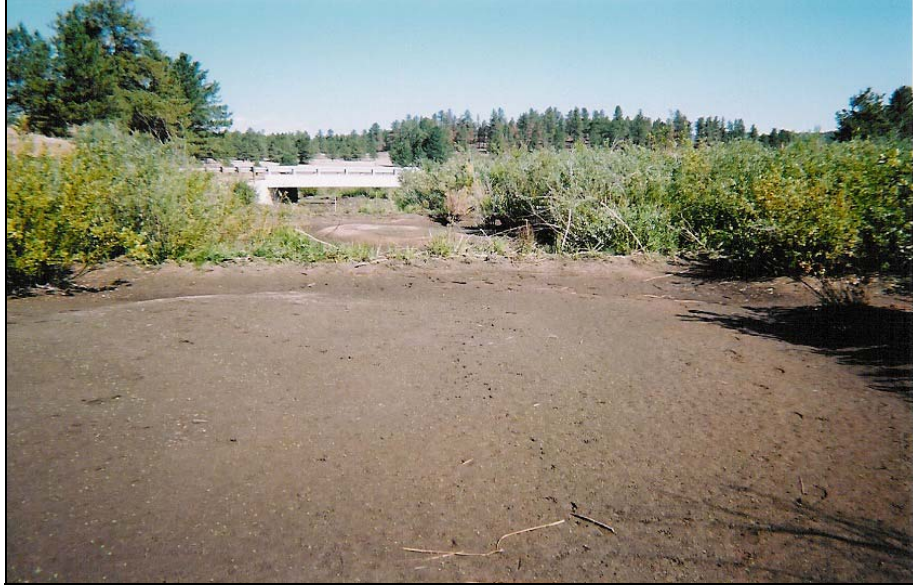
Figure 2-2. Dry creek bed, looking north towards the bridge at Rainbow Falls Park. Trout Creek, CO. August 24, 2002.

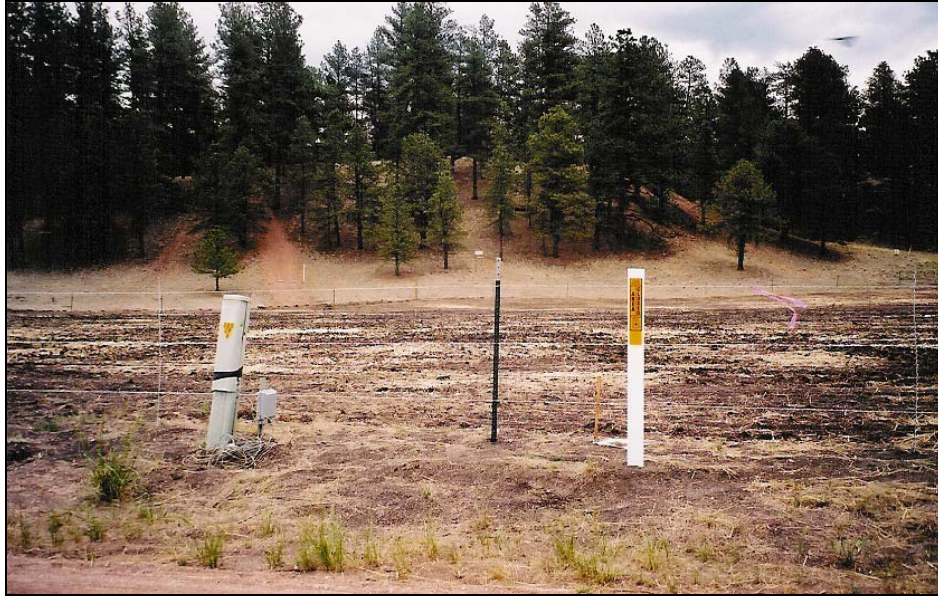
Figure 3-2. ORV trails shown in the background were inaccessible after parking area revegetation. Trout Creek Watershed, CO. July 2002.

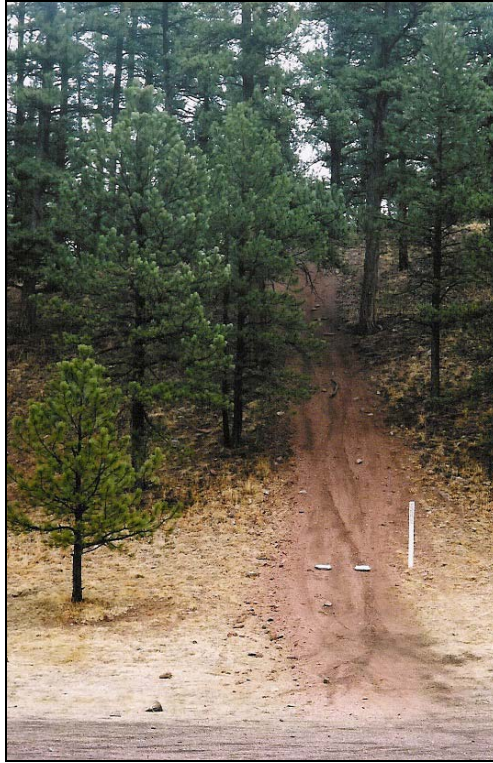
Figure 3-3. Two traps placed on a signed ORV trail. Trout Creek Watershed, CO. Summer, 2002

The same trails used in the ORV use monitoring were used in the erosion study, to relate trail use to soil erosion. Erosion from the signed and unsigned trails, and control areas was monitored using soil erosion traps, a technique that represents erosion rates by integrating inputs over time (Wells and Wohlegemuth, 1987; Corner, 1996). Trap design was modified from an earlier version (Bassman, 1996). Each trap consisted of two foil trays attached, one on top of the other, to form a covered container 30.5 cm wide, 20.3 cm long, and 7.6 cm tall. An opening was created on the 20.3 cm side of the container, with a 2.54 cm lip extending out to conform to the ground surface. Holes were poked on the down slope side of the trap near the top to allow water to flow through after the sediment settled out. Two traps were secured down with 13 cm nails across each trail in concentrated runoff areas, such as rills (Figure 3-3).

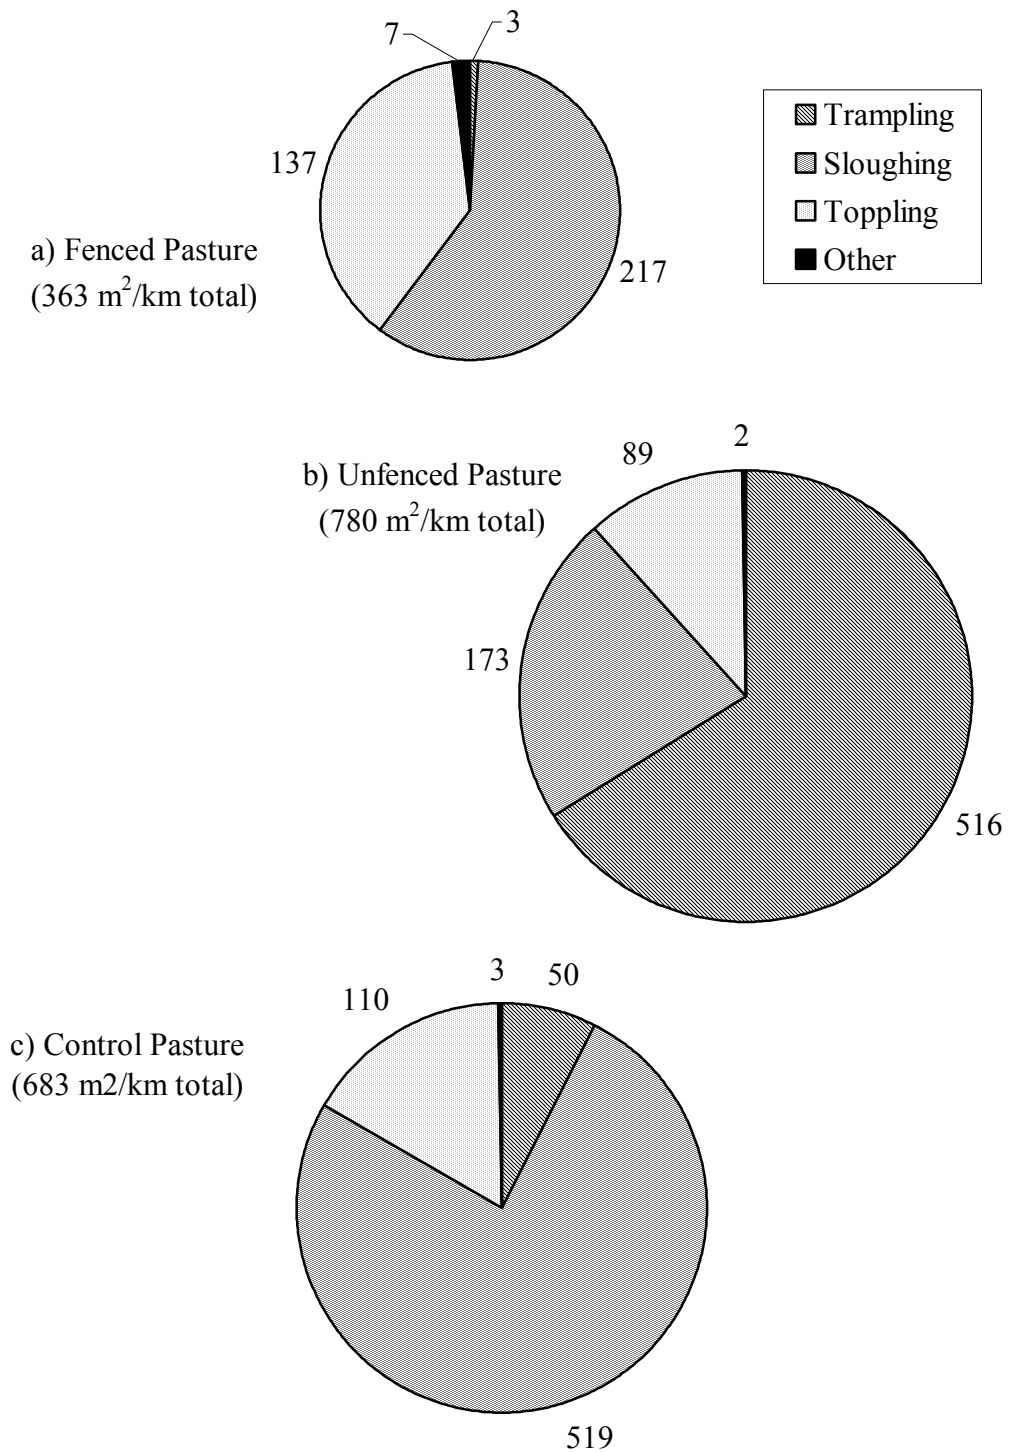
Figure 4-1. Eroded bank by type of erosion, m²/km, a) fenced pasture b) unfenced pasture c) control pasture. Trout Creek, CO. July and August 2002

Characteristics such as type of erosion, bank angle, if the eroded area was associated with a beaver dam, and bankful width and height, were measured. Type of erosion was grouped by trampling, sloughing, and toppling to indicate cause of eroded bank. Trampling caused 3 m²/km of eroded area in the fenced pasture, 516 m²/km in the

unfenced pasture, and 50 m²/km in the control pasture. Sloughing accounted for 217 m²/km of eroded area in the fenced pasture, 173 m²/km in the unfenced pasture, and 519 m²/km in the control pasture. Toppling totaled 137 m²/km of eroded area in the fenced pasture, 89 m²/km in the unfenced pasture, and 110 m²/km in the control pasture (Figure 4-1). Trampling resulted in sloped eroded banks that were patchy and with small clumps of vegetation. Sloughing tended to erode in larger chunks of soil that were steep at the top but provided a gentler slope at the lower end of the bank for vegetation establishment. Toppling typically had high eroded bank areas with near vertical faces. The pastures combined had 8 eroded banks located at the edges of a beaver dams, with an average density of one eroded bank per km.

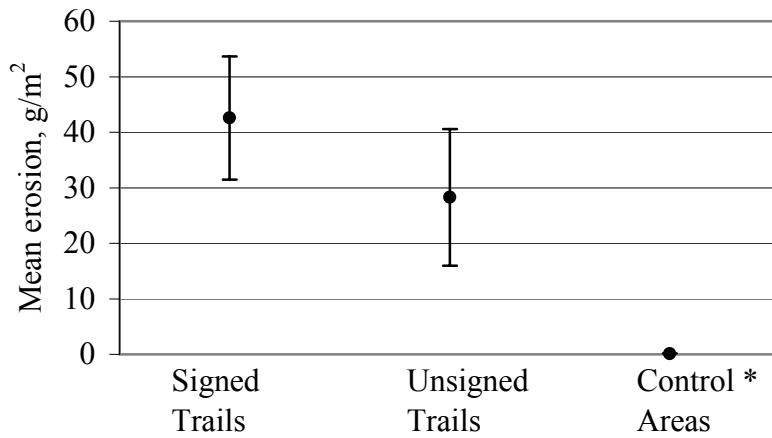
Figure 4-2. Comparison of mean erosion, including plus and minus standard error of the means, on all the signed and unsigned trails, and control areas in Rainbow Falls Park. Trout Creek Watershed, CO. June – August 2002. *the control area standard error is plus and minus .069

The same ORV trails were measured for soil erosion. Erosion was measured after 14 storm events resulting in overland flow. Average erosion on the signed trails was 42.6 g/m², 28.3 g/m² on the unsigned trails, and 0.12 g/m² on the control areas (Figure 4-2) (Appendix A4). Analysis of variance (ANOVA) indicated a significant difference (p=0.02) using a 2-tailed test, between the signed trails and control areas. There was no significant difference between the control areas and the unsigned trails, nor the signed trails and the unsigned trails. Variation between soil erosion in the two traps on each trail was large (Table 4-2). This was expected however, as traps were placed in areas of likely runoff such as rills, and often only one rill was present on each trail.

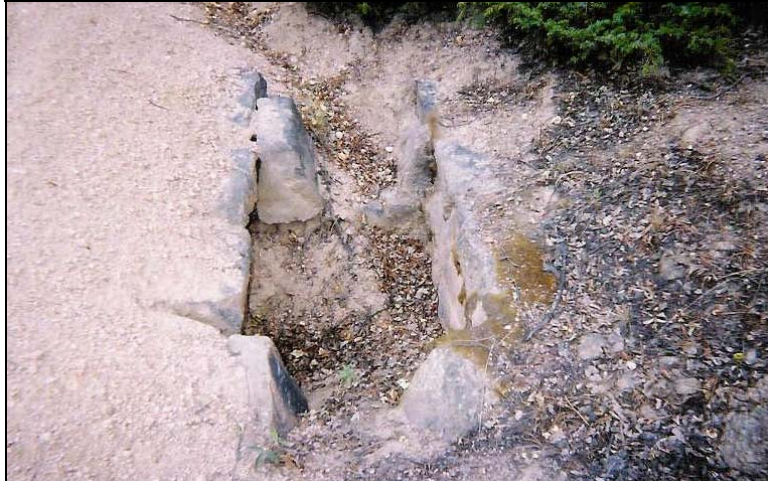
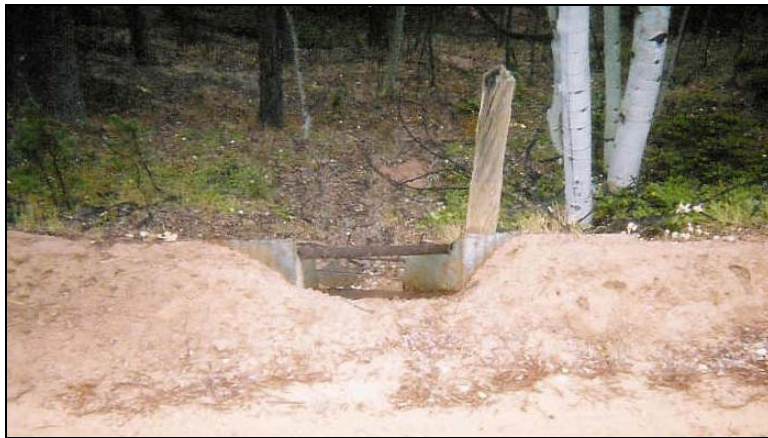
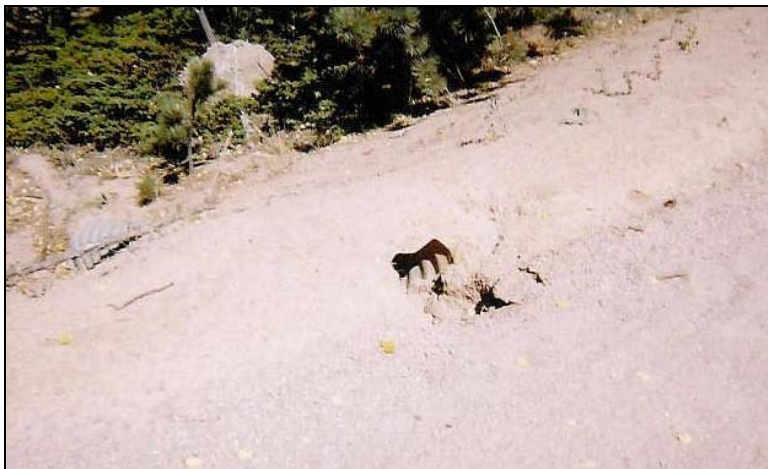
Figure 4-4. Photos of different culvert types along Rampart Range Road. Trout Creek Watershed, CO. 2002.

Sections of road were measured along 7.0 km Rampart Ridge Road representing road sections with culverts, and without culverts. All road sections measured were unpaved. Culvert type varied from circular pipe at the outslope to cemented inlets that channeled water under the road (Figure 4-4). Culverts were not maintained. Culverts had a mean eroded gully volume of 27 m³, and 29 kg erosion per m² of contributing road, while road sections without culverts had a mean gully volume of 7 m³, and 9 kg of erosion per m² of contributing road (Figure 4-5) (Appendix A5). Using ANOVA, no statistical difference ($p < 0.05$) was found in gully erosion between the areas with culverts and without culverts. Of the 17 gullies in areas with culverts, 10 linked to a channel, while 7 out of 14 gullies in areas without culverts areas linked to a channel.

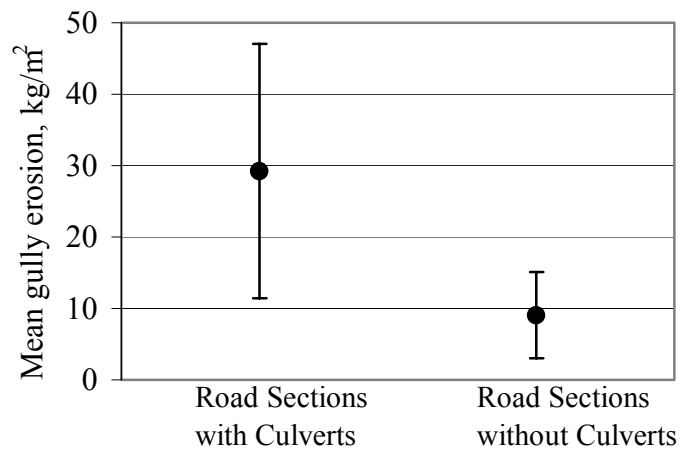
Figure 4-5. Mean gully erosion per area of road, plus and minus one standard error. Trout Creek Watershed, CO. August, 2002.

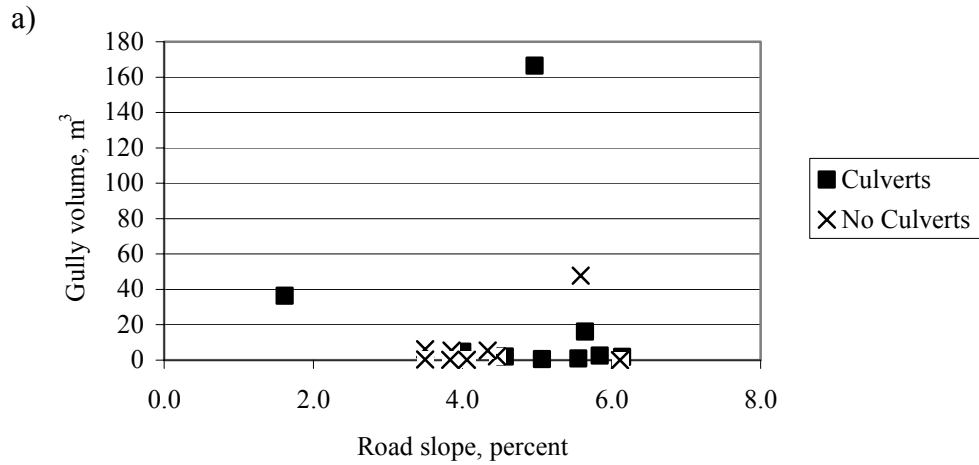
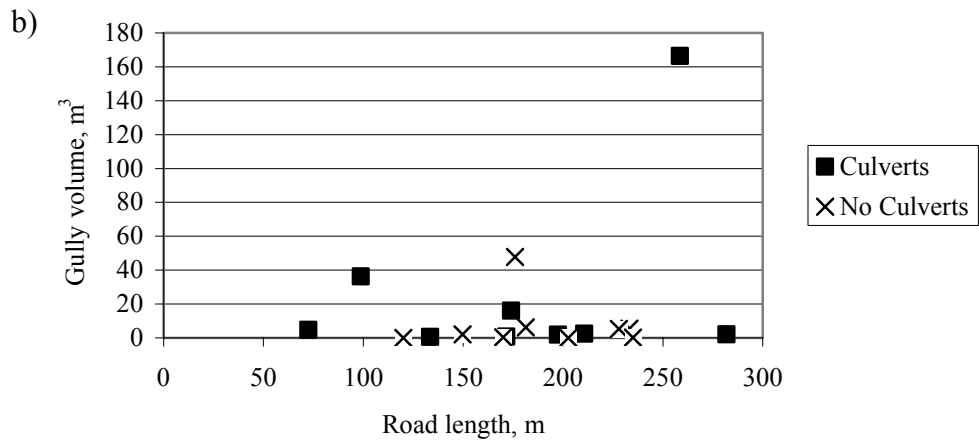
Figure 4-6. Gully volume at the road sections with and without culverts as a function of a) road slope b) road length and c) contributing area.

Regressions between gully volume and road slope, gully erosion and road length, and gully volume and contributing area were plotted (Figure 4-6). In the culvert sections, gully volume, and road slope and contributing area had a positive relationship. When comparing gully volume and road slope, there was a negative relationship in the culvert areas. In the areas without culverts, as contributing area and road length increased, there was no increase in gully volume. However, in the areas without culverts there was a relationship between gully volume and road slope.

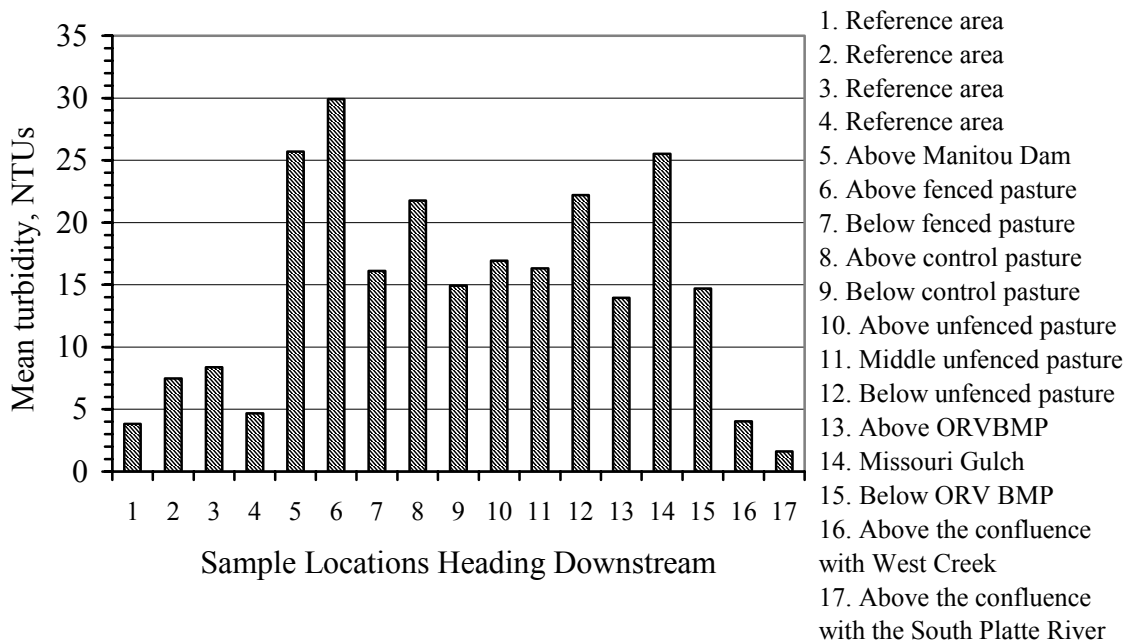
Figure 4-8. Mean turbidity from storm samples at 17 locations. Trout Creek, CO. May-August 2002. *Average values for locations 16 and 17 do not include post Hayman Fire samples

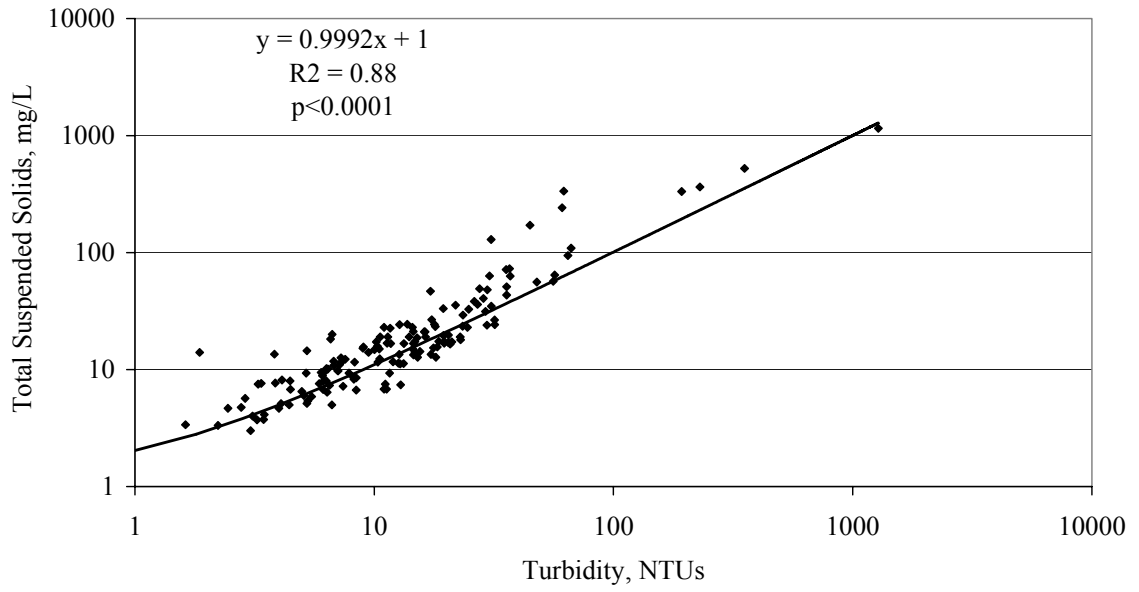
Figure 4-9. Regression between turbidity and total suspended solids. Trout Creek, CO. May through August 2002.

A rating curve was developed to describe the relationship between TSS and turbidity in Trout Creek (Figure 4-9). 153 samples consisting of both storm and non-storm samples resulted in an R^2 of 0.88, and a p value of 0.0001.

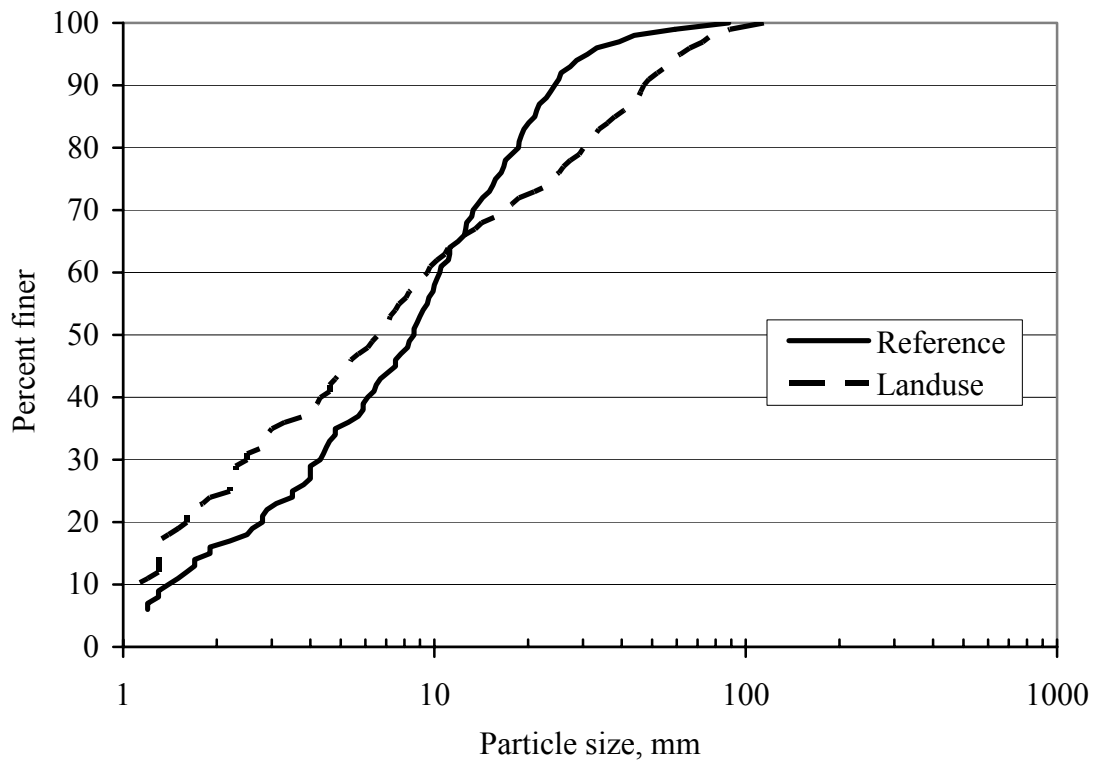
Figure 4-10. Wolman pebble count results at the land-use and reference areas. Trout Creek, CO. August 2002.

Wolman pebble counts were conducted at 10 locations in the land-use area, and 10 locations in the reference area. Mean D_{50} for the land-use and reference area was 6.6 mm and 8.6 mm respectively. In the land-use area 55% of the streambed particles were smaller than 8 mm, and in the reference area 47% of the particles were smaller than 8 mm (Figure 4-10).

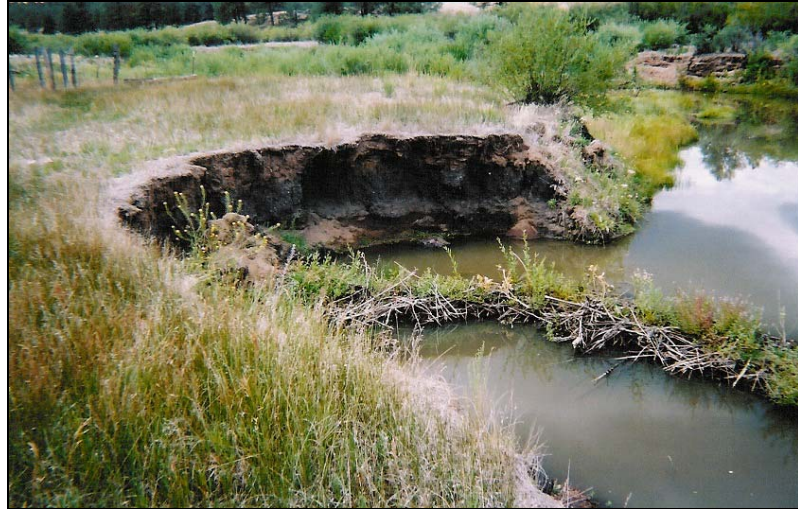
Figure 5-1. Bank erosion related to beaver dams. Trout Creek, CO. Summer 2002.

by causing bank failure upstream or at dams edges (Figure 5-1) (Ruedemann and Schoonmaker, 1938). Another source of sediment is from dam failure, however this is rare and occurs on large dams storing a large volume of water (Gurnell, 1998). A potentially larger effect of beaver dams is they attenuate and inhibit sediment transfer, restore riparian habitat, and stabilize banks (Ruedemann and Schoonmaker, 1938). Evidence of this exists along Trout Creek, as mean TSS at locations 16 and 17 was lower than all upstream samples. Dams also decrease current velocity and shear stress on the channel bed and banks by attenuating stream flow energy (Hammerson, 1994, Gurnell, 1998).

Along the continuous 22 km walked, 344 beaver dams were present. Of these, 209 (61%) were in tact and trapped water and sediment. Of the total number of dams, 57 (17%) had new twigs visibly incorporated into the dams, and 17 (5%) had bank erosion at the dam edges (Figure 5-1). It was possible to identify where the water leaked on 137 dams, and of these, 19% leaked from the top, 73% of the dams leaked from the bottom and/or from gapflow, and 8% had through flow. Average dam height and length were 0.7 m and 13.0 m respectively (Table 5-1) (Appendix A8).

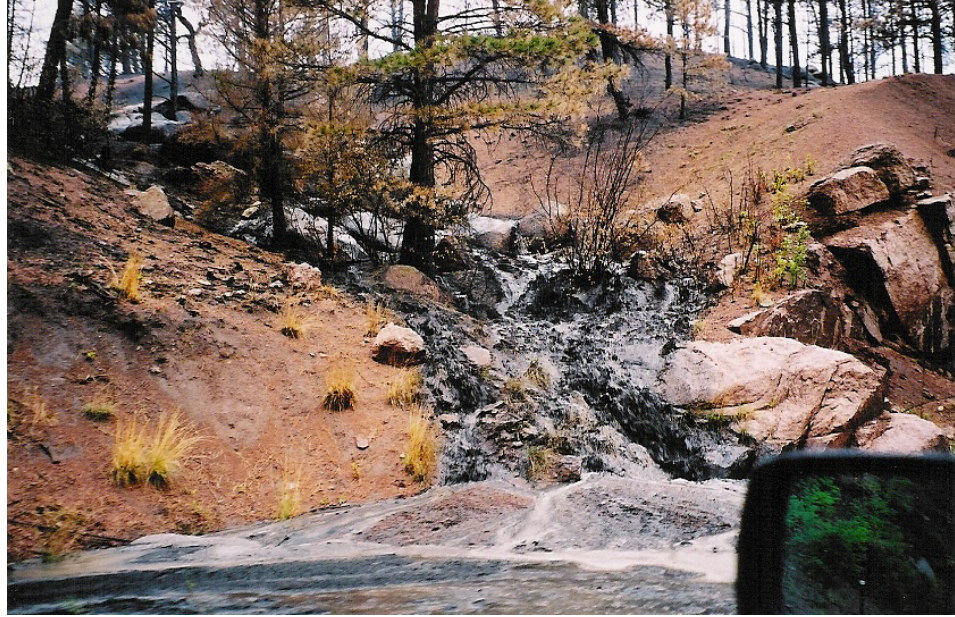
Figure 5-2. First storm event and runoff following the Hayman Fire. Photo taken in the West Creek Watershed, CO. July 4th, 2002.
