Strength-limiting damage and its mitigation in CAD-CAM zirconia-reinforced lithium-silicate ceramics machined in a fully crystallized state

Dan L Romanyk, Yilan Guo, Nyssa Rae, Sydney Veldhuis, Slobodan Sirovica, Garry JP Fleming, Owen Addison

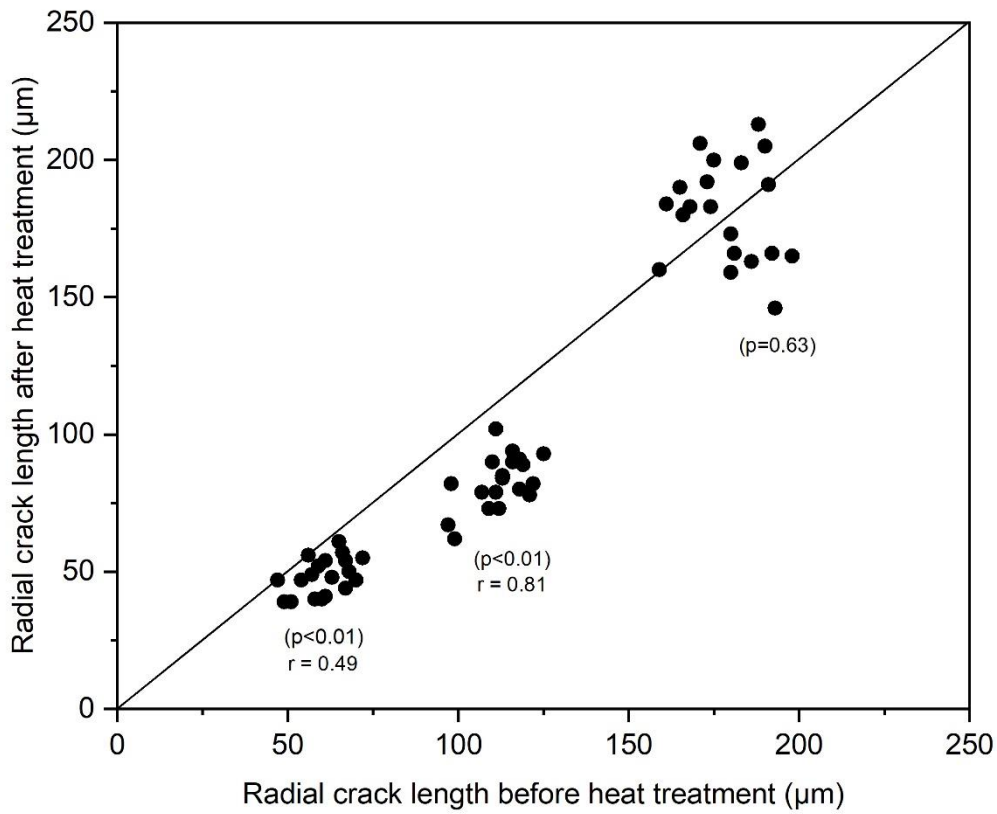
Figure 4: Scatter plot highlighting the relationship between the measured baseline radial crack length associated with a Vickers indentation introduced onto a polished surface (POL) and measured radial crack length following heat treatment (POL-HT). Three indentation forces (0.5, 1.0 and 2.0 Kgf) were used to create three discrete clusters of varying crack lengths. Significance values of the associated changes in radial crack length observed following heat treatment for each indentation force cluster are indicated with the associated Pearson correlation co-efficient (r).

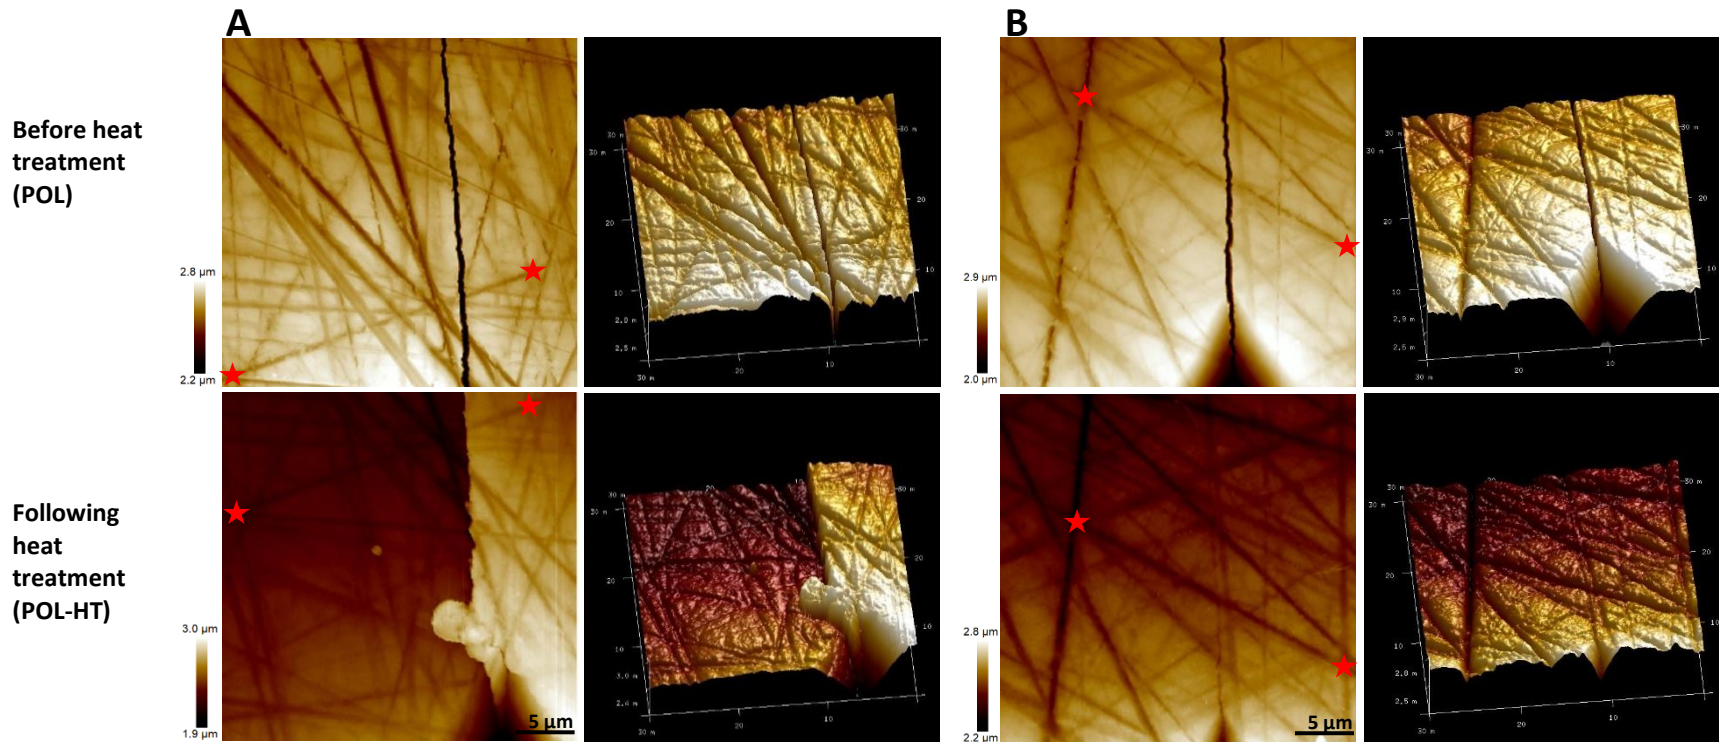
Figure 6: Atomic Force Microscopy (AFM) images of a polished Celtra[®] Duo surface (POL) adjacent to a Vickers indentation (2 Kgf, 10 s) introduced into the polished ceramic surfaces (A) before and (B) following heat treatment (POL-HT). Polishing features have been marked (*) on the two-dimensional images to aid image correlation. Both panels A and B include the region of a radial crack close to the plastically deformed indentation site and bisecting the surface polishing marks. In Panel A, following heat treatment, the surface polishing features remain, however, there has been an upward displacement of the surface adjacent on one side of the crack, likely due to the extension of subsurface lateral cracks introduced during the Vickers indentation process. In Panel B, the radial crack is observed to close with the crack walls becoming more tightly opposed and no associated upward deflection of the surface evident.

The impact of heat treatment on controlled surface defects (Vicker's indents with associated radial cracks) was observed using optical microscopy, SEM and AFM. Radial cracks $<125\ \mu\text{m}$ in length showed a tendency to reduce in length following heat treatment, whereas larger cracks $>150\ \mu\text{m}$ were either increased or decreased in length (**Figure 4**). A SEM image of a Vicker's indent which was associated with a decrease in radial crack length following heat treatment is shown in **Figure 5**. In addition to the crack length reduction, there was a rounding of the central plastically deformed indentation zone and a loss of sharp surface features. At lower magnification, a reduction in surface porosity in the polished surface containing the controlled indents was also evident. AFM measurements of regions of surfaces adjacent to Vicker's indents confirmed crack closure following heat treatment in some cases. However, in other cases, vertical displacement of the surface on one side of a radial crack was evident and was attributed to the extension of subsurface lateral cracks (**Figure 6**).
