Bull Volcanol
DOI 10.1007/s00445-012-0664-3

REVIEW ARTICLE

Potential impacts from tephra fall to electric power systems: a review and mitigation strategies

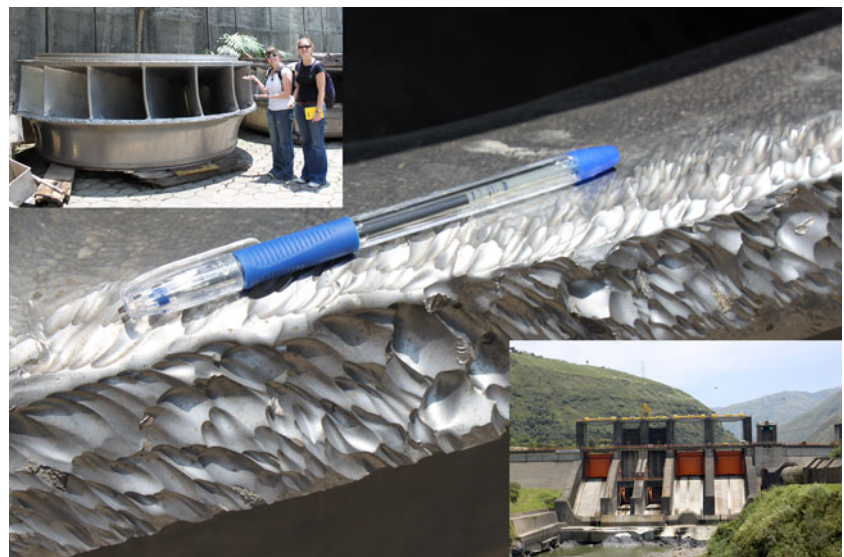
Fig. 3 A severely abraded turbine that was removed from service at the Agoyan hydroelectric power plant, which is sited 5 km east of Tungurahua volcano. Tephra-laden water filtering through the turbines has necessitated the replacement of four turbines in 21 years. *Bottom inset:* The Agoyan Dam and its (orange) floodgates are designed to let highly turbid water bypass the turbines so as to avoid accelerated wear of generation components

However, while the dam turbines, generators and control house are located in a zone of low-frequency tephra fallout, the Pastaza catchment of the dam is often exposed to significant tephra fall, leading to significant suspended solids in the water and occasionally lahar hazards, which are more threatening to the Agoyan HEP than direct tephra fall (Sword-Daniels et al. 2011). Intake mechanisms such as wicket gates, turbine covers and blades are particularly at risk of abrasion from the tephra-laden water. Severe pitting and scouring of the metallic components (Fig. 3) have accelerated their degradation, and four turbines have been replaced in the last 21 years.

To reduce the impacts from the intake of highly turbid water, Agoyan has a specially designed floodgate system in place so that the intake flow can be diverted away from generation components and directly flushed out into the river (Fig. 3, inset). When there is heavy rain, causing an increased risk of tephra-laden floodwaters and lahars, the dam operators monitor water levels and turbidity, and activate the protective bypass system as required.

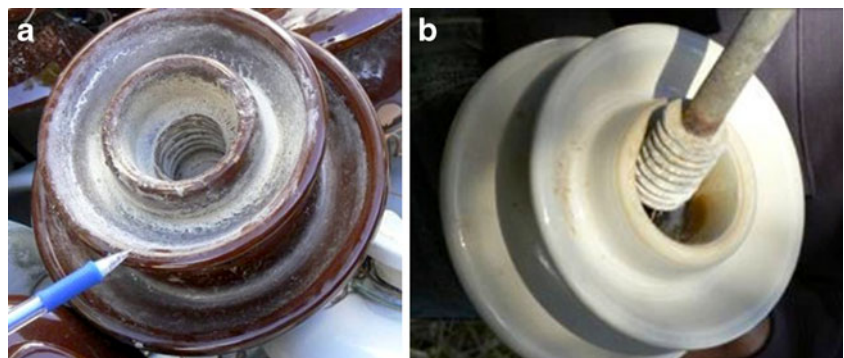
Fig. 4 **a** Fine-grained tephra adhered to the underside of a 33 kV porcelain insulator in Futaleufu, Chile following the 2008 Chaitén eruption. **b** Underside of a 3 kV porcelain insulator that suffered tephra-induced flashover following the 2008 Chaitén eruption. Note the brown burn mark (centre right) from the high intensity arc during flashover

Following the May 2008 Chaitén eruption, a 68-km stretch of 33 kV line to Futaleufu township, Chile (75 km from the volcano) was coated with fine-grained (<0.1 mm particle diameter) rhyolitic tephra of 20 to >300 mm in depth in some areas between 2 and 8 May 2008. Local linesmen reported that 10–20 % of the ceramic insulators suffered flashovers after light misty rain between 6 and 9 May 2008. Following inspections, the lines company decided to replace all insulators on the affected stretch of line, as it was too laborious to clean or assess damage to each insulator. Many of the insulators that had suffered flashover were cracked and exhibited burn marks at the base where it screwed onto the supporting metal pin (Fig. 4). Distribution transformers on the circuit were also reported to have suffered flashover damage.

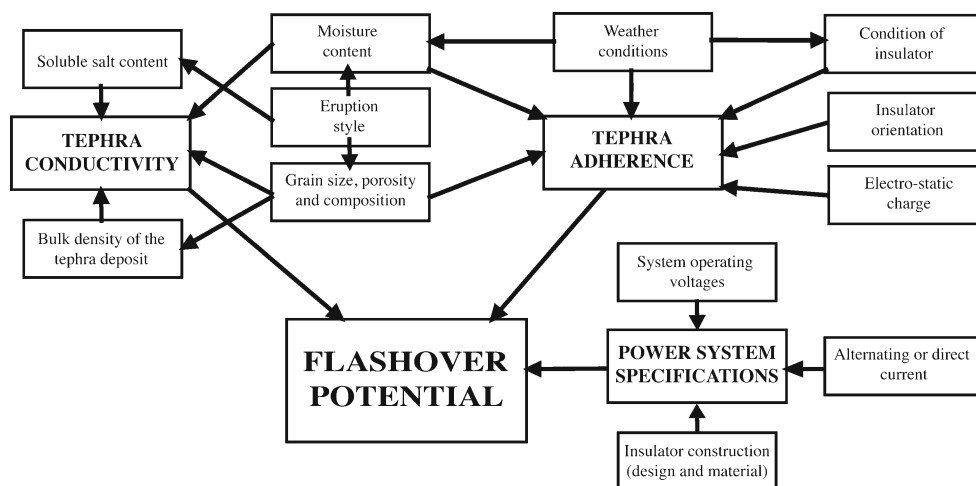
Fig. 7 Flow chart illustrating the many variables influencing tephra-induced insulator flashover (adapted from Johnston 1997b)

Our review has shown that tephra-induced insulator flashover can occur in all sections of a modern power system and is the most common impact from tephra contamination. Factors contributing to tephra-induced flashover are shown in Fig. 7. Given the interdependencies between electrical, volcanological and environmental factors that influence tephra-induced insulator flashover potential, it is difficult to make a reliable prediction whether flashover will occur during a particular tephra fall. However, from the case studies summarised here, simple probabilistic analysis can be undertaken to produce a function that estimates the likelihood of a flashover occurring causing system disruption.

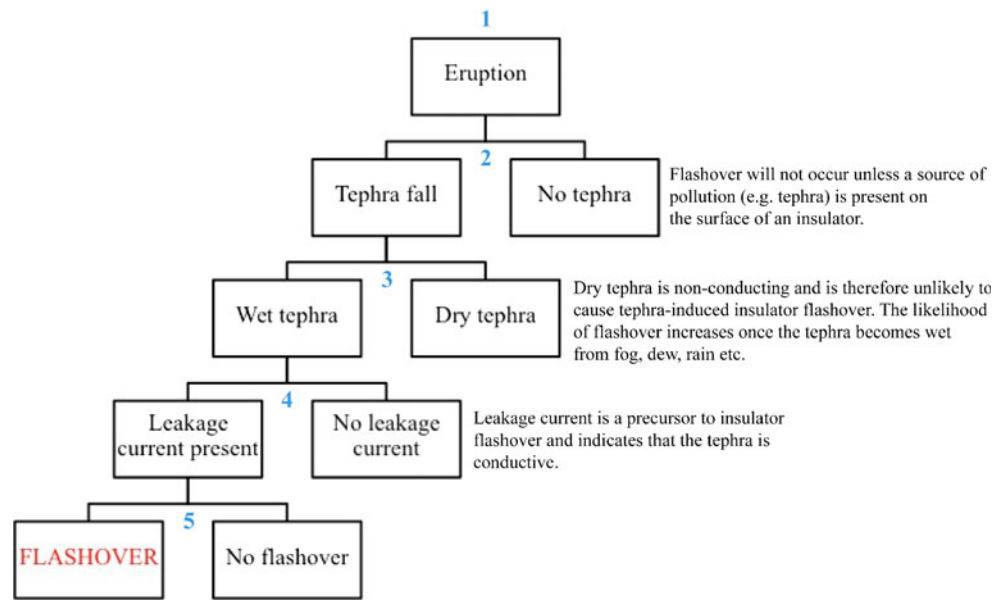
Fig. 8 Event tree showing the sequence leading up to tephra-induced flashover. At present, values for the likelihood of each event occurring at each node are not available to hazard managers or power system operators. The development of fragility functions will help to populate event trees such as this one with more robust data for interpretation

flashover to occur (Fig. 8). Each branch of the tree leads from a necessary prior event to a more specific outcome (e.g. from an eruption to a tephra fall). Several of the events are controlled by external factors, such as conditions at the volcano (eruption style), environmental conditions (wind direction and precipitation), design of the power system, prior contamination of system components, etc. Such information requires input at the time of risk assessment for a particular scenario. However, considering the lack of quantified data for events 3–5 (Fig. 8), our compiled review dataset of flashovers and tolerances allows us to create a fragility function that estimates the conditional probability of a flashover occurring for different tephra thicknesses. This simple, first-order approach is designed to aid system operators in assessing the allowable accumulations of tephra before initiating mitigation strategies.
