FULL-SCALE FIRE TESTS OF POST-TENSIONED TIMBER BEAMS

ABSTRACT: This paper describes a series of full-scale furnace tests on loaded post tensioned LVL beams. Each beam was designed to exhibit a specific failure mechanism when exposed to the standard ISO834 fire. In addition to the beams a number of steel anchorage protection schemes were also investigated. These included wrapping the ends in kaowool, using intumescent paint, covering the anchorage with fire rated plasterboard and covering the anchorage with timber (LVL). The results of the full-scale tests cover temperature distributions through the timber members during the tests, the temperatures reached within the cavity and those of the tendons suspended within the cavity, the relaxation of the tendons during the test, the failure mechanisms experienced, and a summary of the anchorage protection details and their effectiveness. Recommendations for the design of both post-tensioned timber beams and associated anchorages are also provided.

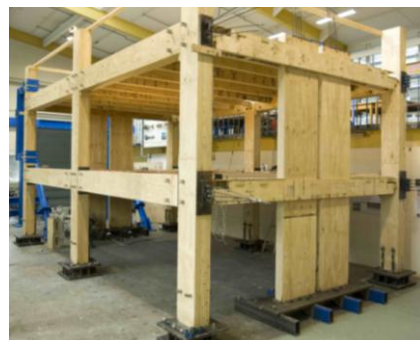
Figure 1: 2/3rd scale post-tensioned structure for seismic testing research at the University of Canterbury

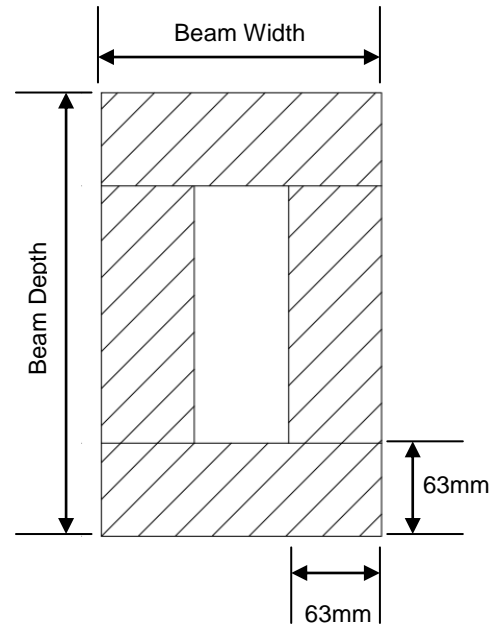
Figure 2: beam cross-section dimensions

Test 1 was a 426 mm deep and 300 mm wide box beam with 63mm thick webs and flanges. The tendons were stressed to a total post-tensioning force of 213 kN. Test 1 was expected to fail after 61 minutes of fire exposure with a shear failure in the bottom corner of the beam, as a result of the reduction of corner thickness due to corner rounding. The test included two Kaowool protected anchorages, two GIB board protected anchorages and two timber (LVL) protected anchorages.

The Test 2 beam was 236 mm deep by 190 mm wide, constructed with 63mm LVL. Test 2 was initially estimated to fail with mid-span combined bending and compression at approximately 43 minutes, which was later revised to 37 minutes, after design revisions. The failure was expected to manifest as crushing in the top fibres. The tendons were stressed with an overall post-tensioning force of 214 kN. The test included two intumescent protected anchorages.

Test 3 was designed after Test 2 failed prematurely. Its purpose was to demonstrate the bending and compression failure which Test 2 failed to show. The Test 3 beam was 300 mm deep by 190 mm wide, again constructed from 63 mm LVL. This beam was predicted to fail in combined mid-span bending and compression at approximately 53 minutes, due to combined bending and compression at the end of the beam due to the axial force and moment applied by the post-tensioning. The tendons were stressed with an overall post-tensioning force of 232 kN. The test included two intumescent protected anchorages and two unprotected anchorages.

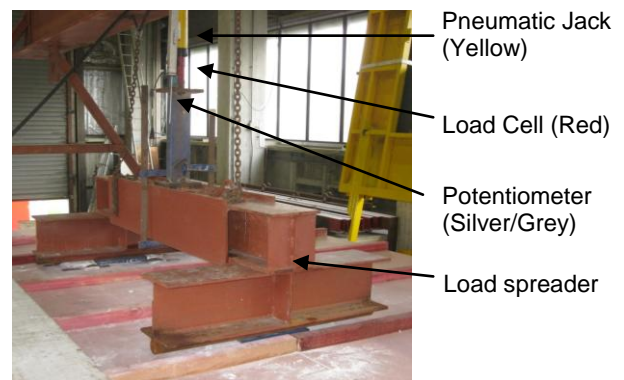
Figure 3: Load spreader bar, load cell, loading jack, and deflection potentiometer used during testing.

To ensure that loads were applied directly to the tested beam, holes were cut in the roof of the enclosure, on top of the beam, and steel plates were placed within them to carry the loads from the spreader beam. Loading was by a computer-controlled pneumatic pump which provided a constant load throughout the test. Eight load cells were used to monitor the loss of post-tensioning forces in the tendons; two were placed on two tendons in the main beam, while the remaining six were placed on the anchorage test members. A load cell measured the total load applied to the beam while a potentiometer was used to measure the deflection of the beam under its load point.

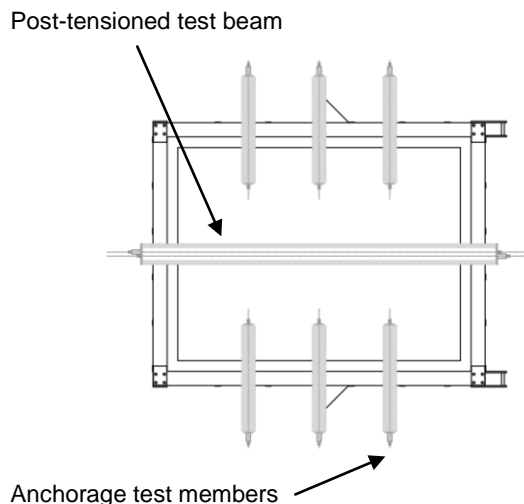
Figure 4: Typical test layout

To ensure that temperatures and pressures were maintained throughout the test furnace, an enclosure was built over the support frame and around the tested post-tensioned beam. In the first two tests, this was achieved by the use of gypsum plasterboard (GIB Fyrelite), while a Hebel block wall with a precast concrete lid was used for the third test. Loads were applied to the test beams, using a pneumatic jack pushing against a removable reaction "A" frame. A spreader bar distributed the load to into two concentrated loads at 1.5 m spacing (Figure 3). To test the performance of protection materials for post-tension anchorages, unloaded short post-tensioned members were attached through the sides of the built enclosure (Figure 4). Gaps were sealed with kaowool or fire rated mastic.

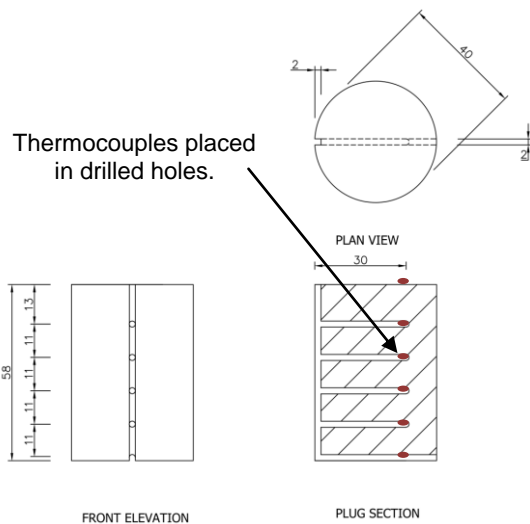
Figure 5: Thermocouple-plug orthographic

K-type thermocouples were used to measure temperatures through the thickness of the timber. A number of thermocouple “plugs” were used. Each plug was 40mm in diameter and 58 mm long. Six holes were drilled into the plug for thermocouples to be placed in. A groove was also cut down the side of the plug to allow for the thermocouple wire. An orthographic drawing of a thermocouple plug is presented in Figure 5, and one of the plugs (before installation) is shown in Figure 6.

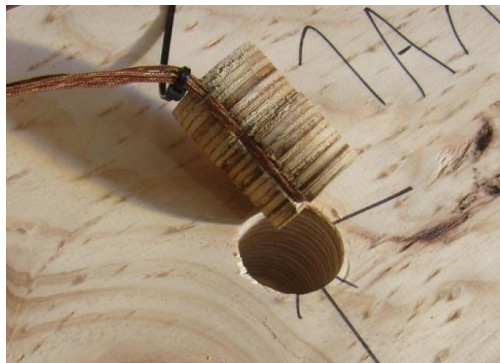
Figure 6: Thermocouple plug and associated hole

These plugs were glued into specially drilled holes in the webs and bottom flanges of each main test beam using the same resorcinol glue which was used in the fabrication of the beams. The holes were drilled with a 41 mm forstner bit which creates a flat bottomed hole. The holes needed to be drilled at the time of fabrication of the beams as there would be no access to the areas after the box beams had been glued together.

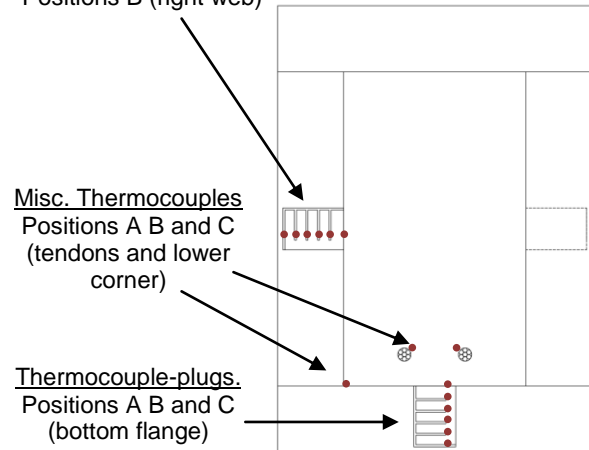
Thermocouple-plugs.
Positions A and C (left web)
Positions B (right web)

Figure 8: Thermocouple-plug placement in cross-section

Thermocouples in the main beams were placed at three positions along the length of the beam: positions A, B and C. Position B is at the mid-span of the beam, position A is 1 m to the left of position B and position C is 1 m to the right, as illustrated in Figure 7 and Figure 8. A plug was placed in the bottom flange of each beam at positions A, B and C, in the left web in positions A and C, and in the right web in position B. A thermocouple was also placed in one of the lower corners of the beam cavity at positions A, B and C. Each tendon in the main beam specimens had a thermocouple attached at positions A, B and C.

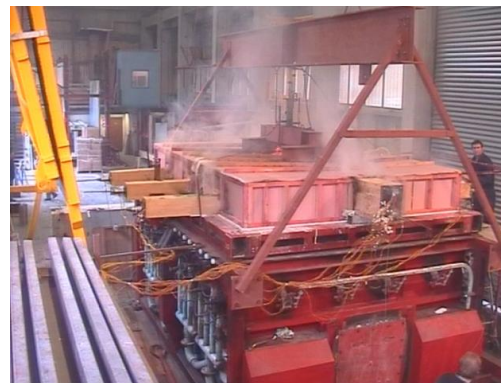
Figure 9: Furnace during the testing of Test 1

the A-frame was clear of the test and the crane became available the test frame and specimen were lifted off the furnace and suspended above the workshop floor where they could be hosed down to cool the members and stop the charring and any continued burning. It took about 5-10 minutes from the end of the test till the test specimens could be hosed down. The specimen was then inspected. Once the specimens were cool enough to handle samples were cut from the beams for later analysis. Some of the anchorage test members, with various anchorage protection details, still had much of their post-tensioning stress at the end of the test, and required careful de-stressing. Figure 9 shows the A-frame over the loaded specimen during the fire test.

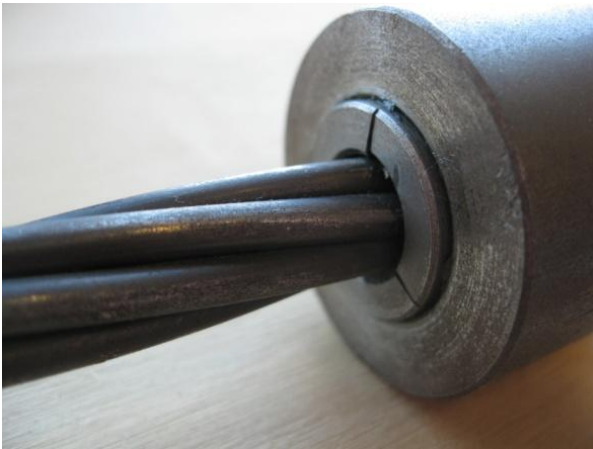
Figure 10: Post-tensioning tendon, and barrel and wedge system used for full scale testing

The tendons used for these tests were 12.7 mm nominal diameter, 7-wire strand (Figure 10), as used in post-tensioned concrete systems. Likewise, the barrel and wedge anchorage system was developed for application in post-tensioned concrete. The anchorages and tendons were supplied by BBR Contech. Tendon properties are listed in Table 2.

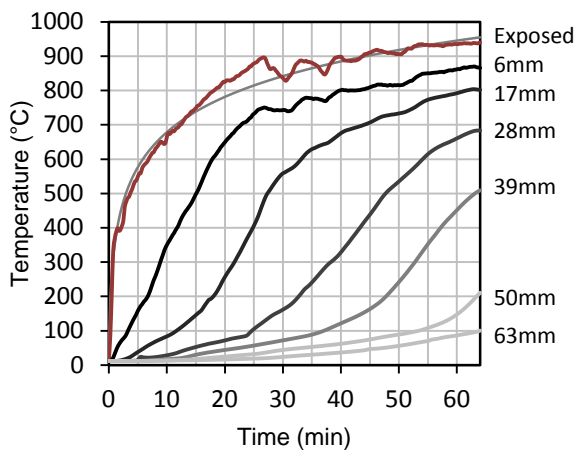
Figure 11: LVL temperature distribution in web of Test 1. Temperatures are presented for various depths below the original LVL surface.

Beneath the surface, the temperatures slowly approached 100 °C and rapidly increased in temperature after 100°C was reached, most likely due to moisture migration and evaporation in the timber.

The bottom flanges heated slightly more quickly than the webs. Two possible explanations for this are that the flange partially shields the web from some of the furnace and therefore receives more radiation, or that the width of the beam became small enough that the two-dimensional heat transfer served to increase the temperature more quickly.

The temperature of the inside face of the LVL did not rise beyond 100°C whilst the beams were still intact. The temperature distribution of the web at various times for the beam in Test 1 is presented in Figure 11. This was typical for all tests.

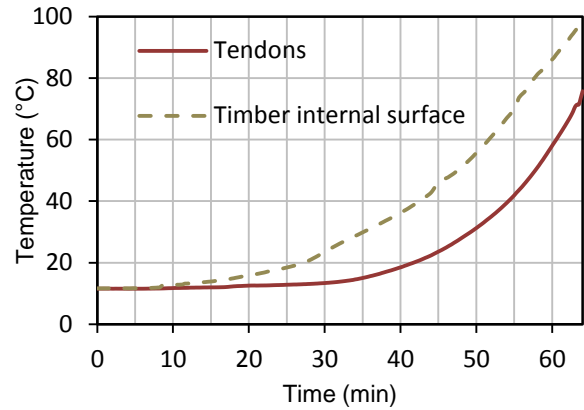
Figure 12: Average temperature of the post-tensioning tendon and the internal surface of the timber cavity of Test 1. Internal surface profile presented as recorded in the lower corner of the cavity.

As the timber sections charred, the inside face of the section became warmer. The tendon within the cavity also increased in temperature. In none of the experiments did the tendons nor the interior internal timber surfaces become hotter than 100°C before failure. In Test 1 the timber surfaces reached 100°C at 64 minutes just before failure whereas the tendon had only reached 75°C. After 45 minutes the internal timber surface was approximately 25-30°C hotter than the tendon. However the tendon temperature may have partially caught up with the timber temperature if the test progressed longer than 64 minutes. The temperature of the internal surface and the tendon are presented in Figure 12.

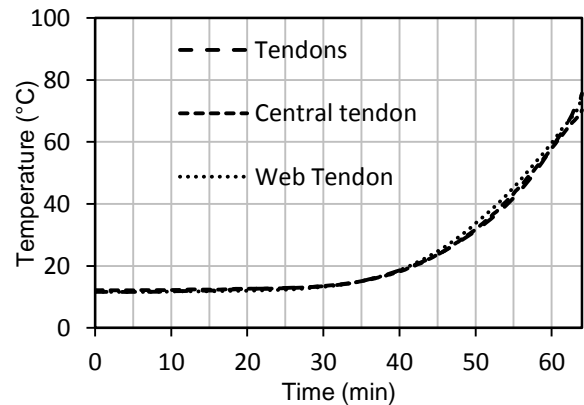
Figure 13: Temperature profiles for different tendon positions.

The position of the tendon within the cavity in Test 1 showed little effect on its temperature. The positions, near the bottom flange, near the web and near the centre of the cavity, showed a maximum temperature difference of 2 °C. The temperature profiles for the tendon at various positions are presented in Figure 13.

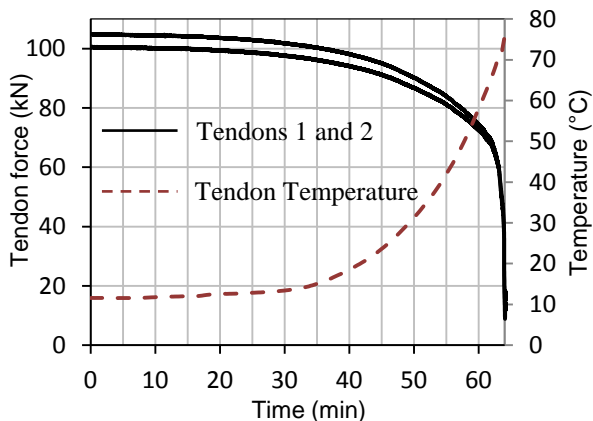
Figure 14: Tendon post-tensioning force and tendon temperature during Test 1.

During Test 1 the tendons had lost approximately 25% of their initial applied stress at 60 minutes. At this time the tendon temperature was approximately 58°C. Before 30 minutes of fire exposure both the temperature and

post-tensioning force were only negligibly affected by the fire. Figure 14 shows the tendon force and temperature of the tendons within the beam in Test 1.

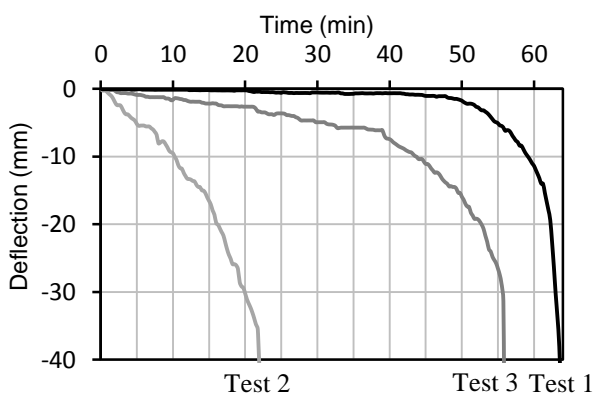
Figure 15: Vertical deflections of the main test beams.

During Test 1 the deflections remained in the order of 0.5 mm-1 mm for the first 45 minutes. Beyond this the deflections started to increase steadily until approximately 64 minutes, where a runaway deflection occurred. The deflections measured during each test are presented in Figure 15.

During Test 2 the deflections increased at an approximately constant rate for 15 minutes, and then increased slightly until failure at 22 minutes. The mechanism of failure was different to what was predicted and occurred earlier than expected. The top flange suddenly disconnected from the rest of the beam. The deflection profile reflects this with rapidly increasing deflections early in the test.

The deflection profile during Test 3 was similar to Test 1. However, due to the beam being a smaller size, deflections were greater. The deflections increased approximately linearly for the first 40 minutes of the test. The rate of deflection then increased over the last 16 minutes of the test. At 56 minutes and approximately 30 mm of deflection the beam failed.

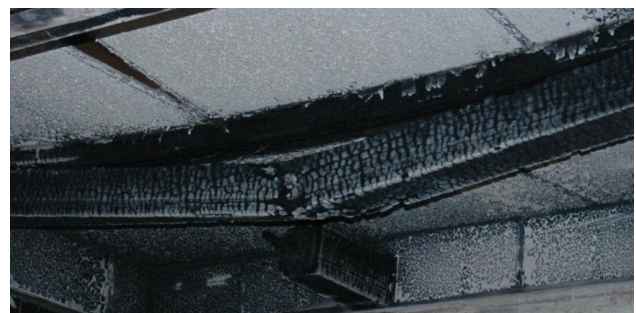
Figure 21: Test 2 beam after the test.

Test 2 failed unexpectedly early. The top flange detached from the webs along most of the length of the beam. One end of the beam remained intact whereas at the other end the flange detached all the way to the end of the beam. The bottom section of the beam formed a channel which crushed near the mid-span of the beam, due to the post-tensioning compression and the compression due to bending. This formed a plastic hinge at the mid-span of the beam which meant only the weaker top flange was capable of carrying any load, causing the beam to fail. This plastic hinge resulted in localized buckling of the web, forcing the webs outward. Figure 20 and Figure 21 show Test 2 after failure. The premature failure of Test 2 led to design method improvements which incorporated the effect of axial loads on a deflected member more accurately.
