COMPOSITES, PART B, VOL. 33, 2002, 355-366**THE MECHANICAL PERFORMANCE OF REPAIRED STIFFENED PANELS:
PART II - FINITE ELEMENT MODELLING**

In this paper the finite element modelling under compressive static load of I-section stiffened panels is reported. A pristine panel is compared with panels containing simulated damage and repaired panels. Predicted stiffness, stress distributions and strength of the panels are compared with experimental results.

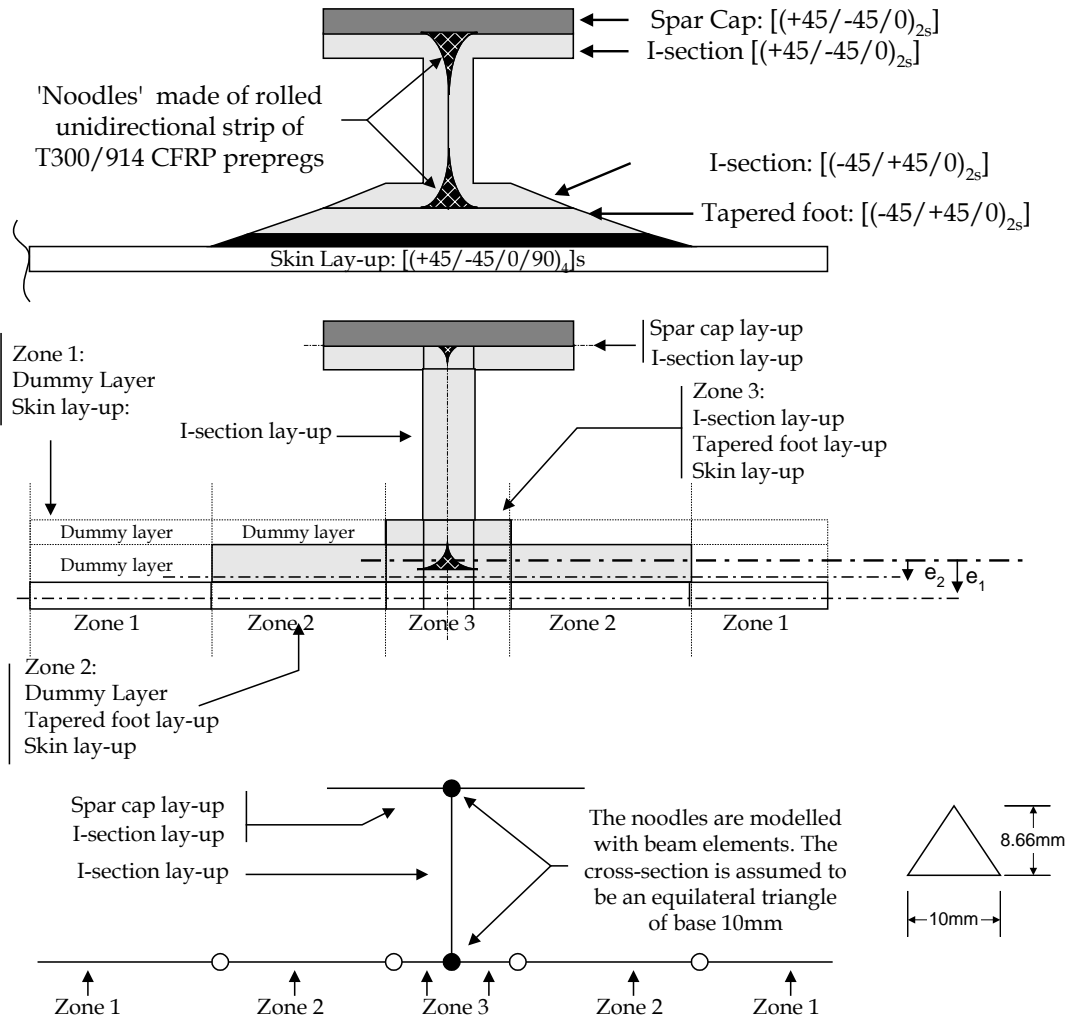
Figure 1: Cross-sectional view of the skin-stiffener attachment and its equivalent shell element modelling approach

The cross-section of the skin/stiffener junction was separated into three zones. The first zone consisted of the skin of the panel, the second consisted of the skin and the tapered foot of the stiffener, and the third zone consisted of the skin, the tapered foot and the base of the stiffener's I-section. Because of the different thicknesses and lay-ups of the sections, an appropriate number of 'dummy' layers was added in zone 1 and zone 2 to make up the maximum number of layers; the numbers of layers then being the same across the entire model. The material in the 'dummy' layers had very low stiffness properties, so that they would not influence the behaviour of the structure.

bending of the structure; an eccentricity e_1 and e_2 was defined for the sections in zone 1 and 2, respectively (i.e. $e_1=0.915\text{mm}$ and $e_2=1.83\text{mm}$), as shown in Figure 1.

The two triangular sections in the stiffeners that are seen in Figure 1, made of strips of rolled unidirectional CFRP prepregs, called ‘noodles’, were also modelled. The noodles were modelled as triangular sections using 3D beam elements (BTS3). It is noted that the BTS3 elements do not support composite properties, and they were therefore modelled as isotropic solids. The beams were placed so that they connect the stiffeners to the skin, and the top of the stiffeners to the web of the stiffeners as shown in Figure 1.

The skin and the stiffeners were modelled using quadrilateral, linear, thick shell elements (QTS4). The QTS4 elements are capable of modelling composite properties as well as geometric non-linearity. For these elements five degrees of freedom (three translations and two in-plane rotations) are usually associated with each node. However, these elements may be used for modelling intersecting shells (i.e. stiffened shell structures) where the shells may be connected to three-dimensional (3D) beam elements, and in this instance six degrees of freedom are automatically defined. Some simplifications have, however, to be taken into account in order to model the skin-stiffener attachment. Figure 1 shows a cross-section of the skin-stiffener junction, as well as its FE idealisation.

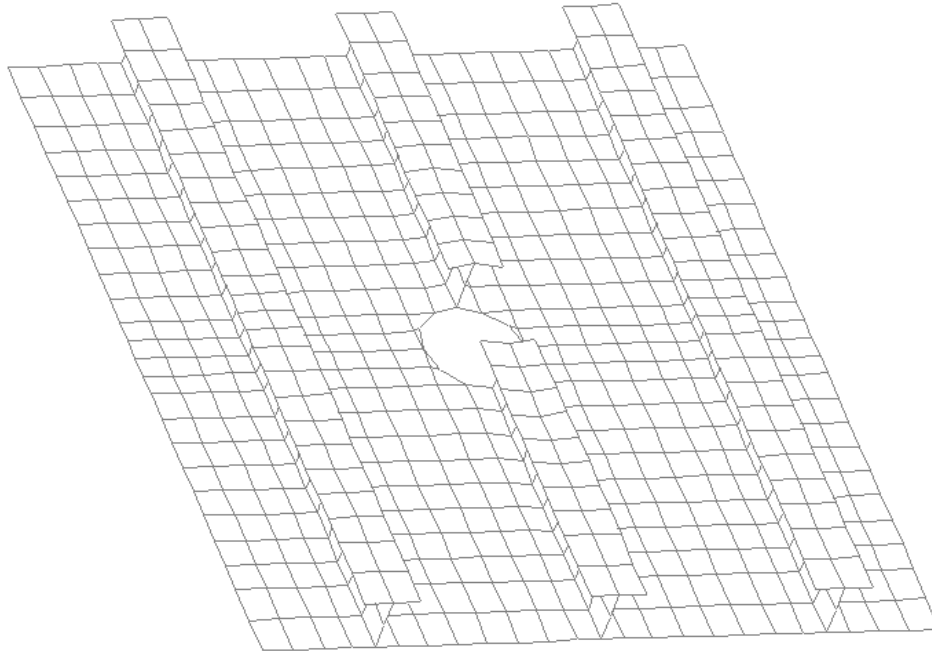
The mesh used for the panel damaged with a through-hole (P2) was identical in principle to that for the undamaged panel and is shown in Figure 2. The geometry and the mesh spacing has been altered appropriately to take into account the cut-out. The majority of elements for the skin and the stiffeners were quadrilateral elements (QTS4), with a few three-node triangular elements around the hole.

Figure 2: Finite element mesh of the damaged panel (P2)

For the panel with a repaired through-hole (P4), the patch was simplified in the FE model in order to avoid using an excessive number of elements. The modelling approach used is identical in principle to the one described above. As the two side stiffeners were unaffected by the damage and the repair, they were therefore modelled as was shown in Figure 2.

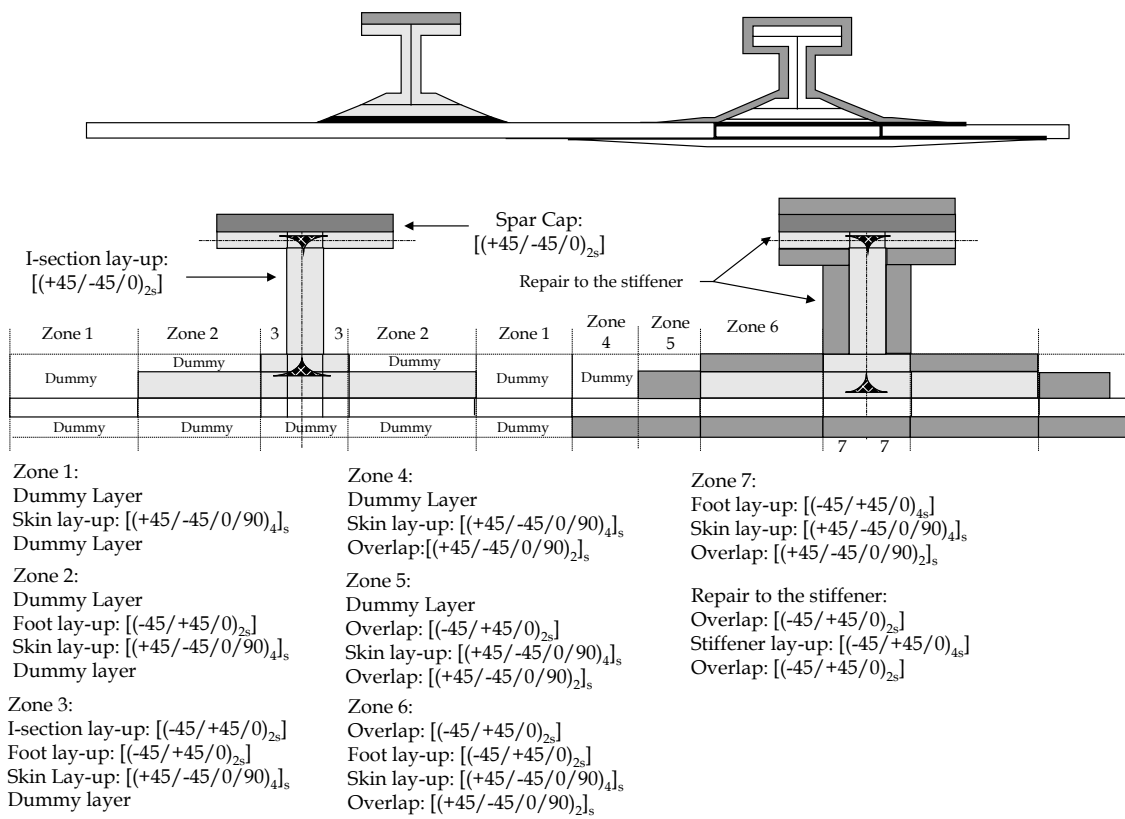
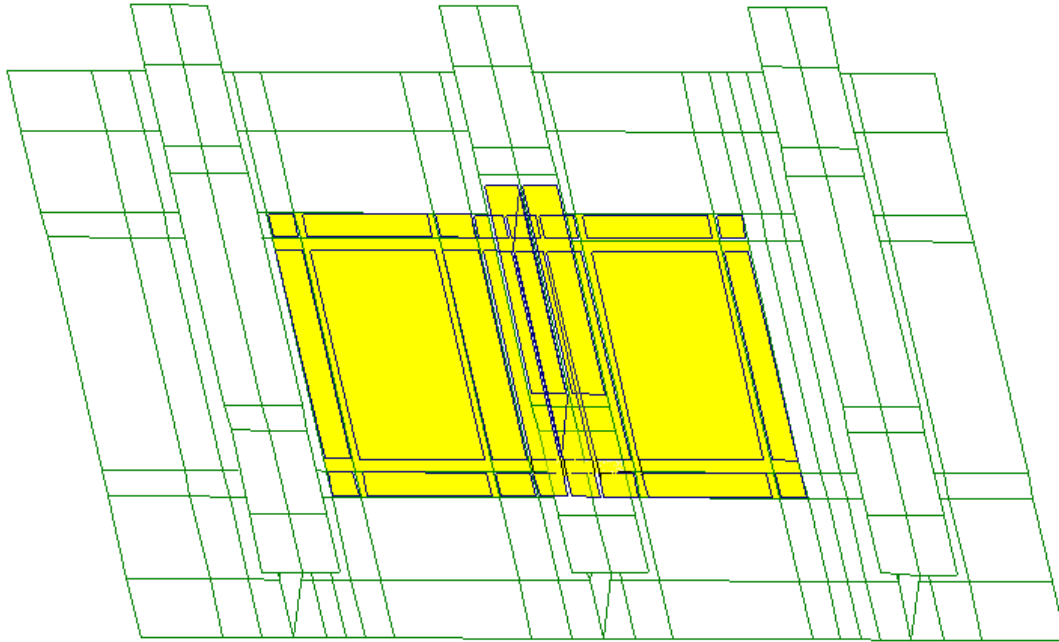
However, the lay-up of the panel around the central stiffener had to take into account the repair patches. The panel was again separated into zones as shown in Figure 3. Because of the different thicknesses and lay-ups of the sections, an appropriate number of 'dummy' layers was added in the different zones to make up the maximum number of layers. The offset in the local neutral axis introduced by the patch was modelled. The material that comprises the patch was assumed to have properties identical to the parent materials, as defined in Table 1.

In Figure 3, the area affected by the repair patch (on the stiffener side) is shown highlighted. The mesh for the repaired panel was identical to the mesh for the undamaged panel.

Figure 3: Cross-sectional view of the skin-stringer attachment on the repaired panel and its equivalent shell elements modelling approach
(the area covering the overlap repair patch is highlighted)

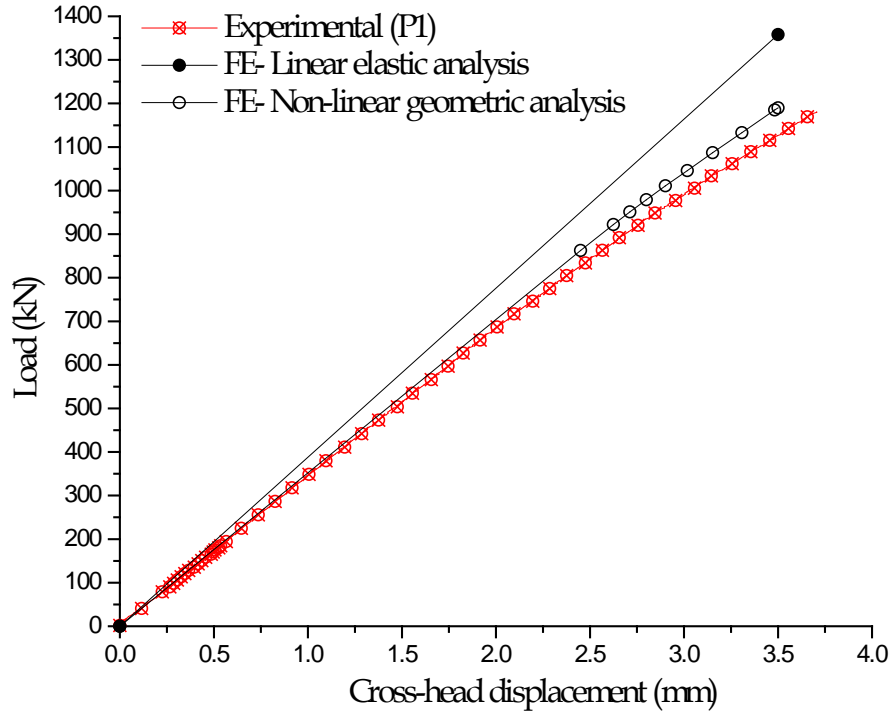
The load-displacement curves obtained from the linear and non-linear elastic FE analyses are compared in Figure 5 with experiment data [1]. The non-linear results show good correspondence with the experimental load-displacement curve. Only when the applied displacement approaches the failure displacement do the curves diverge slightly, and this may be due to progressive damage developing in the panel that was not modelled in the present analysis. On the other hand, it may be seen that the linear elastic analysis yields a stiffer prediction. The experimental and linear elastic curves correspond for small applied displacement, i.e. below 0.5mm, after which they separate. The correspondence of all the curves at low applied displacement was to be expected since non-linear geometry and damage evolution are only likely to have an effect at higher applied displacements.

Figure 5: Experimental and computed load-displacement curves (panel P1)

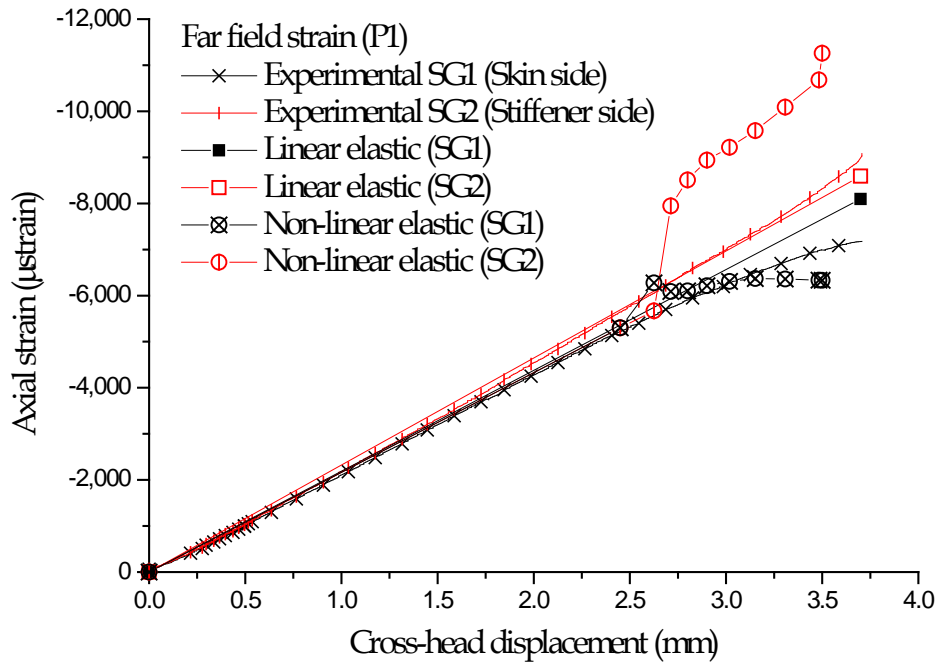
The experimentally measured back-to-back far field strains at the edge of the panel (SG1 and SG2) [1], are compared with strains obtained from the FE analyses in Figure 6. The strains on the skin and stiffener sides are shown for comparison. The averaged FE strains were for an element located 130mm from a loaded end, and 15mm from an unsupported edge (i.e. the location of the SG1 and SG2 strain gauges).

Although the experimental and computed strains were comparable at low applied displacement, the predictions diverged above 2.6mm applied displacement with the SG1 values being better predicted by the non-linear analysis, and the SG2 values by the linear analysis. The non-linear elastic analysis indicates that the panel buckled at about 2.6mm

applied displacement. Such a pronounced deviation in the strains was however not observed experimentally.

Figure 6: Experimental and computed strain-displacement curves (panel P1)

Since the strain gauges measure strains averaged along their 6mm length, there will be a limit to the ability of strain gauges to accurately record the strain field. Indeed, if the gradient in strains along the buckled edge is large, this will lead to differences when comparing calculated FE strain outputs with experimental strains, as was shown in Figure 6. The location of the strain gauge will also be of importance.

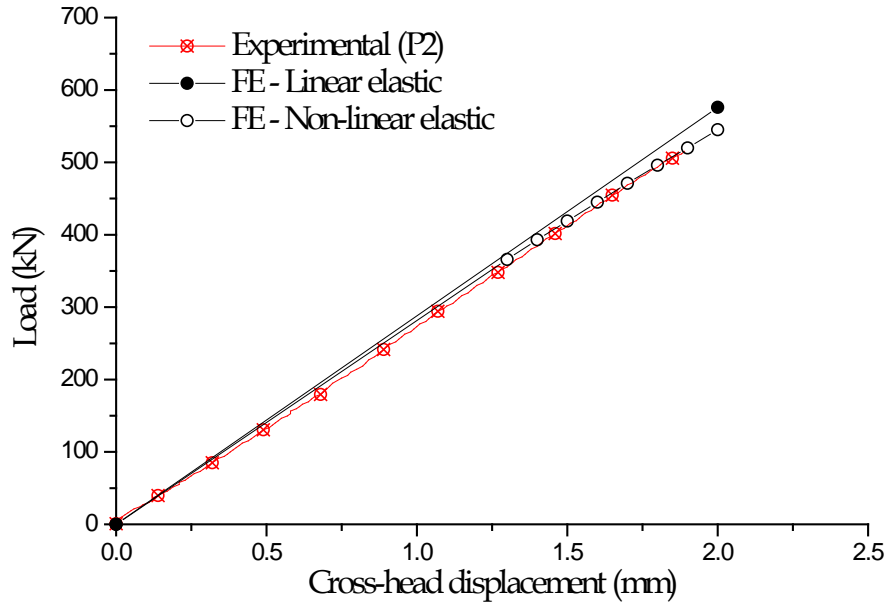
The linear elastic and the non-linear elastic load-displacement predictions are compared with experiment in Figure 8. An excellent agreement is seen between the non-linear elastic FE and the experimental responses. The agreement is still very good between the linear elastic FE and experimental responses, although the curves diverge when approaching the failure displacement. It is recalled that, in Figure 7 the deformed meshes of the damaged panel showed only minimal deformation at the unsupported edges; the panel was not predicted to buckle and this may explain the good agreement between the FE and experimental results.

Figure 8: Experimental and computed load-displacement curves (panel P2)

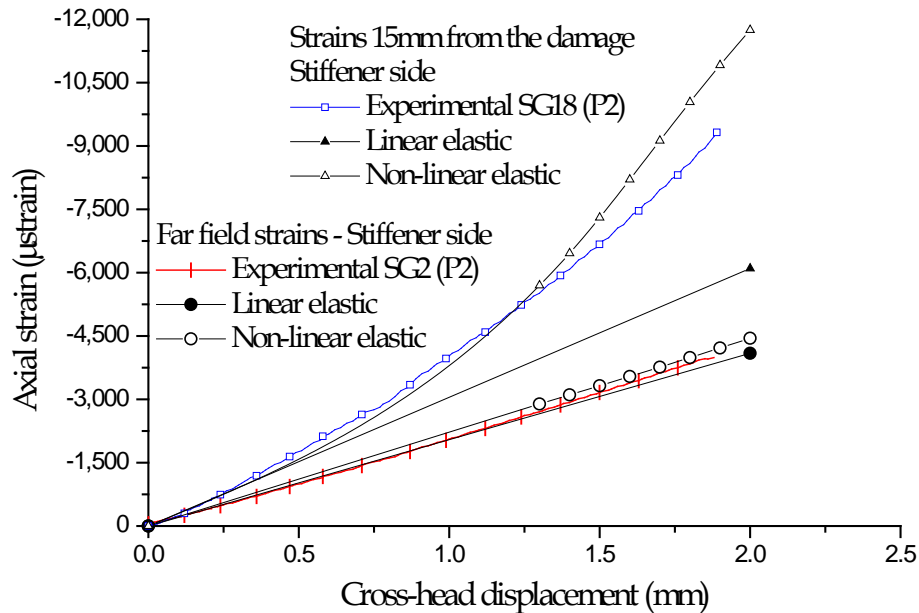
It was found [1] that the experimental strains recorded at 15mm from the cut-out (SG18) were 2.4 times the far field strain (SG2). For clarity, only the experimental and FE strains on the stiffener side are compared in Figure 9.

It may be seen in Figure 9 that both the linear and non-linear FE and the experimental far field strains (SG2) are in very good agreement. However, the choice of analysis (i.e. linear or geometric non-linear) has had an influence on the prediction of strains near the cut-out. The experimental (SG18) and linear FE strains seem to agree for low applied

displacements, although the curves diverge significantly above 0.5mm displacement. The damaged panel was seen in Figure 7 to deform significantly at its centre, which resulted in the increase in strain around the damage. It may be that the linear analysis is inadequate in this case because of the large deformation occurring at the centre of the panel. Indeed, the non-linear FE analysis may be seen, in this case, to lead to the better predictions, although the strains at failure are over-predicted significantly (see below).

Figure 9: Experimental and computed strain-displacement curves (panel P2)

To estimate the failure displacement only results from the geometrically non-linear FE analysis were used, since the agreement between the experimental values and the predicted linear FE axial strains near the cut-out was poor (see Figure 9). The stress resultants at the edge of the cut-out for an applied displacement of 1.88mm (i.e. the experimental displacement at failure) are shown in Table 3.

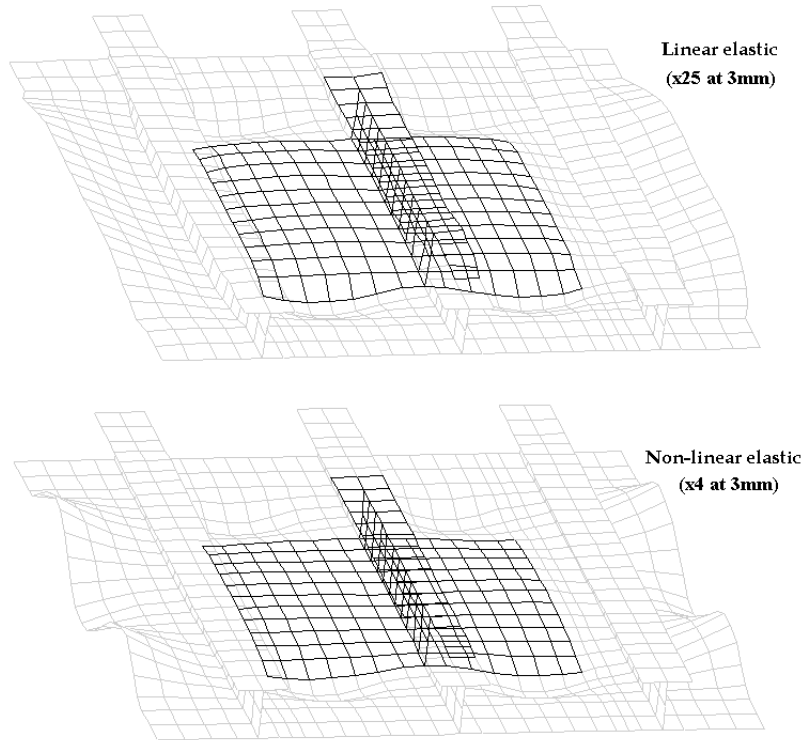
The deformed meshes for the repaired panel may be seen in Figure 10. The deformation is more complex than for the undamaged and damaged panels. The portion of the panel covered by the overlap repair patches (i.e. the region highlighted by the darker mesh) remains fairly flat. The extra thickness provided by the patches stabilises the centre of the panel. The portions of skin bay between the potted ends and the repair patch deforms significantly out of the panel's plane; four 'pockets' may be seen to have formed at these regions. However, these 'pockets' do not result from buckling deformation, but rather from the transition between the thick, patched area, to the unsupported thin skin area. The only noticeable difference between the deformed meshes from the linear and non-linear analyses may be seen at the unsupported edges of the panel. The unsupported edges are predicted to remain flat or to buckle according to whether a linear or a non-linear elastic analysis is done; a conclusion similar than for the undamaged panel. It is noted, however, that only three half-wavelengths are now predicted, rather than four for the undamaged panel.

Figure 10: Finite Element meshes of deformed repaired panels

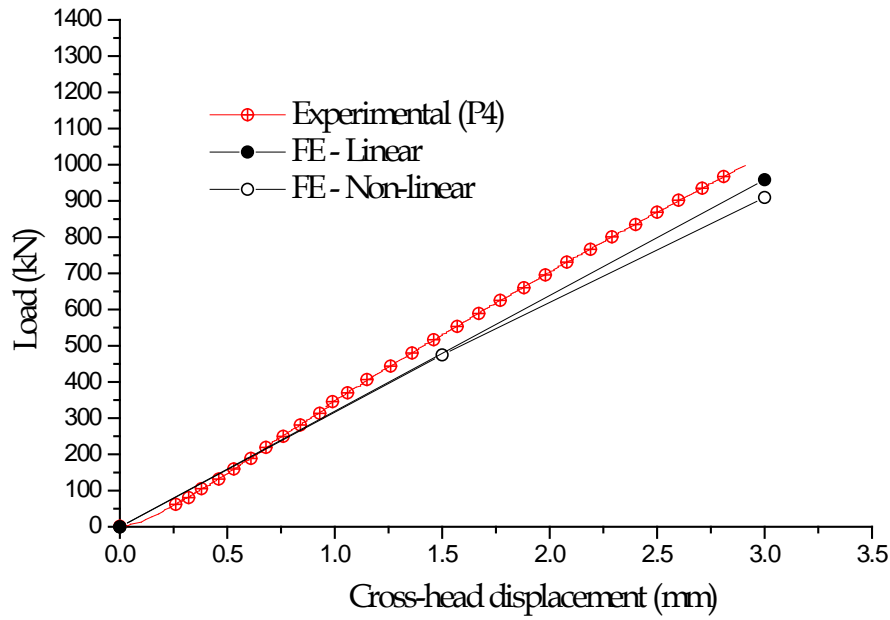
When the linear elastic and the non-linear elastic FE responses for the repaired panel are compared with experiment, the load-displacement slopes of the FE results show very good agreement with experiment. However, the experimental load-displacement curve has an s-shape, and as a result crosses the calculated FE responses for applied displacement between 0.5 and 1mm. The agreement with experiment is nevertheless very good if the slopes of the curves are compared, as shown in Figure 11.

Figure 11: Experimental and computed load-displacement curves (panel P4)

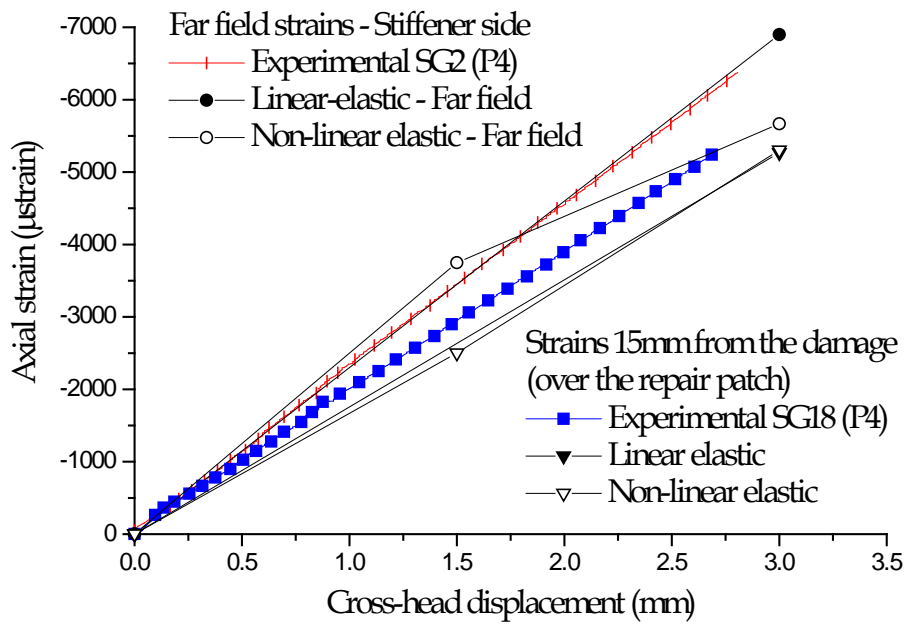
The strains in the repair patch (e.g. SG18) are lower than the far field strains (e.g. SG2) [1] since the excess material provided by the patch protects the damaged area and results in a decrease in strain in the vicinity of the cut-out. The predicted far field strain from the linear elastic analysis was in good agreement with experiment. The prediction from the non-linear elastic analysis, however, was not quite so good, as seen in Figure 12.

Also, the predicted strains in the repair were calculated to be lower than the measured strains. This may be as a result of the modelling approach. In [1] it was shown that the repair patch was graded in size to avoid excessive development of peel stresses at the overlap edge. The patch was, however, idealised in the FE model with a constant thickness and as a result leads to a stiffer prediction than experiment. It is noted that a finer idealisation of the repair patch is possible, although with an associated extra degree of complexity in the model.

Figure 12: Experimental and computed strain-displacement curves (panel P4)
