## Correlation Between Fracture Mechanics Parameters and Fracture Characteristics in Austenites

A. Seibold  
*Kraftwerk Union AG*

CORRELATION BETWEEN FRACTURE MECHANICS PARAMETERS AND FRACTURE CHARACTERISTICS  
IN AUSTENITES

Kraftwerk Union AG,  
Postfach 23 20  
8520 Erlangen  
West Germany

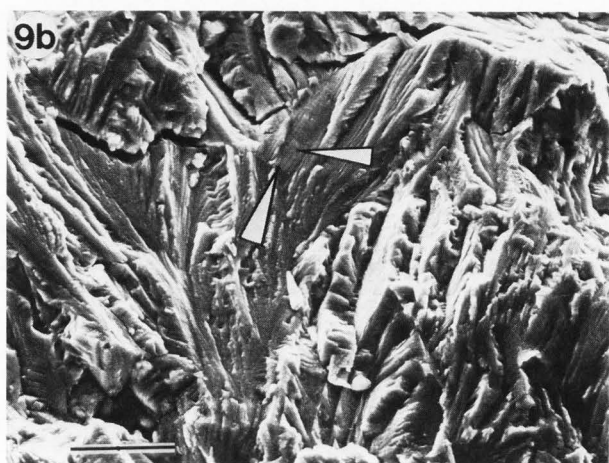
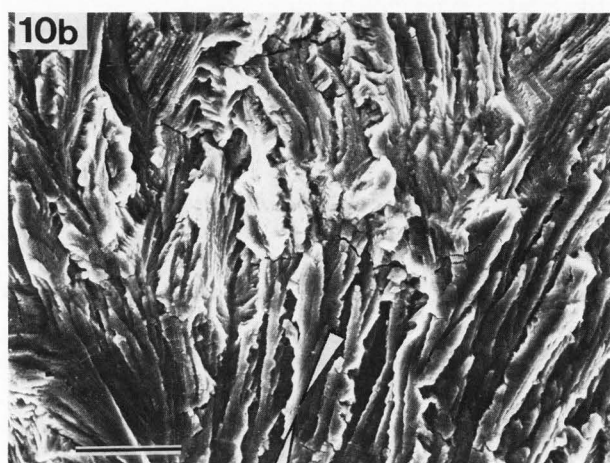
Figs. 10a and 10b: Fatigue striations (arrows) within a fan-like structure, secondary cracks at  $\Delta K = 600 \text{ N/mm}^{3/2}$ ,  $f = 0.1 \text{ Hz}$

Figs. 9 and 10: Fracture characteristics as a function of  $\Delta K$ -value at  $T = 200 \text{ }^\circ\text{C}$  and  $R = 0.2$ .

Bar =  $20 \text{ }\mu\text{m}$  (in figs. 9a and 10a);  $10 \text{ }\mu\text{m}$  (in figs. 9b and 10b).

The number of secondary cracks and the distance between fatigue striations increase at higher  $\Delta K$ -values (Fig. 10). At these  $\Delta K$ -values of about  $600 \text{ N/mm}^{3/2}$  the crack growth rate calculated from striation spacing is in good agreement with the macroscopic crack growth rate. (At lower  $\Delta K$ -values the calculated crack growth rate is higher than the macroscopic one.)
