## COMBINED EFFECT OF COMPOSITION AND SURFACE CONDITION ON CORROSION BEHAVIOUR OF MAGNESIUM ALLOYS AZ31 AND AZ61

Alejandro Samaniego<sup>a</sup>, Irene Llorente<sup>a</sup> and Sebastián Feliu (Jr)<sup>a</sup>.

Centro Nacional de Investigaciones Metalúrgicas CSIC, Avda. Gregorio del  
Amo 8, 28040 Madrid, Spain, (e-mail: [sfeliu@cenim.csic.es](mailto:sfeliu@cenim.csic.es)).

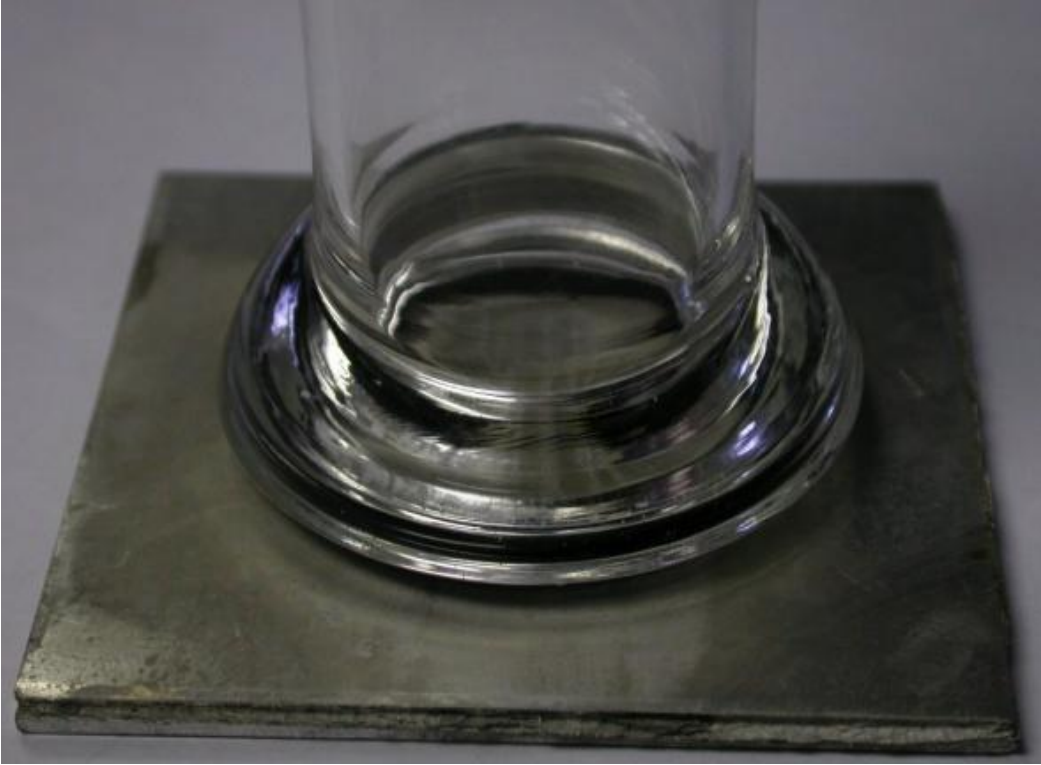
Figure 1.

**Fig. 1.** Detail of the joint between square test specimen and cylindrical cell limiting the exposed area.

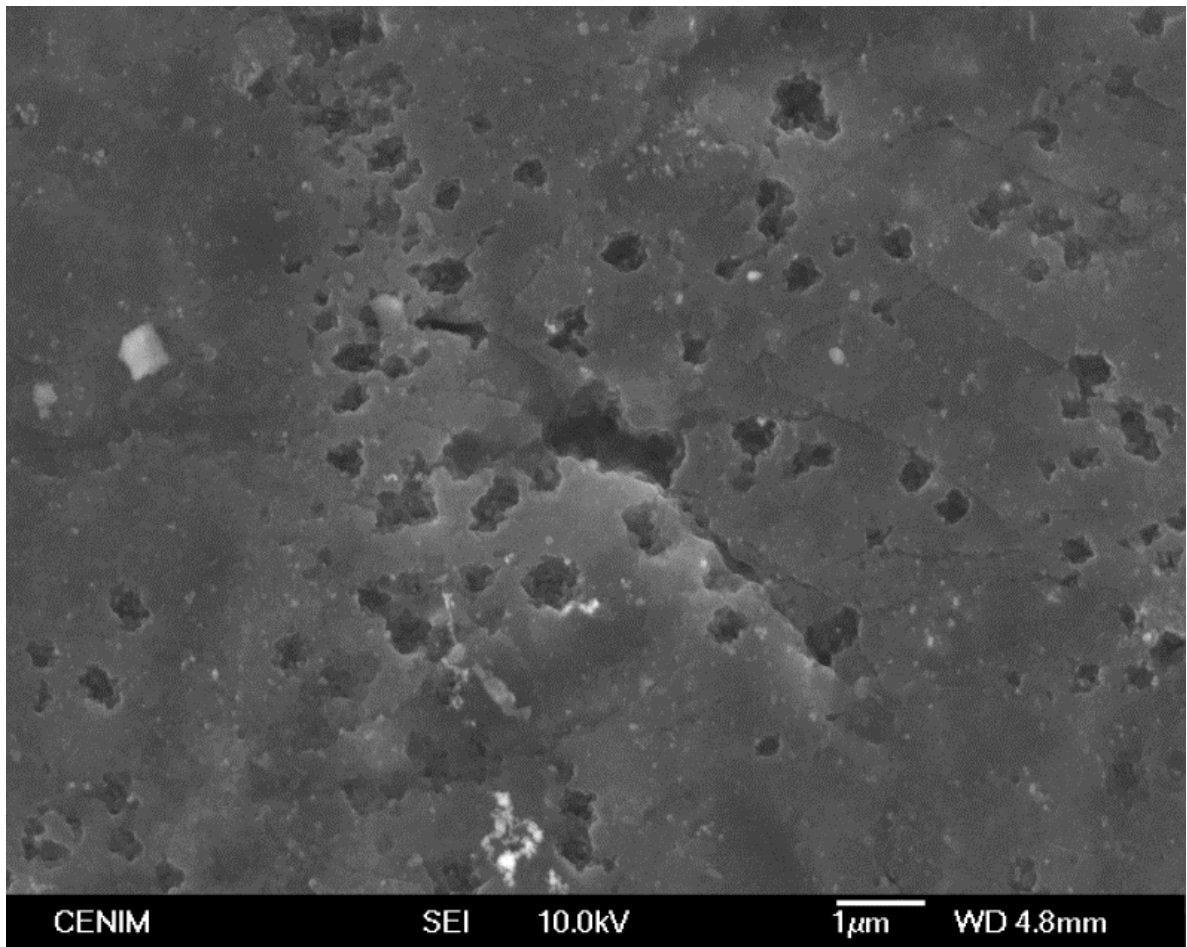
Figure 2

**Fig. 2.** Presence of sub-micron pits on the corroded surface of the tested specimen.

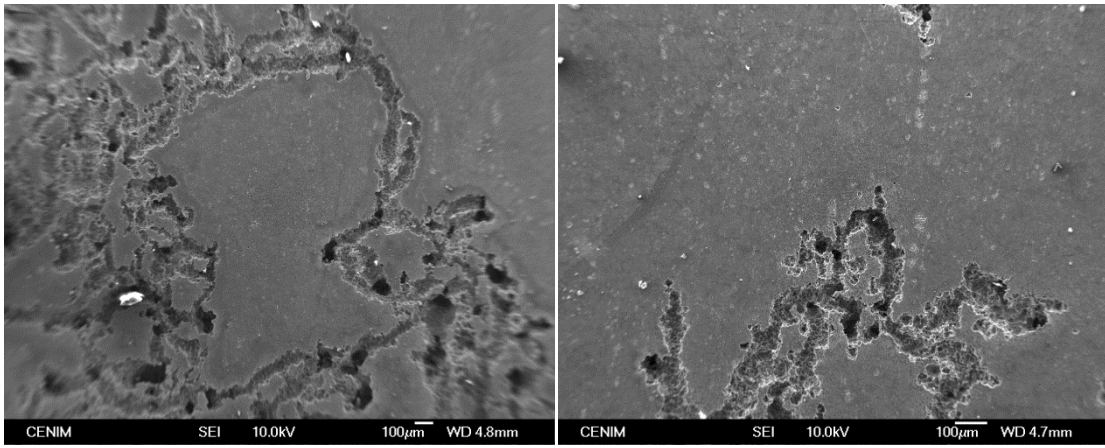
Figure 3

**Fig. 3.** Holes of localised attack (dark spots) distributed on the filament grooves left by filiform corrosion after the removal of corrosion products.

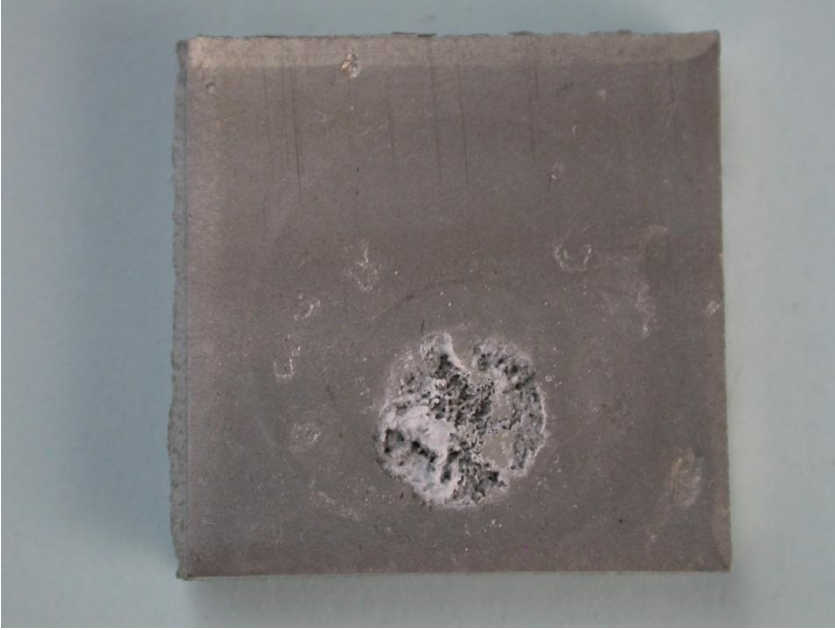
Figure 4

**Fig. 4.** Pits and open cavities on the exposed circular area.

(e.g. morphology in Fig. 6). In the case of the small exposed area, variety of localised forms, including pitting and some open cavities.

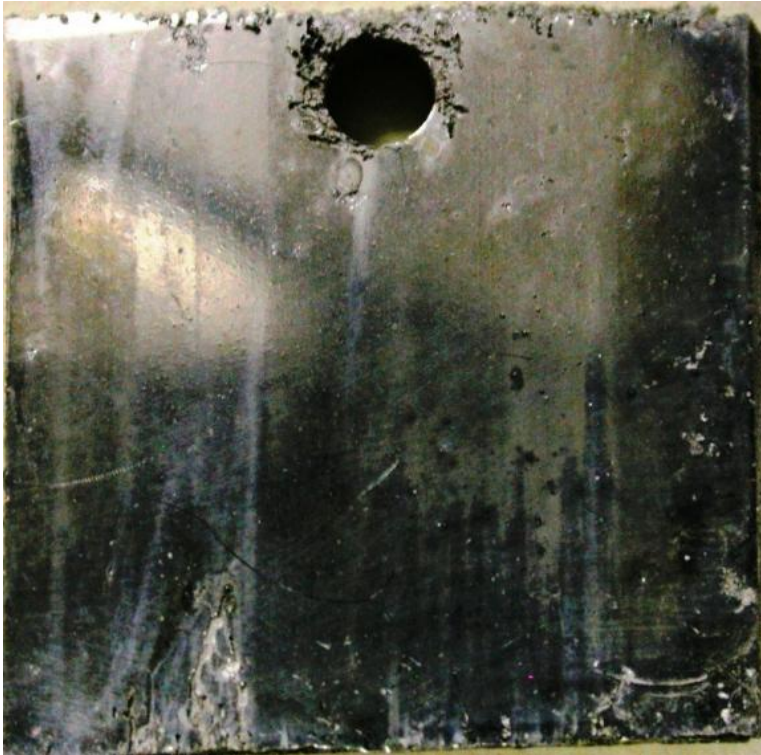
Figure 5.

**Fig. 5.** Uniform attack with some signs of filiform corrosion close to the drilled hole.

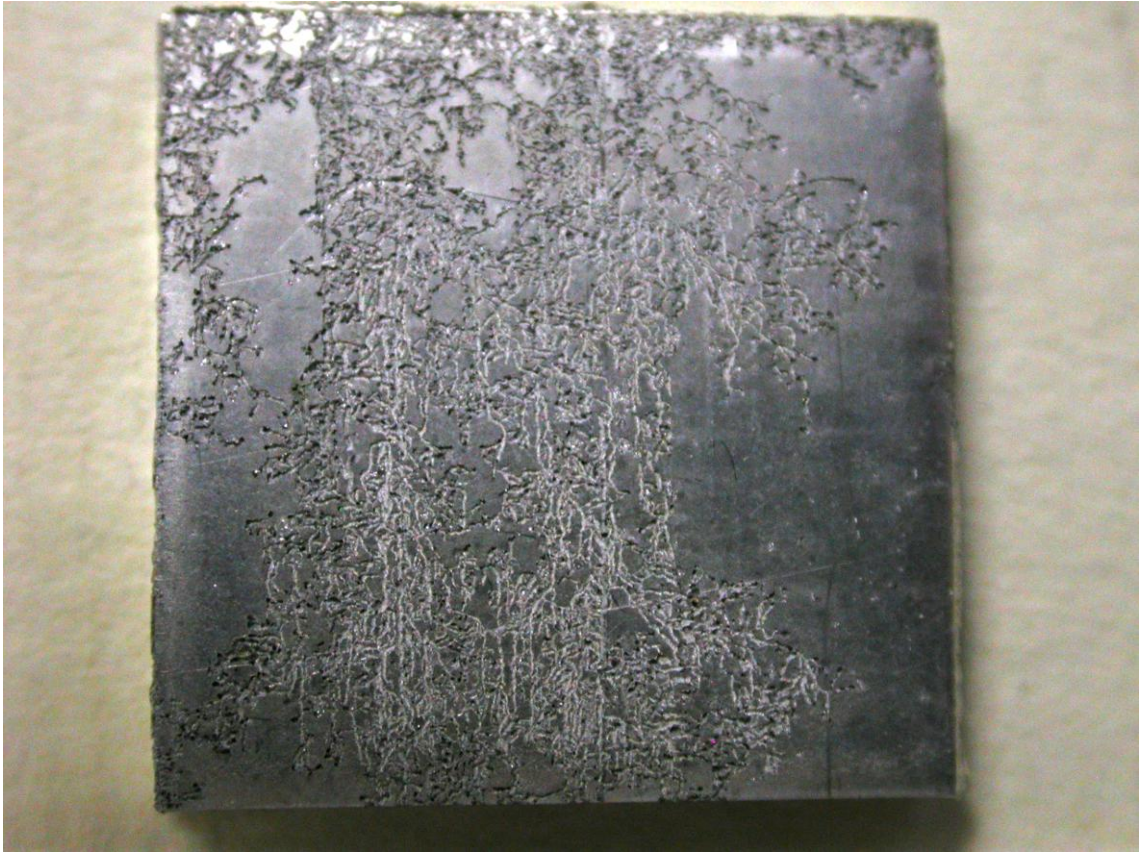
Figure.6

**Fig. 6.** Extensive areas of filiform corrosion.

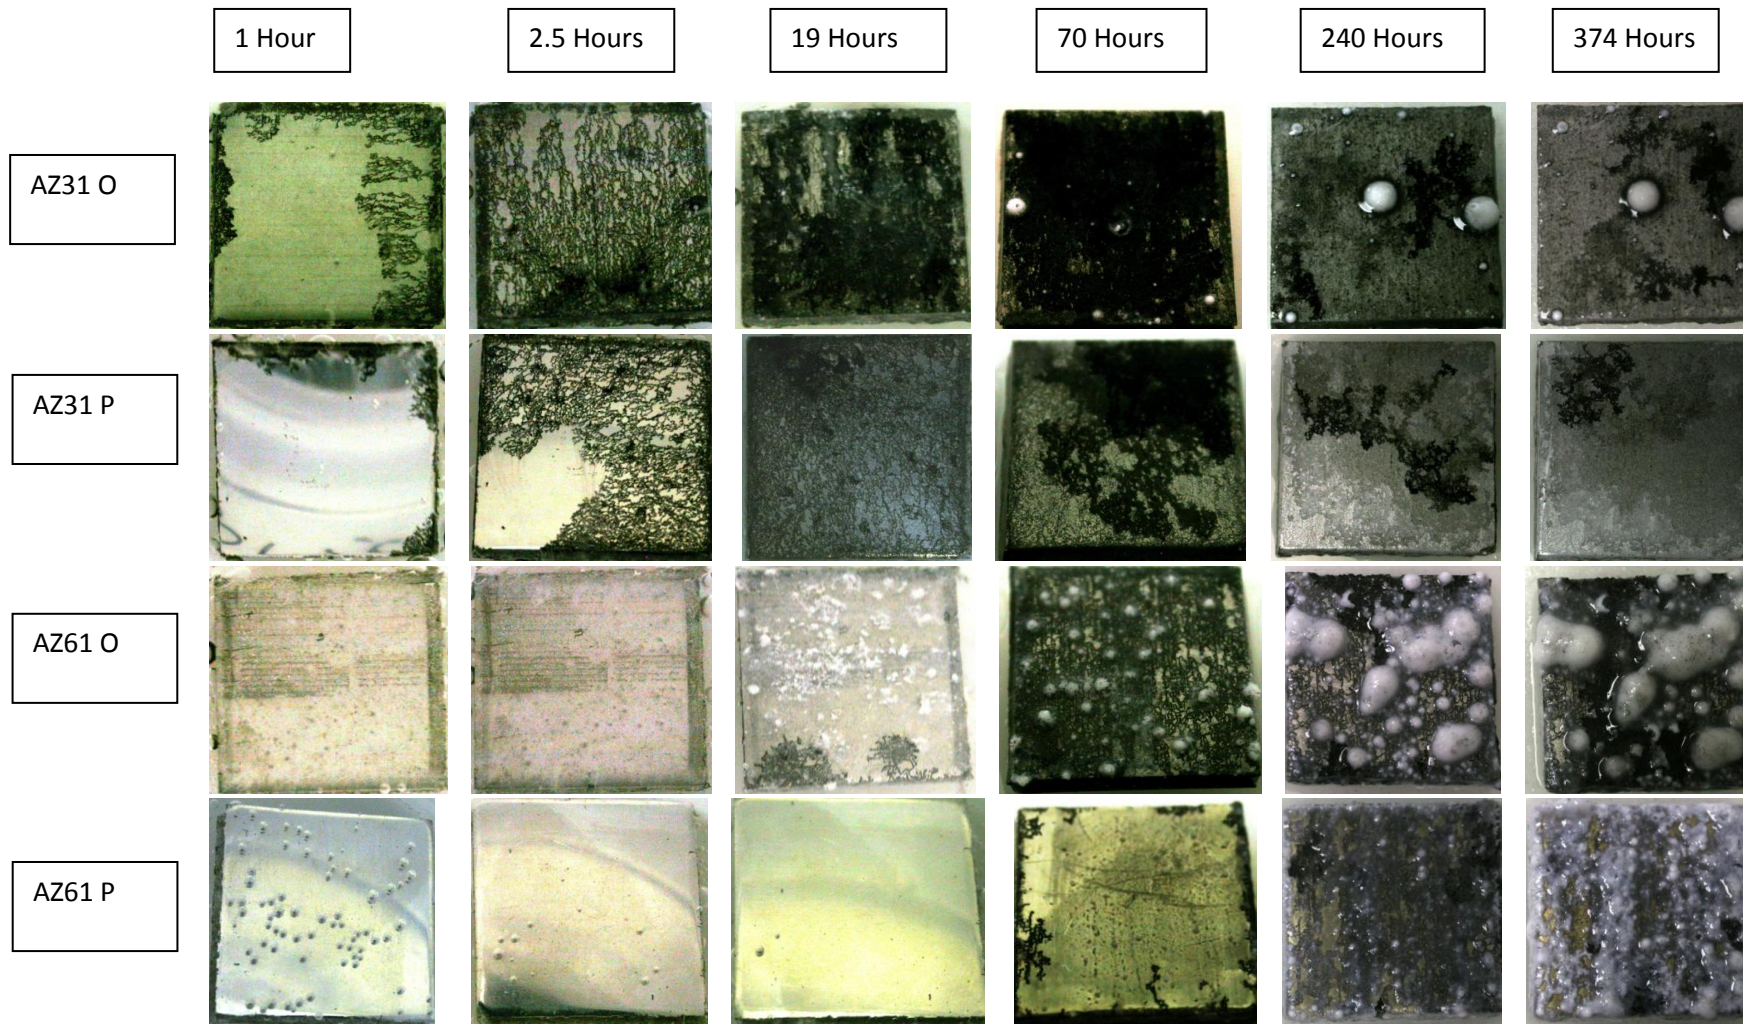
Figure.7

**Fig. 7.** Photographic images of the evolution of corrosion morphology with immersion time for alloys AZ31 and AZ61 in the as-received (O) and polished (P) surface conditions.

In Fig. 7 it is curious to see that after relatively long immersion times –around 200 h for alloy AZ31 in as-received surface condition and around 43 h for the polished condition– the formation of filiform corrosion clusters recommences, these differing from those initially formed by the greater thickness of the filaments and the almost nil tendency to expand and evolve with time.

the present work, this effect seems to be reflected in the corrosion of the polished AZ61 alloy specimens, where a large part of their surface retains for a quite some time the initial shine, while soon the polished surface of the AZ31 alloy, with a notably lower Al content, appears affected by the corrosion (Fig. 7).

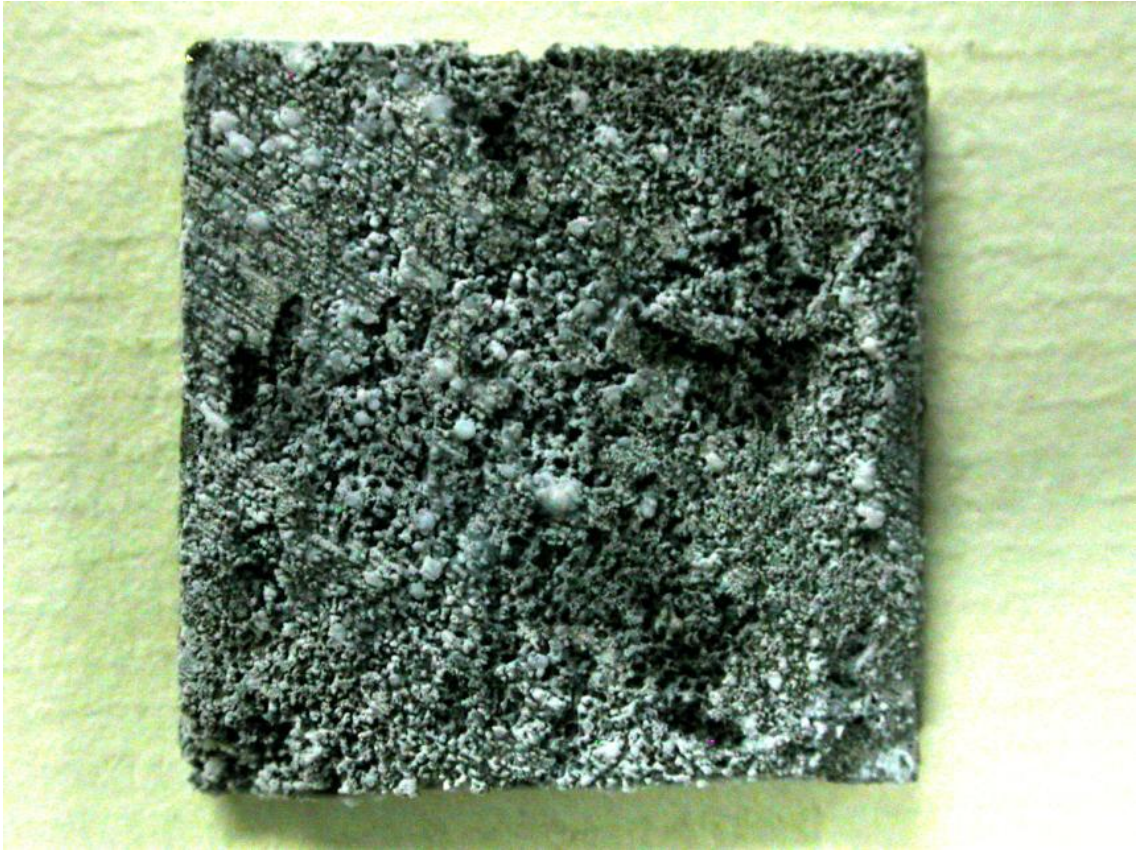
Figure 8.

**Fig. 8.** Intense attack of the AZ61 alloy surface exposed in the as-received condition.

If a significant improvement in the properties of the surface film is to be achieved, the bulk content of Al in the Mg-Al alloys must exceed a certain critical level situated around 4% [20,22]. The Al content is below this level in alloy AZ31 and above it in alloy AZ61. Therefore, an improvement in corrosion resistance due to the segregation of Al on the surface is only foreseeable in the latter alloy. Fig. 8 shows the intense attack of the AZ61 alloy with the surface in the as-received condition.
