Fracture bone healing and biodegradation of AZ31 implant in rats

Keywords: AZ31 magnesium alloy, fracture healing, biodegradation, tomography, histomorphometry, *in vivo*.

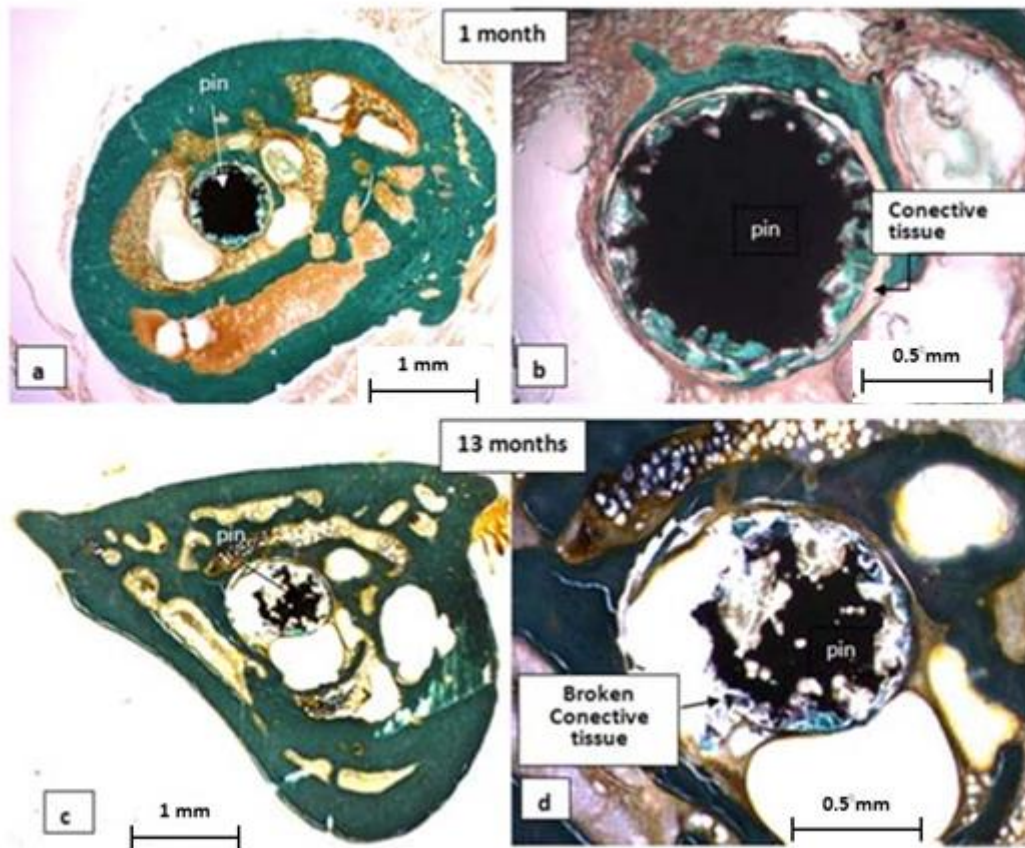
Fig. 2 shows the representative cross section images at different magnifications of the partially resorbed AZ31 implants of group 2 (un-fractured femur and without MgF2 coating) after 1 and 13 months implantation times.

Figure 2. Histological cross-section images of the partially resorbed AZ31 magnesium alloy implants after 1 month (a, b) and 13 months (c, d). Samples a), b) and c) were stained with Masson's trichrome: green-calcified mature bone tissue; orange-uncalcified osteoid tissue; dark red-cell nuclei. Sample d) was stained with haematoxylin enhancing the blue toluidine: dark, almost black-cell nuclei; shades of blue, depending on the degree of maturity of the bone-intercellular substance.

Cells and intercellular substance are differentiated depending on the staining used. However, implanted material always appears undyed and black, which are easily identified. Implants are easily recognized in the initial site of implantation by the new circle of tissue around (as shown in Figure 2). Resorbed implant appears as grey colour so the remaining area in black colour is measured.

After 1 month (Fig. 2a and b) it is possible to see a circular black area identified as the AZ31 implant and evidence of bone neoformation in the medullary cavity, distinguishing a thick trabecula of cortical bone. In the bone trabecula cavities it is possible to see bone marrow of an orange coloured dotted appearance. It can also be seen that the implant is partially resorbed at

the edges (Fig. 2b). The resorbed area has been occupied by inorganic compounds, Mg oxides and hydroxides, corrosion products that surround the surface of the implant. On the other hand, a lamina of fibrous tissue is seen separating the original area of bone tissue that surrounds it, although no foreign body or inflammatory cells have been found. After 13 months the implant is partially resorbed (Fig. 2c and d), being possible to observe breakage of the fibrous tissue encapsulation that surrounds the biomaterial.

In the histological studies after 1 month of implantation it has been seen that there is neither reaction to the foreign body nor any inflammatory reaction (Figs. 2a and 2b). The insertion of any material in an intramedullary cavity generally leads to a process of relative osteolysis or bone resorption which is considered normal. With the AZ31 alloy no such osteolysis has taken place (Figs. 2c and 2d) and the images show osteoblast activity by the presence of bone formation. Osteoclasts were not appreciated. After this first month a thin fibrous layer is seen surrounding the material, and based on polarised light studies this layer corresponds to bone tissue immature (Fig. 2b). After 13 months the studies confirm that the material is completely surrounded by a layer of mature bone tissue. This new bone is firmly adhered to the implant surface. This represents a direct index of the implant's good biocompatibility and its osteoproliferative capacity. These results are in accordance with those obtained by other authors [21,38,51-53]. No histological differences are seen between the reactions that take place on MgF₂ coated and uncoated surfaces.

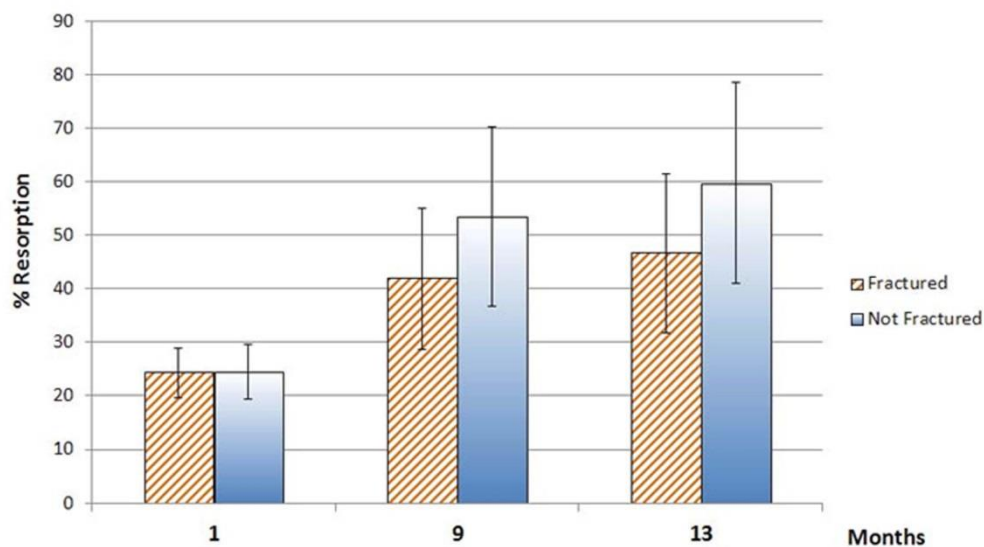
Fig. 3 quantifies the implant resorption percentages, which after 1, 9 and 13 months for the groups 2 and 4 (uncoated implants) rats with un-fractured and fractured femur, respectively. Resorption percentage was calculated considering that the resorbed implant appears as grey colour and the implant area not resorbed appears as black colour. The resorption percentage was calculated from the difference between the original volume and that remaining.

Figure 3. Percentage of AZ31 uncoated implant resorption after 1, 9 and 13 months in Wistar rats with fractured and un-fractured femurs.

Histomorphometric studies reveal that after one month the percentage of resorbed material is similar in both groups. The corrosion that occurs does not alter its central structure and takes the form of pitting corrosion that starts on its surface. Nevertheless, resorption percentage at long implantation times is higher in the group of rats 2 without fractured femur. After 9 months, when the fractures have been consolidated, 41.85% of the material has been resorbed and its central structure is conserved.

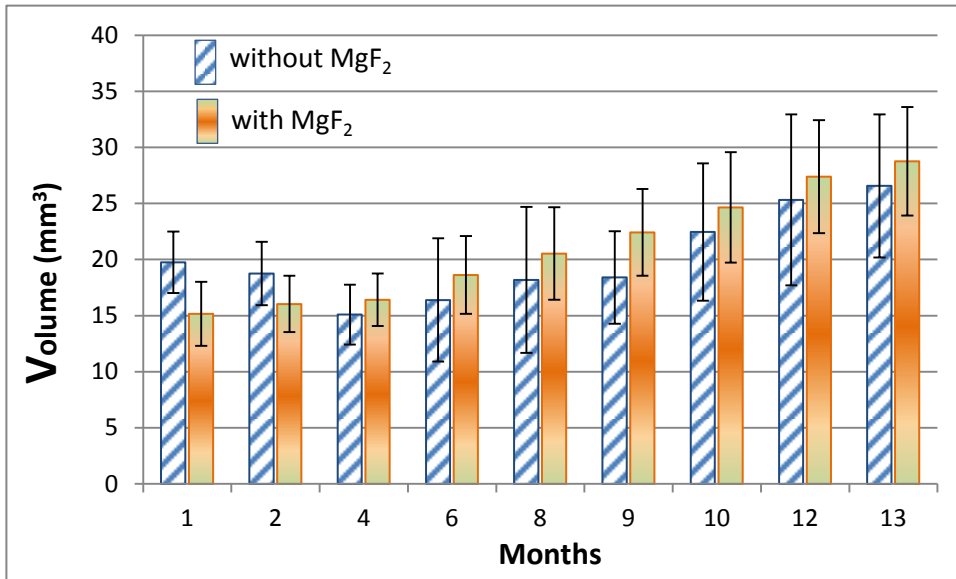
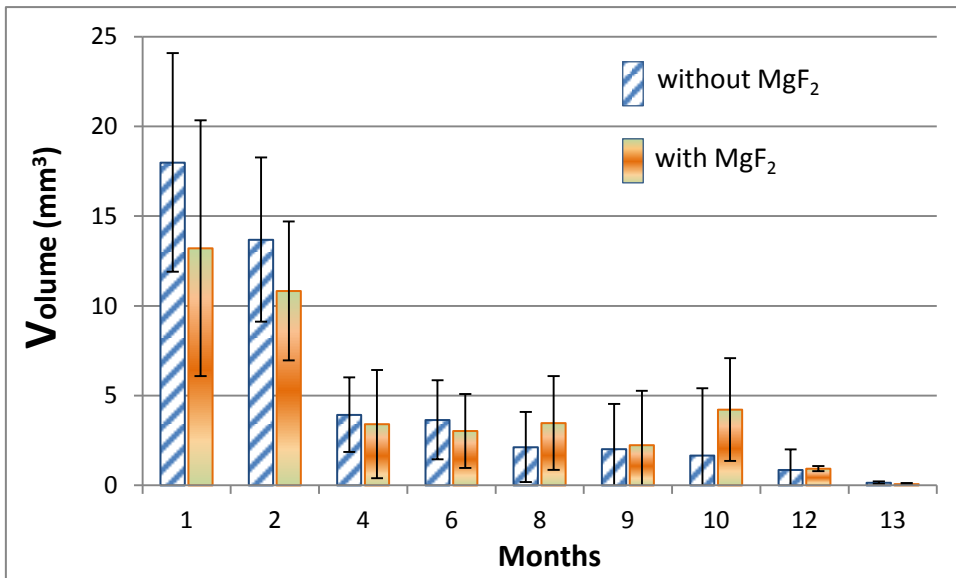
The analysis of the effect of MgF₂ coating on the biodegradation rate of AZ31 implants, was studied in the groups 3 and 4, rats with fractured femur. Images acquired from computed tomography show the corroded implant without possible distinction between the remaining implant and the corrosion products that has been defined as the total volume of the implant. In Figure 4, the total volume of the implant including corrosion products and gas volume in AZ31 with and without MgF₂ coating from 1 to 13 months in Wistar rats with fractured femurs is shown.

Figure 4. Total volume of the implant and corrosion products, a), and gas volume, b), in AZ31 with and without MgF₂ coating from 1 to 13 months in Wistar rats with fractured femur.

MgF₂ coating seems to have a small influence on the biocorrosion process. The first four months of implantation, the modification of the surface slightly reduces the biocorrosion of the implant. However, from the fourth month to the end of the *in vivo* experimentation the trend is reversed due to a higher amount of corrosion products which increases the total volume of the implant. The evolution of the gas volume over time in coated and uncoated AZ31 implants for

rats with fractured femurs was nearly parallel with small differences between them. There were not statistically significant differences between uncoated and coated implants.

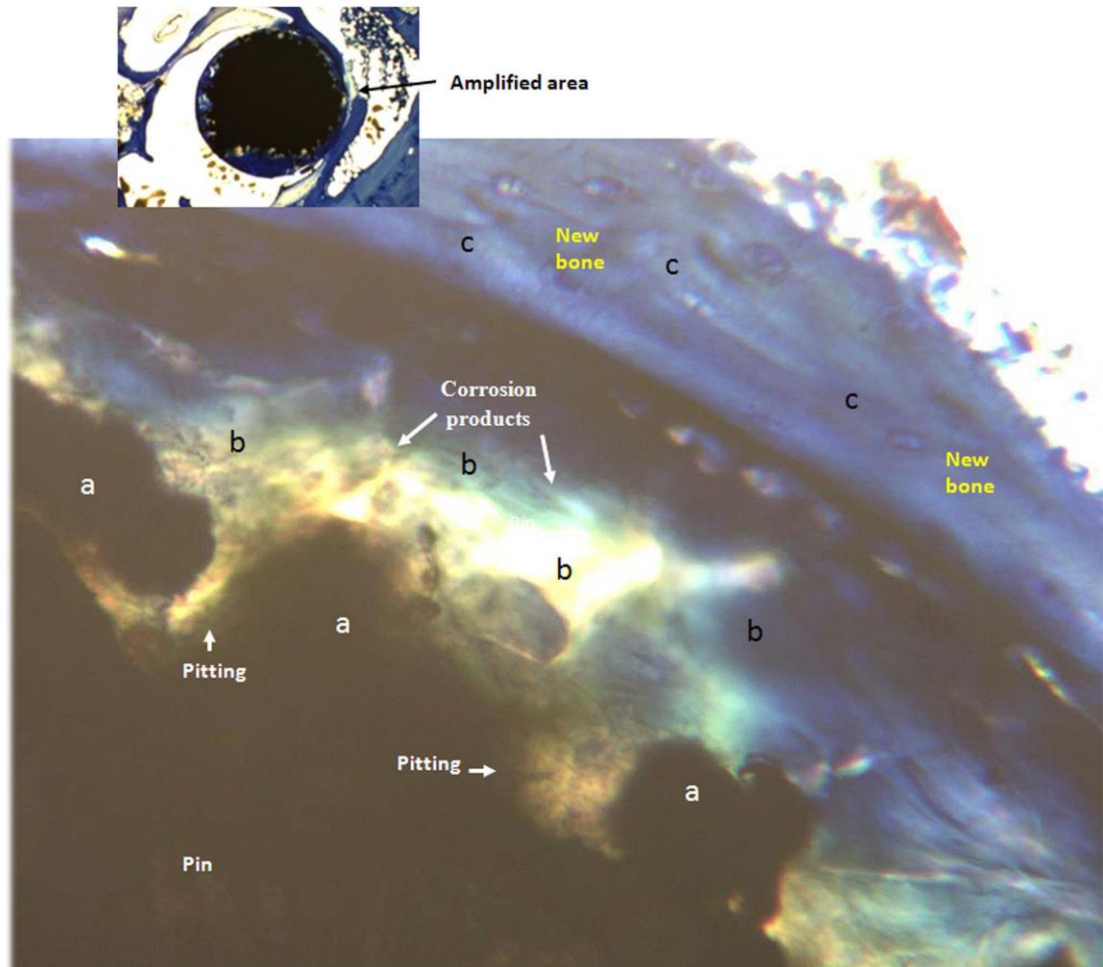
The first semi-reaction starts on the implant surface (with or without surface treatment) right from the initial moments of its insertion. It occurs because the surface is bathed in the physiological fluid containing water and mineral salts, giving rise to the formation of Mg oxide and hydroxide, and probably also the phosphates and carbonates that are deposited on the metal surface as detected in *in vitro* and *in vivo* test [35,36]. The Mg hydroxides form a protective layer, but in a chloride medium, when the chloride ion concentration reaches 30 mmol/L, Mg hydroxides are transformed into highly soluble magnesium chlorides [38]. This promotes the appearance of pitting on the implant surface. If the chloride concentration in the extracellular fluid reaches 150 mmol/L, pitting corrosion becomes severe [38]. Figure 5 shows the deposited corrosion products (identified with letter b in Figure 5).

Figure 5. Histological cross-section images of implanted AZ31 magnesium alloy after 9 months in Wistar rats. Letters in the images: a-pitting corrosion b-corrosion products and c-new bone.

These Mg oxides and hydroxides promote the accumulation of calcium phosphate and therefore the formation of new bone around the implant (Figure 5c) [34]. The accumulated oxides and hydroxides have a similar atomic number to Mg, and for this reason cannot be distinguished from the pin in computed tomography. As a result it was decided to quantify the biodegradation process by measuring the cathodic or reduction reaction (3), i.e. gas pockets by processing the images taken from tomography. The organism is able to absorb the gas produced and expel it by diffusion, but if the hydrogen formation rate is very high the gas excess is accumulated as bubbles around the implant or fracture site (Figure 1a) [35,37]. In groups 1 and 2 (un-fractured femur) the corrosion products from the biodegradation process (equation (1)) remain on the implant surface, to a certain extent protecting the surface from the corrosion process. As the
