工學博士 學位論文

Optimal Numerical/Experimental
Assessment on GFRP for Wind Turbine
Blades in Repairing Process utilizing
Photo Polymerizable Resin

Photo polymerizable resin을 사용한 풍력 터빈 블레이드용 GFRP
repair 공정 시 최적의 수치적 및 실험적 평가

造船機資材工學科

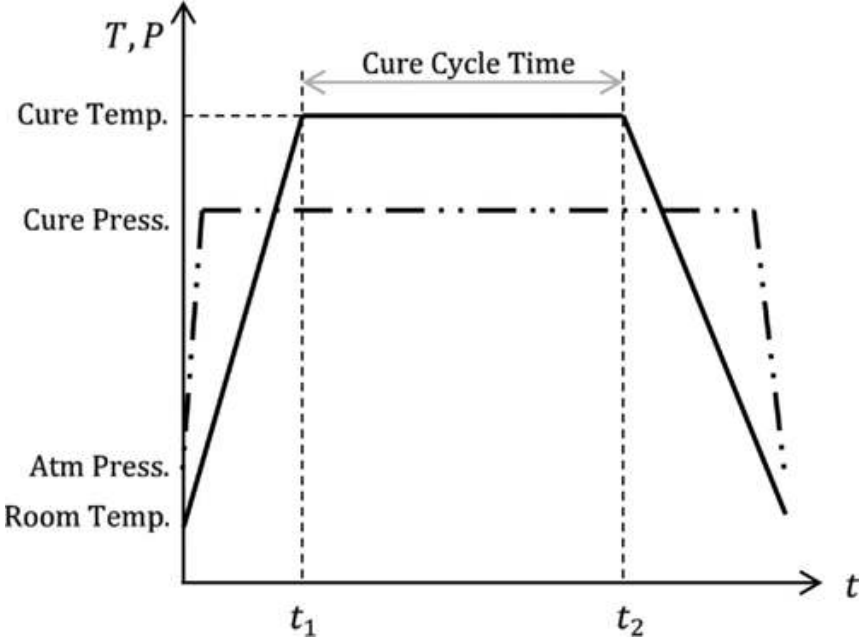
Fig. 2 Standard temperature (T) and pressure (P) cycle (Advani & Murat, 2010)

autoclave cycle time. Khan, et al. (2017) achieved ramp rate up to 15 K min^{-1} via Quickstep processing and found that this technique allows alteration in chemo-rheology of 977-2A thermosetting resin, and so influences the reaction progress. Although the curing path is different from the autoclave curing, the final cross-linked structure is similar.

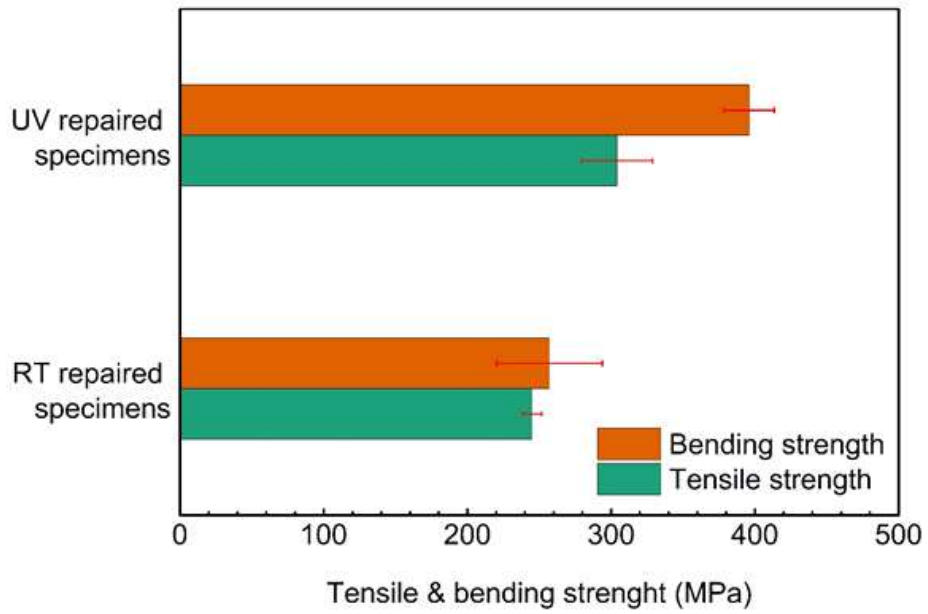
Fig. 13 Experimental results of tensile and bending tests

The experimental results of bending and tensile of both RT and UV repaired specimens are shown in Fig. 13. According to the test results, UV

repaired specimens had the ultimate tensile and bending strength of 257 MPa and 396 MPa, which are both higher than RT repaired specimens. The results in ultimate tensile and bending strength indicate that the RT repaired specimens have the weaker bonding between the repair patches and the fundamental specimens, in contrast to the UV repaired specimens. The typical load-displacement curves of tensile and bending tests of both repaired conditions are shown in Fig. 14. During the tensile test shown in Fig. 14(a), smooth and steady load-displacement curves can be obtained in both repair conditions. A distinction of ultimate strength and the elongation at break is caused by the different interfacial bonding strength between patch and fundamental lamina at different curing and test conditions. The elastic modulus of two load-displacement curves are almost the same because the repair method of attaching an external patch had negligible contribution to the improvement of tensile modulus. The strengthened phenomenon can be verified by the macroscopic fracture morphology which presents the alteration of the failure pattern from adhesive debonding and delamination into integral breakage at the drilled hole. On the contrast, the curves of the bending test shown in Fig. 14(b) illustrates a rough and unstable failure process, and the UV repaired specimens presents the multi-stage plateau fracture phenomenon before critical failure. The fracture pattern of UV repaired specimen reveals the impediment of crack propagation which leads to a delayed failure and a higher ultimate strength. The outstanding properties of photo polymerizable resin contributes to a higher ultimate strength and modulus which revealed a strengthened interfacial bonding between repair patches and fundamental specimens.

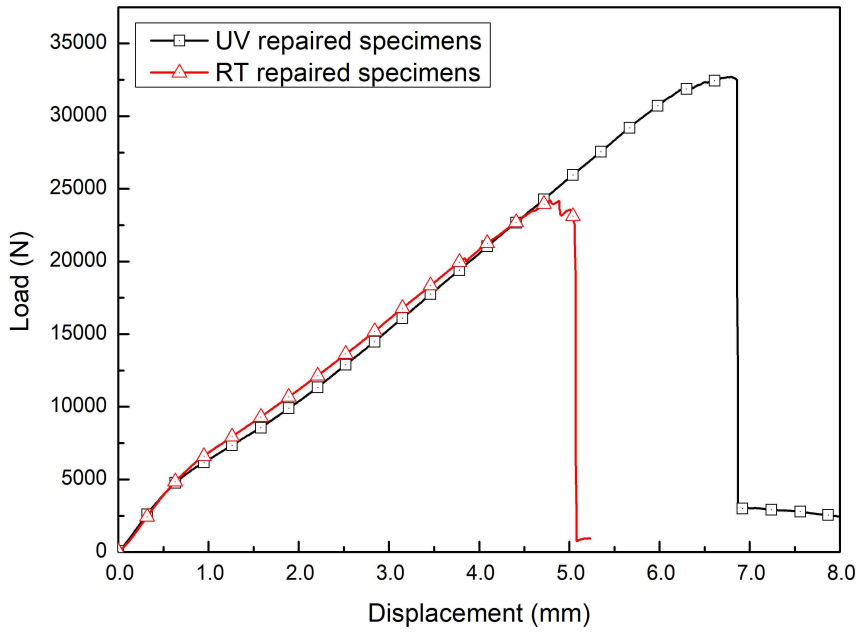
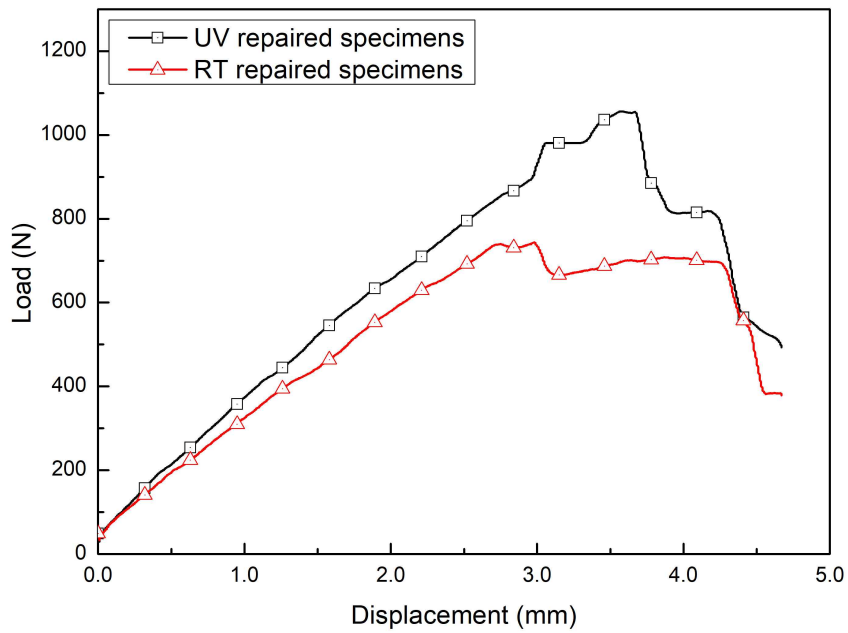
Fig. 14 Typical tensile (a) and bending (b) load-displacement curves of different repaired conditions

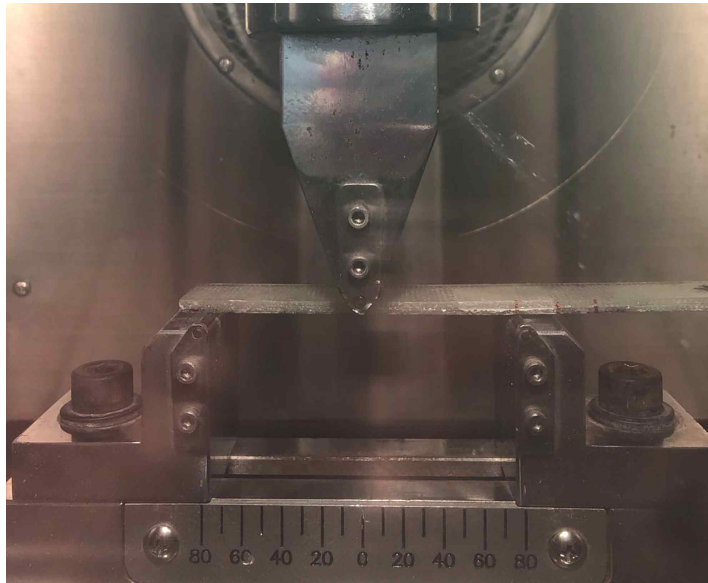
Fig. 16 Photograph of ENF test processing

To realize simulation on FRP laminates, interlaminar and intralaminar property parameters need to be imported. Strength parameters are necessary to introduce the Hashin damage criterion. In order to determine the mode I (G_{IC}) and mode II (G_{IIC}) interlaminar fracture toughness, double cantilever beam (DCB) and end-notched flexure (ENF) tests were conducted according to ASTM D 5528 and ASTM D 7905, respectively. For fabricating the DCB and ENF specimens, two separated GFRP specimens containing 5 laminates were prepared by wet prepreg manufacture technique as mentioned before. The two GFRP specimens were then bonded by photo, or thermal polymerizable resins as the adhesives with one piece of Teflon ply inserted to realize the initial crack on the intermediate slit of the DCB and ENF specimens. The specimens were then conducted to the same curing processing with tensile and bending specimens. For the convenience of the measurement of crack propagation length, calibrations were painted on the side face of the DCB specimens. The test parameters were strictly complied with ASTM and the displacement rate of both tests were 1 mm/s. The ultimate tensile strength and elastic modulus of neat polymer resins were obtained by tensile test on the cured resin specimens fabricated utilizing rubber mold. The photographs of DCB, ENF and resin specimen tensile tests processing are illustrated in Fig. 15, Fig. 16 and Fig. 17, respectively. Fig. 18 shows the typical load-displacement curves of photo and thermal polymerizable resin bonded DCB specimens. The photo polymerizable resin bonded DCB specimens exhibit a better crack propagation impediment comprehensively according to the load-displacement curves. The values of G_{IC} and G_{IIC} were both calculated using compliance calibration method. The central concept of this method is to

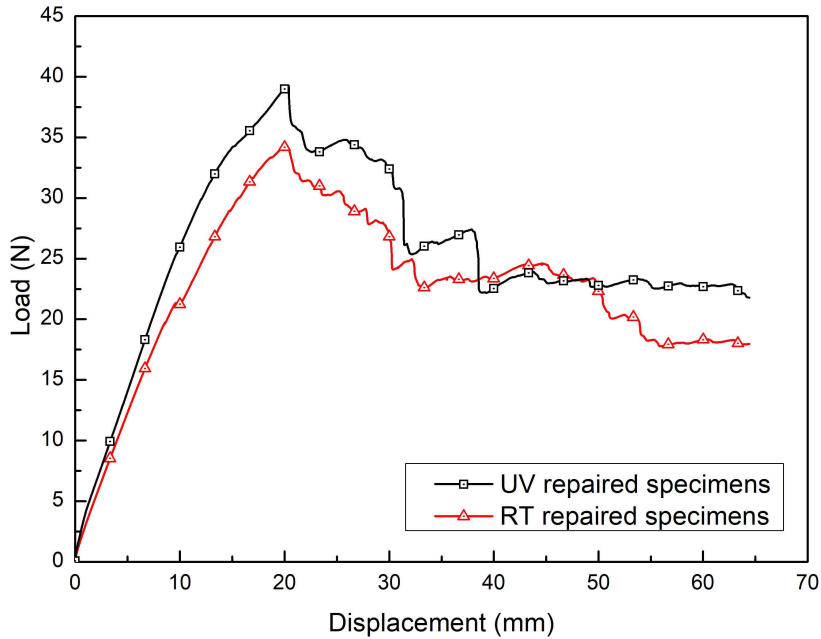
Fig. 18 Typical load-displacement curves of photo and thermal polymerizable resins bonded DCB specimens

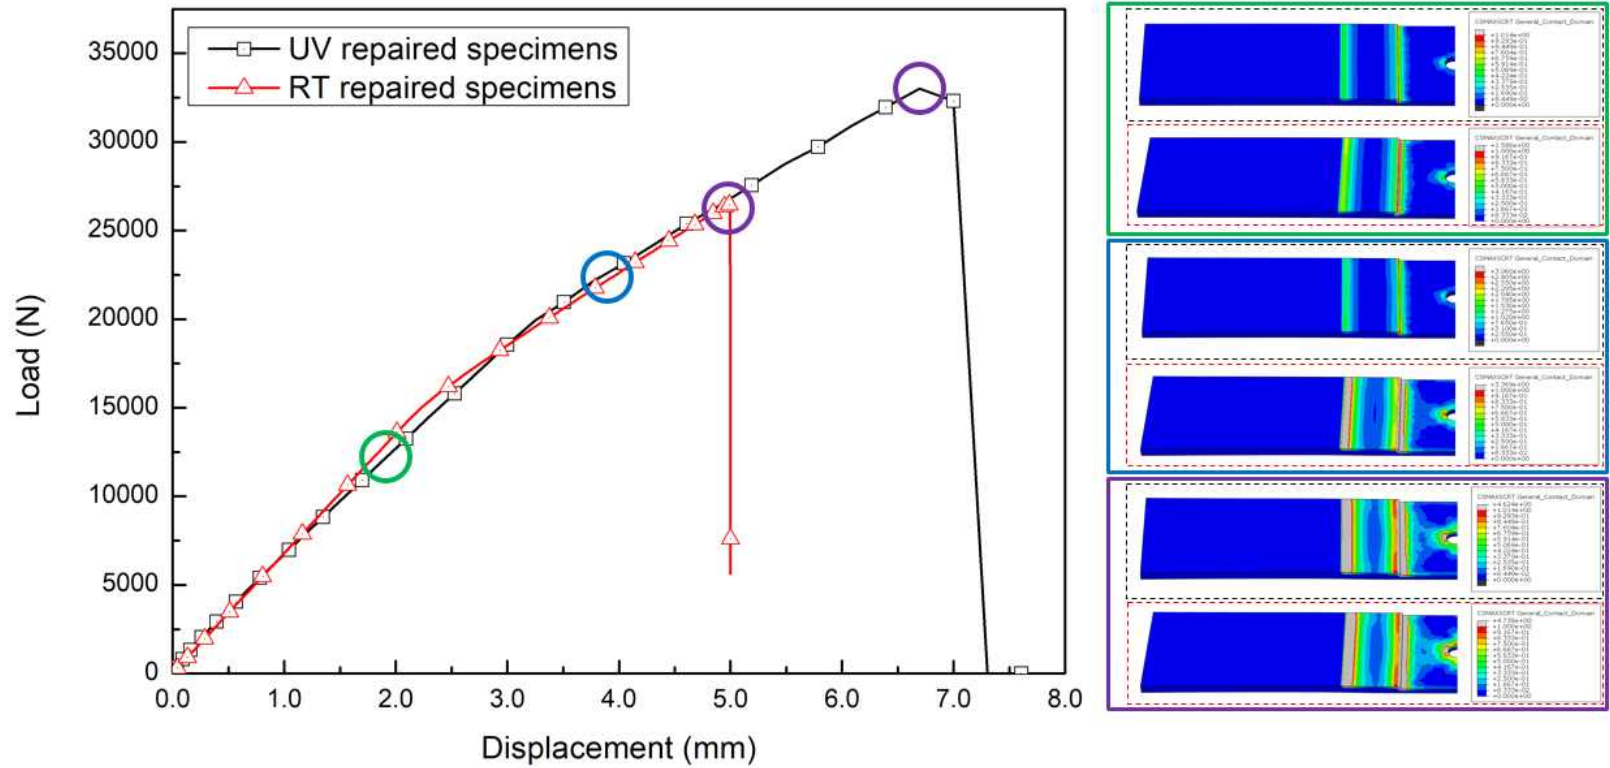
Fig. 23 Load-displacement curves of UV and RT repaired tensile specimens with cohesive damage distribution

The load-displacement curves of UV and RT repaired tensile specimens are shown in Fig. 23, the green, blue and purple circles represent the displacement of 2 mm, 4mm and eventual failure moment and are corresponding to the cohesive damage criterion on the right side, respectively. The simulation results of tensile tests are 251 MPa for UV repaired specimens and 225 MPa for RT repaired specimens. The deviation of ultimate strength compare to experimental results are 2.3% and 8.2% for UV and RT repaired tensile specimens, respectively. For every specified displacement, the distribution of cohesive damage criterion of UV and RT repaired specimens have almost the same tendency, but for RT repaired specimen (red curve), the value of cohesive damage criterion is higher than UV repaired specimen which indicates the more great extent of cohesive damage. The fundamental tensile specimen mainly subjected to the tensile stress and it plays a role of ‘master’ part of the repaired specimen for bearing the tensile load directly, while the external repair patches mainly dominated to shear and traction stress because they are the ‘slave’ part of the repaired specimen. The initial cohesive failure occurred on the edges of the repaired part because of submitting the pure shear stress and traction; but for the rest contact parts, the cohesive elements show delayed failure for the mainly shear stress domination. At the eventual failure moment, the edge of repair laminates; cover ply and hole all present cohesive failure in different extent and the RT repaired specimen show severer cohesive damage than UV repaired specimen.

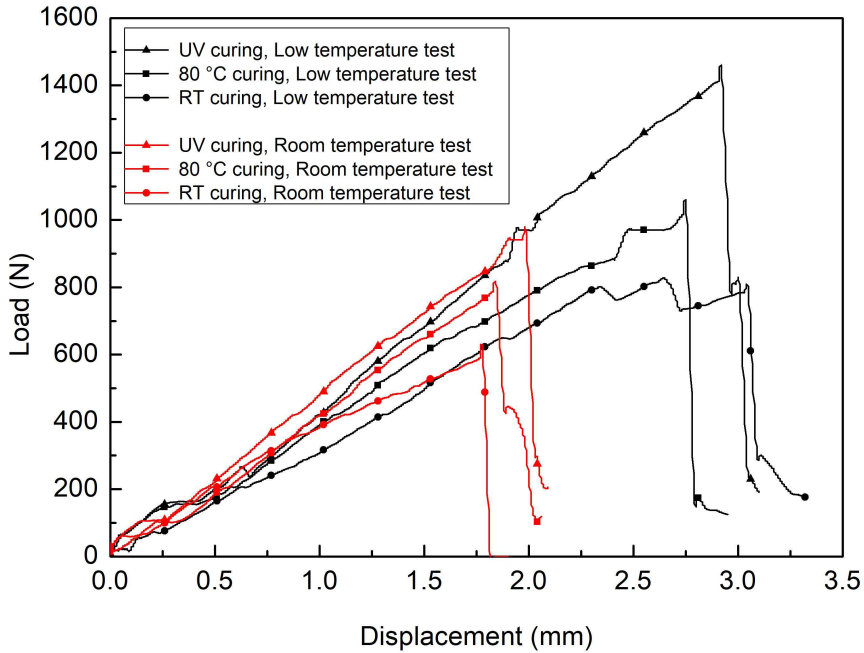
Fig. 33. Load-displacement curves of bending test of different curing and test conditions

The Load-displacement curves of flexure test in Fig. 33 show rough and unstable failure processing. The flexure modulus of UV repaired specimens was higher than room temperature and 80°C repaired specimens both in an ambient and low temperature test environments. The elongation at break in a low temperature environment have an enlarged value about 1 mm. Under the low temperature test situation, the specimens present the multi-stage plateau phenomenon which indicate the impediment of crack propagation leading to a delayed failure and higher ultimate strength. During the bending test, because of the contact of the repair laminates and the indenter, the properties of repair laminate itself become essential. The strong nature of photo polymerizable resin contribute to the higher ultimate strength and the impedance of crack propagation occurred in low test environment. The longer elongation revealed a strengthened interfacial bonding strength between external and fundamental laminates.

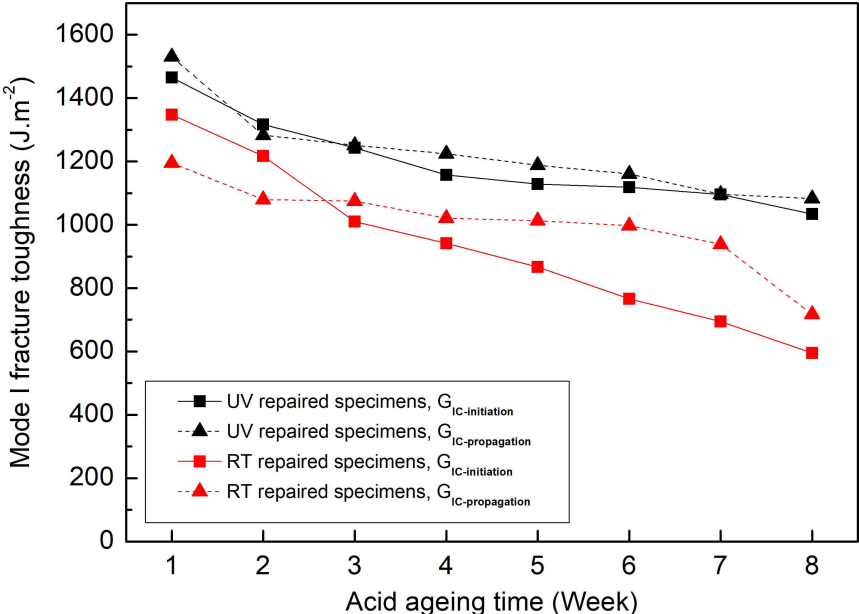
Fig. 41 Mode I fracture toughness of UV and RT repaired specimens after 1 week and 8 weeks acid ageing

The results of the mode I fracture toughness at crack initiation and 2nd propagation of UV and RT repaired specimens after 1 week and 8 weeks acid ageing are shown in Fig. 41. $G_{IC\text{-initiation}}$ is presented to the Mode I fracture toughness of the onset of the initiation crack while the $G_{IC\text{-propagation}}$ is presented to the Mode I fracture toughness of 2nd crack propagation. The $G_{IC\text{-initiation}}$ and $G_{IC\text{-propagation}}$ values of UV repaired specimens all perform higher than RT repaired specimens in acid ageing condition.

The $G_{IC\text{-initiation}}$ and $G_{IC\text{-propagation}}$ values reveal the crack resistance ability at crack initiation and propagation stages. The excellent performance in crack resistance ability of UV repaired specimens demonstrates a better stability and reliability of the application of photo polymerizable resin in acid exposure service environments. The stability of interlaminar fracture toughness of UV repaired specimens are considered as the consequence of the less sensitivity of acid corrosion in acid exposure environment. In the observation of the interlaminar fracture toughness results of RT repaired specimens, the values of $G_{IC\text{-propagation}}$ perform gentler and smoother reduction which differ with values of $G_{IC\text{-initiation}}$. That is because that the outer surfaces of specimens were exposed to the ageing environments at the very beginning and suffered the longest exposure time overall. The severe property degradation of glass fabrics and resins contributed to the noticeable $G_{IC\text{-initiation}}$ decrease but for the $G_{IC\text{-propagation}}$, as occurred at the 2nd crack propagation, performed a more gentle deterioration. The fracture surfaces of DCB specimens after 8 week acid ageing obtain by optical microscope are shown in Fig. 42. The UV

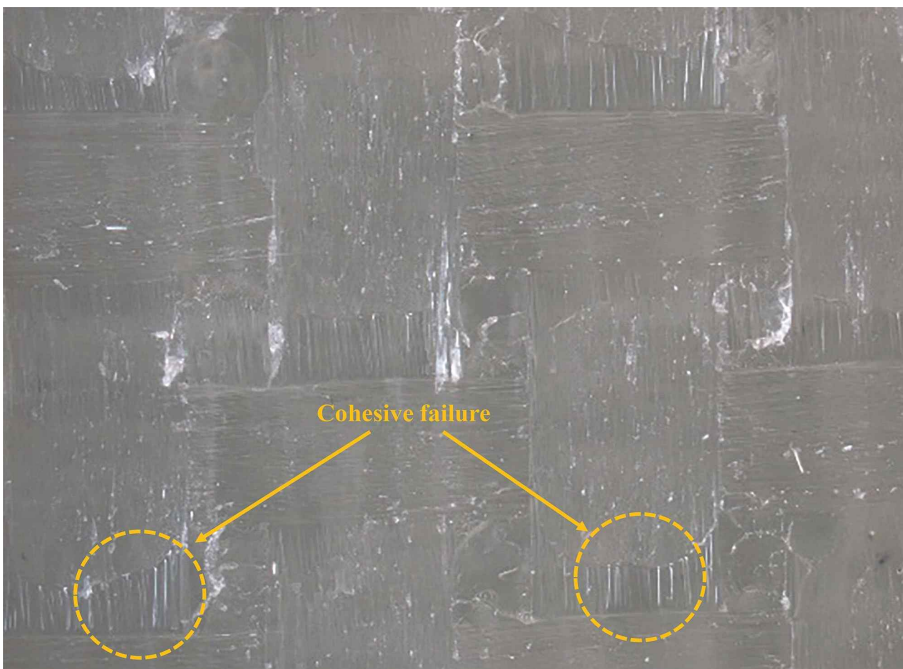
Fig. 42 Photograph of fracture surfaces of UV repaired (a) and RT repaired (b) DCB specimens after acid ageing

repaired specimens present a total delamination and adhesive fracture morphology reveal by exposed fiber and small through-thickness adhesive fracture on the fabric wrap space, which indicate a strong adhesion retained between matrix and fiber. The RT repaired specimens present a partially adhesive-cohesive fracture morphology and the fracture surface is flatter and smoother than UV repaired specimens which revealed the degraded adhesion.

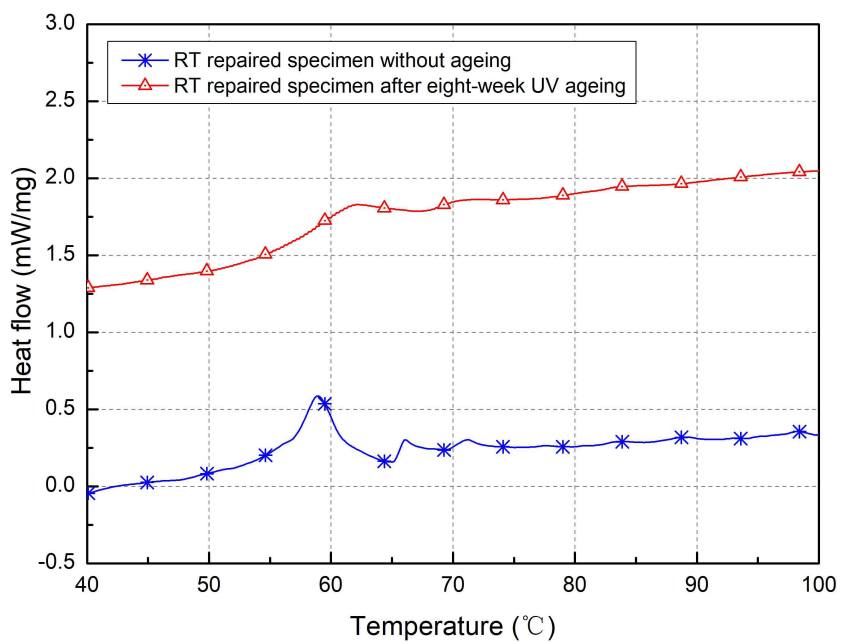
Fig. 52 DSC curves before and after UV ageing of photo (a) and (b) thermal polymerizable resins

A sequence of differential scanning calorimetry (DSC) curves before and after ageing of the UV and RT repaired specimens are shown in Fig. 52. After 8 weeks UV ageing, the T_g value of UV repaired specimens became higher at 58°C after 8 weeks UV ageing which indicated a better crystallinity,

higher density of chemical crosslink contributed by the UV irradiation. The T_g values of RT repaired specimens also have slight shift around 3°C before and after UV ageing, as the consequence of the spontaneously post curing behavior even without a certain external heat source. As the T_g values of RT repaired specimens after UV curing a present small distinction, the negligible effect of UV irradiation on the crystallinity of thermal polymerizable resin is validated. The T_g shifts of UV and RT repaired specimens before and after ageing support other previous results in polymer crystallinity aspect.
