## Control of biodegradation of a Mg alloy in simulated body fluid

# CONTROL OF BIODEGRADATION OF A MG ALLOY IN SIMULATED BODY FLUID

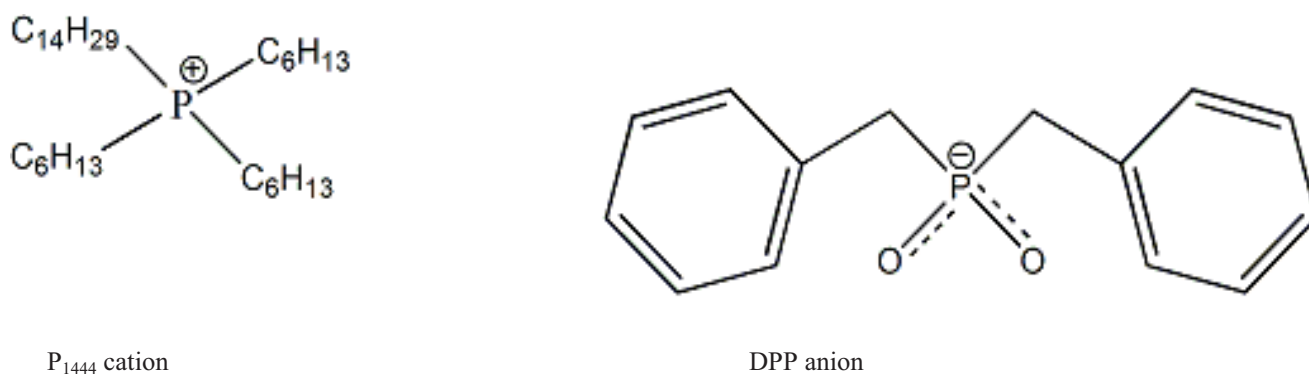
Figure 1 Schematic structures of  $P_{1444}$  cation and DPP anion [14]

The IL used was trimethyl (butyl) phosphonium diphenyl phosphate ( $P_{1444}DPP$ ). It was prepared the laboratory and purified by passing through a column containing a filter agent, alumina and sand to remove any impurities. The schematic structures of the anion and cation that make up the molecule  $P_{1444}DPP$  are shown in Figure 1.

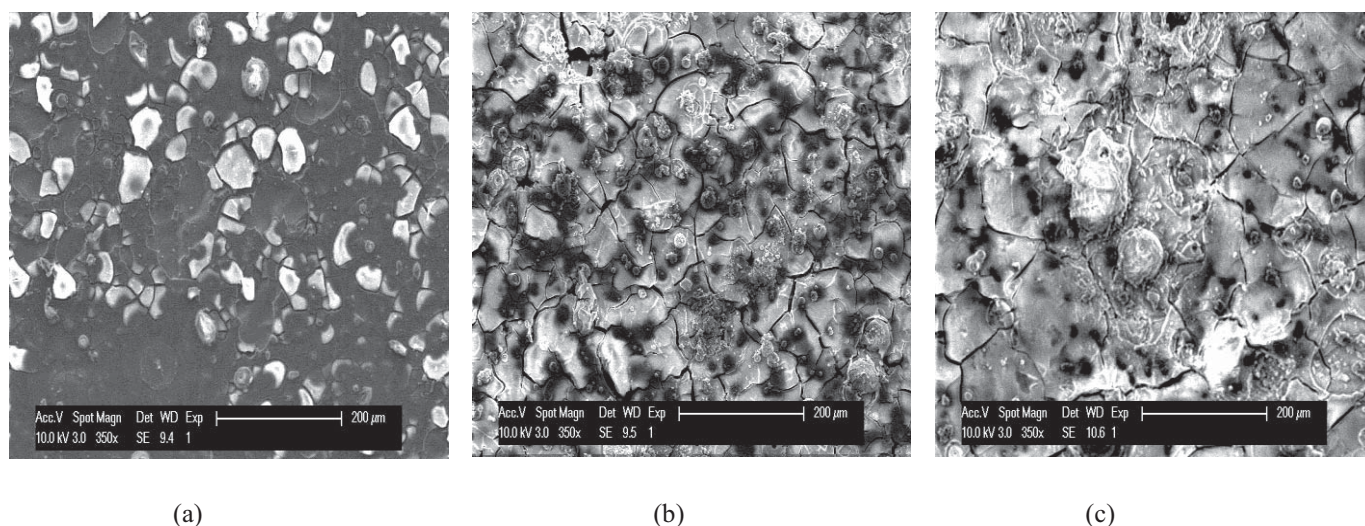
Figure 2 a, b and c is a series of SEM images of specimens after immersion in SBF for 2, 24 and 168 hours respectively. Layers of corrosion product were clearly visible covering the entire surface. “Mud cracking” was particularly evident on the specimens exposed for 24 and 168 hours. The cracks are thought to result from internal compressive stresses developed during drying in the SEM [15]. The greater extent of mud cracking on the surfaces of specimens exposed for 24 and 168 hours indicates thicker corrosion product layers. The EDS data obtained after 24 hours immersion in SBF (Figure 3) indicates the presence of oxygen, magnesium, calcium and phosphate on the surface of the corroded AZ31. The presence of oxygen and magnesium is consistent with a corrosion product of  $Mg(OH)_2$ , while the calcium and phosphate are thought to be associated with the SBF.

Figure 2 SEM micrographs of AZ31 specimens after immersion in SBF for (a) 2 hours, (b) 24 hours, (3) 168 hours

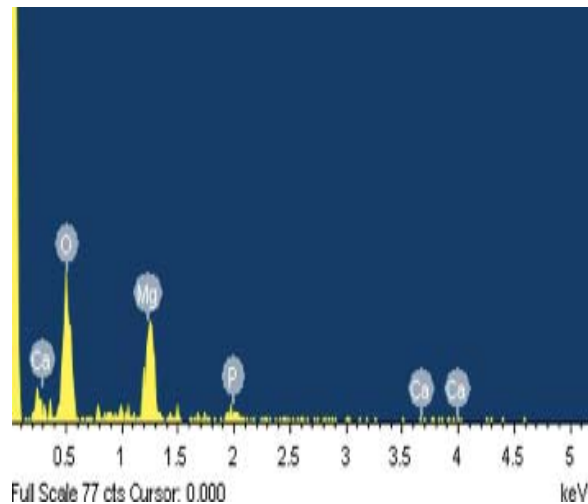
Figure 3 EDS data obtained from corrosion product on the surface of a specimen after immersion in SBF for 24 hours

gas generation [16]. The evolution of hydrogen and associated pH changes are not desirable for in-vivo biological situations. Ca and P elements that were observed using EDS, arise from other components in the SBF solution. Ca and P deposition were always found with the presence of Mg and O. This suggests that Mg corrosion may have an influence on the precipitation process of Ca and P from the SBF. The relation between Mg corrosion and the deposition of calcium phosphate has previously been discussed [17]. Because hydroxyl ions are generated by Mg corrosion, the local pH around cathodic sites increases compared to the bulk solution. At higher pH,  $\text{HPO}_4^{2-}$  is unstable and likely to convert to  $\text{PO}_4^{3-}$ . As a result, calcium phosphate precipitates rapidly from solution. The accumulation of calcium phosphate has also been found during in-vivo tests [18]. The presence of calcium phosphate deposits are undesirable and could under some circumstances threaten the life of a patient with an Mg implant, as large precipitates that develop may block an artery near the stent or travel to the other parts of body. A reduction in corrosion rate would mean a smaller increase in local pH, which in turn would influence the deposition process.

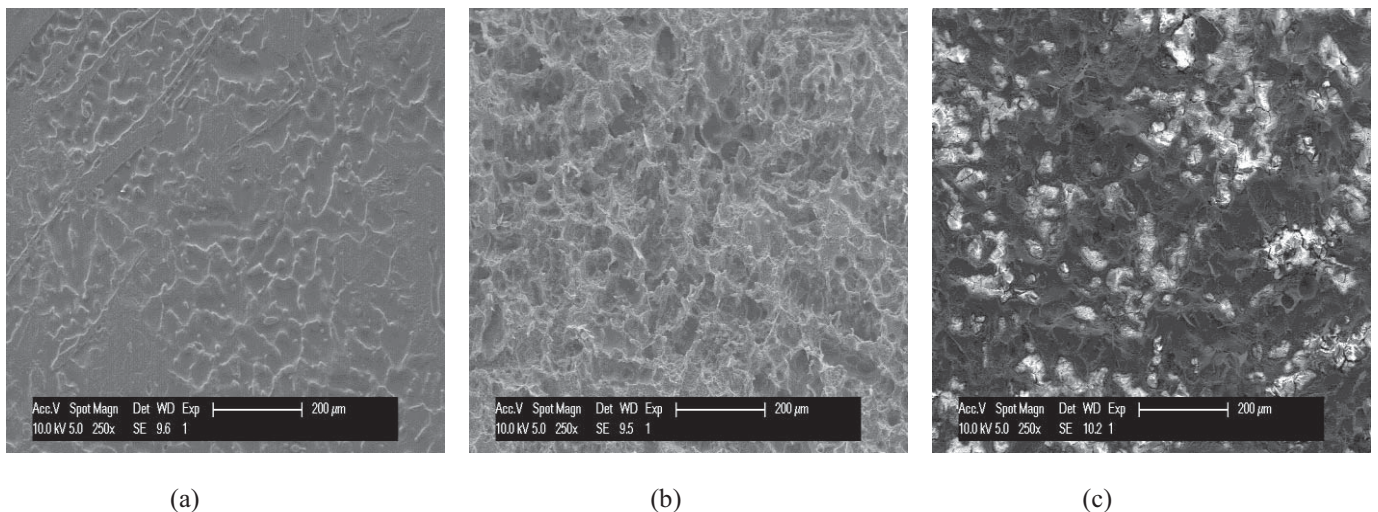
Figure 4 shows the SEM images of specimens after the corrosion products had been removed. Some corrosion product was still present on the specimen exposed for 168 hours. The corrosion product was probably too thick to be removed by immersion in the chromic acid solution for 60 seconds. These micrographs show that the surface of the alloy was pitted, and that pitting became more extensive and deeper with longer immersion time.

Figure 4. SEM micrographs of AZ31 specimens after immersion in SBF for (a) 2 hours, (b) 24 hours, (3) 168 hours with the corrosion product removed.

Figure 4 show that AZ31 in SBF suffered severe localized pitting corrosion. The corrosion mechanism for AZ31 in SBF has previously been discussed [19]. The microstructure of AZ31 magnesium alloy consists of  $\alpha$  phase (solid solution) with a small fraction of  $\beta$  phase ( $\text{Mg}_{17}\text{Al}_{12}$ ), and Al-Mn intermetallic particles, which are mainly distributed in the  $\alpha$  phase [16]. Because the content of the  $\beta$  phase in AZ31 is small, and the corrosion potential of Al-Mn is higher than other phases in this alloys [20], the influence of  $\beta$  phase on the corrosion behavior of AZ31 is thought to be less compared with the influence of the Al-Mn particles. The localized corrosion mainly initiates adjacent to Al-Mn particles in  $\alpha$  phase. Pits with a range of depth occurred adjacent to the Al-Mn particles over the whole surface. Pit depths increased with immersion time, and with time precipitated corrosion product eventually covered the entire specimen surface. As shown by the SEM images and 3-D profilometry results, some small areas on IL treated surface were not attacked in SBF. It seems that IL may have reacted with AZ31 surface and protected some parts of surface from corrosion but not others. At this time, it is not known exactly how the IL interacts with the magnesium alloy, and how the IL provides protection for the alloy surface. However, it is hypothesized that the IL reacts to form a barrier film on the magnesium-rich  $\alpha$  phase, which provides the protection from corrosion of AZ31 in SBF. However, this barrier film was non-uniform in its coverage of the surface. In some regions where the film may have been too thin or absent, corrosion pitting was able to occur. For a film to provide protection on an Mg alloy, a homogeneous film with uniform coverage across the entire surface is required, and achieving this is the aim of future work.

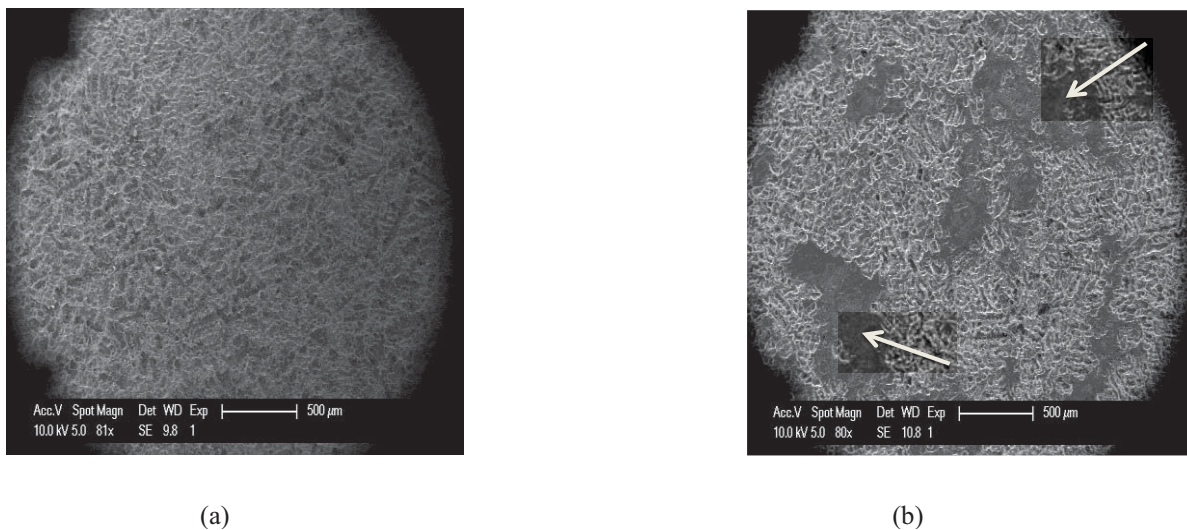
The SEM images in Figure 5 show the differences in the alloy surface (with corrosion products removed) for the untreated condition and the IL treated condition after exposure to SBF solution for 24 hour. The SEM images show that pits of a greater range of depths covered the whole surface of untreated specimen (Fig 5 a). While there was similar pitting on the IL specimen (Fig5 b), there were still some areas that had not been attacked by the SBF.

Figure 5 SEM images for (a) untreated AZ31 and (b) IL treated AZ31 after immersion in SBF for 24 hours with corrosion product removed

The SBF is an aggressive solution, which contains about 0.1M Cl<sup>-</sup> as shown in Table 1. Therefore when AZ31 was immersed in SBF solution, it suffered severe pitting corrosion (See SEM micrographs in Figure 5). The surface of the alloy was covered with a layer of corrosion product, the thickness of which increased with increased immersion time. Mg, O, Ca and P elements were found in the corrosion product layer. Mg and O suggest that the corrosion product was most likely Mg(OH)<sub>2</sub>. Mg dissolves in aqueous environments by an electrochemical reaction with the formation of magnesium hydroxide and hydrogen

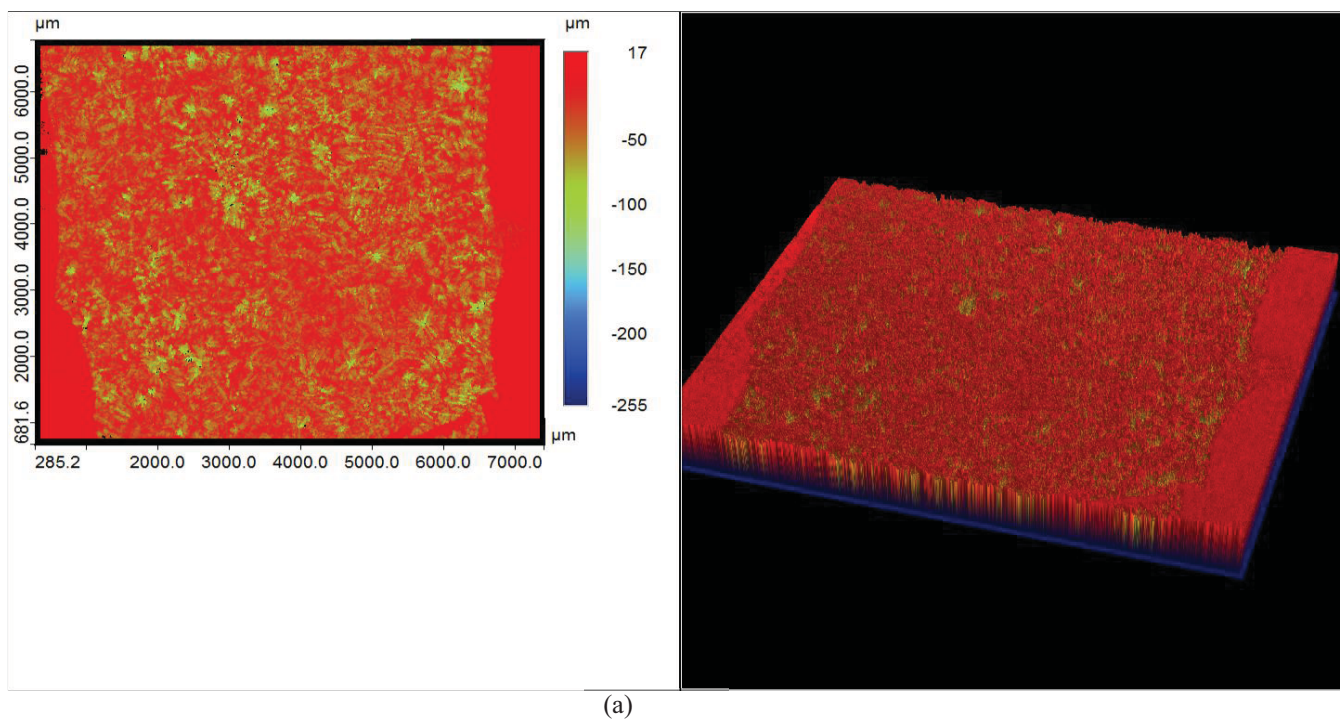
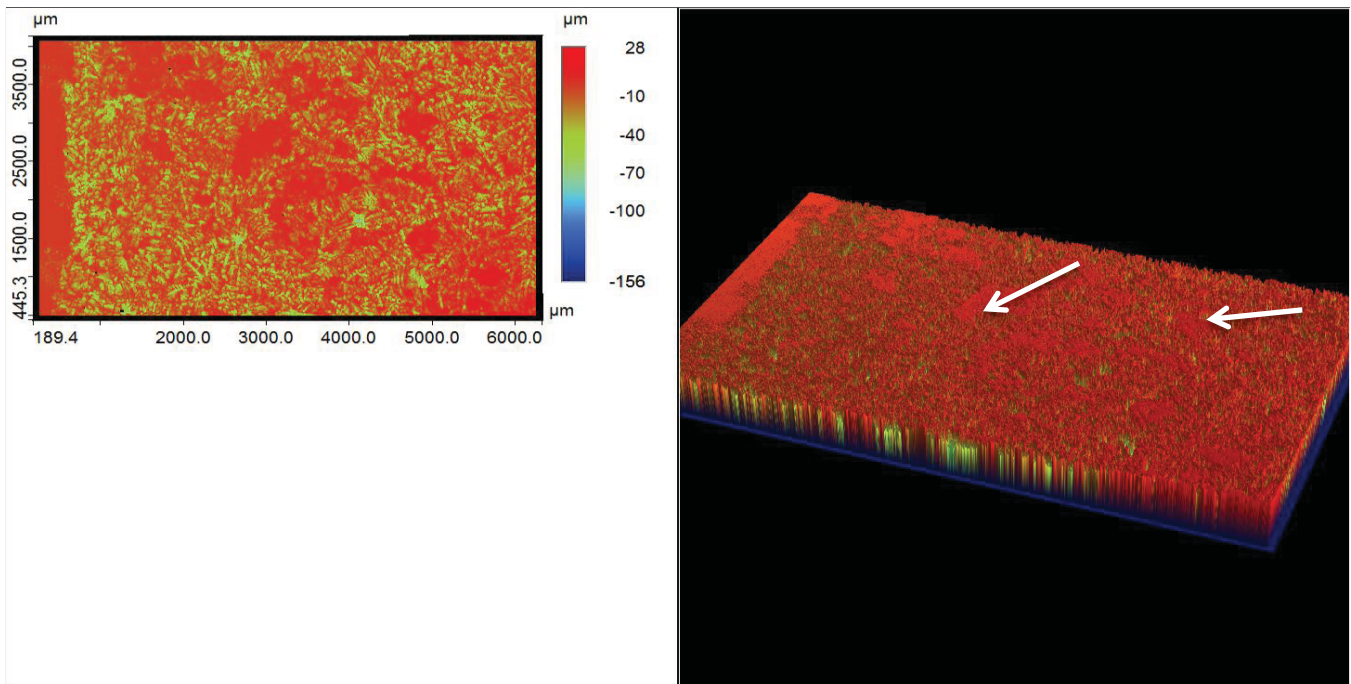
Figure 6 a and b show the surface morphology determined using optical profilometry analysis of untreated AZ31 and IL treated specimens after immersion in SBF for 24 hours. The 3-D images reveal that the variation in depth and density of the pits on the specimen surface. The pits appeared to be evenly distributed all over the surface of the untreated specimen (Figure 6 a). However, some areas on the IL treated specimen were protected from pitting (Figure 6 b). The optical profilometry 3-D images are similar to those obtained with the SEM results. A histogram (Figure 7) prepared from the optical profilometry

Figure 6 Optical profilometry images showing the distribution of pitting on the surface of (a) untreated AZ31 and (b) IL treated AZ31 in SBF for 24hours

Based on the optical profilometry analysis, the range of the pits depths and the total number of pits on the IL treated specimen were lower in comparison with the untreated specimen. Therefore, even in the corroded areas, corrosion of the IL treated specimen was reduced in comparison with the untreated specimen. The effectiveness of the pre-treatment with IL was also shown by the reduced volume of total pits when the IL was present.

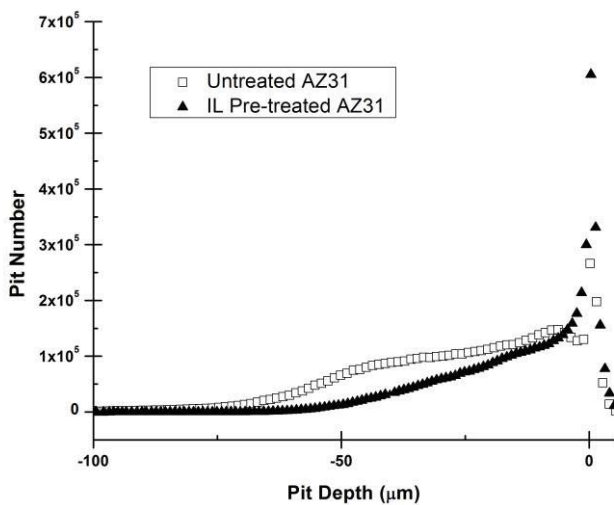
analysis shows the distribution of the pit depths with corresponding pit numbers. These data demonstrate the effects of the pre-treatment. Pit depths on the IL treated specimen were up to 50  $\mu\text{m}$  deep, while the pits depths on the untreated specimen were up to 75  $\mu\text{m}$  deep. Furthermore, there were a greater number of pits on the untreated specimen compared to the IL treated specimen. Also, the IL treated specimen had a significantly larger non-corroded area. Zero pit depth corresponds to areas of no corrosion. Values on the x axis little greater than zero correspond to peaks associated with the grinding damage from specimen preparation.

Figure 7 Histogram results from optical profilometry analysis of the untreated AZ31 and pre-treated AZ31 after immersion in SBF for 24 hours.
