Title	Reduction of corrosion behavior of magnesium alloy by PCL surface treatment
Author(s)	Wong, KHM; Yeung, KWK; Lam, JKO; Chu, PKH; Luk, KDK; Cheung, KMC
Citation	The 55th Annual Meeting of the Orthopaedic Research Society, Las Vegas, NV., 22-25 February 2009.
Issued Date	2009
URL	http://hdl.handle.net/10722/62523
Rights	Creative Commons: Attribution 3.0 Hong Kong License

Reduction of corrosion behavior of Magnesium alloy by PCL surface treatment

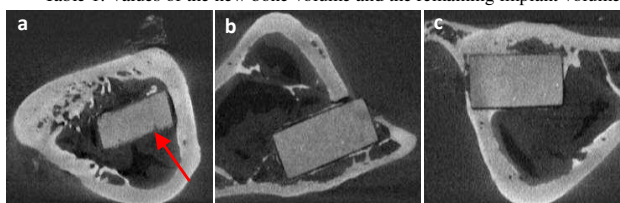
Figure 1. Micro-CT image of the implants after reconstruction. (a) untreated; (b) PCL1 and (c) PCL2

From the reconstruction images as shown in Figure 1, corrosion was found on untreated samples (red arrows) but not observed on PCL1 and PCL2 samples. By observing the 3D reconstruction models as shown in Figure 2, all the samples demonstrated the new bone formation on the material surface (white in colour). The actual values of the remaining implant volume and newly formed bone volume were displayed on Table 1. By comparing the treated and untreated samples, the untreated magnesium alloy showed the least volume of new bone formation and largest volume reduction of the implant after 2 months implantation, whereas PCL2 sample has the highest bone volume. The histological analysis confirmed that the newly formed bone tissue was observed around all of the implants. New bone (yellow arrows) and osteoblasts (green arrows) were observed in Figure 3.

In order to visualize the corrosion morphology and to quantify the *in-vivo* corrosion rate, micro-CT scan was employed. The micro-CT images showed that both PCL1 and PCL2 coatings were able to protect the magnesium alloy even under *in-vivo* conditions. Moreover, with the use of micro-CT, the volume changes of all samples were quantified. The result suggested that the untreated implant had the fastest corrosion rate but the polymer treated samples showed no

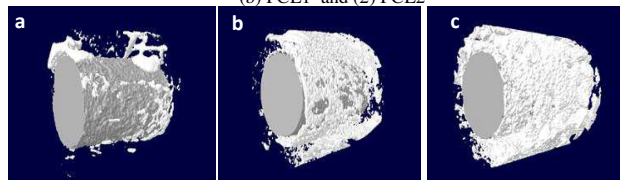
Figure 2. 3D model of the implants with newly formed bone. (a) Untreated; (b) PCL1 and (c) PCL2

Furthermore, bone formation could also be observed and quantified by using micro-CT analysis. Newly formed bone was found around the implants of both treated and untreated samples in which these observations proved their biocompatibility. No adverse effect was found after implantation. Although corrosion occurred on the untreated sample, new bone formation was still observed around the implant. The result was found to be comparable with others' findings. Both Witte et al.⁴ and Xu et al.⁵ suggested that although corrosion occurred on their magnesium based alloys, newly bone formation was found around the implant. However, by comparing the new bone volumes in our present experiment, it was found that the untreated sample got the least amount of new bone formation than the treated samples. This was mainly related to the magnesium ion release. As demonstrated in the previous *in-vitro* cytotoxicity test, the osteoblastic activity was affected by the magnesium ion concentration. During corrosion, large amount of magnesium ion released may inactivate new bone formation. Therefore less new bone was formed around the untreated sample.

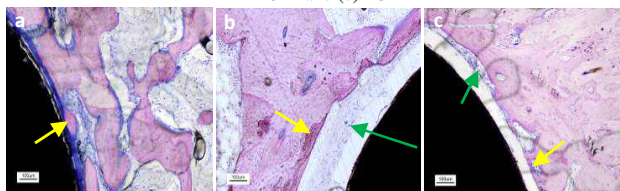
Figure 3. Histological photographs of gimesa stained of the bone tissue formed around the implants. (a) Untreated; (b) PCL1 and (c) PCL2

For the histological analysis, since gimesa also contained eosin, apart from staining nucleus, cytoplasm could be stained as well. For the area that was purple in colour was the mixture of blue and red colours, it represented the new bone growth area. Moreover, large amount of osteoblast was found around the polymer treated samples which led to more bone formation. Furthermore, no inflammation was found around the implants which suggested that no harmful effect occurred to the surroundings.
