Practicalities of BVID detection on aerospace-grade CFRP materials with optical fibre sensors

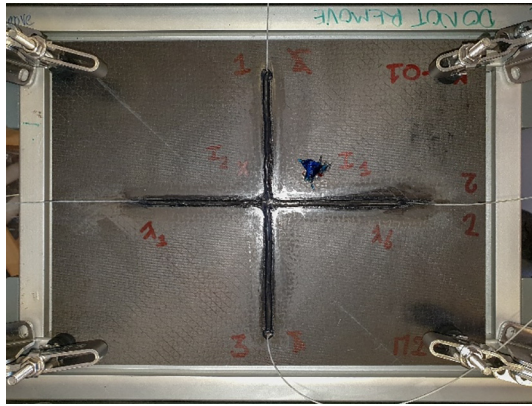
Fig. 1. Photograph of an M2 panel clamped into the impacting frame, showing the surface mounted fibres and impact locations I1 and I2.

manufacturing process can be found in Appendix A: composite panel manufacturing. All panels were trimmed for obtaining the final dimensions of 225 × 300 mm, as illustrated in Fig. 1 and Fig. 2.

The fibres were bonded to the CFRP by encapsulating them over the whole length with a layer of HBM X120 two-component epoxy adhesive designed for optical fibres [51]. This is shown on M1/M4 and M3 in Fig. 3 and on M2 in Fig. 1. The strain measurement wires were annealed in 3 temperature cycles from RT to 120 °C prior to their installation to guarantee stable FBG operation at operational temperatures (up to 85 °C) [43,62,63]. Both the sensor as well as the installation method have been previously tested to survive standardized in-flight conditions for temperature, pressure, humidity, fluid susceptibility, vibrations and tensile fatigue, as described in more detail in [43]. We showed that in-flight temperature cycling (−65 ± 85 °C) had no noticeable effect on the quality of the Bragg peak shape [43].

The panels were clamped in a frame as shown in Fig. 1 and impacted by an INSTRON CEAST 9350 Drop Tower Impact System. The impact energies were experimentally calibrated beforehand for a desired BVID indentation without visible impact damage. The size of the delamination of each BVID was determined via analysis of the impact location with a DolphiCam CF08 handheld C-scan with a sensing area of 33 × 33 mm and 124 × 124 transducer elements [64].

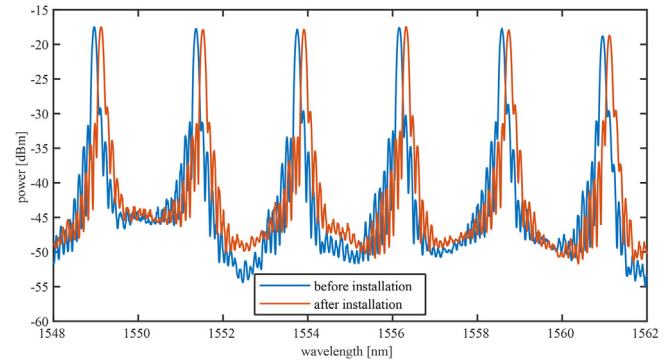
Fig. 4. Reflected power spectrum of 6 wavelength-multiplexed FBGs on the horizontally mounted fibre before and after installation on a M1 panel.”

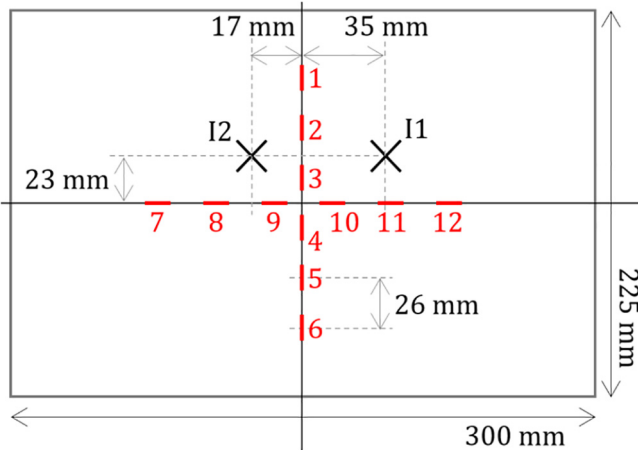
Fig. 2. Dimensions of the CFRP panels with bonded optical fibres with the FBGs locations marked in red and impact location by black crosses labeled I1 and I2.

The results of the calibrated impact energies are summarized in Fig. 18. Note that for M3, 4 impacts close to each other were needed to create a BVID with the desired delamination and indentation. Each panel was impacted at two different locations (I1 and I2), as illustrated on Fig. 2, with the same impact energy. A detailed image of the BVIDs on an M1 panel and an M3 panel can be observed in Fig. 3 left and Fig. 3 right respectively. For each combination of material and impact energy, 2 panels were tested, yielding 4 BVIDs per scenario. Fig. 18

In this section we will estimate the size of the area in which BVID detection can be successfully carried out, depending on the material system and considering the previously derived thresholds for M1 and M3. Every panel was impacted consecutively at locations I1 and I2, as indicated in Fig. 2. For M2 and M4, one impact energy was used to create the BVID, and for M1 and M3 two different energies were investigated. For each impact energy, two panels were impacted,

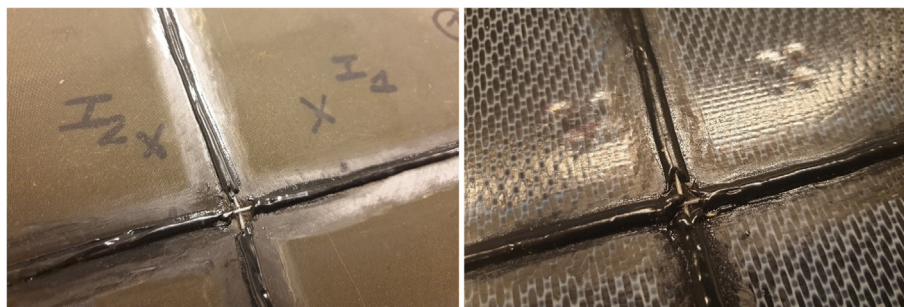
Fig. 3. Centre photograph of an M1 panel (left) and an M3 panel (right) showing the surface mounted fibre configuration and BVID indentation at the marked impact locations.

bagging and curing inside an autoclave at 180 °C and 7 bar. The panels had a stacking sequence of $[+45/-45/0_2/90/0]_s$ and an eventual thickness of 2.21 mm. Fig. 3 (left) shows the centre view of an M1 panel.

For the manufacturing of thermoplastic composite panels referred to as M3, the material Tenax® TPCL PEEK-4-40-HTA40 3 K supplied by TOHO-TENAX was selected [47]. The material consisted of a CF/PEEK fabric 5HS (5 harness satin) with 0.31mm nominal thickness per ply, 40 % of resin weight fraction and a fiber areal weight (FAW) of 285 gsm. The stacking sequence of the thermoplastic panels was $[0/90/45/-45/0/90/-45/45/0]$, resulting in a final panel nominal thickness of 2.79 mm. The panels were trimmed from larger laminates manufactured in a hot-plate press following a compression moulding process. The laminate was first stacked by hand and located into a metallic frame which acted as material retainer. Two polyimide sheets with release agent were placed at both sides of the laminate. Two metallic caul plates were also used for a proper flat surface finish. The consolidation cycle consisted of a heating ramp at approximately 2 °C/min up to a consolidation dwell of 30 min at 400 ± 10 °C with an applied pressure of 1 MPa. Fig. 3 (right) shows the centre view of an M3 panel.

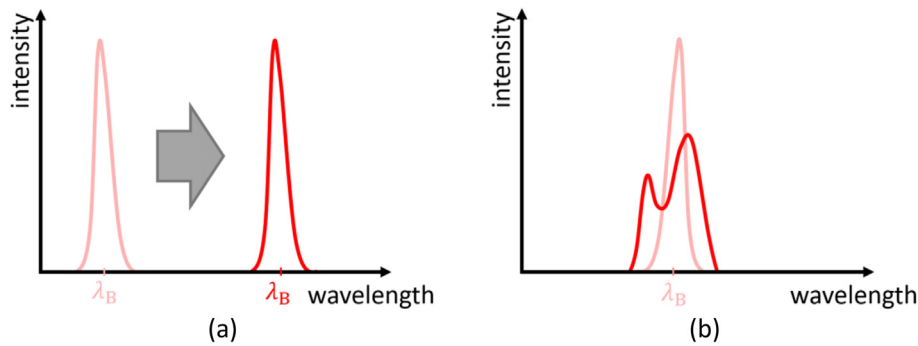
Fig. 5. Schematic representation of (a) uniform strain acting along the length of an FBG, yielding a wavelength shift and (b) an increase in non-uniform strain yielding a deformation (exaggerated) of the Bragg spectrum. the reflection spectrum in the unstrained situation is in light red and the strained situation is in dark red.

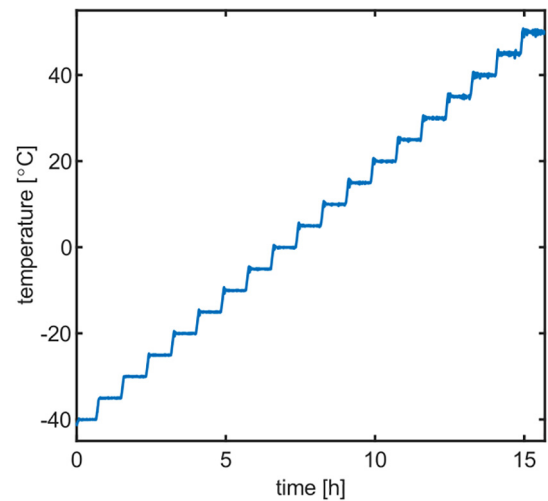
Fig. 6. Temperature profile of the environmental chamber.

Two instrumented M1 and two instrumented M3 panels were placed in a Thermal Vacuum Chamber J2235 by Temperature Applied Sciences [60]. The temperature was increased from -40 °C to $+50$ °C in steps of 5 °C with dwell times of 45 min to ensure a stabilized temperature when performing the spectral measurements. The temperature profile obtained by the thermocouple of the environmental chamber can be seen in Fig. 6, and the spectra were recorded 4 times in the last 15 min of each step.

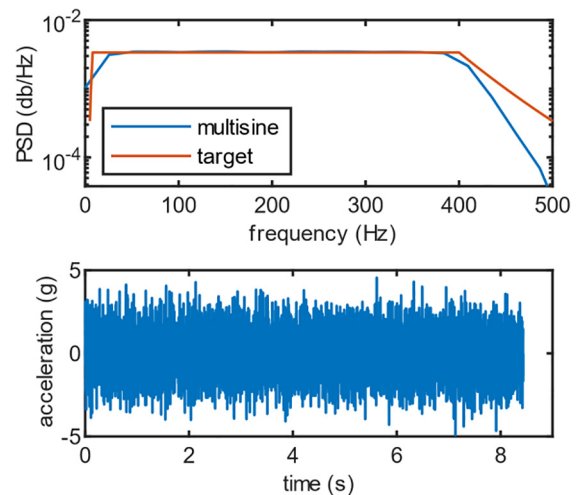
Fig. 7. Power spectral density function (top) and (portion of the) acceleration profile (bottom) of the vibration signal.

To represent the vibrations associated with running aircraft engines, we attached one M4 panel to a shaker and applied a Standard Vibration Test [61] frequency spectrum as can be seen in Fig. 7. The spectra of the fibres were acquired for 60 s both in the absence and in the presence of the standardized vibrations.

To investigate the effect of on-ground aircraft vibration on the acquisition of the damage indicators, one M4 panel was subjected to the standardized acceleration profile of Fig. 7, while the spectra of the 12 Bragg peaks were acquired at 2 Hz for 60 sec. In order to investigate the spread of the Bragg wavelength, a linear trend was removed from the Bragg wavelength signal for every sensor, and the variation of the sensor was analysed. This is depicted for one of the 12 FBGs in Fig. 14, where the Bragg wavelength in function of time during vibrations is shown in the top graph, and the detrended signal in the bottom graph. The detrended signals of all 12 sensors were combined and the distribution on the signals with and without vibrations can be seen in Fig. 16.

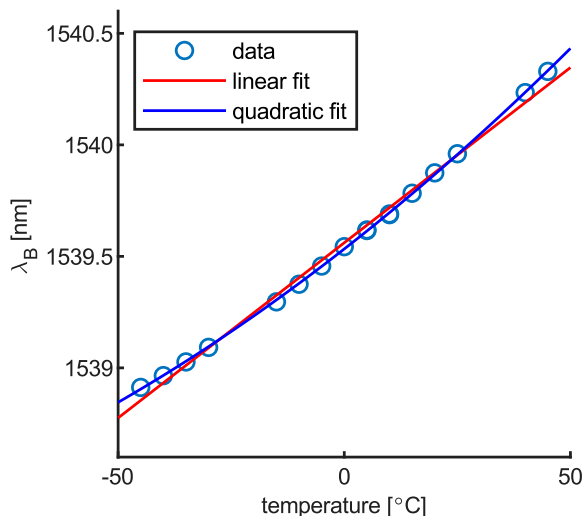
Fig. 8. Bragg wavelengths of an FBG sensor on an M1 panel in function of temperature with a linear and quadratic fit.

ear and quadratic fit were applied, as shown for one sensor on an M1 panel in Fig. 8.

tion and 15.47 ± 1.31 pm/°C in the vertical direction for M1 with $R^2 = 99.50 \pm 0.57\%$, and 13.85 ± 0.77 pm/°C in the horizontal and 13.88 ± 0.89 pm/°C in the vertical direction of M3 with $R^2 = 99.74 \pm 0.16\%$. The standard deviation of the sensitivities and direction dependence illustrate that individual temperature characterization of each FBG sensor is meaningful. Note that a significant improvement of the fit is achieved when opting for a quadratic curve, as shown in the example of Fig. 8. The average R^2 -value of all 48 sensors for their quadratic fit was $99.96 \pm 0.06\%$.

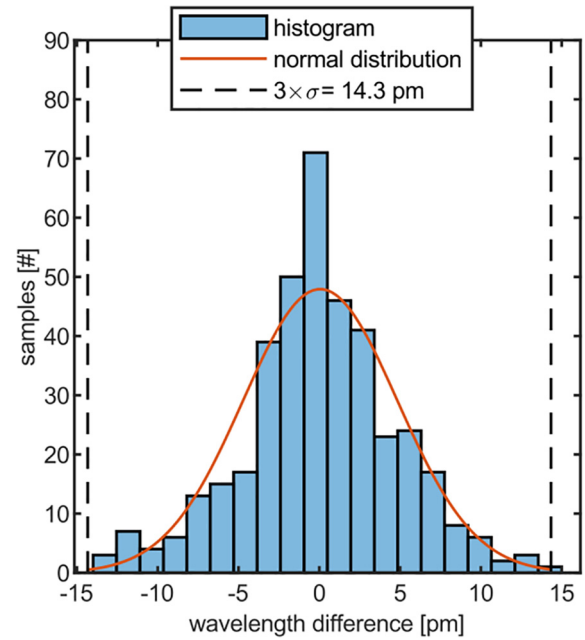
Fig. 9. Histogram and fitted normal distribution of the difference values between measured and temperature reconstructed Bragg wavelengths for M1.

This reconstruction was performed for all 48 sensors at all temperature levels of the climate chamber data set. The differences of every reconstructed Bragg wavelength with the actual measured Bragg wavelength were combined per material and are shown in a histogram for M1 in Fig. 9 and for M3 in Fig. 10, respectively.

We observe that compensating for temperature differences yields mean deviations from the actual Bragg wavelength of 0.05 ± 4.78 pm for M1 and 0.31 ± 5.59 pm. Considering a near certainty confidence interval of 99.7%, compensating for temperature imposes a lower threshold (τ) on the $\Delta\lambda_B$ damage indicator of $\tau_T(\Delta\lambda_B) = 14.3$ pm for M1 and $\tau_T(\Delta\lambda_B) = 16.8$ pm for M3.

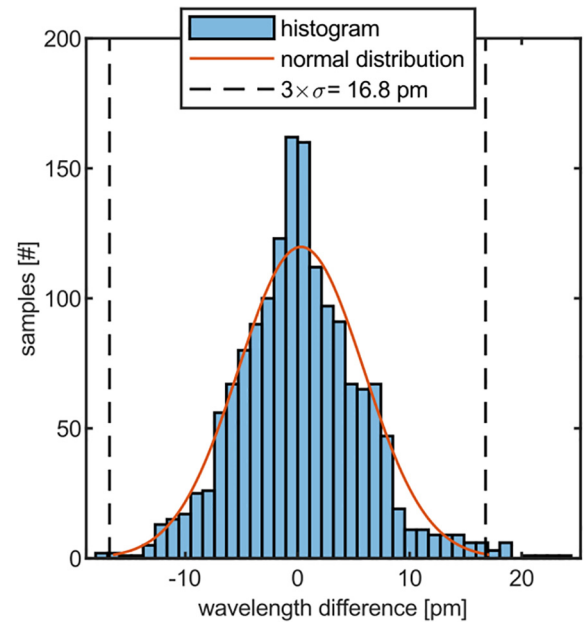
Fig. 10. Histogram and fitted normal distribution of the difference values between measured and temperature reconstructed Bragg wavelengths for M3.

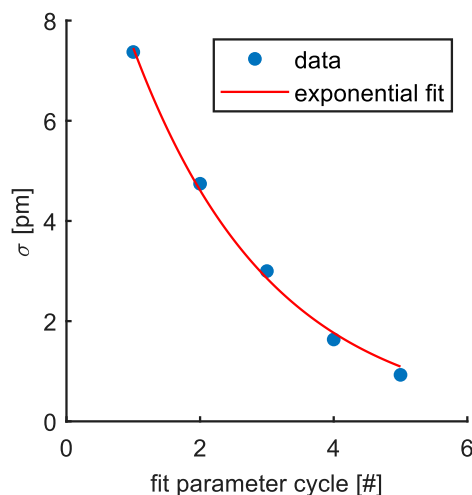
Fig. 11. Variance on the difference between the measured and the reconstructed Bragg wavelengths during annealing cycles.

used, as shown in Fig. 11. This shows that the repeatability of the temperature response increases by temperature cycling, as the variance on the error can be decreased below 1 pm. In practice the repeatability may depend on the material system, optical fibre packaging and mounting adhesive, mounting direction, stiffening of the component, etc. Since temperature cycling of a large instrumented component will possibly not always be feasible, we continue with the thresholds obtained in the previous analysis of $\tau_T(\Delta\lambda_B) = 14.3$ pm for M1 and $\tau_T(\Delta\lambda_B) = 16.8$ pm for M3 as “worst case scenario” values.

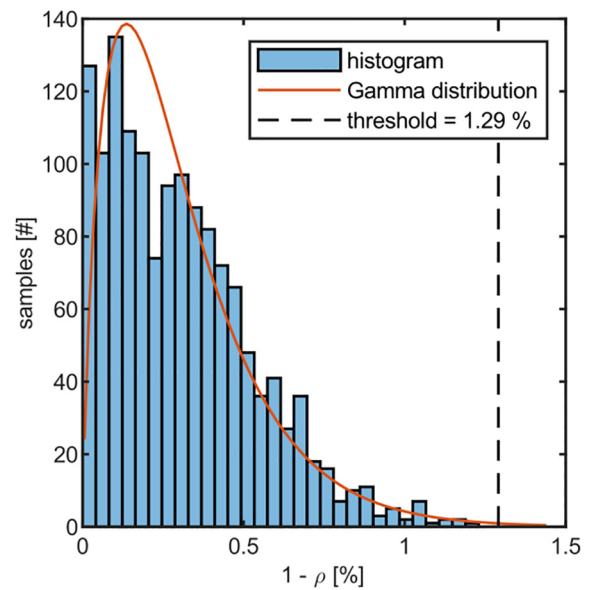
Fig. 12. Histogram and gamma distribution of the correlation coefficients at all temperature differences for M1.

tures. All correlation coefficients were combined per material and the histogram and gamma distribution of the $1 - \rho$ values can be found in Fig. 12 and Fig. 13 for M1 and M3 respectively.

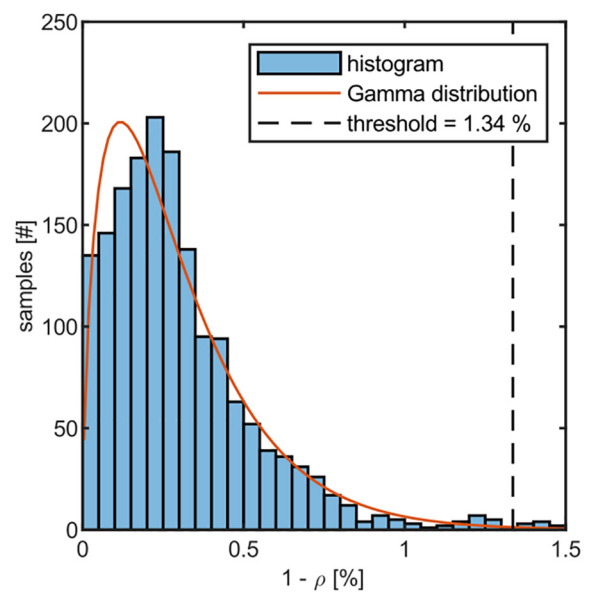
Fig. 13. Histogram and gamma distribution of the correlation coefficients at all temperature differences for M3.

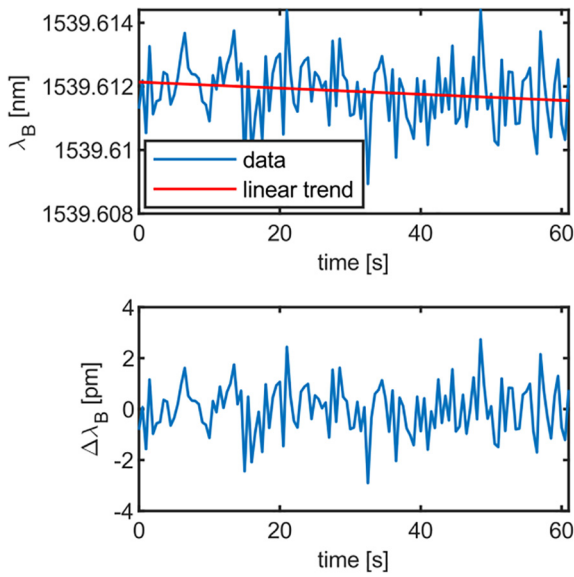
Fig. 14. Bragg wavelength of 1 FBG during vibration (top), and variation on that Bragg wavelength with linear trend removed (bottom).

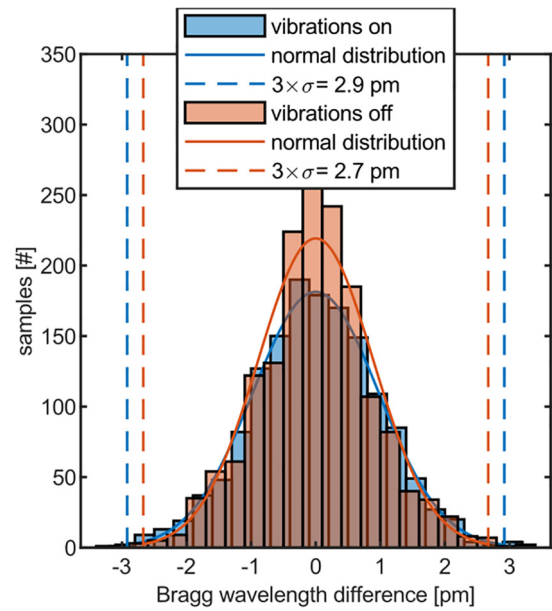
Fig. 16. Histogram and normal distribution of the Bragg wavelength variation with vibrations on and off.

From Fig. 16 we can observe that there is a variation present on the measurement and determination of the damage indicator of up to a few pm. This is the case in the presence, but also in the absence of vibrations, with a slightly larger variance in case of vibrations. Taking again a confidence interval of 99.7%, this results in a detection threshold of $\tau_{vb}(\Delta\lambda_B) = 2.9$ pm. We performed similar repeatability tests in the absence of vibrations, but at elevated temperatures of 42 °C and 54 °C We obtained the Bragg wavelength of the 12 sensors on 1 M1 panel at 2 Hz for 1 min and determined the confidence interval around λ_B as $3\sigma = 2.1$ pm at 42 °C and $3\sigma = 1.9$ pm at 54 °C, which agree with the spread at RT in the absence of vibrations.

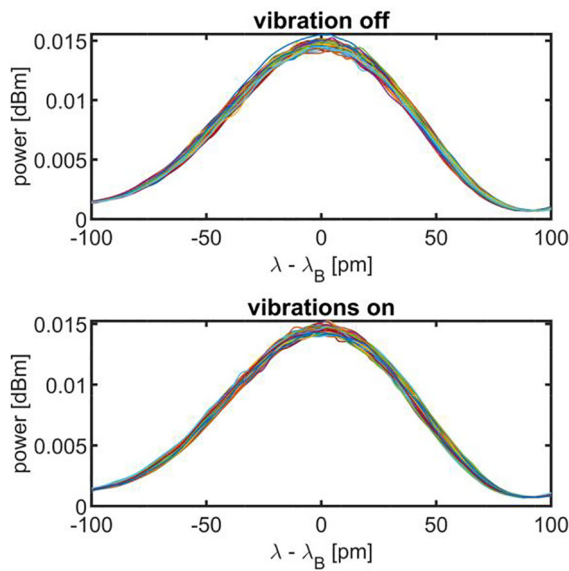
Fig. 15. 120 correlated Bragg peaks of 1 FBG with vibrations off (top) and vibration on (bottom).

Similarly, we correlated all Bragg peaks with those of the first spectrum at the start of the measurement. An overlay of 120 Bragg peak measurements of one FBG can be seen in Fig. 15 in the absence (top) and presence (bottom) of vibrations. The histograms and corresponding gamma distributions of the $1 - \rho$ values for all FBGs can be observed in Fig. 17. The CDF confidence bound of 99.7% is slightly higher in the absence of vibrations, with a value of $\tau_{vb}(1 - \rho) = 1.00\%$. This means the presence of on-ground vibrations has only a minor effect on ρ .

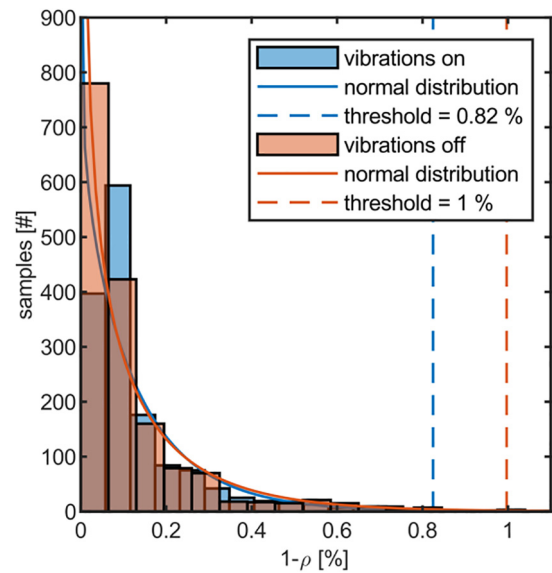
Fig. 17. Histogram and gamma distribution of the correlation coefficient with vibrations on and off.

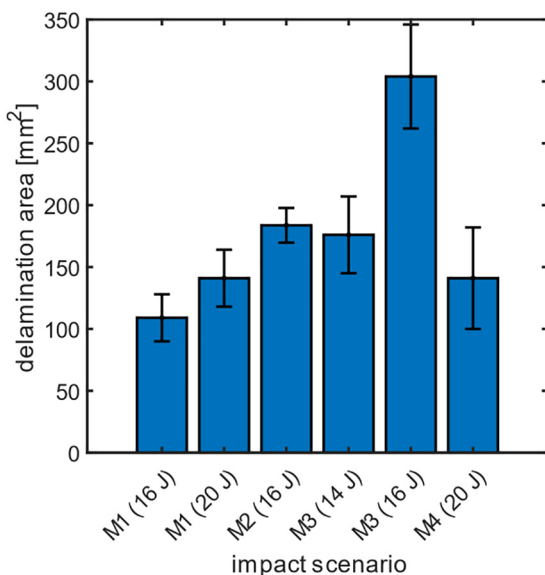
Fig. 18. Average delamination area and standard deviation of the BVIDs per impact scenario.

also shows the average BVID area obtained from the C-scan data of these 4 similar impacts which were between 109 ± 19 mm² for M1 at 16 J and 304 ± 42 mm² for M3 at 16 J. Fig. 19 shows an example C-scan reconstruction in 2D of a 16 J impact on M1 creating a 111 mm² BVID. An ellipse (also visible in Fig. 7) was fit to determine the area of each BVID.

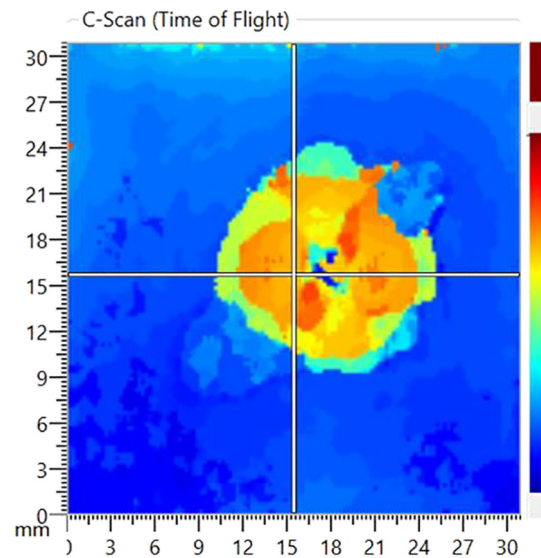
Fig. 19. C-scan data reconstruction in 2D of an example BVID of 111mm^2 on M1 (16 J) showing in dashed line the ellipse used for deriving the BVID's area.

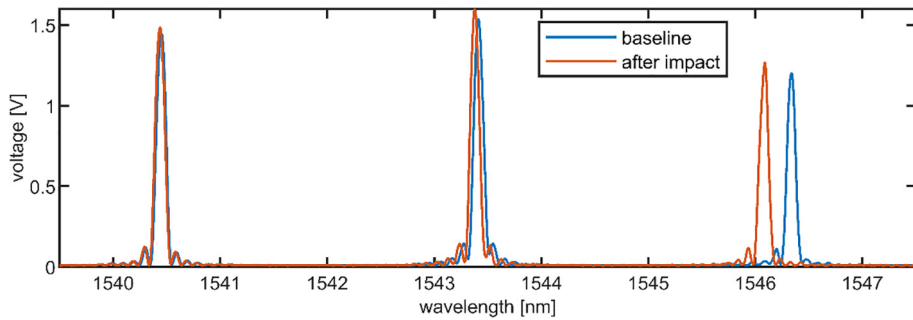
Fig. 21. Spectrum of sensors 1 to 3 for the 20 J impact at location I2 on M1.

The spectra of the first 3 sensors before and after the 20 J BVID at location I2 can be observed in Fig. 21. Although wavelength shifts of 200 pm can be clearly observed, the shape of the peaks doesn't change noticeably, yielding subthreshold $1 - \rho$ values. Fig. 22 shows the spectra before and after the BVID directly under the vertical fibre, and here

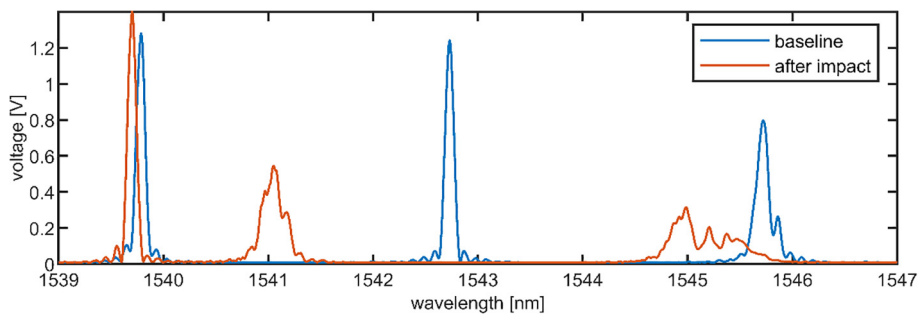
Fig. 22. Spectrum of sensors 1 to 3 for the 20 J impact directly under the vertical fibre on M1.

a clear distortion in the spectrum is observable, yielding $1 - \rho$ values of about 10%. This suggests that only a BVID with delamination extending under an optical fibre sensor array can be observed by a distortion in the spectrum with the correlation coefficient. The average BVID delamination area for all materials is $187 \pm 66\text{mm}^2$ (see Fig. 18), which implies a delamination radius of $7.7 \pm 4.6\text{mm}$, if we assume a circular BVID. This suggests a minimum detection distance of the same magnitude between the fibre sensor array and the BVID's centre.

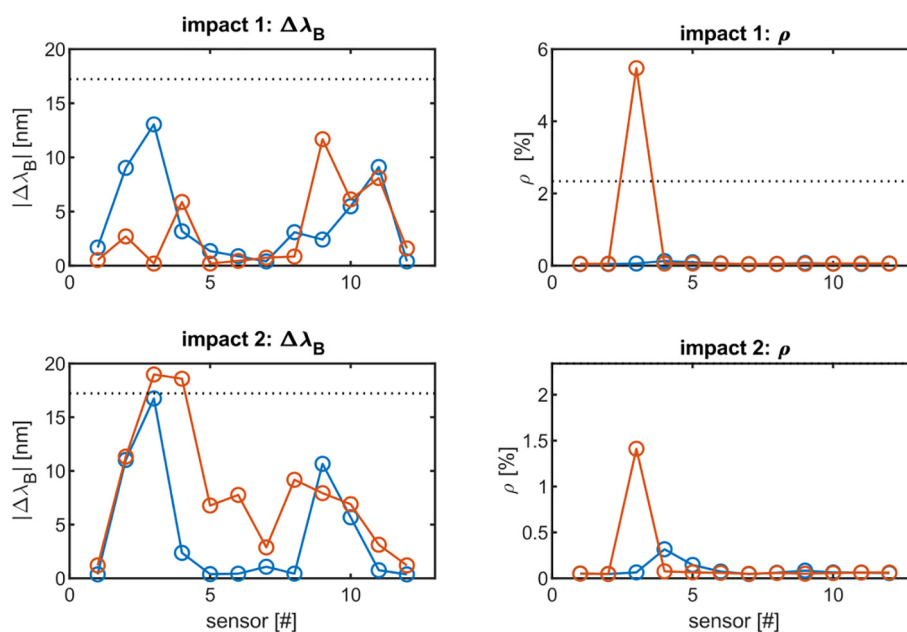
Fig. B.1. Damage indicators for the BVIDs on M2: wavelength shift (left) and correlation coefficient (right) for impact 2 (top), impact 1 (bottom). The damage indicators for different panels are represented by different colours.

The correlation coefficient damage indicators for the materials M2, M3 and M4 displayed in the right panels of Figs. B.1–B.3 respectively, show a similar result for BVIDs at 17 mm. Only 3 individual sensors pass the threshold.

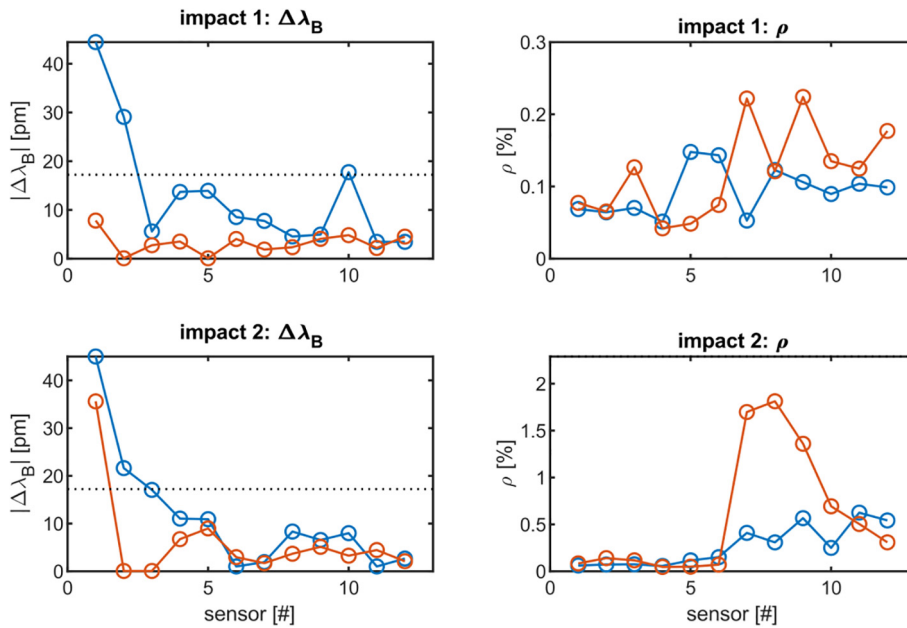
Fig. B.3. Damage indicators for the BVIDs on M4: wavelength shift (left) and correlation coefficient (right) for impact 1 (top), impact 2 (bottom). The damage indicators for different panels are represented by different colours.
