The Influence of Temperature and Moisture on the Mode I Fracture Toughness and Associated Fracture Morphology of a Highly Toughened Aerospace CFRP

T. J. Katafiasz^{1*}, E. S. Greenhalgh¹, G. Allegri², S. T. Pinho¹, P. Robinson¹

Abstract

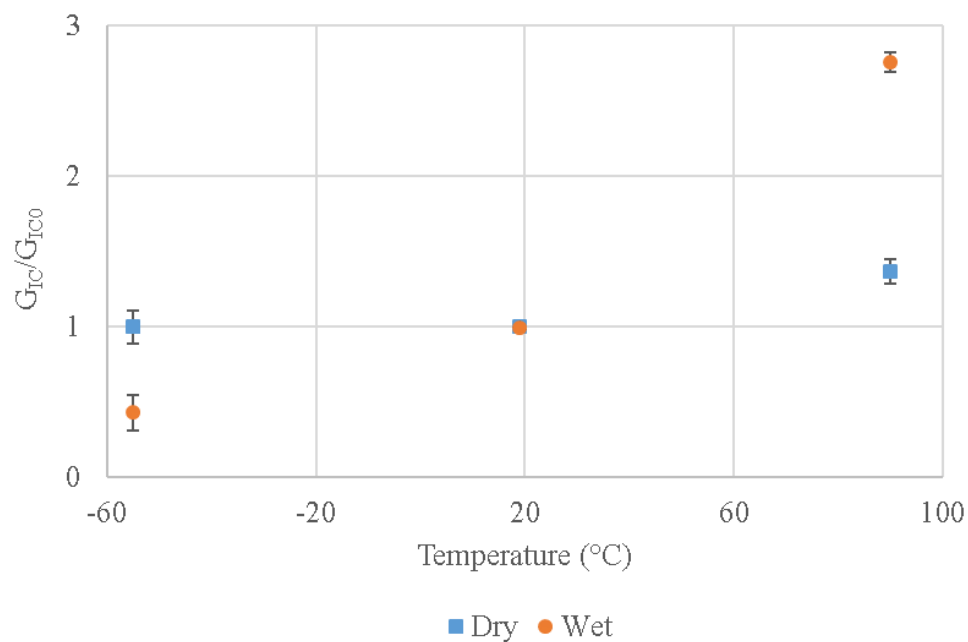
Figure 1. Normalised mode I fracture toughness (G_{IC}/G_{IC0}) versus temperature (°C)

Figure 1 presents the mode I averaged steady-state propagation toughness versus test temperatures and moisture content, and the graphs in Figure 2 and Figure 3 show the corresponding toughness values versus crack length for the three testing temperatures considered, in both the dry and wet conditions. The wet/hot condition presented an *R*-curve behaviour, whereas the other test conditions were insensitive to crack length. Table 1 presents the normalised initiation and propagation toughness data for each condition, with all the data having been normalised with respect to the dry/RT propagation toughness, hereafter referred to as G_{IC0} . The sparsity of data points for the cold tests was due to the slip-stick nature of the crack propagation at -55°C, leading to fewer stable crack lengths having been recorded during testing.

The dry propagation toughness values presented a negligible variation between the dry/cold and dry/RT tests, and a 37% increase from dry/RT at dry/hot. The wet toughness values exhibited a stronger dependence on temperature than the dry ones, with a 57% drop in toughness in wet/cold conditions, and a 176% increase in toughness

in wet/hot testing, compared to the reference dry/room temperature toughness. The highest toughness was therefore associated with the wet/hot condition, and the lowest was attained in the wet/cold scenario.

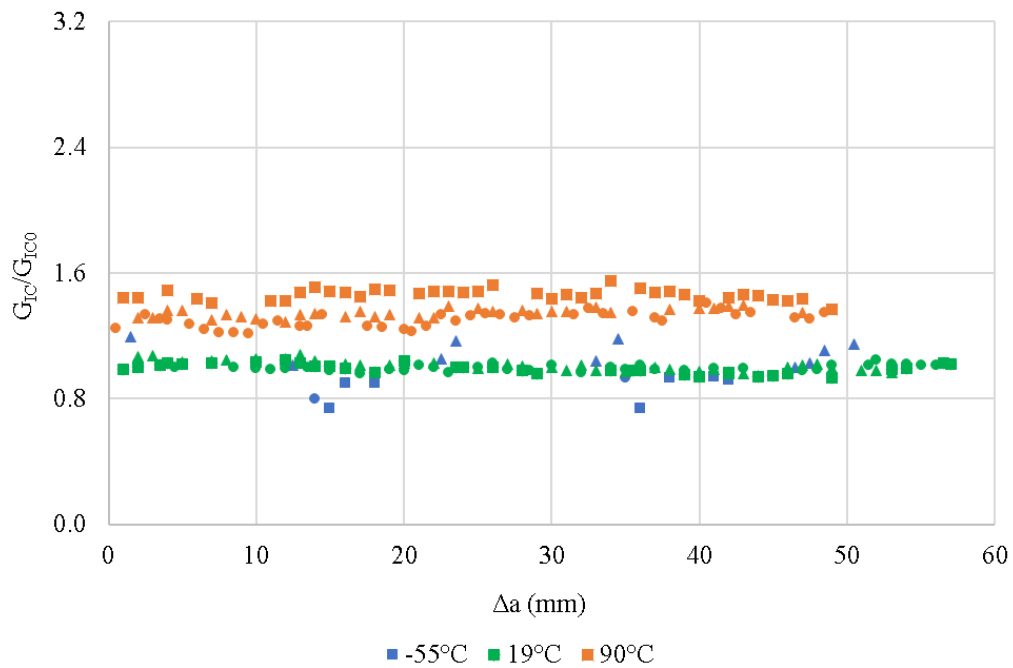
Figure 2. Normalised mode I fracture toughness (G_{IC}/G_{IC0}) versus change in crack length (mm) for the dry specimens

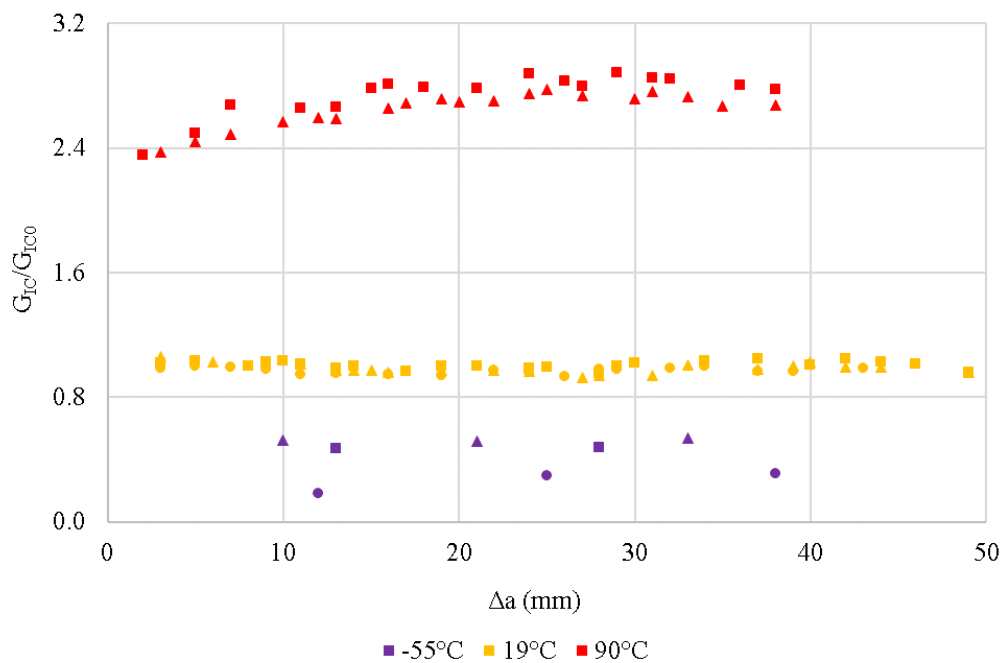
Figure 3. Normalised mode I fracture toughness (G_{IC}/G_{IC0}) versus change in crack length (mm) for the wet specimens

The wet/hot morphologies presented the highest levels of ductile flow across both the epoxy and toughening particles. High levels of fibre/matrix debonding were noted in this regime, leading to a highly ductile and tortuous crack path, and hence a substantial 176% increase in fracture toughness, compared to the dry/RT tests. It is evident that the toughening particle/epoxy interface was weakened by the moisture conditioning prior to testing. However, the eventual dis-bond between the particles and the surrounding matrix was not visible following testing in wet/hot conditions, due to the substantial plastic deformation affecting of the phases in the ply interlayer. The degradation of the fibre/matrix interface in the wet/hot tests explains the observed rise in the toughness with crack length (Figure 3).
