On the early stages of localised atmospheric corrosion of magnesium–aluminium alloys

M. Shahabi-Navid¹, Y. Cao², J. E. Svensson³, A. Allanore⁴, N. Birbilis⁵, L. G. Johansson³ & M. Esmaily⁴✉

The surface film on pure magnesium and two aluminium-containing magnesium alloys was characterised after 96 h at 95% RH and 22 °C. The concentration of CO₂ was carefully controlled to be either 0 or 400 ppm. The exposed samples were investigated using X-ray photoelectron spectroscopy, Fourier transform infrared spectroscopy, X-ray diffraction, and electron microscopy. The results showed that when the alloys were exposed to the CO₂-containing environment, aluminium cations (Al³⁺) was incorporated into a layered surface film comprising a partially “hydrated” MgO layer followed by Mg(OH)₂, and magnesium hydroxy carbonates. The results indicated that aluminium-containing magnesium alloys exhibited considerably less localised corrosion in humid air than pure magnesium. Localised corrosion in the materials under investigation was attributed to film thinning by a dissolution/precipitation mechanism.

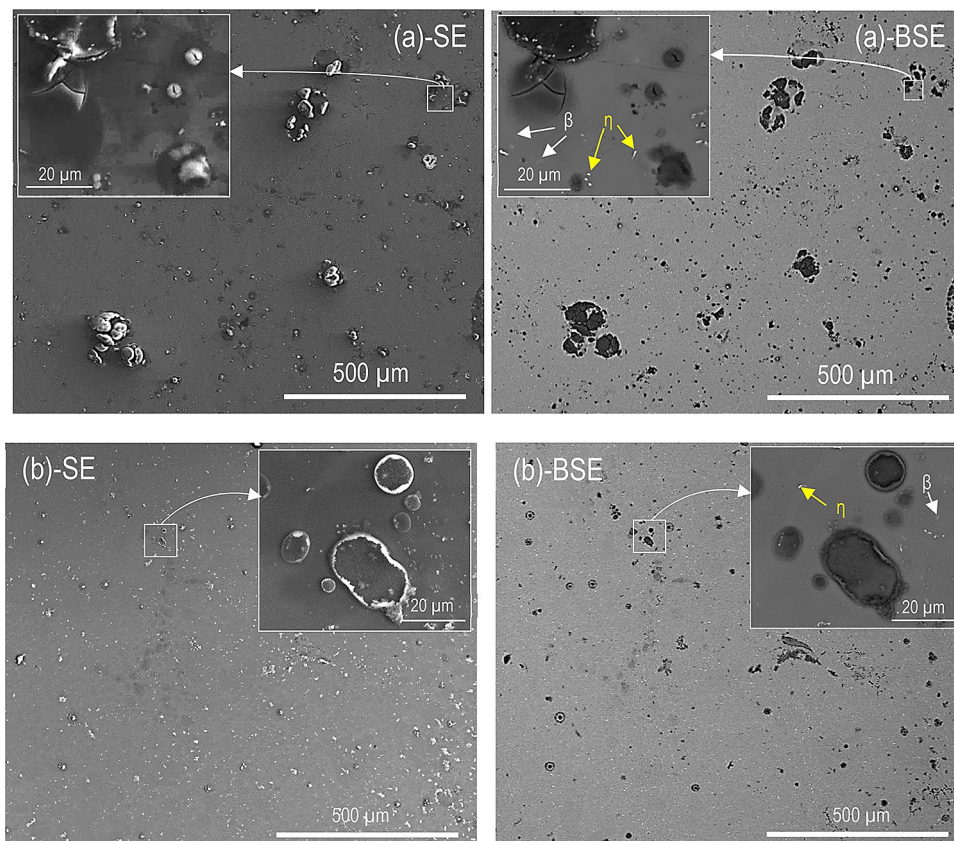
Figure 2. SE and BSE micrographs showing the surface morphology after 96 h exposure at 95% RH and 22 °C. (a) AM50, 400 ppm CO₂, (b) AM50, no CO₂.

Figure 2 depicts alloy AM50 exposed in the presence and absence of 400 ppm CO₂, showing corrosion product nodules of different sizes, similar to those observed on CP Mg. However, the filiform corrosion was not observed on alloy AM50. The corrosion product nodules were often associated with η - and β -phase particles in the alloy matrix (see BSE images in Fig. 2). Similar to CP Mg, the corrosion products formed in the presence of CO₂ contained cracks. The main effect of CO₂ on the corrosion morphology of alloy AM50 was clusters of large corrosion product nodules that only appeared in the presence of CO₂ (compare Figs. 1 and 2).
