# Fast, Accurate, and Reliable Detection of Damage in Aircraft Composites by Advanced Synergistic Infrared Thermography and Phased Array Techniques

**Abstract:** This paper presents an advanced methodology for the detection of damage in aircraft composite materials based on the sensor fusion of two image-based non-destructive evaluation techniques. Both of the techniques, phased-array ultrasonics and infra-red thermography, are benchmarked on an aircraft-grade painted composite material skin panel with stringers. The sensors systems for carrying out the inspections have been developed and miniaturized for being integrated on a vortex-robotic platform inspector, in the framework of a larger research initiative, the Horizon-2020 ‘CompInnova’ project.

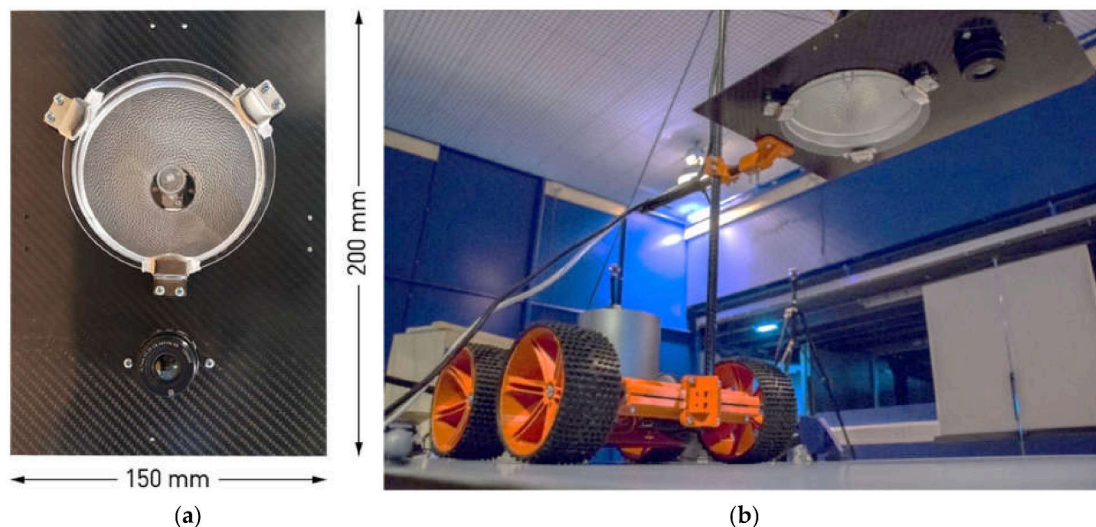
**Figure 2.** IRT module (a) dimensions and arrangement and (b) mounted on the prototype Vortex Robot Platform developed by Luleå University of Technology [31,32] for automated aircraft skin inspection of BVID by Pulsed Phase-informed Lock-in Thermography (PPI-LT).

The module was assembled by mounting the sensor and source on an autoclave-cured carbon fiber reinforced polymer (CFRP) plate. Figure 2a presents the module face, while Figure 2b demonstrates it mounted on the VR platform. The lens protruded from the plate by 20 mm while the lamp position in the reflector was recessed by 30 mm from the plate. The dimensions of the sensor and the complete module were  $30 \times 30 \times 45 \text{ mm}^3$  and  $200 \times 150 \times 100 \text{ mm}^3$ , respectively. The optimization of the module height (distance of plate from the surface under examination) was performed under the condition of IFOV maximization while maintaining full thermographic information from the surface. The IFOV should be maximum for the corresponding scanned area to be as wide as possible, which minimizes the acquisition timescale requirement for the whole aircraft structure. Based on this, a module height of 400 mm from the surface provided a optimal field of view of  $320 \times 240 \text{ mm}^2$ . Indicatively, a much smaller field-of-view of  $200 \times 150 \text{ mm}^2$  was measured at a module height of 250 mm. Most importantly, the respective weights of sensor and complete module, 70 g and 407 g, are indicative of the compactness and maneuverability offered, which makes them ideal for the targeted field application and mounting method. Prior to the start of IRT inspection, the lens end piece was focused on the surface under examination and a sensor calibration procedure, where the following involved exposure of the sensor to uniformly hot and cold surfaces, in sequence. During the initial phase of PPI-LT, the lock-in frequency was selected after the identification of the thermogram associated with the maximum contrast among those that were collected at various frequencies. In the second step, the surface within the field of view was analyzed in detail by locking thermography at the selected frequency.

The stiffened panel was initially scanned by PPI-LT for rapid wide-area identification of damage location, after which PA inspection was pursued. This primer task was undertaken with the IRT module that was integrated on the VRP, as seen in Figure 2b as a lab-scale demonstration of the envisioned fully automated NDT solution for rapid

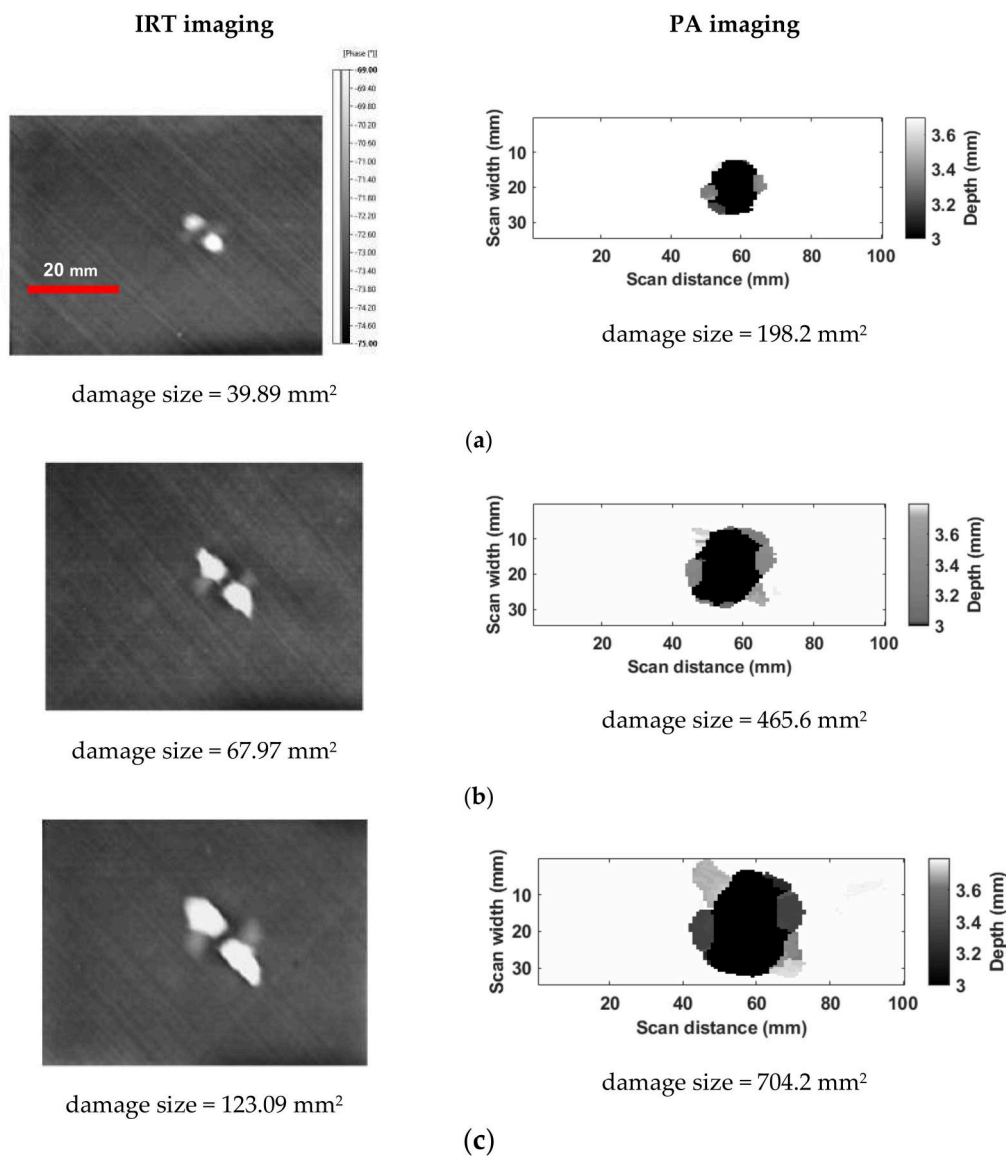
**Figure 5.** Detection of damage by rapid PPI-LT (thermograms, left column) and subsequent high-resolution characterization by PA imaging (right column) for 18-layers coupons with different impact energies: (a) 8 J, (b) 12 J, and (c) 20 J.

By observation of the thermographic results that are presented in Figures 4–6, it is concluded that damage is captured with exceptional precision by the developed PPI-LT approach and sensor in all types of specimens. It is interesting to note that the technique not only assesses the presence of damage, but it can represent its main geometrical features, such as shape and orientation, as documented by the high contrast area corresponding to damage in  $-45^\circ$  laminas in the thermograms. In certain cases, such as Figure 5b,c, the barely visible dent produced at the site of impactation is also visible (dark circular mark at the damage center). The increasing extent of damage with increasing impact energy is efficiently assessed by IRT. Hence, it entails that the developed PPI-LT approach and sensor can not only identify damage presence, but can also provide its basic dilatational characteristics.

Observing PA C-scan images of impact damages that are presented in Figures 4–6, the following general observations can be derived: the impact damage size increases with impact energy, and damage tends to propagate along the 45° to fiber direction. In all coupons, the impact damage shows large sub-surface damage, with little or no external indication of the impact. Hence, it is vital to carry out detailed NDT inspections on the composite aircraft's external surface during heavy maintenance. In all coupons and laminates, IRT imaging shows the good detectability of damage, but the damage area is consistently smaller in size when compared to C-scan. This is because, under the rapid mode requirement of the target application, IRT is used as a fast initial indicator of damage presence; hence, PPI-LT does not offer the resolution that is required for performing full damage analysis. On the other hand, low-speed selective PA on IRT-identified areas only offers the added high-resolution feature that is required for this. In higher thickness coupons, IR thermograms exhibit lower sensitivity on impact damage, even though PA detects large sub-surface damage. These results indicate the importance of impact damage detection and the need for 100% inspection. However, adopting the proposed inspection strategy, 100% detailed inspection of the whole structure using thorough, but also time-consuming, PA can

Hence, in the next step, the PA module was integrated on to the vortex robot for automated scanning of the stiffened panel. Initially, the PA hardware was pre-loaded with a configuration file with all of the PA inspection parameters, as mentioned earlier; subsequently, PA hardware control was handed over to the robot. The robot interfaces with PA hardware through a custom-developed communication controller to control the PA data acquisition, storage, and water-pump operation for delivering water mist as couplant at the foot of the transducer. The robot then moves to the designated target area on the stiffened panel, around the damages (D1, D2, and D3), and it sequentially performs separate PA line scans. Each line-scans are of fixed 150 mm length and a width of 34.5 mm. The right-hand side graphs of Figure 7 represent the results of the assessment of impact damages on the stiffened panel performed by the PA module mounted on the VRP. The impact damage 'D1' on the skin region is well detected, as shown in Figure 5a. However, damage 'D2' exactly on the web region is not detected, but the damage 'D3' is partially detected. as shown in Figure 7. The thickness of the skin and flange region in the stiffened panel is 1.6 mm and 2.1 mm Figure 5b, c, respectively. At the T-junction region formed by the intersection of both the flanges, there is no backwall reflection of the ultrasonic waves due to the geometric curvature and web width, and, hence, the small damage 'D2' imaging was not successful. Furthermore, it was observed that, on the back-face of the panel, at the transition region between the skin and flange of the stringer, there is an accumulation of excess resin and, hence, at this region there is no reflection of the ultrasonic waves for a short width of 3–5 mm. Because to this reason, the damage 'D3' is partially masked, as shown in Figure 5c.

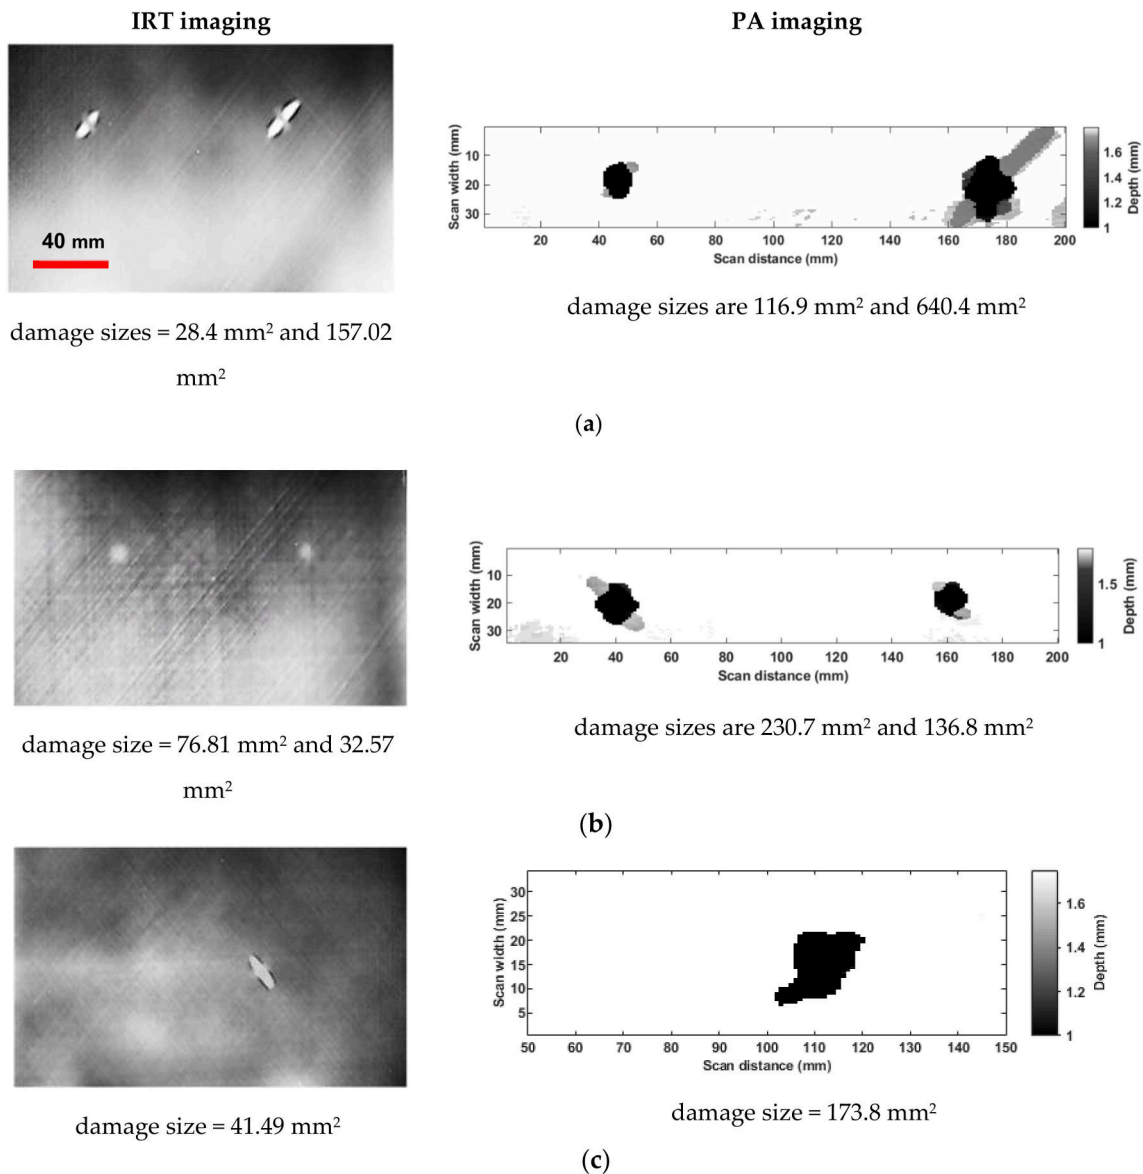
**Figure 6.** Detection of damage by rapid PPI-LT (thermograms, left column) and subsequent high-resolution characterization by PA imaging (right column) on flat laminates (9 layers) with estimated impact energies (a) 4.5 J (b) 5.5 J and a curved laminate with estimated impact (c) 4.5 J.
