Effect of Impact Velocity in Erosive Wear of Austempered Ductile Iron

Kazumichi SHIMIZU, Noboru SHIRAMINE*,
Minoru FUJITA* and Toru NOGUCHI*

Abstract

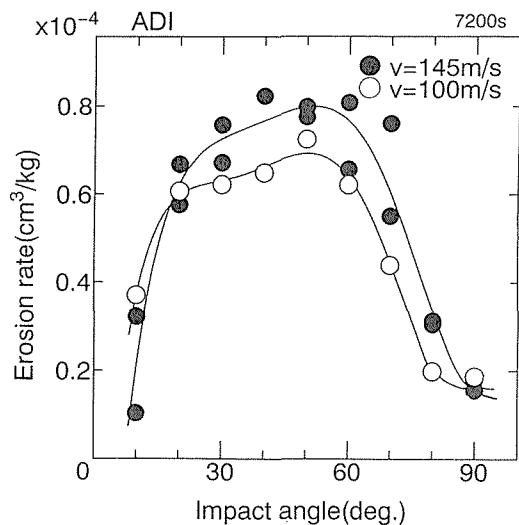
Figure 7 Erosion rate vs. impact angle, ADI

Figure 7 shows the relation between the impact angle and the erosion rate after blasting for 7200s at $V=100$ m/s and 145 m/s with ADI. At $V=145$ m/s and also at $V=100$ m/s, erosion rate reaches a maximum at $40^\circ\sim 60^\circ$ quite different from SS400. Compared with SS400 the erosion rate of ADI is, at $V=145$ m/s, 20%, and at $V=100$ m/s, it is 23%, very small values due to quite different phenomena. It is clear that impact angles does not have

much influence on erosion rate and eliminate the effect of impact velocity.

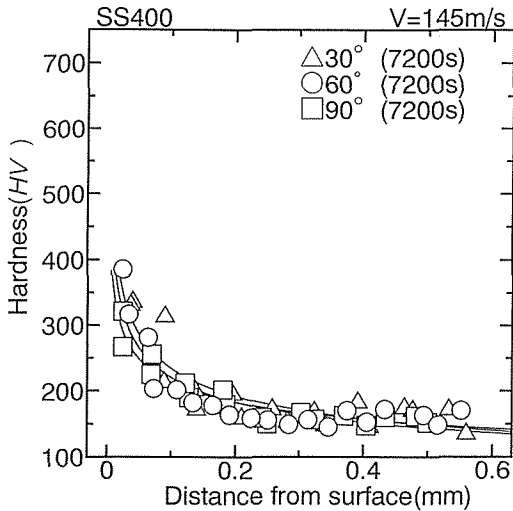
Figure 10 Hardness (HV) vs. distance from surface, SS400

To confirm the superior erosion resistance of ADI compared with SS400, the hardness near the surface was measured. Figure 10 and 11 show the hardness distribution of SS400 and ADI in the depth direction, for impact angles of 30°, 60°, 90° with 7200s of blasting. The initial Vickers hardness (HV) of SS400 is about HV150 but on the eroded surface, it is HV380, showing a hardening caused by the impacts. The initial hardness value of ADI is around HV350 and on the eroded surface it reaches HV750. To establish the reason for this remarkable hardening, the amount of retained austenite was measured by X-ray diffraction method. For impact angles of 30°, 60°, and 90°, there is about 40% of the matrix before the test, but only 3 to 5% after the test (7200s). The Micro-Vickers hardness test shows that the surface hardness was almost the same at 600s the value after at 7200s, and the transformation of the retained austenite to martensite is considered to be complete already at 600s. The results lead to the assumption that, the austenite on the surface transforms into martensite by the impacts, and that the erosion rate is slowed by the hardening. As erosion proceeds, the top martensite layer is worn away and the austenite in the under lying surface transforms into martensite maintaining the hardness to some depth below the surface. Further, impact velocity has little influence on the erosion rate of ADI.
