**Title: Bending resistance of repaired column members and shear resistance of opening frames with repaired column of Japanese conventional wooden houses**

Type of article: **Note**

Author's name: **Kei Sawata, Masahiko Toda, Satoru Kanetaka, Yoshihisa Sasaki, Takuro Hirai**

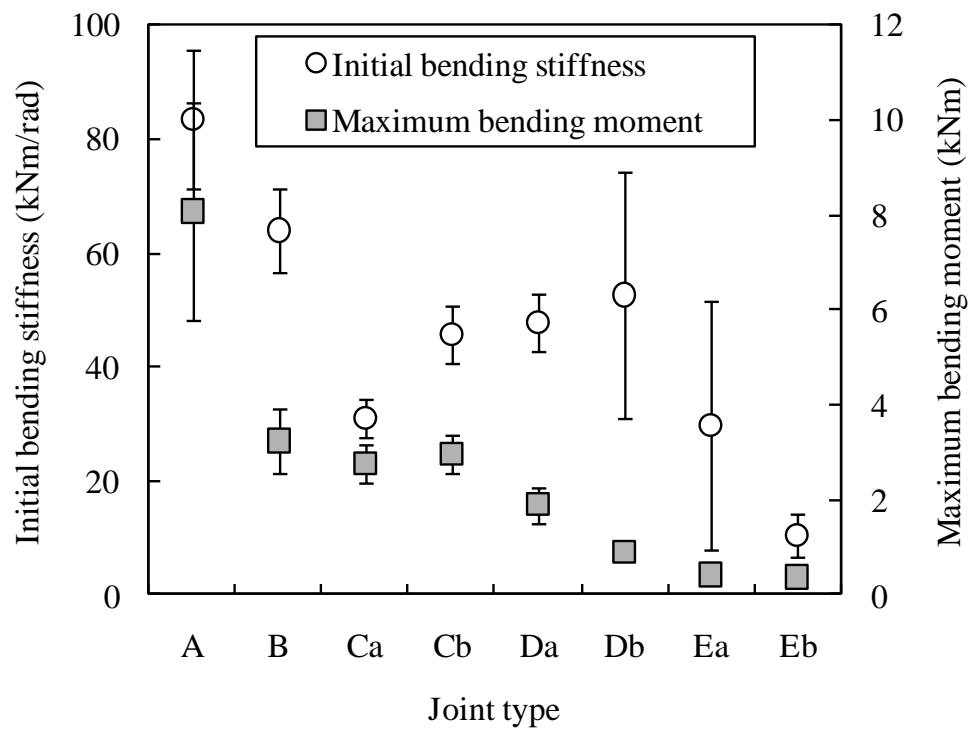
Fig. 5. Initial bending stiffness and maximum bending moment on each joint types.

Fig. 5 shows the initial bending stiffness and the maximum bending moment of each joint type. The initial bending stiffness differed noticeably depending on joint types and loading directions. Type B showed the highest initial bending stiffness of those repair methods and its initial bending stiffness was 77% of the control specimen (type A) in average. Type Eb showed the lowest values and its initial bending stiffness was 12% of the control specimen in average. The initial bending stiffness of joint types Ca and Cb was observed difference due to loading direction, and that of type Ca was 68% of that of type Cb. However, the other was not clear the effect of loading direction on the initial bending stiffness because types Db and Ea had large standard deviation.

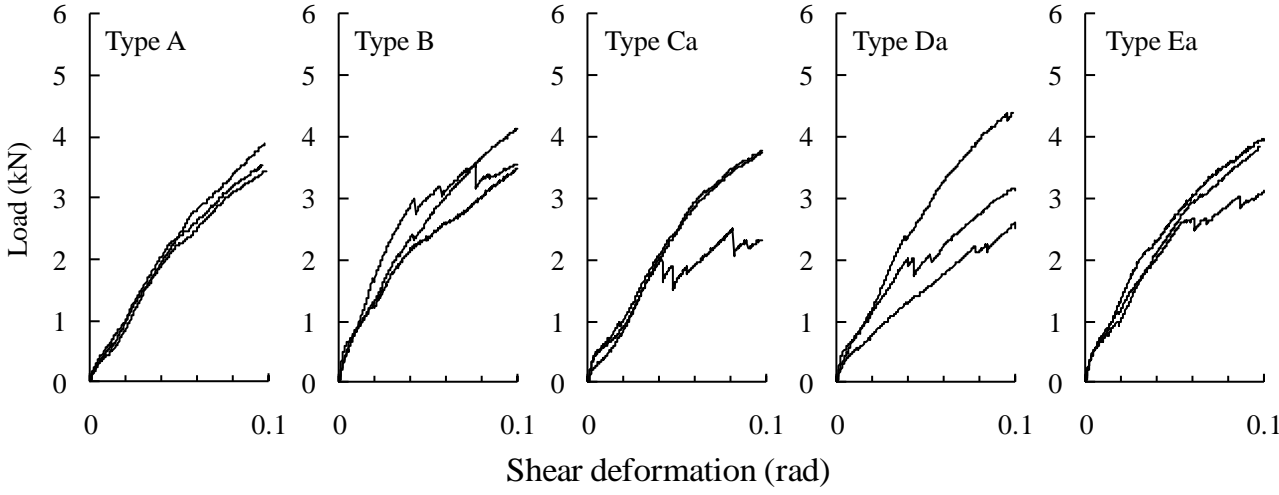
Fig. 6. Envelope load-deformation curves of conventional frame specimens.

The conventional frame specimens broke at the tenon of door head member or cotter pin of door head-column joints (areas I or II in Fig. 3); however, bending deformation of the repaired column obviously was not observed until racking test terminated. Fig. 6 shows the envelope load-deformation curves obtained from the racking tests of conventional frame specimens. The specimens broke by tension fracture or plug shear at the tenon of door head member showed low load (some of types Ca, Da and Ea). The load-deformation curves of specimens broke by partial compression at cotter pin or split at the tenon of door head were little affected by the repair methods, and those load gradually increased up to near  $1/10\text{rad}$ .
