Repair of Full-scale Timber Bridge Chord members by Shear Spiking

REPAIR OF FULL-SCALE TIMBER BRIDGE CHORD MEMBERS BY SHEAR SPIKING

Abstract

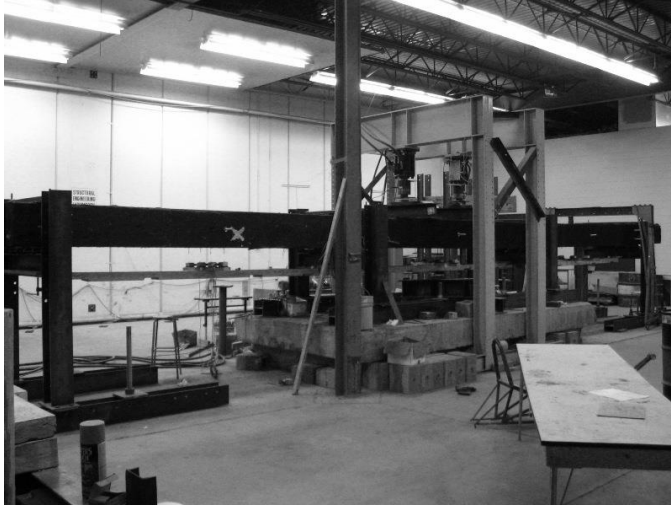
A three-span, four stringer bridge chord was constructed as shown in Figure 1. The materials were donated by the Association of American Railroads and had been used in a previous

Figure 1: Photograph of Full-Scale Specimen

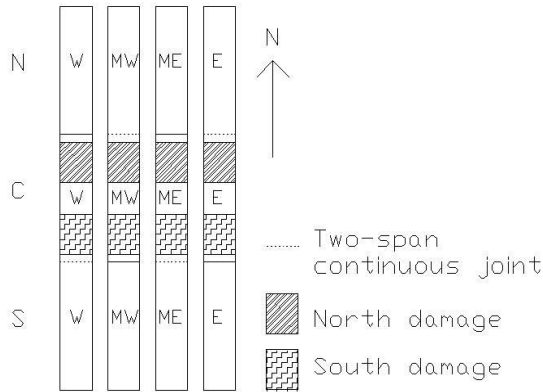
In each of the three spans, each of the four stringers was given a set of labels for various segments of the bridge chord specimen, as shown in Figure 8.

Figure 8: Stringer Labels

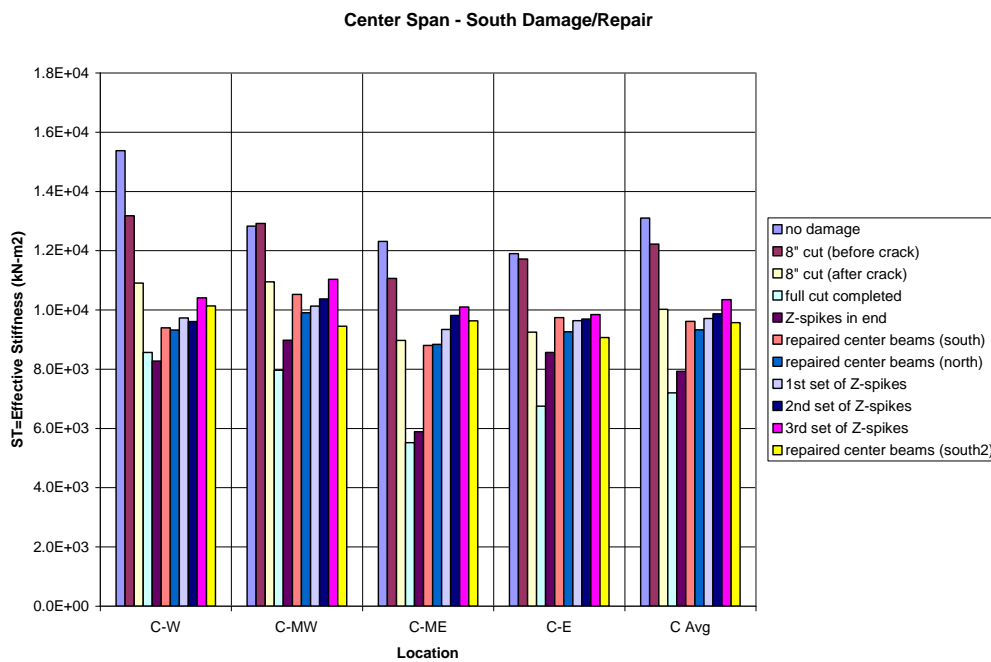
The patterns of changing ST of the center span due to the south end damage/repair are shown graphically in Figure 9. The load-deflection data used to calculate the effective stiffness for the south end damage/repair can be found in Burgers et al. (2005).

Figure 9: Effective stiffness of the center span due to south damage/repair

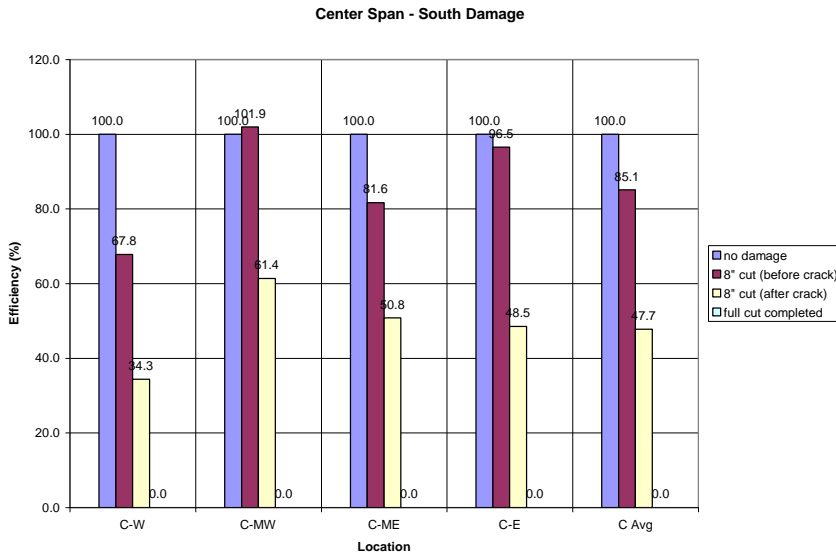
The decreases in efficiency caused by the progression of damage are shown in Figure 10. The “no damage” state was used as ST_k and the “full cut completed” state was used as ST_i in calculating efficiency from Equation 2. The efficiency equation and states ST_i , ST_j , and ST_k were used, but the definition of efficiency does not hold, since the data shown was for progression of damage and not repair. Instead the figure shows how the effective stiffness decreased with increasing damage. It was evident that the cut reduced the effective stiffness of each stringer.

Figure 10: Efficiencies of the center span due to south end damage (ST_i = “full cut completed” and ST_k = “no damage”)

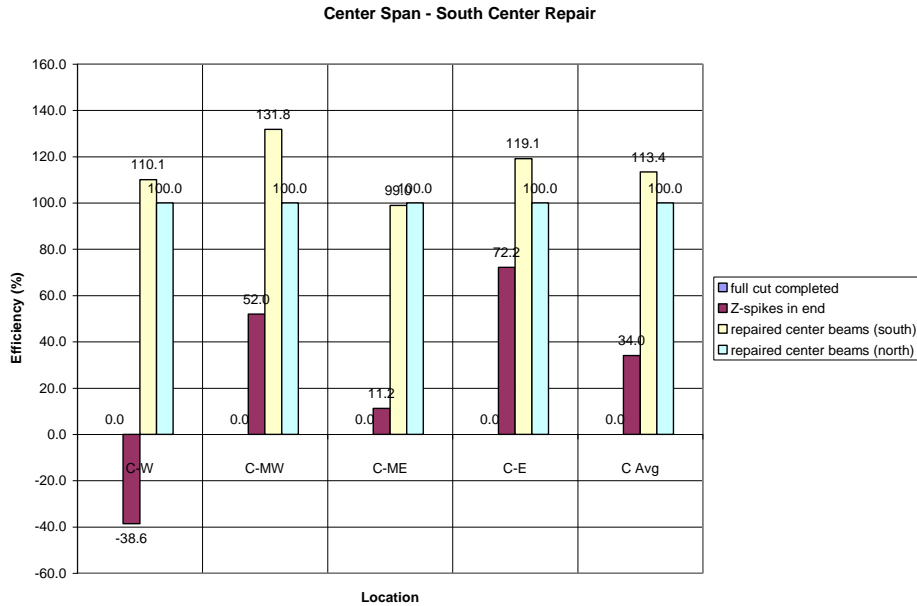
The efficiencies of the center repair progression are shown in Figure 11. The “repaired center beams (north)” state was used as ST_k and the “full cut completed” state was used as ST_i in calculating efficiency from Equation 2. It was evident that the installation of Z-spikes in the middle of the center span increased the effective stiffness. The effective stiffness was higher after the south half of the center of the span was repaired than when both the south and the north halves were repaired. A possible explanation is that the loss of the “sound” timber due to the drilling of the holes for the Z-spikes had more of a negative effect than positive effect of the insertion of the Z-spikes. Note that in the west stringer, the efficiency decreased with the addition of the shear spikes near the end of the damage. This interesting phenomenon was also observed in previous studies, i.e. Radford et al. (2000) and Schilling et al. (2004).

Figure 11: Efficiencies of the center span due to south end center repair (ST_i = “full cut completed” and ST_k = “repaired center beams (north)”)

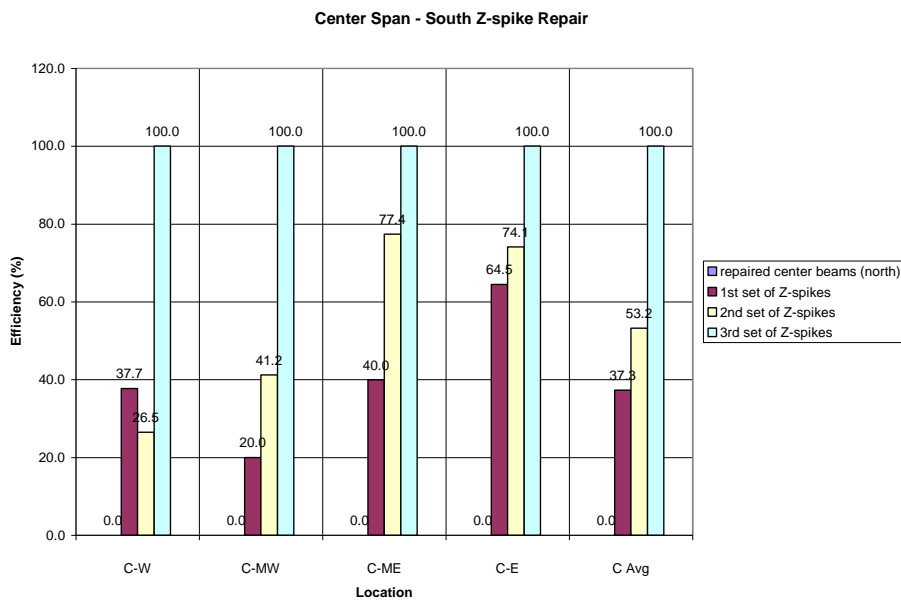
The efficiencies of the Z-spike insertion progression are shown in Figure 12. The “no damage” state was used as ST_k and the “full cut completed” state was used as ST_i in calculating efficiency from Equation 2. It was evident that the installation of Z-spikes to repair the cut increased the effective stiffness. On average, the last set of Z-spikes (inserted at the quarter point of the damage) had more effect than either of the other two sets. On average, the second set (inserted at the three-quarters point of the damage) had less effect than the other two sets.

Figure 12: Efficiencies of the center span due to south end Z-spike repair (ST_i = “repaired center beams (north)” and ST_k = “3rd set of Z-spikes”)

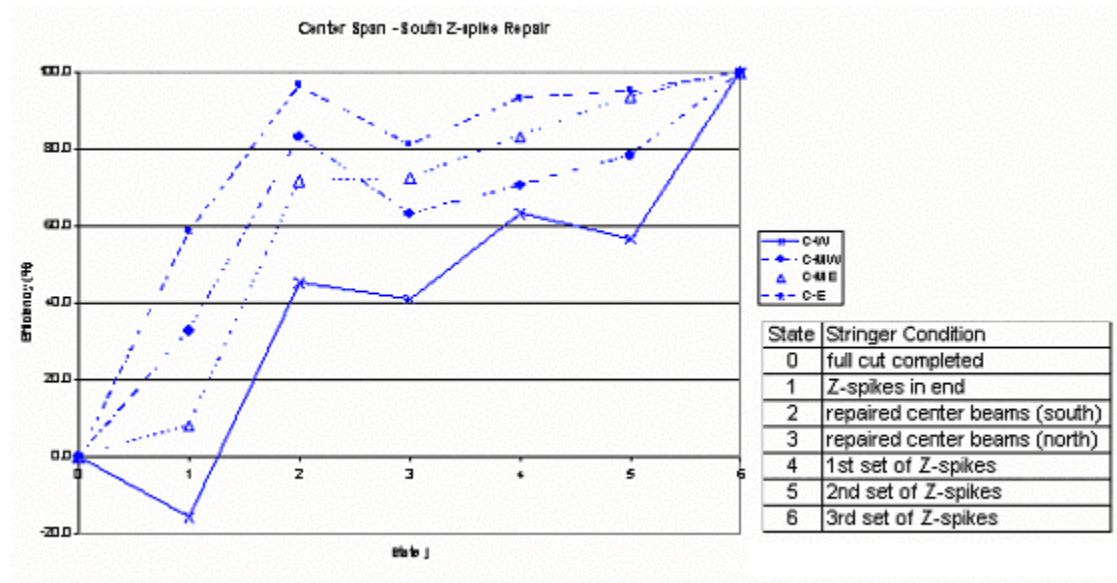
The efficiencies of the combination of the center repair and the Z-spike repair are shown in Figure 13. The “3rd set of Z-spikes” state was used as ST_k and the “full cut completed” state was used as ST_i in calculating efficiency from Equation 2. It was evident that each of the four stringers followed approximately the same behavior from state to state. The efficiency of all four stringers increased in the first and second states, then decreased or remained approximately the same in the third state, then increased again in the fourth, fifth, and sixth states.

Figure 13: Efficiencies of the center span due to south end repair (ST_i = “full cut completed” and ST_k = “3rd set of Z-spikes”)

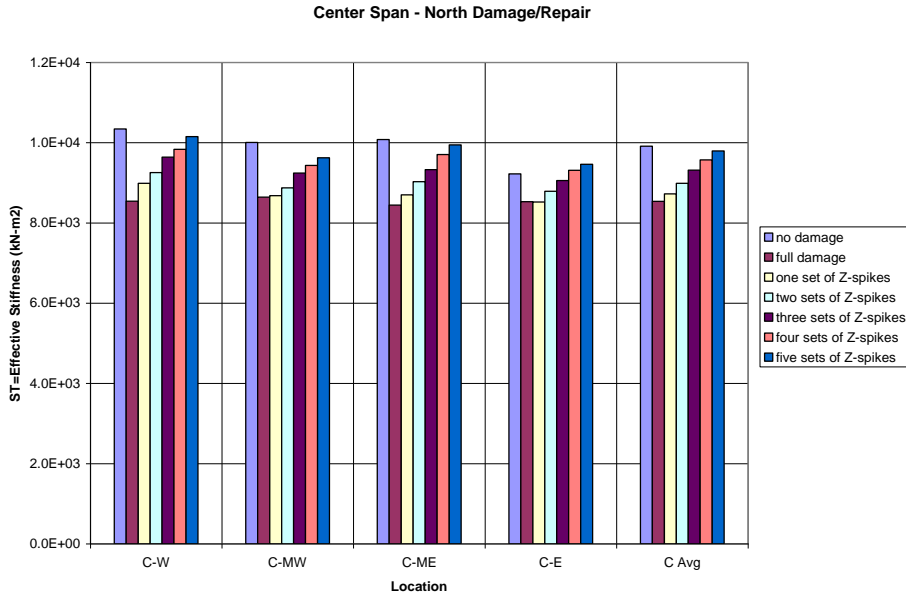
For the damage/repair in the north half of the center span of the beams, the stiffness and efficiency for each member in the center span were calculated before the damage, after the damage, and with each incremental addition of the five sets of Z-spikes. The patterns of changing measured ST of the center span due to the repair of the inflicted damage in the north end are shown graphically in Figure 14. The load-deflection data used to calculate the effective stiffness for the north end damage/repair can be found in Burgers et al. (2005).

From Figure 14 it is evident that the installation of Z-spikes increases the effective stiffness of the stringers in the center span. For the four stringers in the center span, the average effective stiffness was 8.72×10^3 kN-m² for the first set of Z-spikes, 8.99×10^3 kN-m² after adding the second set, 9.32×10^3 kN-m² after adding the third set, 9.57×10^3 kN-m² after adding the fourth set, and 9.80×10^3 kN-m² after adding the fifth set.

Figure 14: Effective stiffness of the center span due to north end damage/repair

The effective stiffness increases of the four stringers varied throughout the testing. For example, after the installation of the first set of Z-spikes, the effective stiffness values were 8.99×10^3 kN-m², 8.68×10^3 kN-m², 8.70×10^3 kN-m², and 8.52×10^3 kN-m² for the west, middle west, middle east, and east stringers, respectively. After the installation of the fifth set, the corresponding effective stiffness values were 10.2×10^3 kN-m², 9.62×10^3 kN-m², 9.95×10^3 kN-m², and 9.46×10^3 kN-m², respectively.

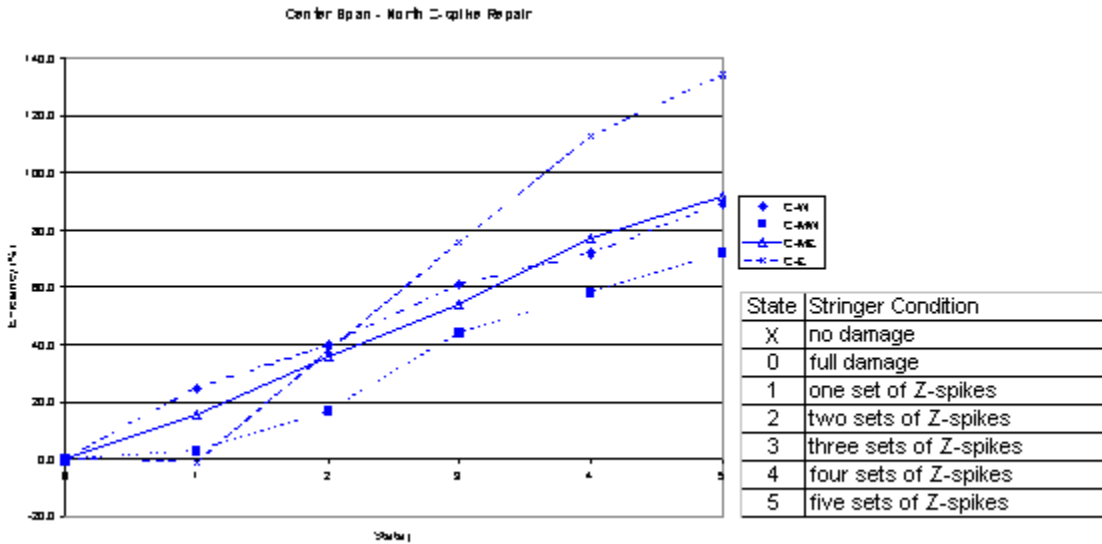
The efficiencies of the Z-spike repair are shown in Figure 15. The “no damage” state was used as ST_k and the “full damage” state was used as ST_i in calculating efficiency from Equation 2.

From Figure 15 it is evident that the installation of Z-spikes increases the efficiency of the members in the center span. For the four stringers in the center span, the average efficiency was 13.4% for the first set of Z-spikes, 32.6% after adding the second set, 56.7% after adding the third set, 75.3% after adding the fourth set, and 91.6% after adding the fifth set. After five sets of Z-spikes, the effective stiffness was nearly the same magnitude as that of the members before they experienced damage due to the cut. One value (C-E) actually exceeded the original effective stiffness, that is, the efficiency was 134%. The unexpected damage was the most severe in this member, thus it is believed that the effective stiffness exceeded the original effective stiffness because the addition of Z-spikes was repairing the cut that was made in the north half plus part of the unexpected damage that occurred in the south half.

Figure 15: Efficiency of the center span due to north end damage/repair (ST_i = “full cut completed” and ST_k = “no damage”)

The increase in effective stiffness of the four members varied throughout the testing. For example, after the installation of the first set of Z-spikes, the increases in effective stiffness were 24.8%, 2.7%, 15.8%, and -1.2%, for the west, middle west, middle east, and east stringers, respectively. After the installation of the fifth set, the corresponding increases in effective stiffness were 89.5%, 72.1%, 92.0%, and 134.4%, respectively.
