Siddons, Craig and Macleod, Calum and Yang, Liu and Stack, Margaret (2015) An experimental approach to analysing rain droplet impingement on wind turbine blade materials. In: EWEA 2015 Annual Event, 2015-11-17 - 2015-11-20, Paris expo Porte de Versailles. ,

An experimental approach to analysing rain droplet impingement on wind turbine blade materials

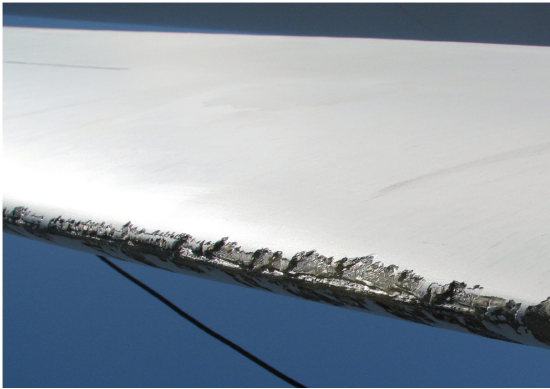
Figure 1: An example of leading edge erosion [2]

Leading edge erosion is an urgent and important issue in the wind turbine industry, and many examples of eroding blades have been observed in the past, an example of which can be seen in Figure 1. The issue is of the up-most importance as the energy yield from the turbine can be substantially reduced as shown by Sareen et al. [1]. In the study, the conditions of different types and severities of erosion were constructed as observed from damaged blades on actual wind farms which included pitting, gauging and delamination. Using the authors calculations, energy production losses were estimated to be between 3.5% and 23.5% with respect to the severity of the damage pattern present. Also, if left unattended the structural integrity of the blade could also be at risk. In reality however, this is not the case and wind turbine blades are regularly maintained to prevent any loss in energy capture/ potential revenue to the owner. Whilst onshore the issue is of lesser importance, offshore turbines suffer from considerably greater logistical constraints. This means that wind farm operators are incentivised to minimise the frequency and severity of maintenance on their turbines, in order to reduce costs.

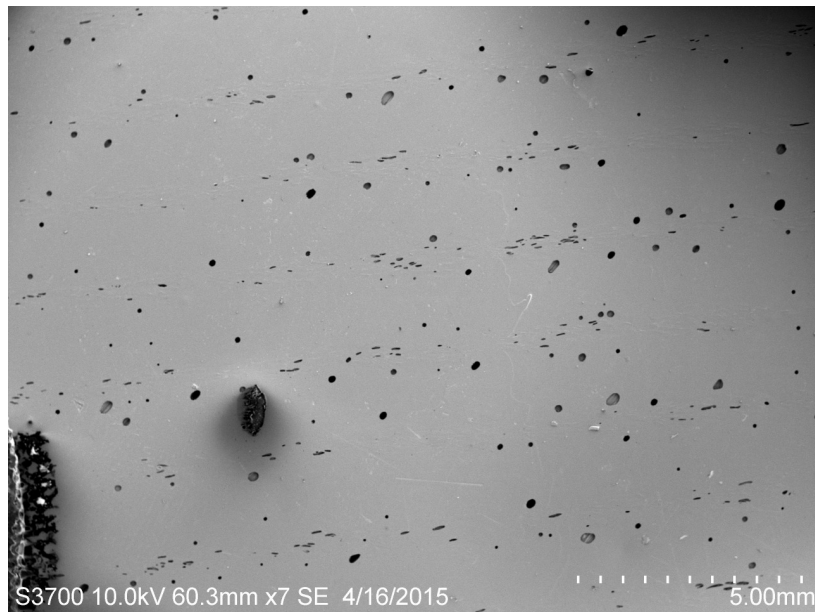
Figure 2: Presence of pre-existing pin holes in the untested sample

SEM analysis was performed on one of the blank samples as shown in Figure 2. Pin holes of approximately 150-270 μ m in diameter can be seen- these pin-holes are an unavoidable consequence of infusion formation process and is the result of small air bubbles caught in the vacuum bag. The vacuum infusion process can minimise these defects compared to other formation

processes, but they can not be wholly avoided.

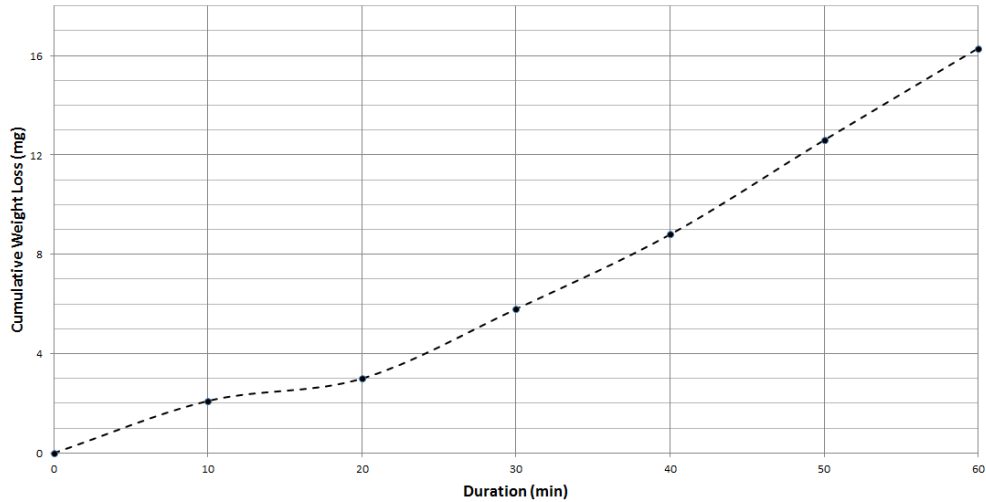
Figure 3: Mass loss- time relationship of a sample subject to a droplet diameter of 2.5mm, at 60 m/s through a rainfall rate of 25 mm/h.

Figure 3 shows the wastage effects over the duration of a test for a sample. The test was stopped at regular intervals to allow for the sample to dry before the mass loss due to erosion could be measured. It can be seen that no incubation period is present at the beginning of the testing, meaning that damage resulting from liquid impingement is immediately reflected as material degradation on the sample.

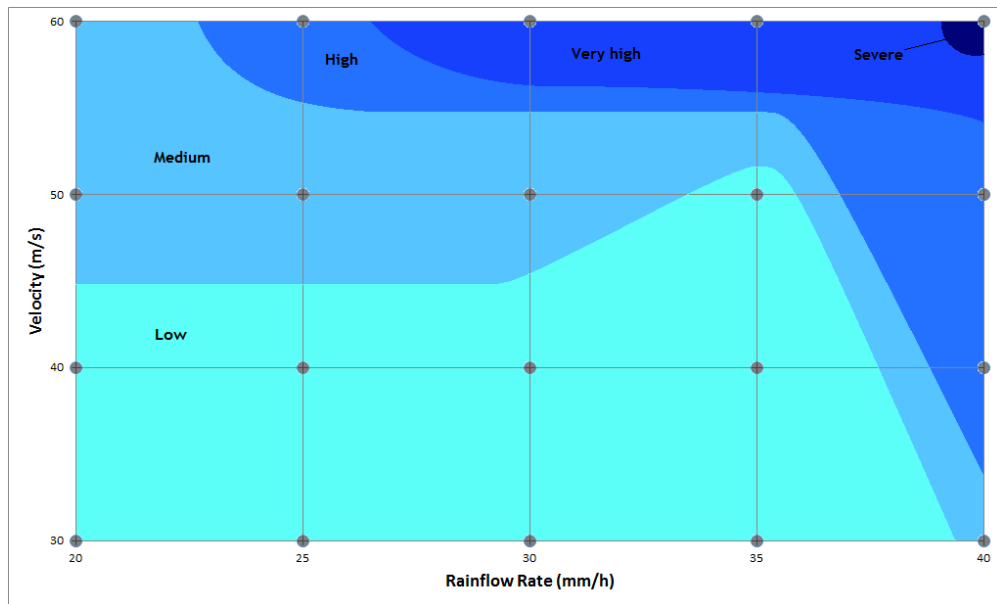
Figure 4: Wastage map showing the measured mass loss varying the impingement velocity against rainfall rate. The duration of each test was 40 minutes and the droplet diameter was 2.5mm

The map shows the boundary conditions of the relationship between rainfall rate and impingement velocity, Table 1, sets out the boundary conditions for mass loss for each region. Approximate boundary lines have been drawn based on the experiments performed, represented by the gray points presented on the map.

As expected, a higher velocity impingement at higher rainfall rates produced the most severe erosion behaviour. A slight discrepancy can be observed at 35mm/h and 50m/s; however, this can be considered an anomaly as a general trend is present on the map.

Table 1: Classification of the parameters of mass loss for Figure 4.

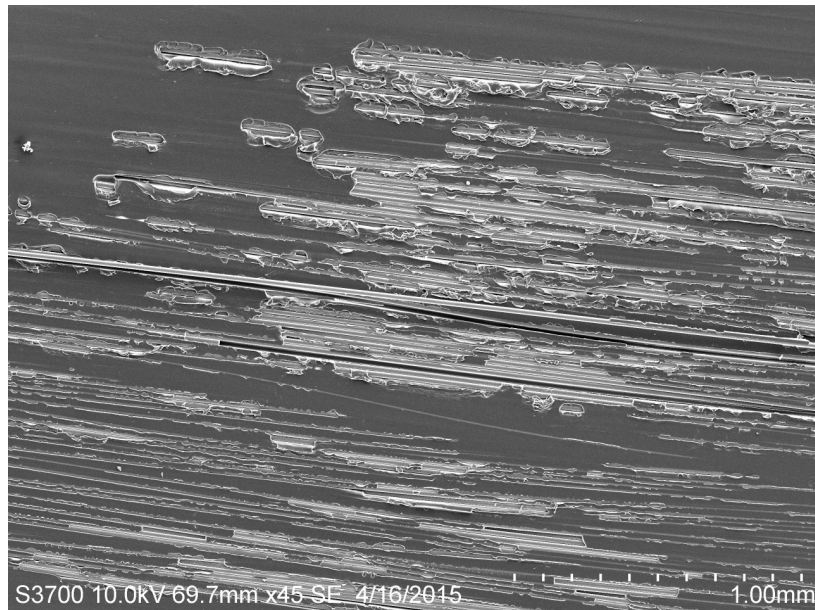
Figure 5: SEM image showing a sample exposed to an impact speed of 30m/s though 30mm/h of rainfall for 40 minutes using droplets of approximately 2.5mm in diameter.

As explained further on, Figure 5 shows how these pin-holes are exploited as an initiation point for water droplet erosion.

Figure 5 represents the damaging effects of rain droplet erosion. This sample had a comparatively light exposure

at a velocity of 30m/s for 40 minutes through a rainfall rate of 30mm/h. Most notably the surface morphology as shown in Figure 5, did not show any evidence of pin-holes, as previously mentioned in Section 2.2- it can therefore be deduced that it was quite likely the erosion initiated from these surface defects. Fibre exposure was present on the sample; however, the top layer of fibres remained predominantly aligned, suggesting that at this stage only the surface epoxy was affected.

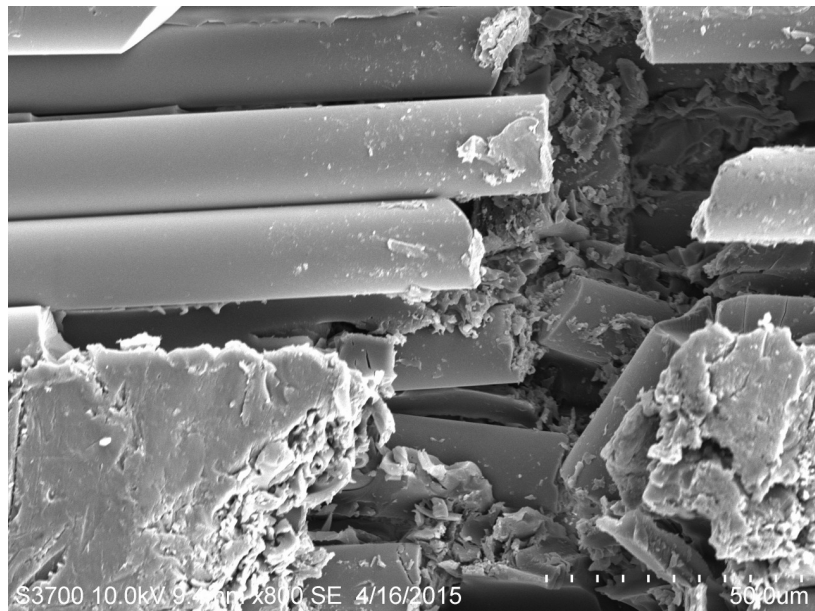
Figure 6: SEM image showing a sample exposed to an impact speed of 60m/s though 25mm/h of rainfall for 40 minutes using droplets of approximately 2.5mm in diameter.

Another sample as seen in Figure 6 was exposed for 40 minutes at a rainfall rate of 25mm/h at a velocity of 60m/s. It can be seen in the image that the 20 μ m diameter fibres sustained breakage after a period of time. Whether the damage occurred before or after the surface epoxy had eroded away is difficult to determine, and may be key to analysing the damage mechanisms in the overall composite.
