Impact Angle Effects on Erosion Maps of GFRP: Applications to Tidal Turbines

Rafee Abdulmajeed Rafee Ahamed¹ · Cameron M. Johnstone¹ · Margaret M. Stack¹

Abstract Tribology in marine renewable technologies has become of increasing interest due to the implications for developing improved materials for tidal and wave energy conversion devices. This on-going research mainly focuses on tidal devices; the materials of interest are primarily polymer-based composite materials that are used to provide structural integrity while reducing weight. These are specifically applied to turbine blades to withstand the high impact loadings in seawater conditions. At present, current materials in test trials have demonstrated some limitations in service. In this paper, some advanced experimental research has been carried out to investigate the tribological mechanisms of potential candidate composite materials to be used in tidal turbines by firstly considering the effects of various erosion parameters on the degradation modes, with and without particles in still and seawater conditions. The erosion mechanisms of composite materials used in tidal turbine blades have been evaluated using Scanning Ele

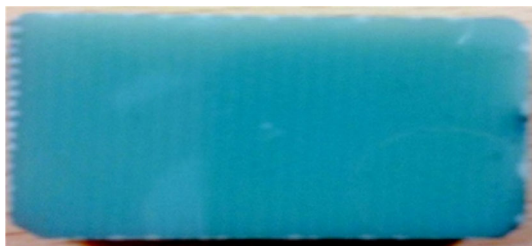
Fig. 2 Rectangular specimen (36 mm × 25 mm × 6 mm)

A schematic diagram of the slurry impingement jet rig is shown in Fig. 1. The rig is equipped with a 'T'-shaped ejector, and it controls the erosion parameters by setting up the ratio of inlet nozzle to the outlet nozzle diameter (d/D), and the L-distance [9]. The erosion test was performed at three different impact velocities of 2.5 , 4.5 and 6.5 ms^{-1} , and the corresponding combinations of inlet and outlet nozzles are 2.8 and 6.52 mm (2.5 ms^{-1}), 3.6 and 6 mm (4.5 ms^{-1}), and 3.6 and 4.48 mm (6.5 ms^{-1}). The impingement angle was adjusted in the range of 15° – 90° . The slurry mixture consists of 3.5% of the salt and 3% of irregular silica sand as an erodent (Table 2). The silica sand particles were supplied by the Fife Silica Sands Ltd. The samples were tested one at a time by fixing onto the specimen holder and eroding for 30 min (Fig. 2).

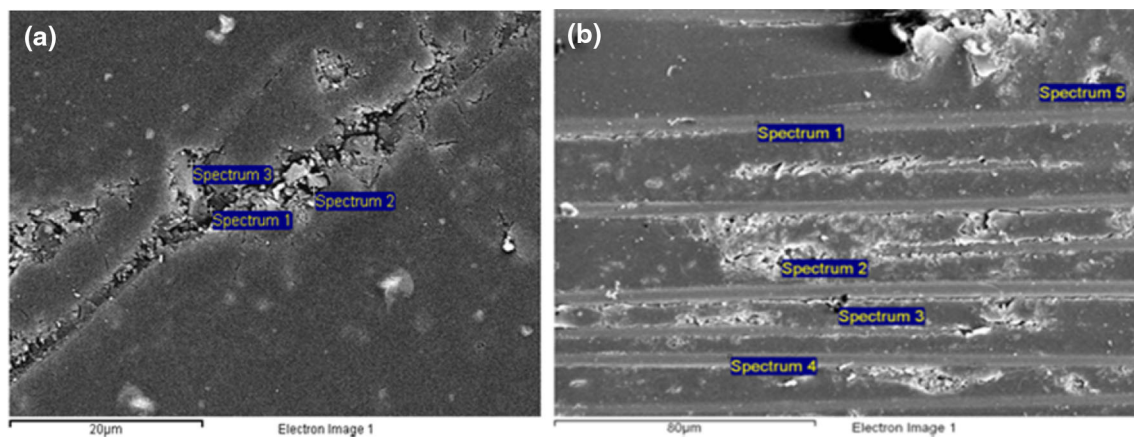
Fig. 11 SEM surface images of eroded **a** 6.5 ms^{-1} , **b** 4.5 ms^{-1} at impingement angles 75° and 15°

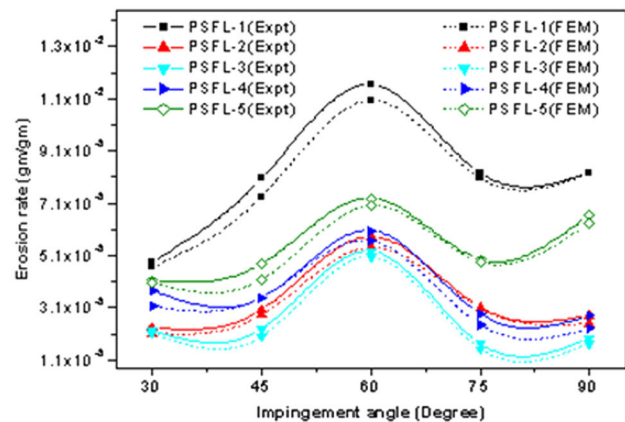
Fig. 17 Semi-ductile erosion behaviour [18]
