# Stability Upgrade of a Typical Philippine Ferry

Dracos Vassalos, Sokratis Stoumpos, Evangelos Boulougouris

## ABSTRACT

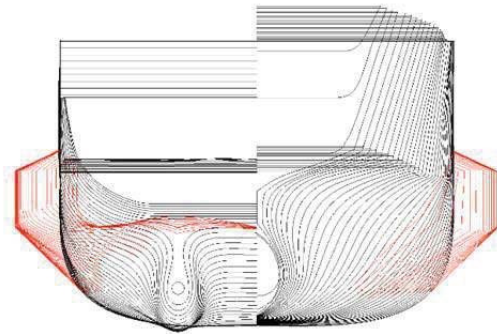
Figure 1 Sponsons with ducktail fitted on the existing hull.

The additional structural parts that are considered for the enhancement of buoyancy and stability are sponsons located at each side of the vessel with a ducktail formation at the aft end. Both modifications will affect buoyancy as well as hydrodynamic properties, which with proper consideration could lead to an increase of the propulsive efficiency and, potentially, to a reduction of fuel consumption or to an increase of service speed. The geometry of these appendages is illustrated in figures 1 and 2. Such a solution will allow the removal of the solid ballast. The resulting hull form has sufficient stability as indicated in the following.

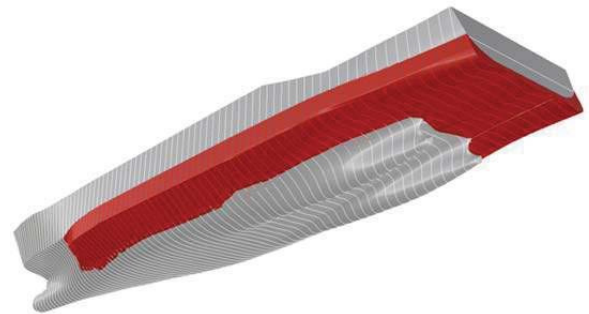
Figure 2 Body plan view of upgraded vessel.

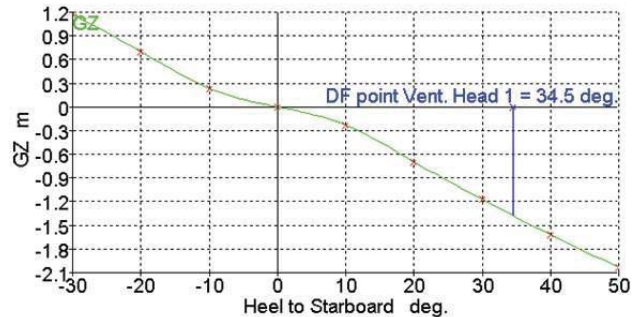
Figure 3: GZ curve existing ship

whilst the existing fails to comply with. This is also apparent comparing figures 3 and 4.

The results demonstrate that the existing ship loses stability in the scenario considered, which involves one-compartment damage. In a real scenario the existing ship will capsize almost instantly following one-compartment damage.

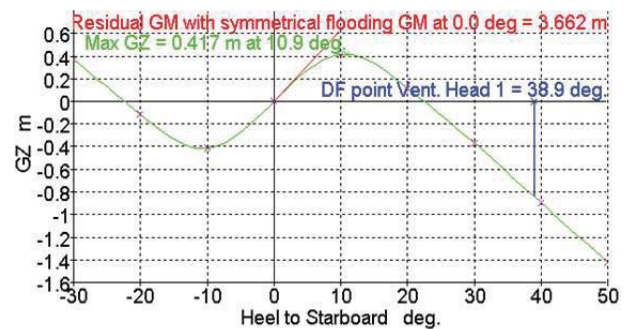
Figure 4: GZ curve upgraded ship

In contrast to the existing ship, the upgraded vessel has a range of positive stability of about 20 degrees. This meets the minimum requirements of damage stability set by SOLAS, namely angle at equilibrium post damage area under the GZ curve as well as residual GM as seen in Tables 5, 6 and 7.
