# Physical modelling of backward erosion piping in foundation beneath levee

**ABSTRACT:** Centrifuge model tests are performed to observe piping progression in foundation beneath levee and to examine influence of repeated seepage and thickness of foundation ground on piping progression. Once the pipe is formed beneath the levee, hydraulic gradient upstream of the pipe tip becomes larger while that along the pipe becomes rather small. Shift of this large hydraulic gradient position to the upstream with rise of the flood water level leads to the large subsidence of the slope in the protected side and marked increase in flow rate. Repeated seepage and thickness of the permeable foundation layer have influence on stability of levee against piping. Repeated seepage makes the piping progression faster and levee vulnerable to the piping formation. With the thinner permeable foundation layer beneath the levee, the levee is at higher risk to cause brittle failure while the required hydraulic gradient to cause piping is larger.

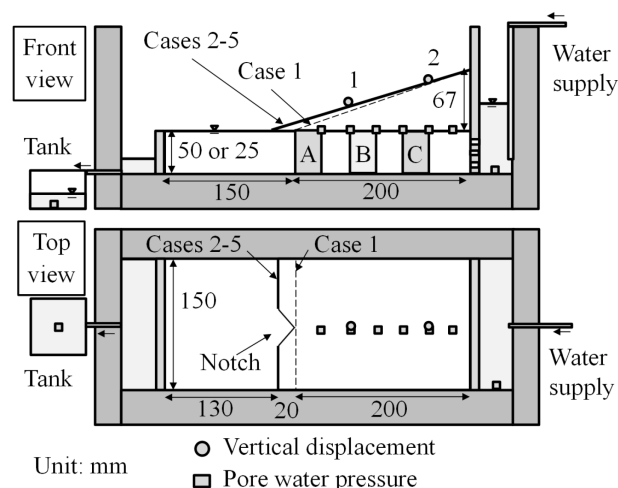
Figure 1. Model setup

Typical model levee in the centrifuge tests is shown

in Figure 1. In the tests, only the slope on the protected side is modelled. The slope is 1V:3H, which follows the recommendations on levee slope in Japan. Slope length (or seepage length) is 200 mm in the model scale. Thickness of the permeable foundation ground is either 50 or 25 mm and length of the exposed area, i.e., distance from the slope toe to the protected side boundary of the model, is either 130 or 150 mm. Seepage test is conducted in a centrifugal acceleration field of 50G. Corresponding prototype length of the model slope is 10 m and the thickness of the foundation ground is either 2.5 or 1.25 m.

Rise of water level on the flood side is modelled by supplying water to the reservoir in the upstream side, as in the tests by Horikoshi and Takahashi (2015). There are two partition plates near the both sides of container as shown in Figure 1. The upstream partition plate that separates model ground from the upstream reservoir has many holes in the area contacting with foundation ground. Water can easily flow through these holes into the foundation

The foundation ground is prepared by compaction with relative density of 30%. To observe the erosion of the foundation soil visually, the coloured sands are placed as shown in Figure 1 (Areas A, B and C). The model embankment is made with the Kaolin clay and is formed in the separate mould and is placed on the foundation ground before saturating the foundation ground.

In this study, five tests are performed; Case 1 is the case without notch at the middle of the slope toe, while the notch is made at the middle of the slope toe in the other cases. The shape of the notch is shown in Figure 1. In Case 3, repeated seepage is given to the model ground. In this case, the flood water level is raised until outflow of coloured sand from Area A is observed, and then the water level in the upstream side is dropped to the foundation ground surface level. The second seepage is given with the same rising rate of the flood water level. In Case 4, the thickness of the foundation ground is half of that in the other cases. In Case 5, material used for the model embankment is changed to the jelly for visual observation of the piping progression. Test conditions for all the cases are summarized in Table 3.

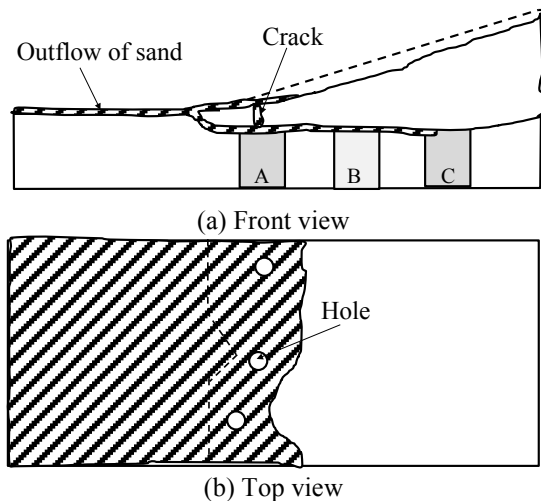
Figure 2. Typical failure mode (Case 2)

Figure 2 shows typical piping-induced failure mode observed in the tests. In all the cases except Case 4 with the thinner foundation layer, outflow of the sand in the foundation ground progressively occurs with rise of the flood water level. Loss of the sandy soil near the slope toe leads to excessive settlement of the slope toe. Because of this, cracks on the slope are formed around the toe. Through these cracks, outflow of the foundation soil also occurs and it accelerates outflow of the foundation soil with forming sand volcanos around the toe of the slope. As a result, large volume of the foundation soil flows out and the pipes percolates to the upstream, leading to the very large settlement of the entire slope.

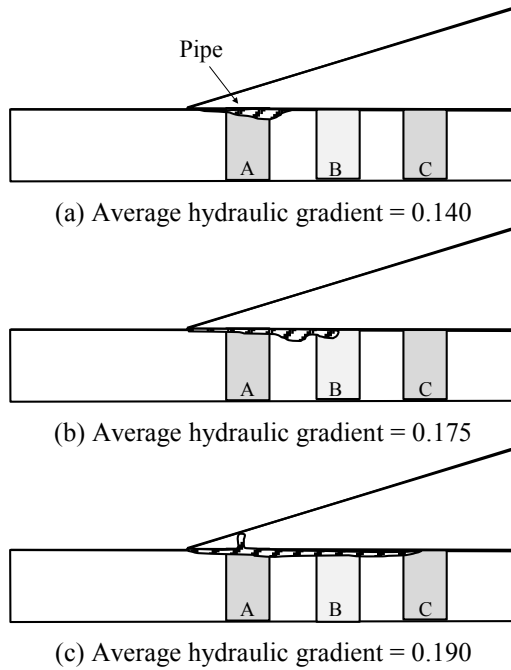
Figure 3. Observed piping progression (Case 3, front view)

Figure 3 shows typical piping progression observed. In this figure, the progression in the second seepage of Case 3 is shown as an example. In Cases 2~4, similar formation of pipe is observed from

the front transparent window. The pipe is firstly formed beneath the slope toe and propagates along the interface between the embankment and foundation ground toward the upstream with rising of the flood water level. The size of the pipe is not constant, but repeatedly shows expansion and contraction with piping progression.

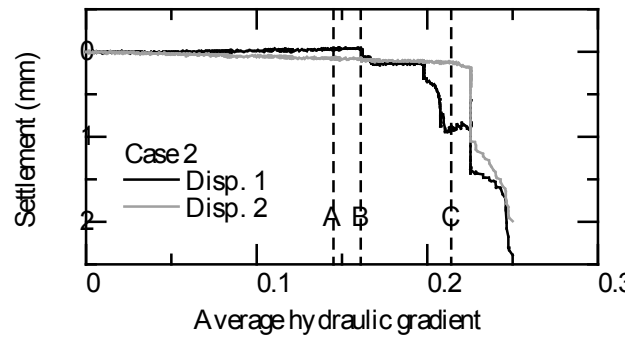
Figure 5. Vertical displacements measured at Points 1 and 2 on the slope (Case 2)

Changes in vertical displacement on the slope in Case 2 are shown in Figure 5 as an example. Three vertical lines in the figure indicate the average hy-

draulic gradient at which outflow of the coloured sand from the areas shown in Figure 1 is observed at the slope toe. In all the cases except Case 4, the vertical displacements of the slope gradually change with outflow of the coloured sands. Marked settlement is observed when the tip of the pipe reaches the middle of the slope, i.e., outflow of the coloured sand from Area B is observed at the slope toe. It can be said that the piping has influence on the stability of levee once the tip of the pipe reaches the middle of the slope.

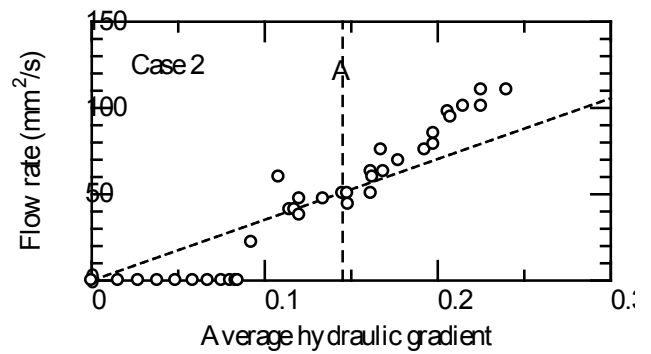
Figure 6. Change of flow rate with average hydraulic gradient (Case 2)

Change of flow rate with average hydraulic gradient in Case 2 is shown in Figure 6 as an example. The flow rate is calculated by water level change in the drainage tank that collects the outflow water at the downstream boundary. The value shown in the figure is the flow rate per unit width of the model slope. A vertical line indicates the average hydraulic gradient to cause the first outflow of the coloured sand from Area A at the slope toe. The broken line is the flow rate when the seepage flow through the porous media is assumed, i.e., the flow rate without piping. If there is no pipe and water seeps through the foundation ground homogeneously, the flow rate linearly increases with average hydraulic gradient as plotted with the broken line.

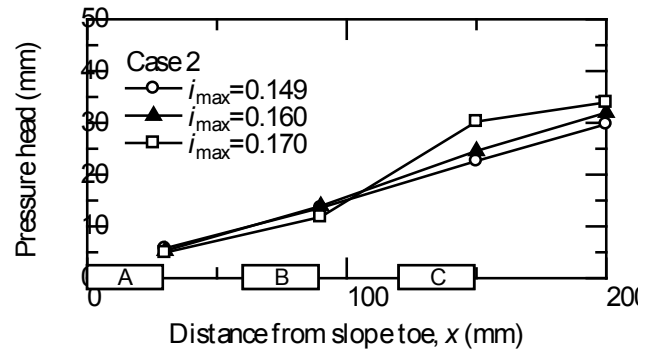
Figure 7. Distribution of pressure head at interface between embankment and foundation ground (Case 2, around onset of outflow of coloured sand from Area B)

Distributions of pressure head at the interface between embankment and foundation around the onset of the outflow of the coloured sand from Area B for Case 2 and Case 3 in the second seepage are shown in Figures 7 and 8 as examples. The slope of the plot corresponds to the local hydraulic gradient. In Cases 1~3, it is seen that the local hydraulic gradient at the area from which outflow of coloured sand is observed decreases after observing outflow of the coloured sand from that area; For instance, the local hydraulic gradient between  $x = 30$  mm and  $x = 90$  mm at the average hydraulic gradient ( $i_{ave}$ ) of 0.170 becomes smaller than that at  $i_{ave} = 0.160$  in Figure 7. Similarly, the local hydraulic gradient between  $x = 60$  mm and  $x = 120$  mm at  $i_{ave} = 0.150$  becomes smaller than that at  $i_{ave} = 0.122$  in Figure 8. At the same time, the local hydraulic gradient upstream to the tip of the pipe becomes larger. Shift of this large hydraulic gradient position to the upstream with rise of the flood water level leads to the large subsidence of the slope in the protected side.

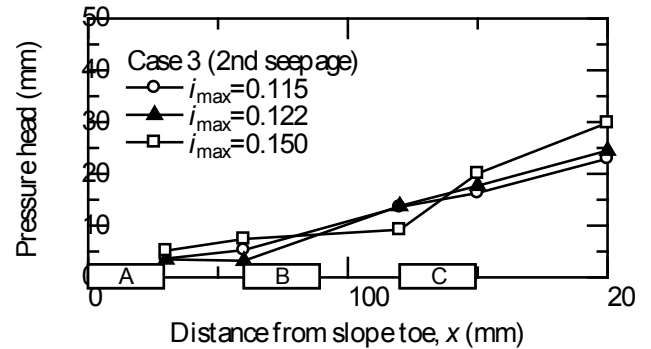
Figure 8. Distribution of pressure head at interface between embankment and foundation ground (Case 3, around onset of outflow of coloured sand from Area B in second seepage)

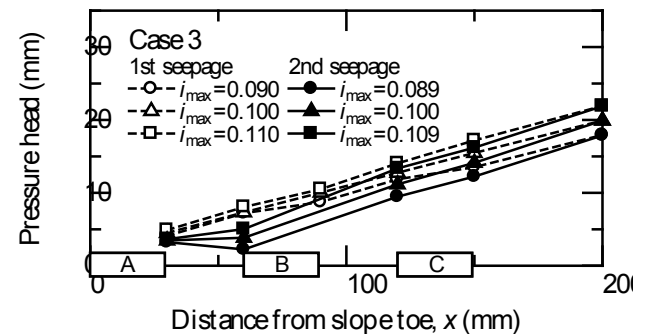
Figure 9. Distribution of pressure head at interface between embankment and foundation ground (Case 3, around onset of outflow of coloured sand from Area A)

Pressure head distributions at the interface between the embankment and foundation ground around the onset of the outflow of the coloured sand from Area A in Case 3 are shown in Figure 9. The broken lines are for the first seepage, while the solid lines are for the second seepage. It is observed that the pressure head in the second seepage is smaller compared to that in the first seepage, especially near the slope toe. Comparison of the local hydraulic gradient between  $x = 30$  mm and  $x = 60$  mm suggests that the pipe formed in the first seepage remains or a weak zone is formed beneath the slope toe. This may be the reason why the required average hydraulic gradient to cause outflow of the coloured sand from Area A in the second seepage is smaller than that in the first seepage in Case 3.

gradient change shown in Figure 9, it can be said that repeated seepage makes the piping progression faster and vulnerable to the piping formation.

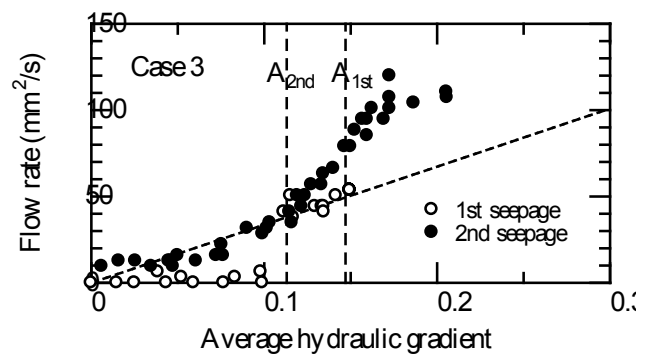
Figure 10. Change of flow rate with average hydraulic gradient (Case 3)

Changes of the flow rate with average hydraulic gradient in Case 3 are shown in Figure 10. It can be seen that deviation of the observation from the no-pipe condition (indicated by the broken line as in Fig. 6) in the second seepage starts at the average hydraulic gradient of 0.114, which is much smaller than the average hydraulic gradient required to cause the first outflow of the coloured sand in the first seepage (0.147). From this and the local hydraulic

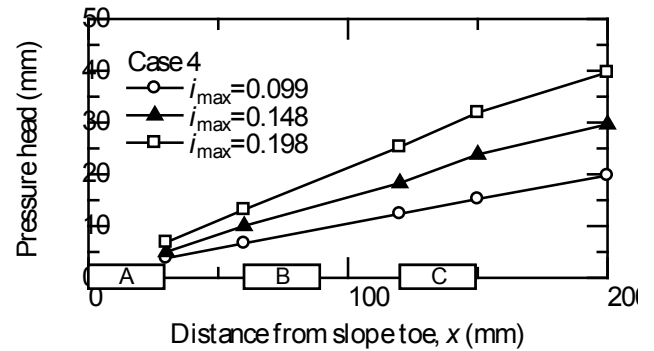
Figure 11. Distribution of pressure head at interface between embankment and foundation ground (Case 4)

Distributions of the pressure head at the interface between the embankment and foundation ground in Case 4 are shown in Figure 11. In contrast to the other cases, the pressure head monotonically increases with the average hydraulic gradient. Marked increase in the local hydraulic gradient cannot be seen. Because of this, the average hydraulic gradient required to cause outflow of the coloured sand in Case 4 is much larger than the other cases.

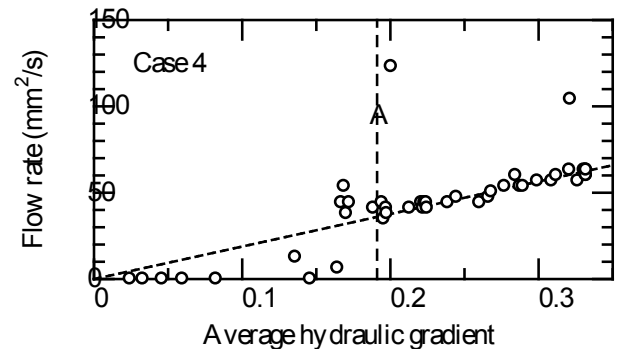
Figure 12. Change of flow rate with average hydraulic gradient (Case 4)

Change of the flow rate in Case 4 is shown in Figure 12. In all the cases except Case 4, marked deviation of the observation from the no-pipe condition is observed, while such tendency cannot be seen in Case 4. In Case 4, even after the first outflow of the coloured sand, amount of the sand outflow is small and no deviation of the observation from the no-pipe condition is observed before failure. As explained in the previous section, since the change in the local hydraulic gradient along the seeping direction is less in Case 4, the required average hydraulic gradient for piping is larger, resulting in the quicker percolation of the pipe and brittle failure of the slope.
