**Effect of spherical dents on microstructure evolution and rolling contact fatigue of wheel/rail materials**

# Effect of spherical dents on microstructure evolution and rolling contact fatigue of wheel/rail materials

**Keywords:** Wheel/rail materials; Spherical dents; RCF; Microstructure evolution

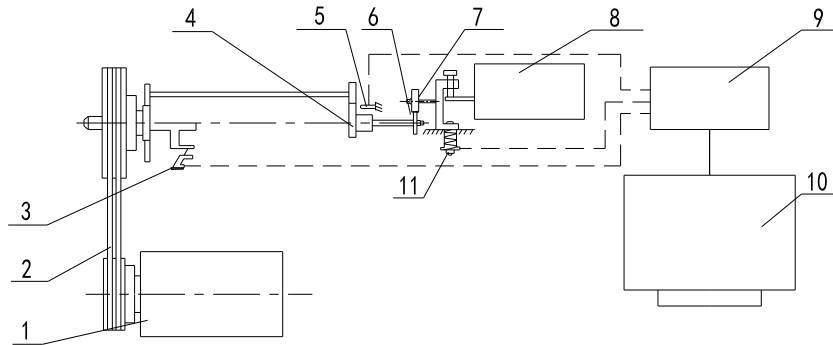
**Fig.1**

Fig.1: Schematic diagram of the machine.

1. DC motor; 2. Drive belt; 3. Torque sensor; 4. Drive shaft gears; 5. Photosensor; 6. Lower roller; 7. Upper roller; 8. Driven shaft gears; 9. Controller; 10. Computer; 11. Load sensor

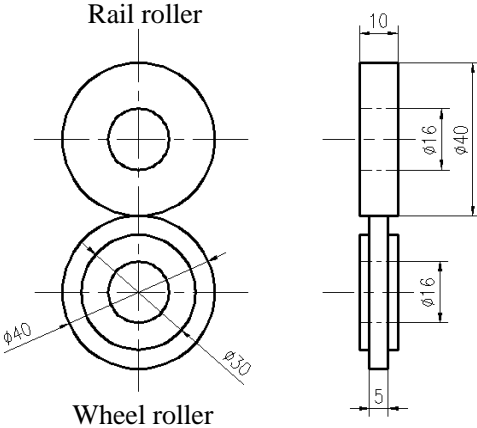
**Fig. 2**

Fig.2 Scheme size of the wheel and rail rollers.

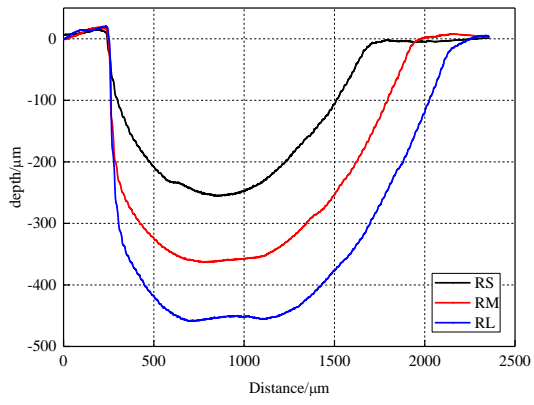
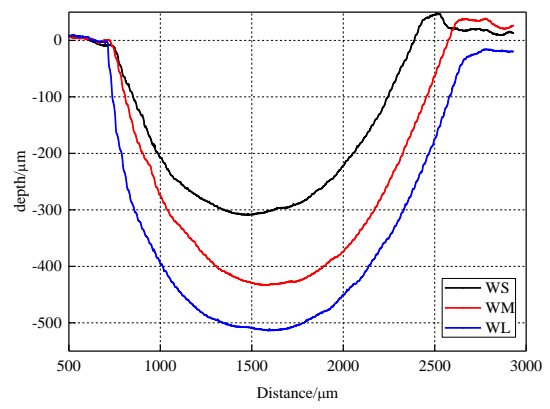
**Fig.3**

Fig.3: Scheme of dents on wheel/rail simple before testing, (a) rail; (b) wheel.

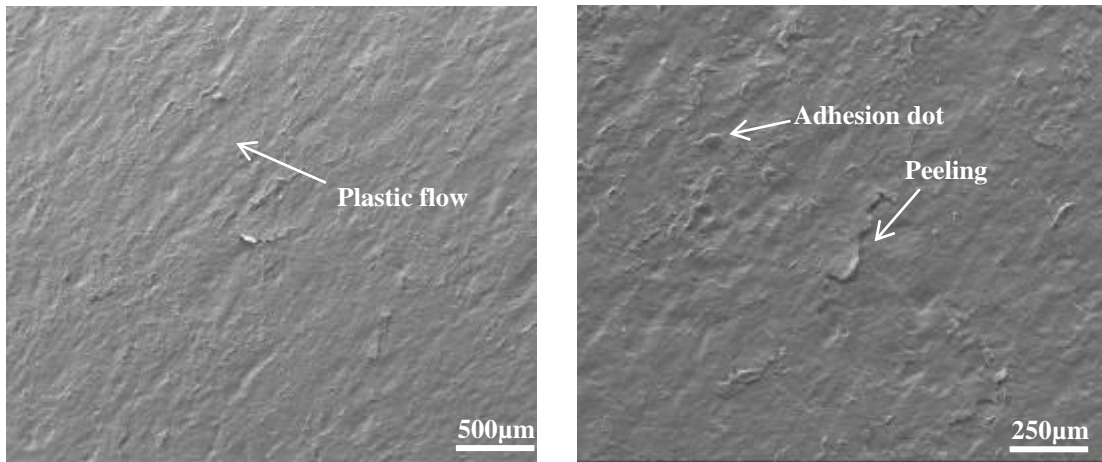
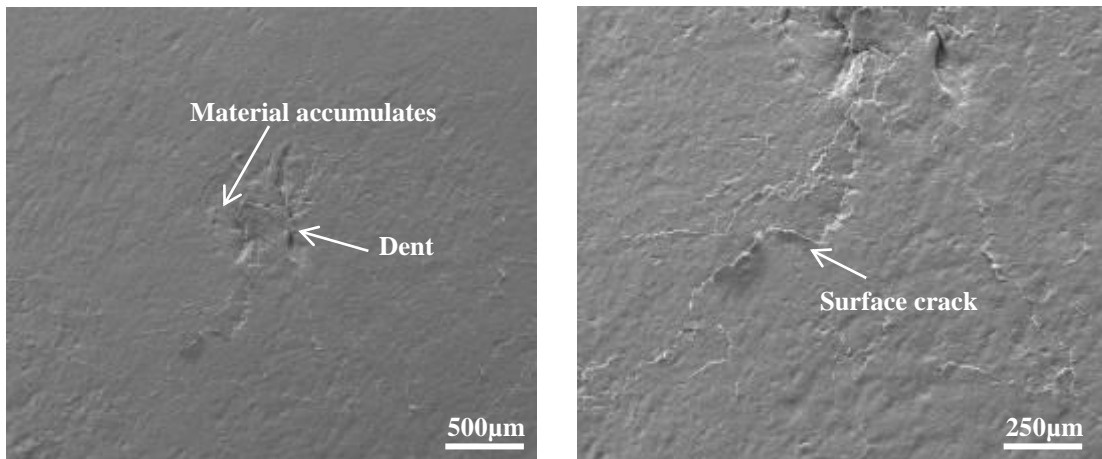
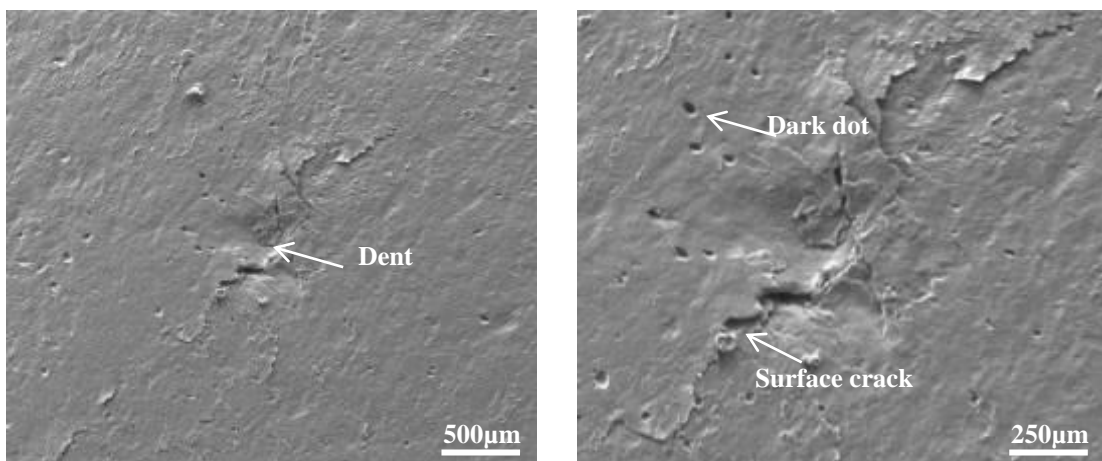
**Fig.5**

Fig.5: SEM micrographs of surface damage of wheel rollers, (a) WN; (b) WS; (c) WM; (d) WL.

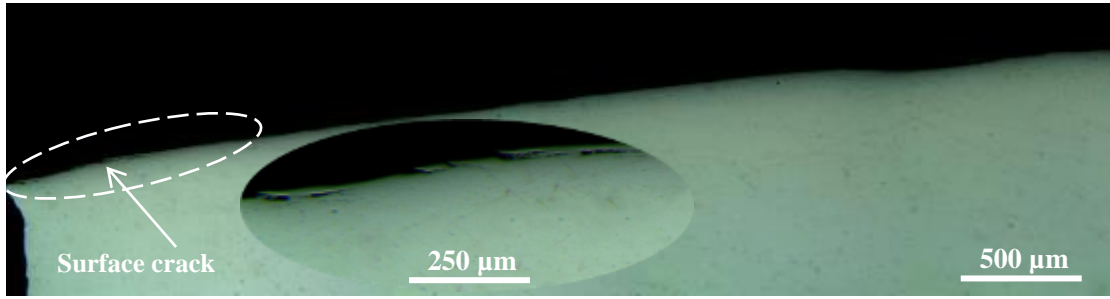
Fig.8

Fig.8: OM micrographs of fatigue cracks on the section of rail rollers, (a) RN; (b) RS; (c) RM; (d) RL.

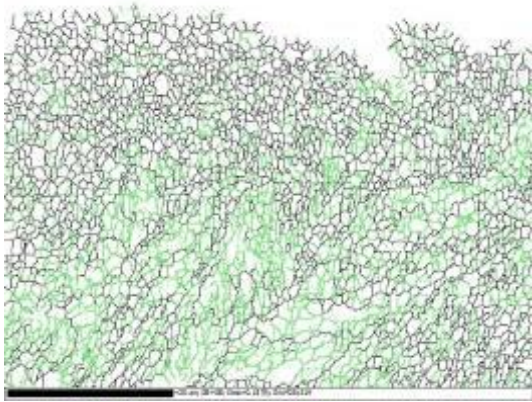
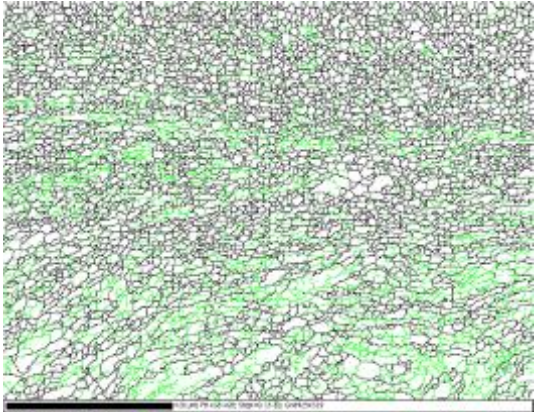
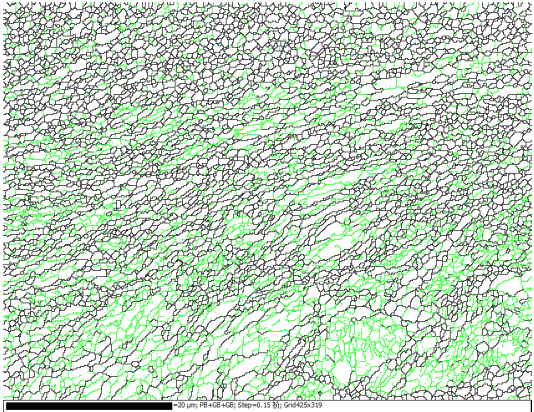
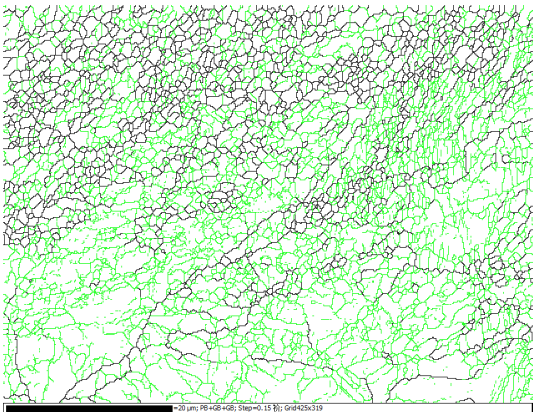
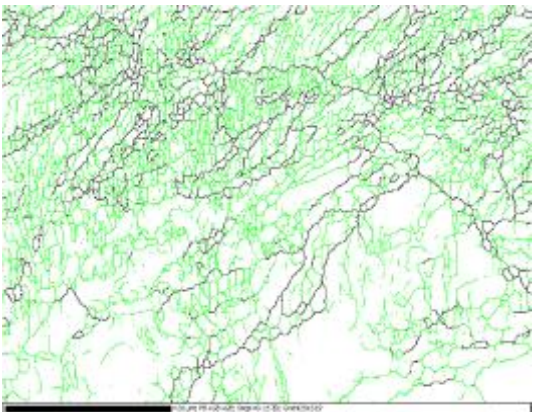
Fig.12

Fig.12: Inverse pole figure (IPF) of wheel/rail rollers, (a) WN; (b) WM (in the front of dent); (c) WM (in the rear of dent); (d) RM (in the front of dent); (e) RM (in the rear of dent)

Adhesion describes the tangential force resulting at the wheel–rail contact [23]. In these experiments, the slippage is set as 0.91%, which provides a relatively high adhesion coefficient between the rail/wheel surface [24]. This way, the tangential force acting on the contact area is large enough to drastically change the microstructure of grains and cause severe plastic deformation. Severe plastic deformation of the wheel/rail materials caused by the heavy and cyclic contact loading is known to have a great influence on RCF crack initiation [25]. The wear rate and material ratcheting are coupled factors which determine the depth of plastic deformation. Fig.14a shows material movement in front and rear areas on defected rail roller. In the edge of the front area, the tangential force compels the material sliding and forms an accumulation layer. As a result, the plastic deformation fills up the dent on one side. On the other hand, in the rear area, the tangential force can be divided into two components acting on the edge of dent. Since the edge of dent is not parallel to the surface, one of the force component rapidly removes material at the edge of dent and leaves a slope there. The second force component acts on this slope again and then the material is removed layer by layer. Therefore, the depth of plastic deformation in the front area is larger than that in the rear area as Fig. 6 presents. Due to such an unbalanced deformation distribution, the yield strain in the front area is more than 2 times the strain in the rear area. It can be inferred from Figs.12 and 13 that a high strain area is usually associated with large misorientation, and

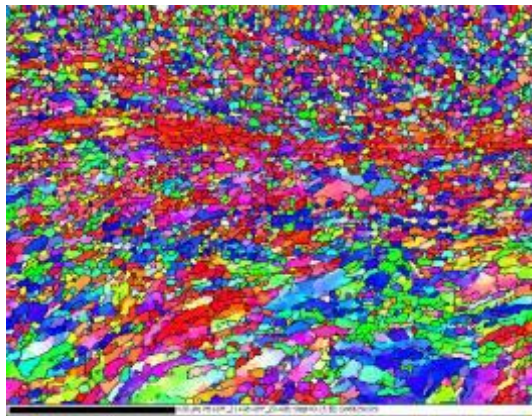
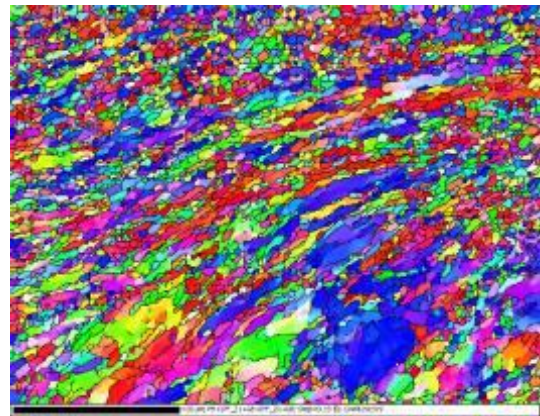
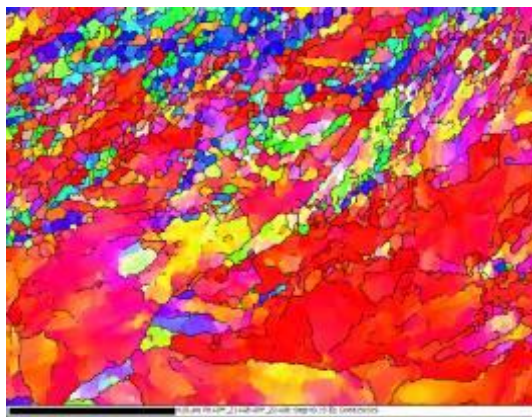
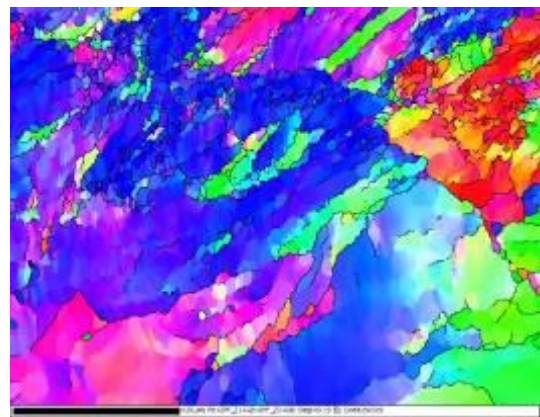
Fig.13

Fig.13: Strain contouring of wheel/rail rollers, (a) WN; (b) WM (in the front of dent); (c) WM (in the rear of dent); (d) RM (in the front of dent); (e) RM (in the rear of dent)

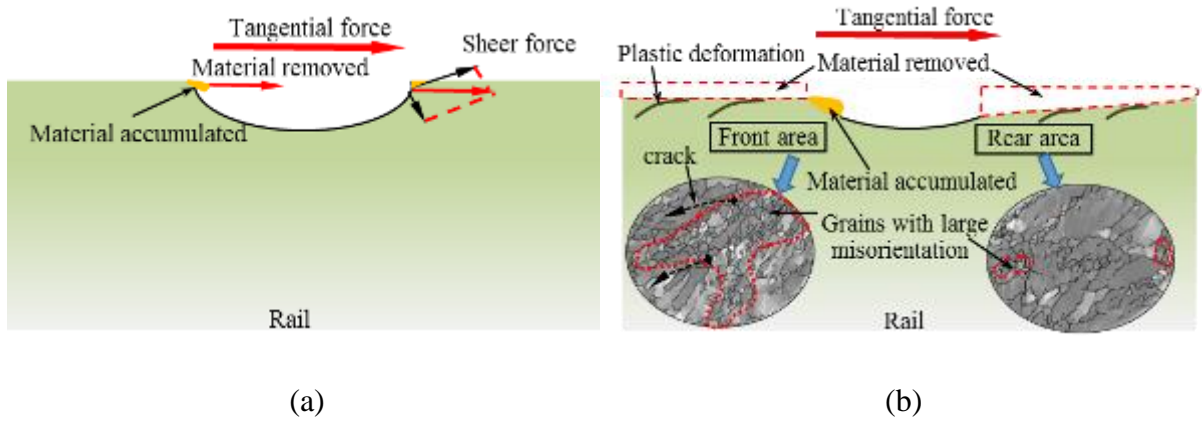
Fig. 15

Fig.15: Crack growth mechanism around the wheel dent, (a) early cycles; (b) the next cycles (direction of tangential force changed).

Because of the inversion of tangential force on wheel roller, the “front area” in the previous period turns into “rear area” in the current period. As it is mentioned above, the rear area of the dent has a higher wear rate. In the primary cycles, the material accumulates in the front area of dent (Fig.15a). Subsequently, the plastic deformation is easily worn and forms a new plastic deformation layer with single flow direction as the “front area” changes into “rear area”. As a result, a fiber texture with small misorientation emerges in the rear of dent. As a previous paper mentions [26], tiny cracks tend to propagate in the area with small misorientation (Fig.15b). The other side of dent experiences the transformation from “rear area” into “front area”. Due to low wear rate in “front area”, the microstructure is affected by two plastic deformation lines with different flow directions. The previous plastic deformation is rolled up (Fig.6), the continuous fiber texture is destroyed (Fig.12b) and the microstructure is mainly anisotropic, which slows down the crack growth. This way, the crack in rear area of dent on wheel roller is longer than that in the front area (Fig.10).
