THERMOGRAPHY ANALYSIS ON WELDING DEFECTS AND INTERNAL EROSION OF CARBON STEEL PIPELINE

Maznan Ismon¹, Izzuddin Zaman^{1,2}, Ng Chee Seng

¹ Faculty of Mechanical and Manufacturing Engineering, ² Structural Integrity and Monitoring Research Group, Universiti Tun Hussein Onn Malaysia, 86400 Batu Pahat, Johor, Malaysia
E-Mail: maznan@uthm.edu.my

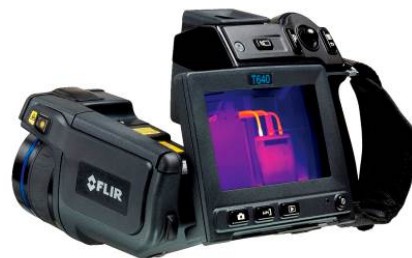
Figure-2. FLIR T640 camera

For erosion inspection, a series of different temperature energy sources were implemented. As a result, exposure of thermal gradient across the erosion defects under supplemental of different temperature energy sources were viewed and captured by FLIR T640 thermal imaging infrared camera as illustrated in Figure 2.

In term of thermal imaging process, all experiments were conducted through FLIR T640 thermal imaging infrared camera. Operating temperature of the infrared camera was ranged from -40°C to 2000°C with

thermal sensitivity less than 0.035°C at 30°C . In additional, the detecting wavelength of the infrared camera is $7.5 \sim 14\mu\text{m}$. Periodic image storage processing time of the infrared camera was ranged from 14s to 24 hours per frame.

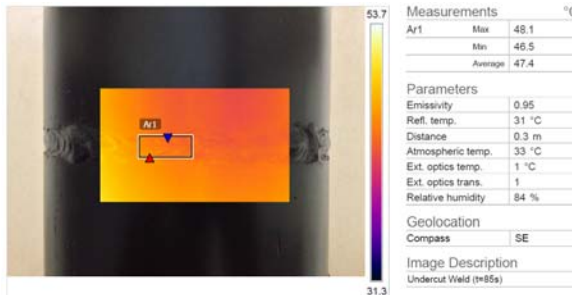
Figure-4. Infrared thermal image of undercut weld

In term of undercut weld, result shows that the differences of surface temperature in between specimen surface and undercut weld are insignificant due to penetration of undercut defect is relatively low. In this situation, bad formation of metal coalescence during welding process of undercut weld have influence the propagation of thermal energy to tip of the weld causing relatively low temperature was distributed at the tips of the weld as shown in Figure 4.

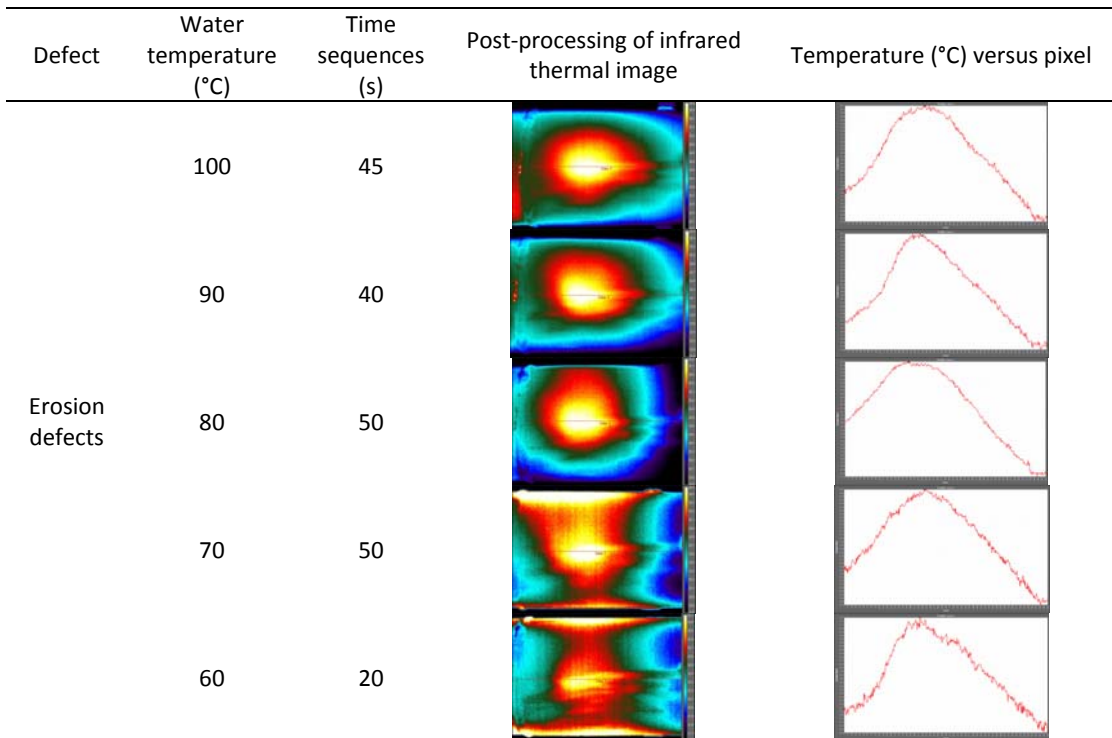
Figure-8. Comparison of post-processing infrared thermal images

process. With application of line ROI (Region of Interest), graphs surface temperatures versus pixel were generated. As a result, variations of surface temperature across the erosion defects are similar even if the implemented energy sources are different. At this point, result verified that

significant decrement of surface temperature was present in the specimen when the depth of the depth of erosion defect was reduced constantly although exposure of erosion defects from the obtained infrared thermal images is nearly invisible for experiment under supplemental of
