Andreades, C, Malfense Fierro, G-P & Meo, M 2020, 'A Nonlinear ultrasonic SHM method for impact damage localisation in composite panels using a sparse array of piezoelectric PZT transducers', *Ultrasonics*, vol. 108, 106181. <https://doi.org/10.1016/j.ultras.2020.106181>

A Nonlinear ultrasonic SHM method for impact damage localisation in composite panels using a sparse array of piezoelectric PZT transducers

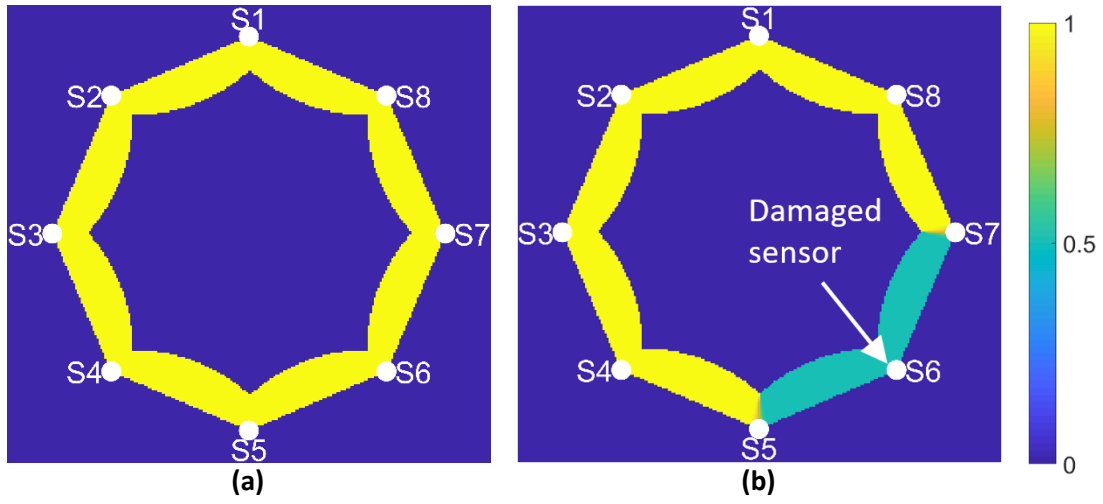
Figure 9: Plot of correlation coefficients between the forward and backward signals in outer sensor-to-sensor paths using eight functional sensors (a) and after replacing S6 with a partially damaged sensor (b).

Starting from the sensor functionality check conducted on CFRP panel 1, when all eight transducers were operating normally, the correlation coefficients between the signals in both directions of each sensor-to-sensor path (ie. r_{12} to r_{81}) were all assigned with a value of 1 (see Figure 9a) based on the procedure explained in Section 3.1. However, when a partially damaged transducers was included in the array at position S6, both r_{56} and r_{67} were marked with a value of 0.5 while the remaining r values remained equal to 1 (Figure 9b). This confirmed the capability of the proposed algorithm to detect a malfunctioning sensor.

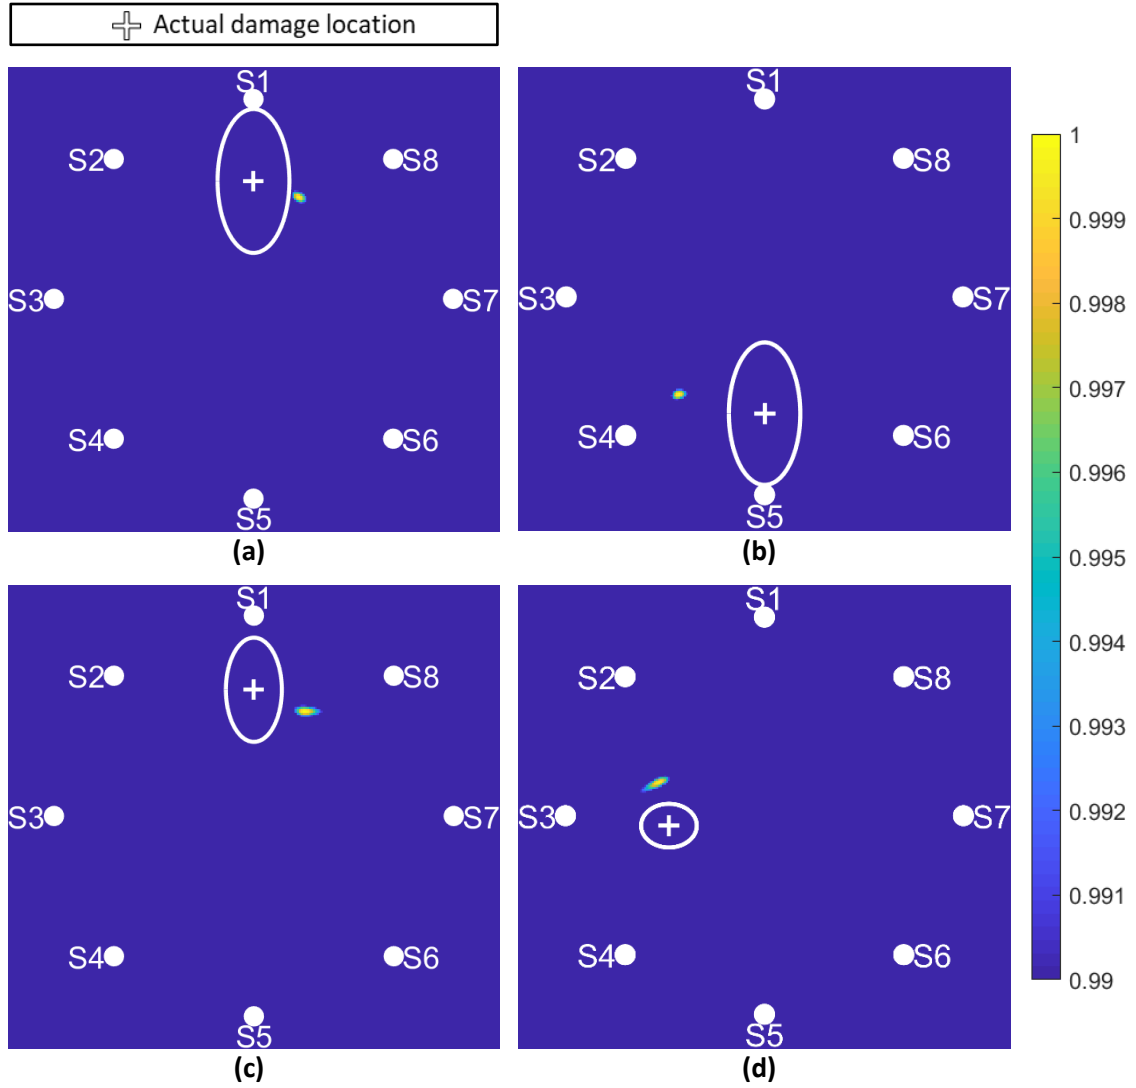
Figure 11: Normalised map with threshold of nonlinear parameter β in CFRP panel 1 - array position 1 (a), panel 1 - array position 2 (b), panel 2 (c) and panel 3 (d). The ellipses represent the actual size of internal delamination.

About the damage localisation results, in CFRP laminate 1 the determined value of f_S related to the highest signal amplitude was found to be 280 kHz for sensor array position 1, and 237.1 kHz for position 2. In panels 2 and 3, f_S was 357.9 kHz and 341.9 kHz respectively. After performing ultrasonic wave transmission at f_S (ref. Section 3.2), the normalised map of nonlinear parameter β on CFRP panel 1 was plotted for each sensor array position (1 and 2), as illustrated in Figure 10a and Figure 10b. The analogous maps of β for panels 2 and 3 were presented in Figure 10c and Figure 10d. In Figure 11, the same maps were plotted after applying a threshold from 0.99 to 1, for better illustration of the peak values of β . According to these maps, the BVID was successfully located in all different cases within an error range of 4 to 22 mm (average of ~ 12 mm). It must be noted that the localisation error was measured from the estimated damage location to the boundary of BVID. If the error was measured from the centre of impact, the corresponding range would be 23 to 43mm. However, this would not be sensible because stronger acoustic nonlinearities may arise from specific areas (e.g. bigger delamination areas) within the damaged region, and not necessarily from the centre of impact. In fact, the C-scans provided in Figure 4 indicated that the areas of bigger delamination were off-centred, and in most cases, they were close to the estimated damage position.
