High Temperature Corrosion under Laboratory Conditions Simulating Biomass-Firing: A Comprehensive Characterization of Corrosion Products

Okoro, Sunday Chukwudi; Montgomery, Melanie; Jappe Frandsen, Flemming; Pantleon, Karen

Published in:
Energy and Fuels

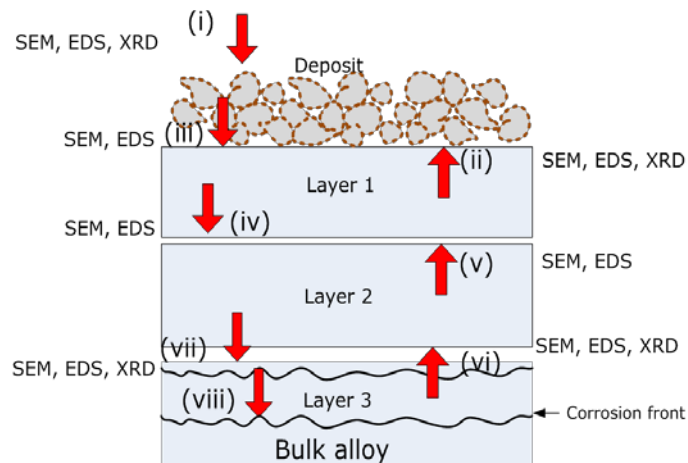
Figure 2. Schematic illustration of the depth-resolved top view characterization process. Arrows are used to show the direction from which the characterization was carried out. Employed characterization techniques at each point are also shown.

Plan view ‘top-down’ analysis was carried out on exposed samples without any embedding. Microscopic, spectroscopic and diffraction based characterizations were first carried out directly on the surface of the exposed sample and then, combined with removal of various layers of the corrosion product. A schematic sketch showing the directions and locations from which the characterization stages were undertaken is shown in Fig. 2.

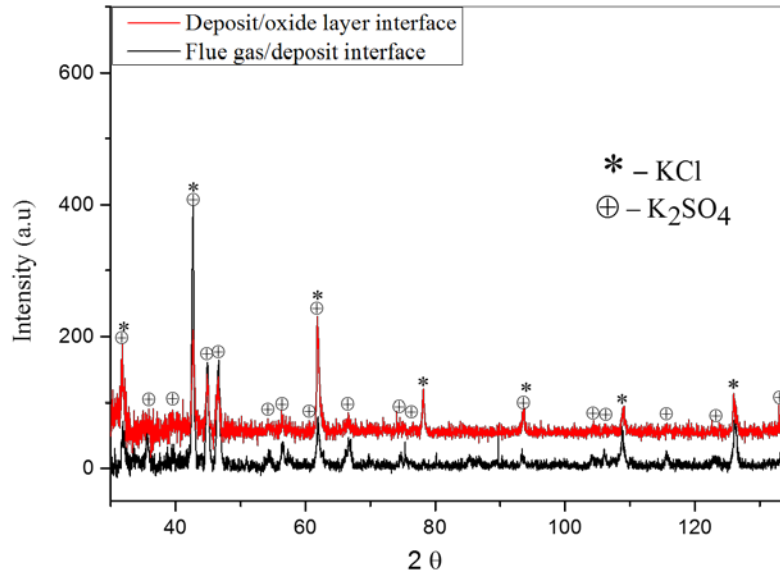
Figure 7. XRD phase analysis on the synthetic deposit, both at the flue gas/deposit interface and at the deposit/corrosion product interface, (i.e. points (i) and (ii) in Fig. 2).

The diffractograms in Fig. 7 were recorded by XRD on the exposed sample, both at the deposit/flue gas interface and at the deposit/corrosion product interface (points (i) and (ii) in Fig. 2). Apart from KCl, K_2SO_4 can be identified on both measured sites (according to Joint Committee Powder Diffraction Standard (JCPDS) cards; 41-1476 and 83-681 for KCl and K_2SO_4 respectively).

XRD phase identification thus supports the EDS-data with respect to the sulphation of the initial deposit to yield K_2SO_4 (see results in Table 3). However, the additional detection of KCl by XRD (in conjunction with identification of K and Cl by EDS) also suggests incomplete sulphation of the deposit particles during exposure.
