## Micromechanical Investigation of Fatigue Damage in Uni-Directional Fibre Composites

Proceedings of 6th International Conference on Fatigue of Composite

2015

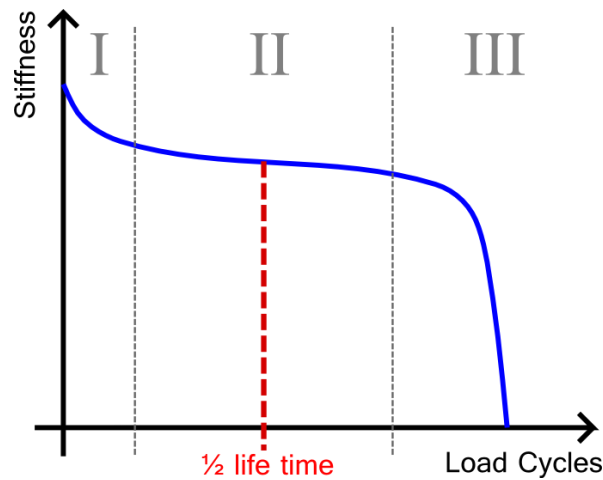
Figure 3: Typical stiffness degradation curve for composite, with indication of approximate location of half-life time.

Prior to the 3D XCT examination, the specimen was subjected to tension-tension fatigue loading and stopped at around half life time. Half-life time indicates the approximate half-life of the sample deducted from the life-time of several specimens tested to fracture. Figure 3 shows a sketch of the typical stiffness degradation

behaviour during tension fatigue for this composite. The half-life is approximately in the centre of the linear part (II) of the stiffness degradation curve
