## Micromechanical Time-Lapse X-ray CT Study of Fatigue Damage in Uni-Directional Fibre Composites

Jespersen, Kristine Munk; Lowe, Tristan; Withers, Philip J.; Zangenberg Hansen, Jens ; Mikkelsen, Lars Pilgaard

Proceedings of the 20th International Conference on Composite Materials (ICCM20)

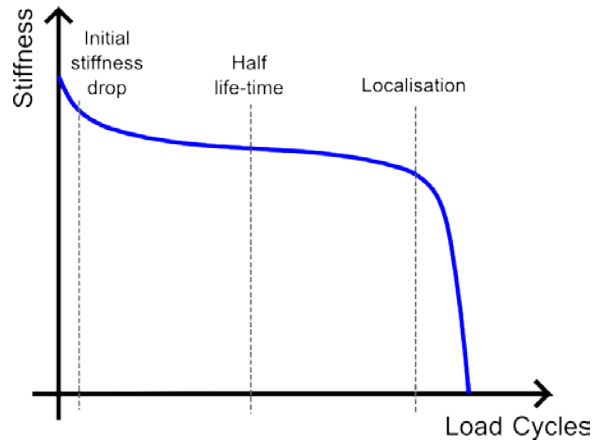
Figure 3: Typical stiffness degradation behaviour of considered composite. Approximate locations of the stopped fatigue tests are indicated on the figure.

Fatigue tests were carried out on several butterfly specimens using an Instron 8800 hydraulic machine. A few tests were run until fracture to have an idea about when to stop the remaining tests. Figure 3 shows the typical stiffness degradation curve for this type of composite. The current study considered three tests stopped at different locations, as indicated in the figure. The locations were chosen at positions where the curve shows a different behaviour; in the initial stiffness drop region, in the linear region, and in the final localisation phase.

Scans were performed on fatigued samples stopped at the locations shown in Figure 3. No damage was observed in the sample stopped in the “initial stiffness drop”. It would be expected to see matrix

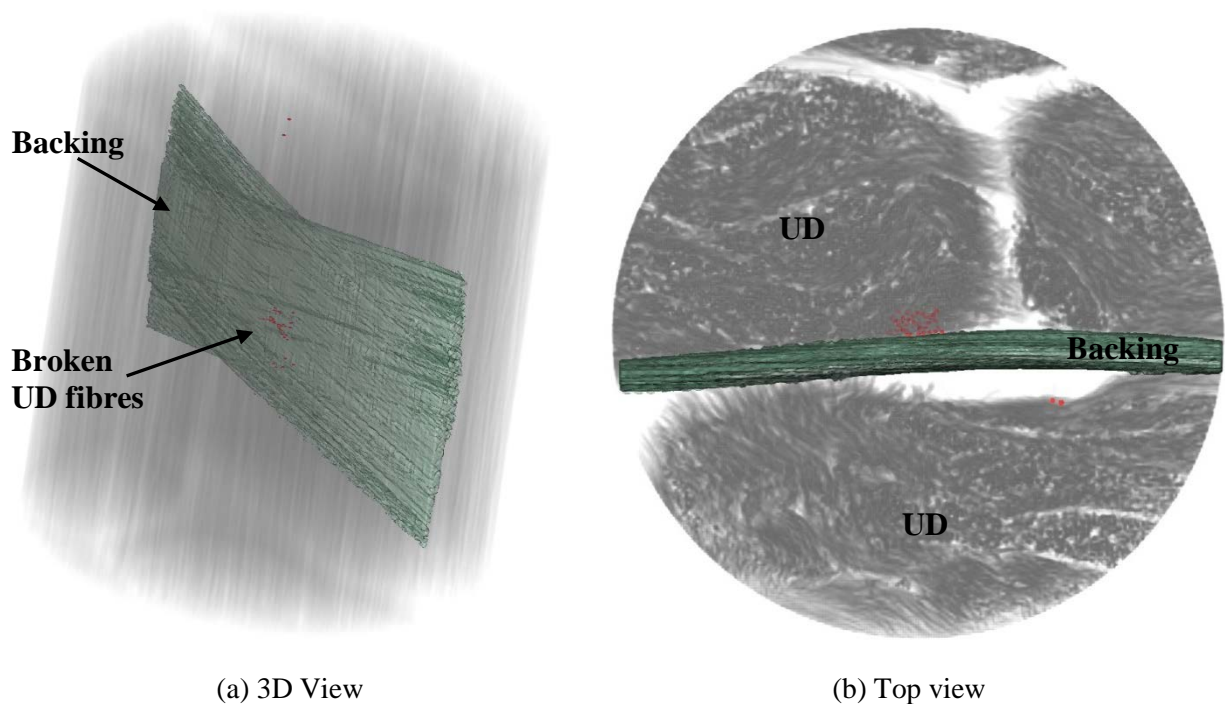
Figure 7: Distribution of broken UD fibres in scan performed on the sample subjected until around half life-time. The broken fibres are marked by red discs in the UD bundles which are shown as transparent light grey. The backing bundles are marked in green.

Figure 7 shows 3D segmentation of the broken UD fibres relative to the backing (green) for a sample subjected to half life-time where the broken fibres are marked as red discs. The fibres were manually segmented by eye, to give a volumetric visualization of the distribution of the broken fibres. Work is ongoing on developing an automated method for locating the UD fibre fractures.

It is seen from Figure 7 that a few broken fibres exist locally close to the double backing layer, which is in contact with the UD bundle. The backing and the UD bundles are only in contact on one side, and broken fibres are only observed on this side. Figure 8 shows a similar view of the material subjected to almost full fatigue life.
