Madison County, Kentucky Hazardous Materials Commodity Flow Analysis

MADISON COUNTY, KENTUCKY HAZARDOUS MATERIALS COMMODITY FLOW ANALYSIS

FINAL REPORT

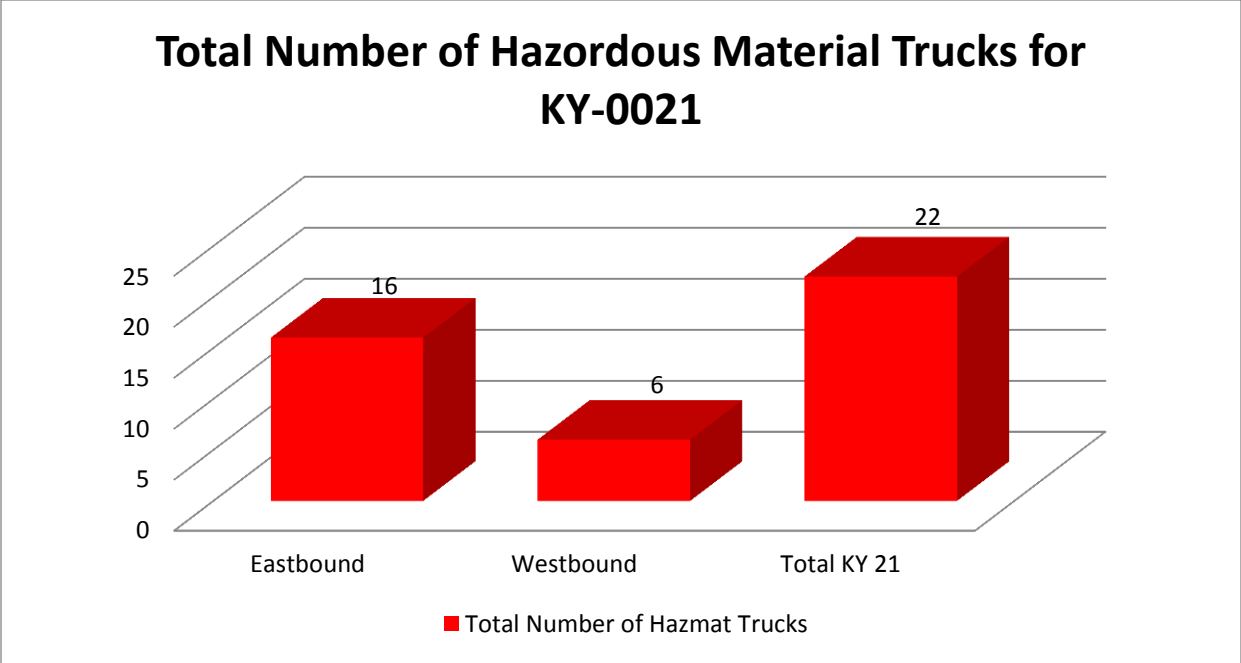
Figure 2.1 Placarded commercial trucks observed in the KY-0021 corridor

The total number of placarded trucks on KY-0021 during the study period, as show in Figure 2.1, was 22, with 16 recorded for the East bound lane and 6 recorded for the West bound lane. As shown in Figure 2.2 an average of less than 1 truck was recorded for both East and West bound lanes and for KY-0021 as a whole. When extrapolated, it is estimated that the number of placarded trucks per day on KY-0021 would be approximately 7 ($0.28 \text{ avg. placarded trucks per hour observed} \times 24 \text{ hours} = 6.72$). This means that on a 24-hour daily basis hazmat trucks make up roughly 1.02% of the truck traffic or 0.05% of the total daily traffic on KY-0021 in Madison County. When comparing the total placarded truck traffic and the average hourly placarded truck traffic for East and West bound lanes there is only a small difference in the number of trucks, with East bound lanes containing the highest amount.

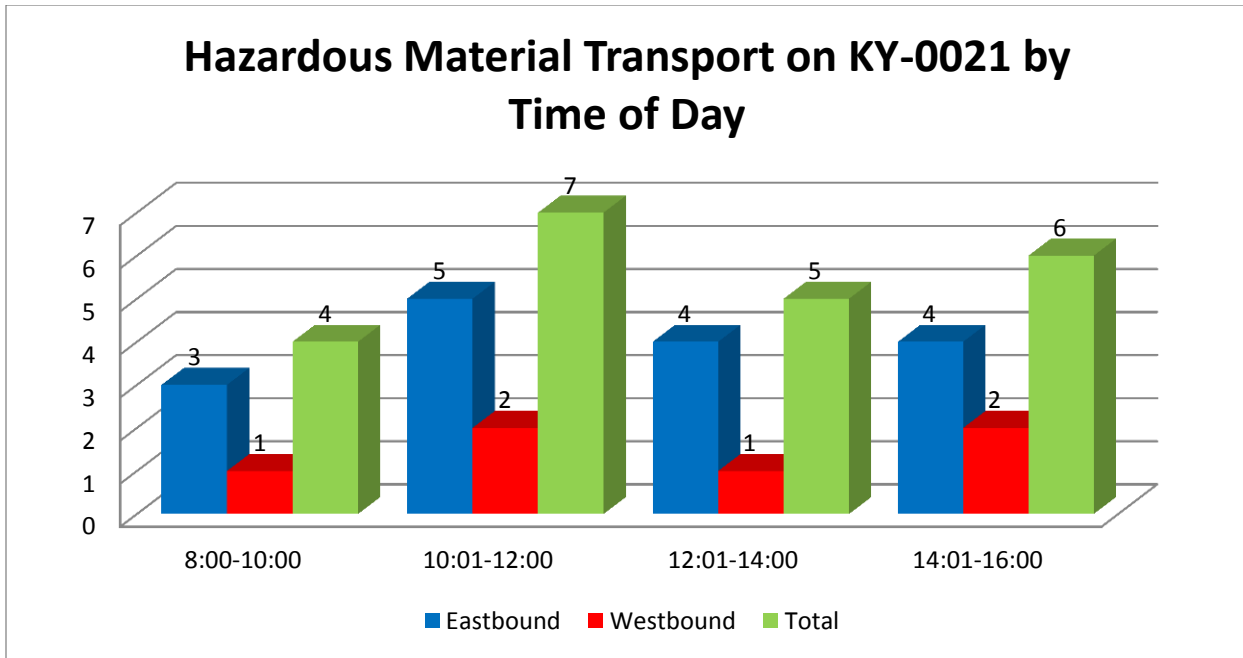
Figure 2.5 Placarded commercial truck traffic observed in the KY-0021 corridor by time of day

As shown in Figure 2.5, overall the highest truck volume for the study period was observed in the late morning and late afternoon hours, 7 and 6 respectively, with the lowest overall volume being observed in the early morning hours, 4. The East bound lanes follow the same pattern with the highest volume seen in the late morning, 5, and the lowest volume seen in the early morning, 3. The West bound lanes differ slightly with the highest volume seen in the late morning and late afternoon hours, 2 and 2 respectively, and the lowest volume seen in the early morning and early afternoon hours, 1 and 1 respectively.

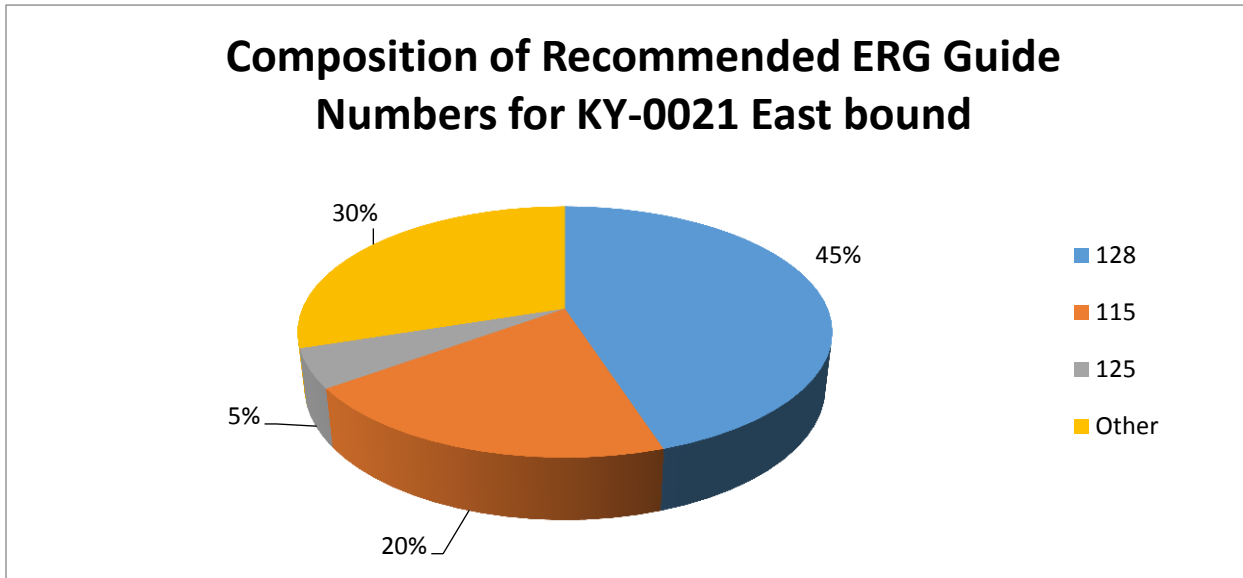
Figure 2.8 Composition of the most frequently used ERG's for East bound lanes

The most frequent guide number for both East and West bound lanes of KY-0021 in Madison County is 128 (Flammable Liquids, Water Immiscible) as shown in Figure 2.8 and 2.9. This guide number encompassed 45% of observed placards for East bound lanes and 57% of observed

placards for West bound lanes. Other frequent guide numbers for East bound lanes included 115 (Gasses – Flammable) and 125 (Gasses – Corrosive).

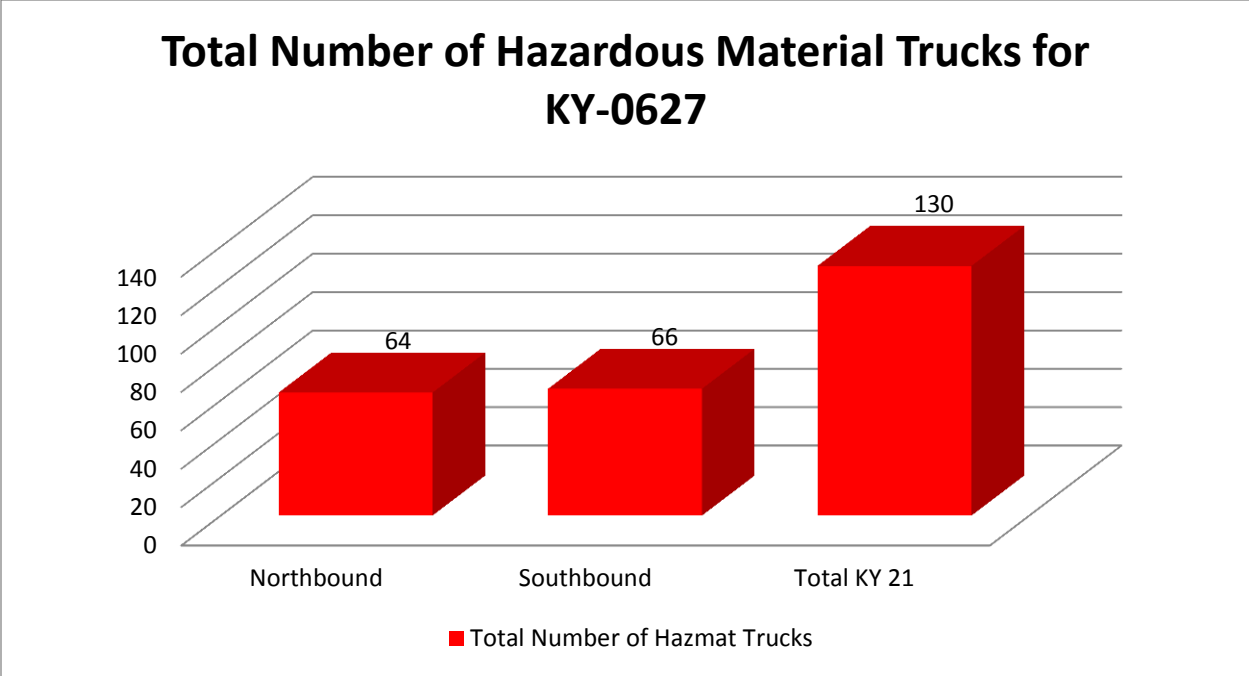
Figure 3.1 Placarded commercial trucks observed in the KY-0627 corridor

The total number of placarded trucks on KY-0627 during the study period, as show in Figure 3.1, was 130, with 64 recorded for the North bound lane and 66 recorded for the South bound lane. As shown in Figure 2.2, an average of approximately 2 trucks per hour was recorded for both North and South bound lanes and for KY-0627 as a whole. When extrapolated, it is estimated that the number of placarded trucks per 24-hour day on KY-0627 would be approximately 48 (2 avg. hazmat placarded per hour x 24 hours = 48). This means that on a 24-hour daily basis hazmat trucks make up roughly 6.92 % of the daily truck traffic or 0.75% of the total daily traffic on KY-0627 in Madison County. When comparing the total placarded truck traffic and the average hourly placarded truck traffic for North and South bound lanes there is only a very small difference in the number of trucks, with South bound lanes containing the highest amount.

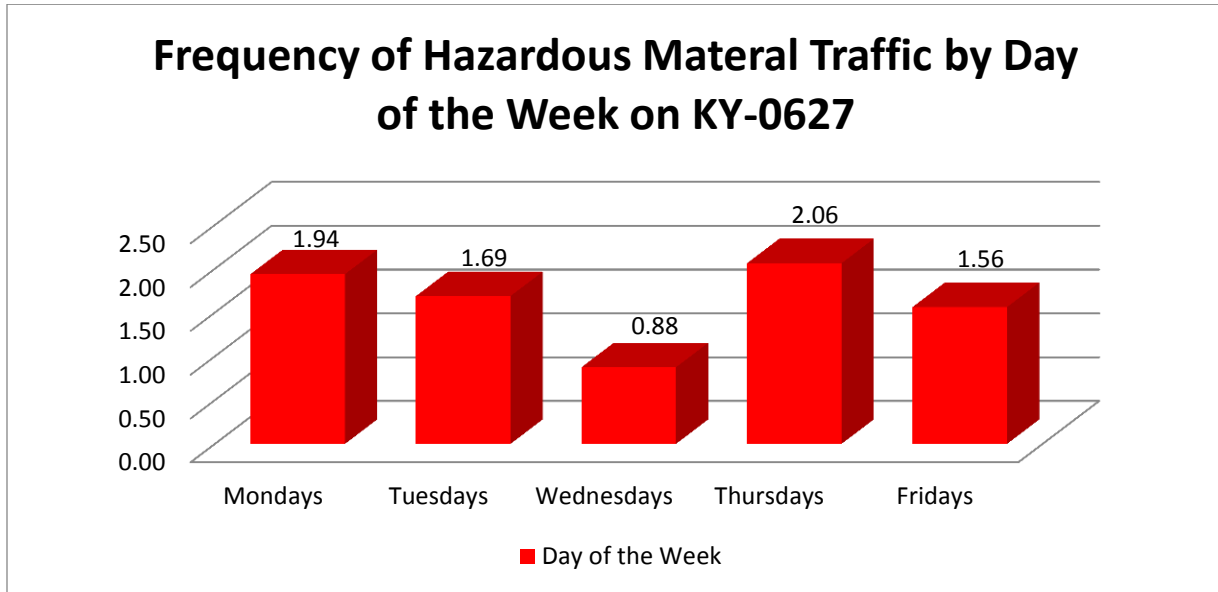
Figure 3.3 Placarded commercial truck traffic hourly averages by day of the week

As shown in Figure 3.3, differences did exist based on the day of the week when observations were made. The highest per hour average was seen on Thursday and Monday, 2.06 and 1.94 respectively. The lowest per hour average was on Wednesday when the hourly average was less than 1, 0.88 to be exact. A similar pattern can be seen in Figure 3.4, which shows the average number of placarded trucks per day for North and South bound lanes, according to day of the week. Both North and South bound lanes had the lowest traffic volume on Wednesday. The highest traffic volume for North bound lanes was on Tuesday and for South bound lanes on Thursday.

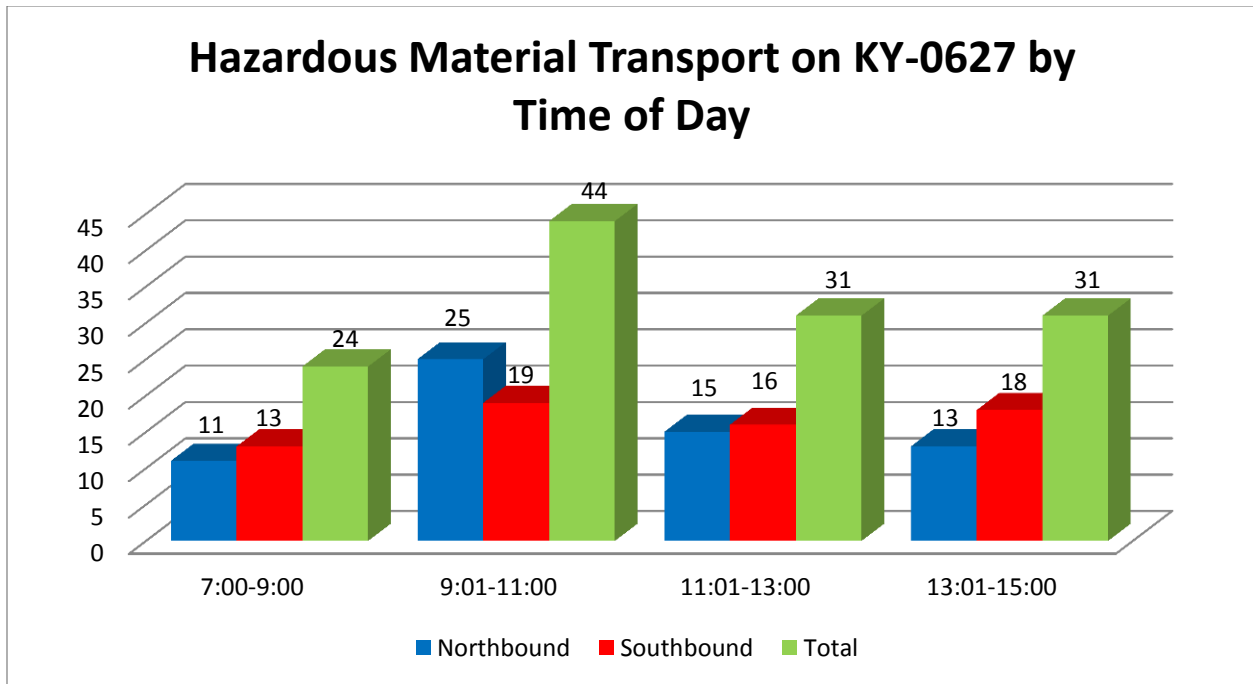
Figure 3.5 Placarded commercial truck traffic observed in the KY-0021 corridor by time of day

As shown in Figure 3.5, overall the highest truck volume for the study period was observed in the late morning hours, 44, with the lowest overall volume being observed in the early morning hours, 24. The North and South bound lanes follow this same pattern with the late morning hours having the highest volume, 25 and 19 respectively, and the early morning hours having the lowest volume, 11 and 13 respectively.

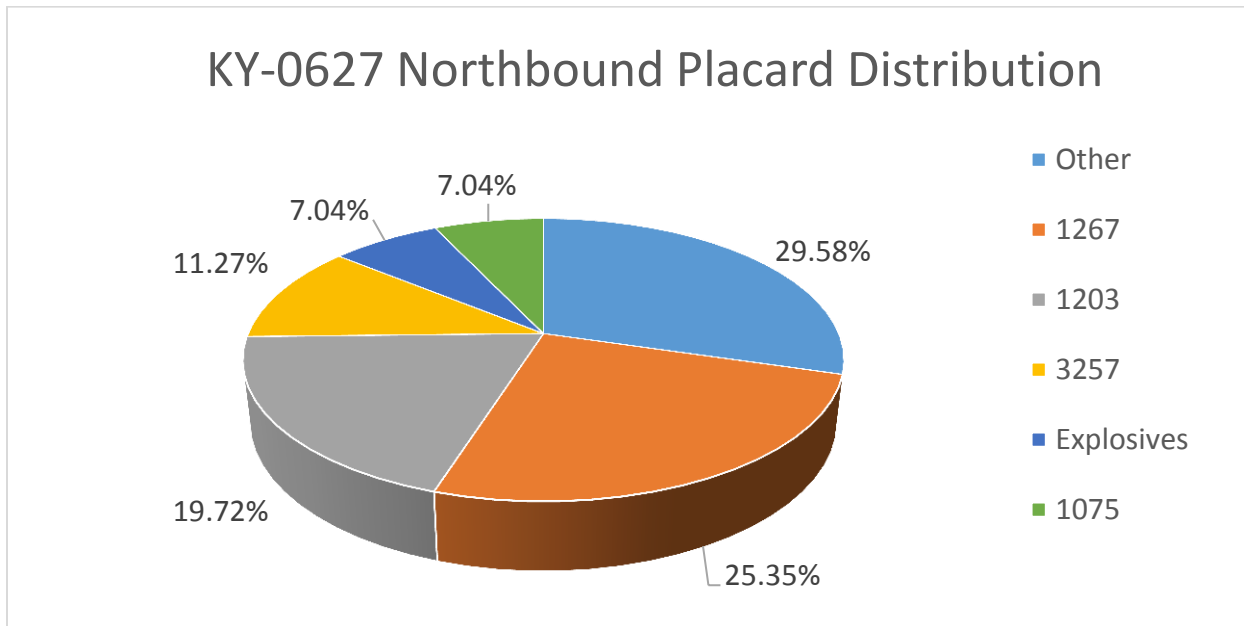
Figure 3.6 Distribution of placard numbers on KY-0627 North bound as percentages of grand total

Analysis of the placard data was performed to assess what materials were being transported within the KY-0627 corridor. Based on Figure 3.6, the most frequently transported hazmat for North bound lanes was Petroleum Crude Oil (ID no. 1267). Other frequently transported hazmats on the North bound lane of KY-0627 included Petrol / Gasoline (ID no. 1203), Elevated

Temperature Liquids (ID no. 3257), Explosives and Flammable Gases / Propane (ID no. 1075). Figure 3.6 also shows that 25.35% of all the placards observed on East bound lanes were ID no. 1267, 19.72% were ID no. 1203, and 11.27% were 3257.

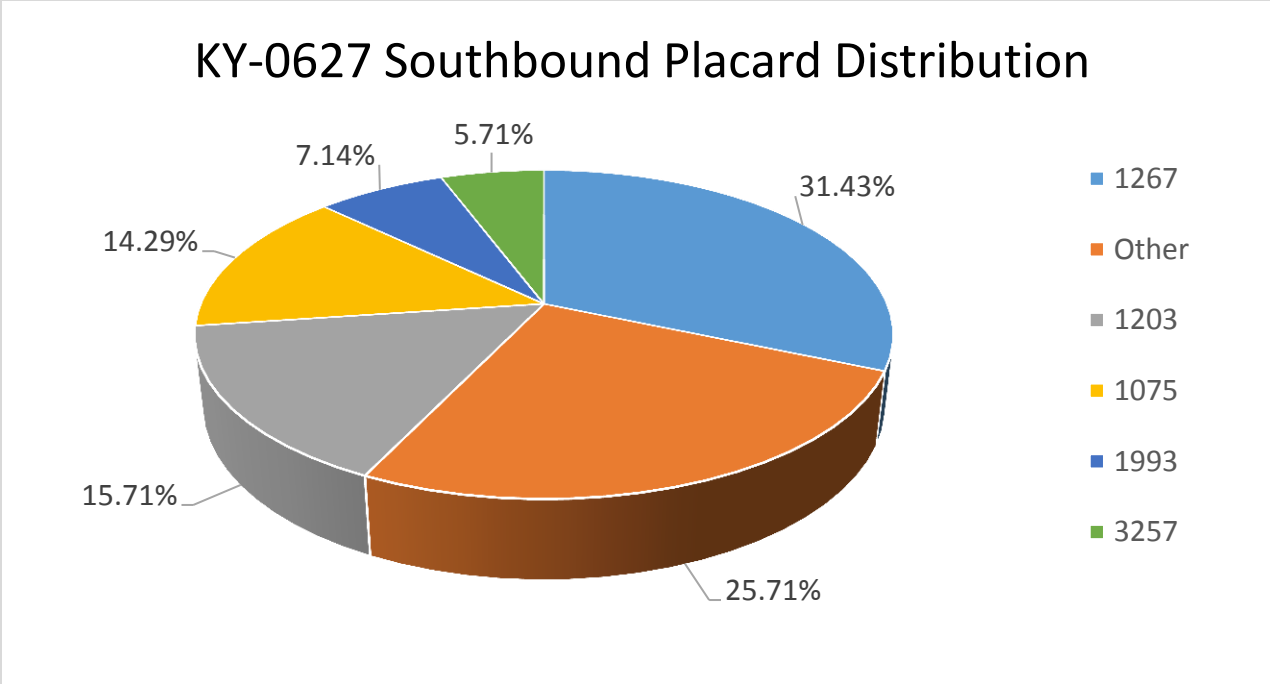
Figure 3.7 Distribution of placard numbers on KY-0627 South bound as percentages of grand total

Analysis of the South bound lane of KY-0627 was performed identical to the analysis for the North bound lane. As shown in Figure 3.7, the most frequently transported hazmat was also Petroleum Crude Oil (ID no. 1267) with this comprising 31.43% of all total observed placards. Other frequently transported hazmats also included Petrol / Gasoline (ID no. 1203), Flammable Gases / Propoane (ID no. 1075), Combustible Liquids / Diesel Fuel (ID no. 1993), and Elevated Temperature Liquids (ID no. 3257).

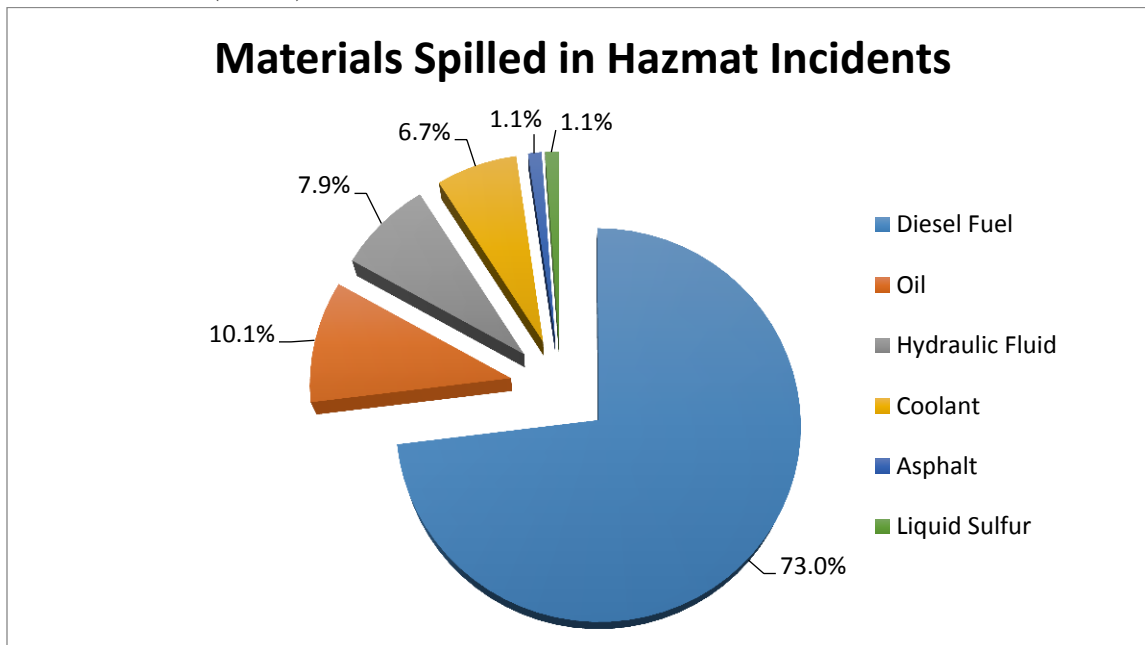
Figure 4.1. Materials spilled in Madison County hazmat incidents, 2005 – 2014.

Data consisted of incidents, which were reported between 2005 and 2014 in Madison County. A total of 78 incidents were reported that required emergency response for vehicle spills that released materials such as diesel fuel, oil, coolant, and liquid sulphur (Figure 4.1). The primary hazardous materials released were diesel fuel (73%), oil (10.1%), hydraulic fluid (7.9%), and coolant (6.7%). Hazmat incidents occurred on roadways throughout Madison County as shown in Figure 4.2. The majority of incidents occurred on I-75 (46.8%).
