A Landslide Risk Rating System for the Baguio City, Philippines Area

Submitted to the Department of Civil and Environmental Engineering
in Partial Fulfillment of the Requirements for the Degree of
Master of Engineering in Civil and Environmental Engineering

Massachusetts Institute of Technology

June 2004

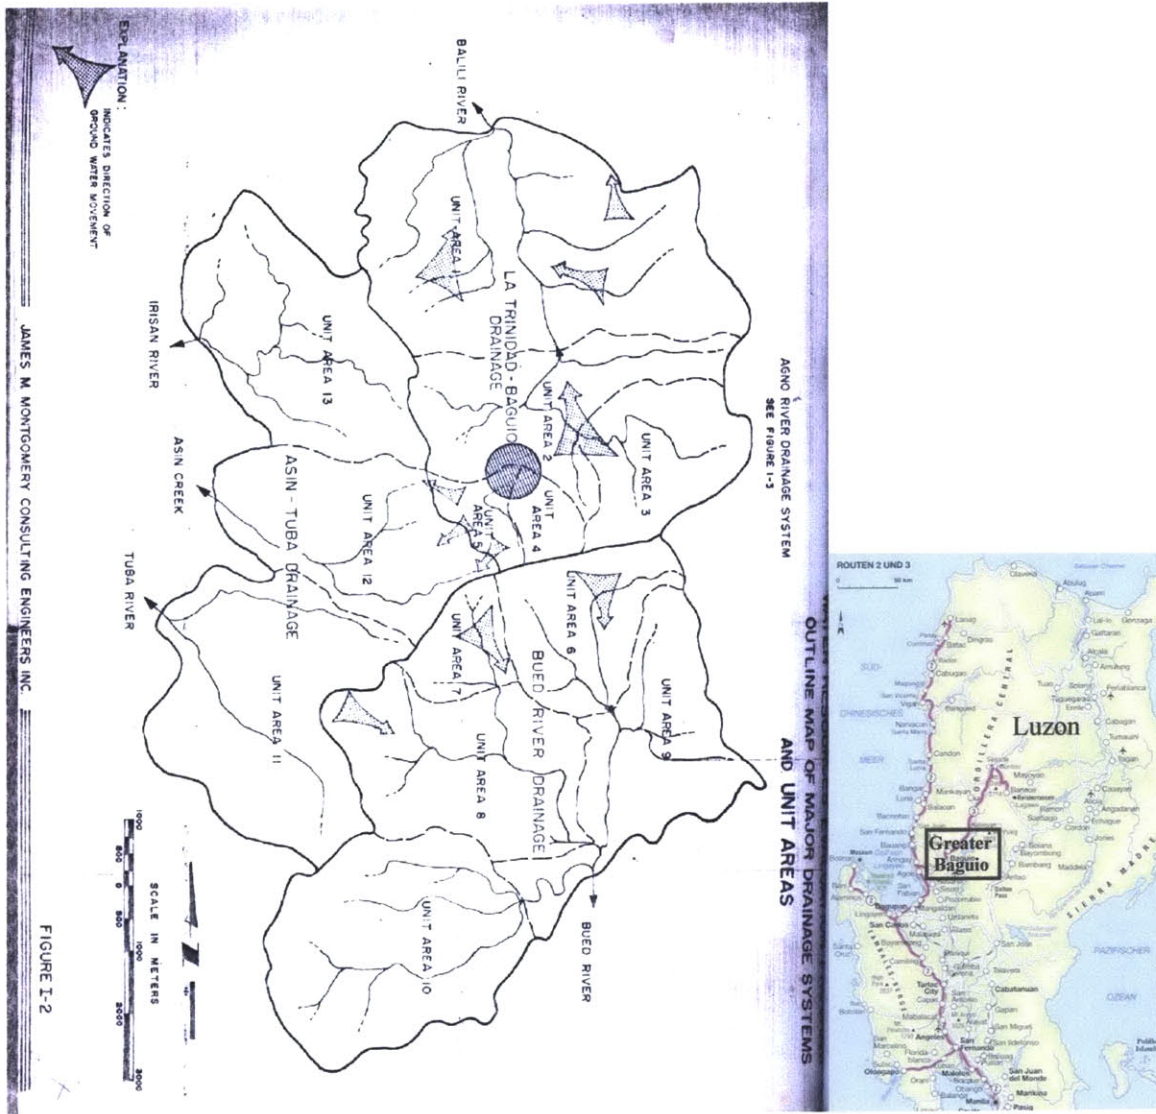
Figure 2.1 Major Drainage Systems in the Baguio City Area (Montgomery Consulting Engineers, 1974)

The Baguio plateau is located at the apex of four major drainage systems which drain away from the City radially (Figure 2.1). These drainage systems are the La Trinidad-Baguio system to the north, the Asin-Tuba system to the west/northwest, the Bued River system to the south/southwest, and the Agno River system to the east (Mendoza, 1983).

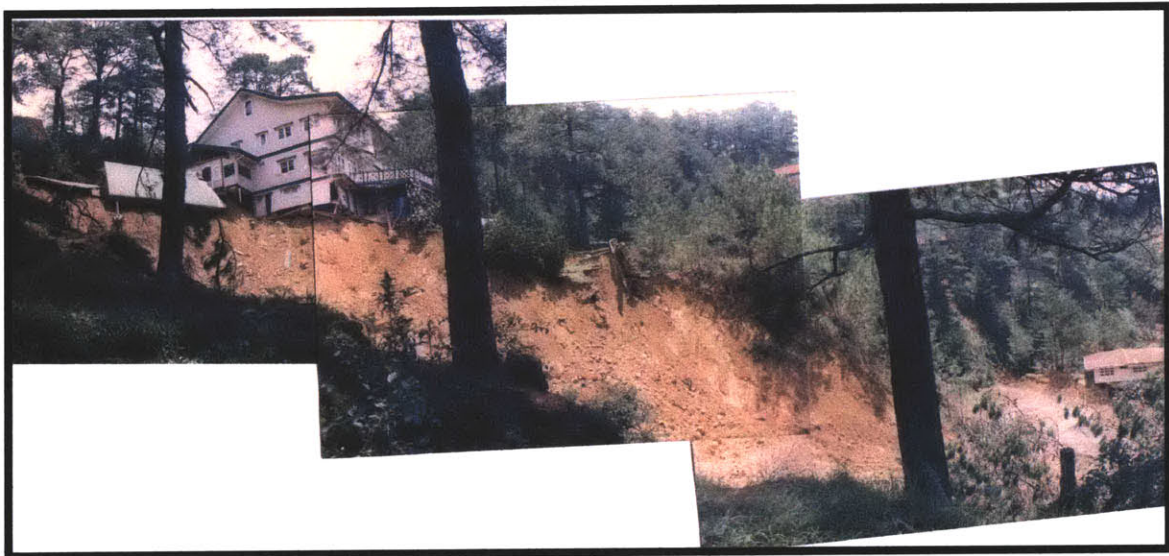
Figure 3.7 Topographic Profile of the Landslide (Geotecnica, 1987)

The pre-slide topography is shown in Figure 3.7. It can be discerned from the profile of the ground still covered with trees and grass.

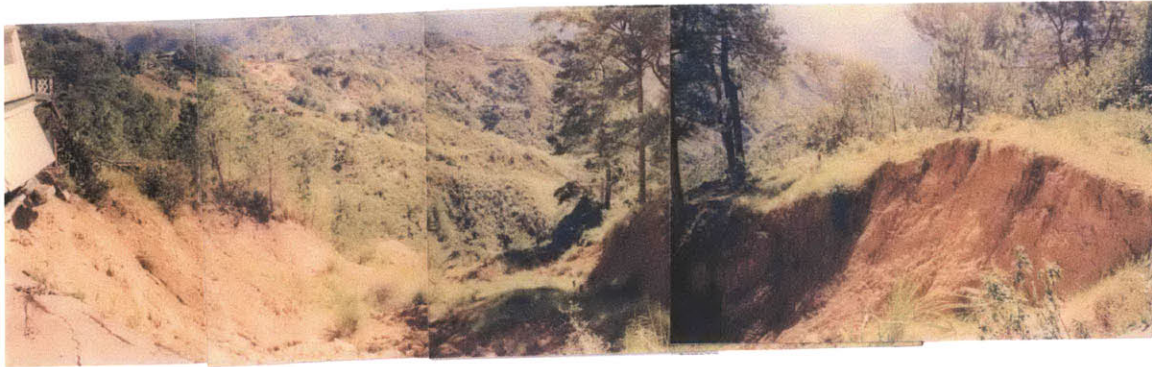
Figure 3.8 shows the slope failure as seen from its crest. The scar of the failure surface is seen at the left and the right sides of the photograph.

Figure 3.8 View of Slope Failure from its Crest (Geotecnica, 1987)

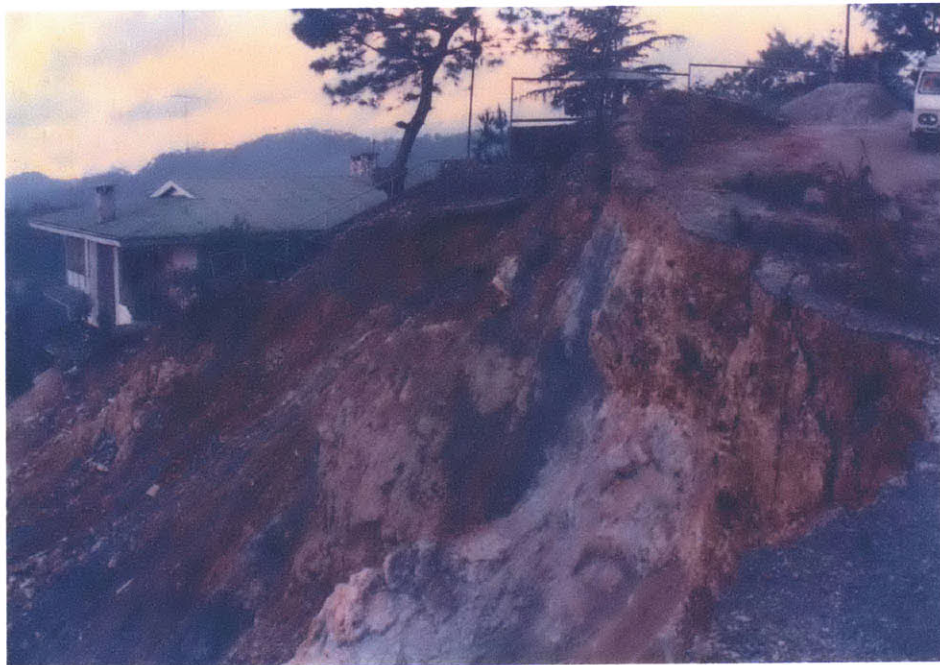
Figure 3.9 shows the highly weathered pyroclastic rock (residual soil) involved in the V. de los Reyes St. landslide.

Figure 3.9 The Crest of the Landslide (Geotecnica, 1987)

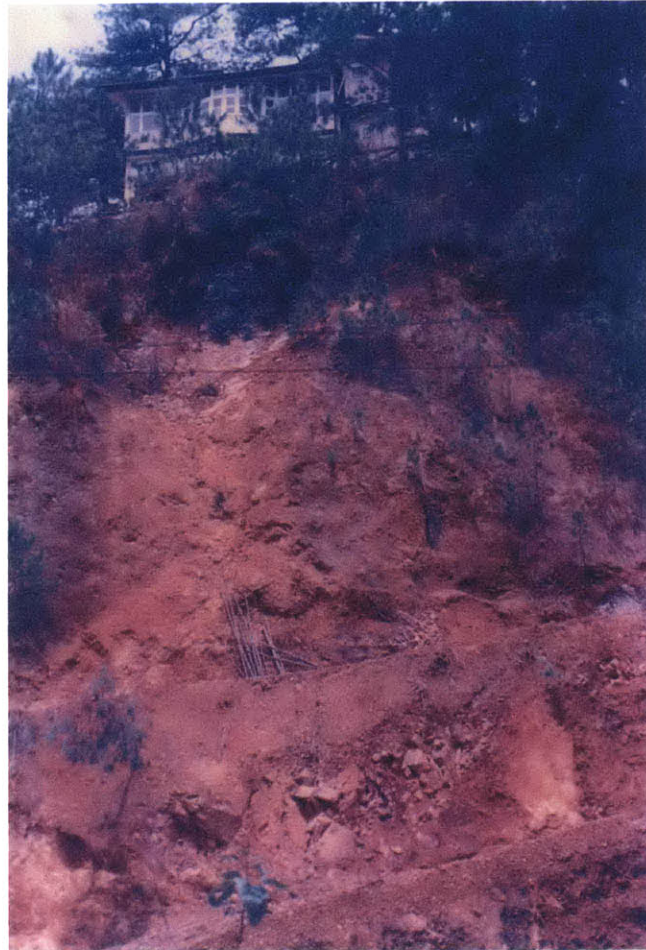
Under the residual soil shown in Figure 3.11, the exposed ground is also in an advanced state of weathering. The house affected by the slide is shown at the top of the photograph.

Figure 3.11 Front View of Landslide (Geotecnica, 1987)

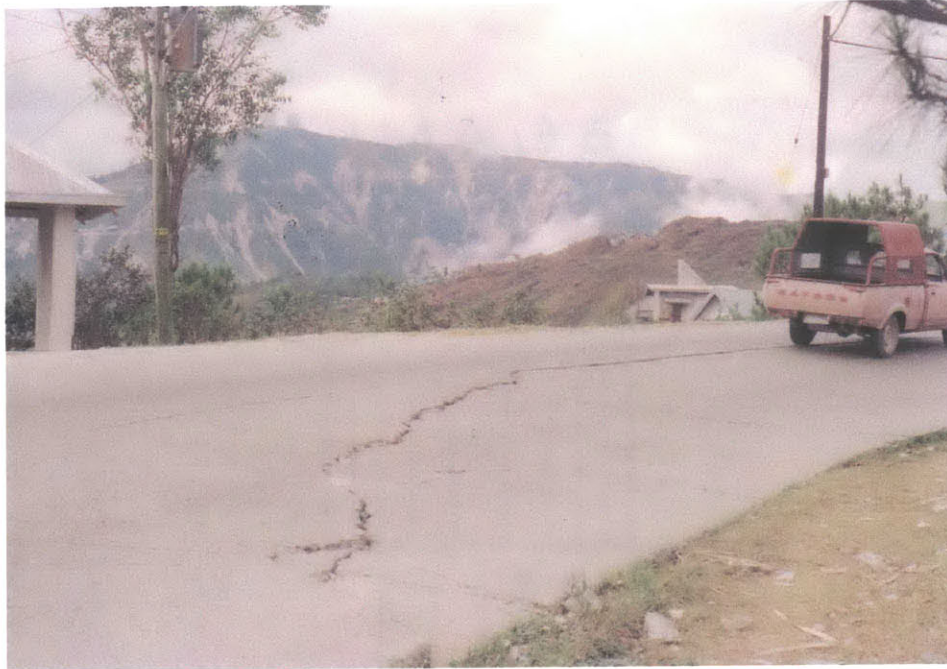
The background of Figure 3.14 shows the landslides in the Mirador Limestone after the earthquake. The mid-ground shows rocks of the Baguio Formation. The foreground of the photograph shows the tension cracks found on Marcos Highway after the earthquake.

Figure 3.14 Effects of the 16 July 1990 Earthquake (Geotecnica, 1990)

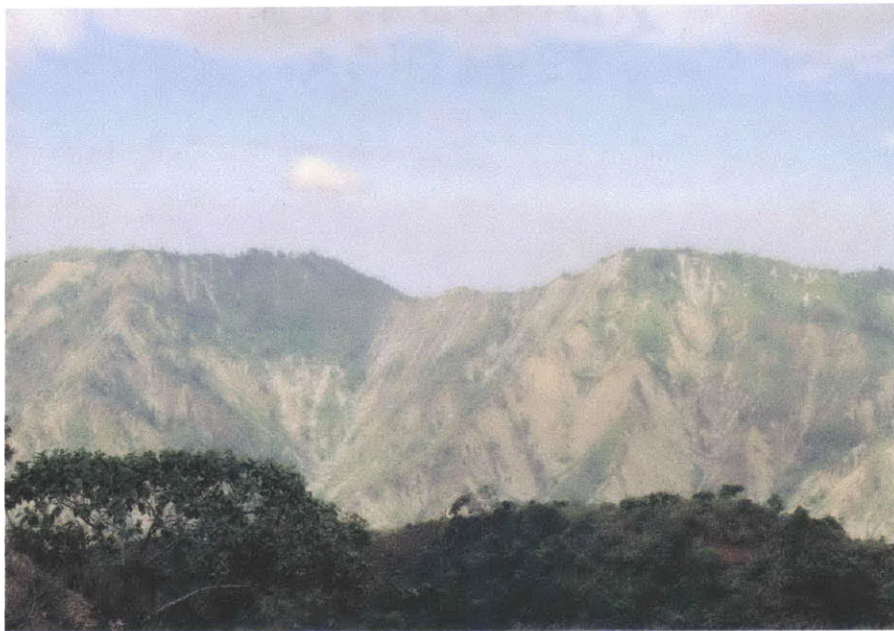
The portions of the mountain shown in the background of Figure 3.16 that have no green cover are all landslides in the Klondyke Formation that were induced by the 1990 earthquake. The slides, being less than 1m deep, typically involved only the residual soil cover.

Figure 3.16 Shallow Slope Failures Observed After 1990 Earthquake (Geotecnica, 1987)

The slides that were less than 1 m deep were small to medium, with volumes ranging from 1,000 to 5,000 cu. m. They were unevenly distributed due to the extreme variations in the geologic and topographic conditions in the area. The slides generally had triangular, elongated shapes (Figure 3.16). The shallow slides are typical of moderate to steep slopes with limited differences in elevation. The height of the slope was found to have no influence on the occurrence of landslides, but the slope angle is critical in that steeper slopes experienced more landslides. The joint pattern of the parent rock is marginally involved (Pantucci, 1994).

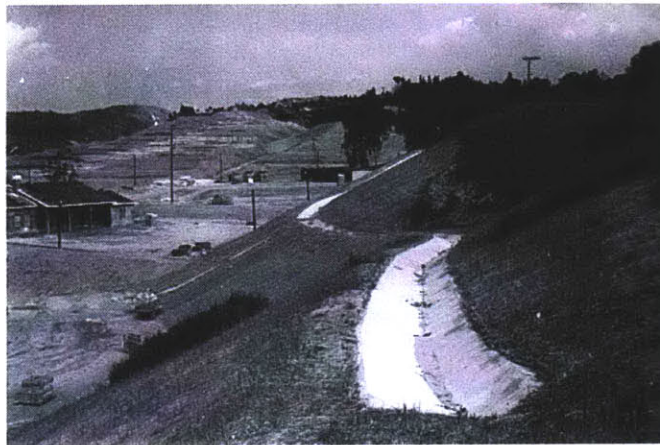
- d. Improvement of surface drainage system to reduce downward percolation of rainwater into slopes. This can be in the form of providing appropriate grades so that surface water flows away from the slope. Additional drainage measures can consist of concrete-paved ditches (Figure 4.2) or buried culvert pipes (Coduto, 1999).

Figure 4.2 Concrete-paved Ditch (Coduto, 1999)
