# Hot salt stress corrosion cracking by silver chloride in Ti-6Al-2Sn-4Zr-6Mo

Yitong Shi<sup>1</sup>; Sudha Joseph<sup>1</sup>; Trevor Lindley<sup>1</sup>; Rebecca Sandala<sup>2</sup>; Edward Saunders<sup>3</sup>; David Dye<sup>1</sup>

## Abstract

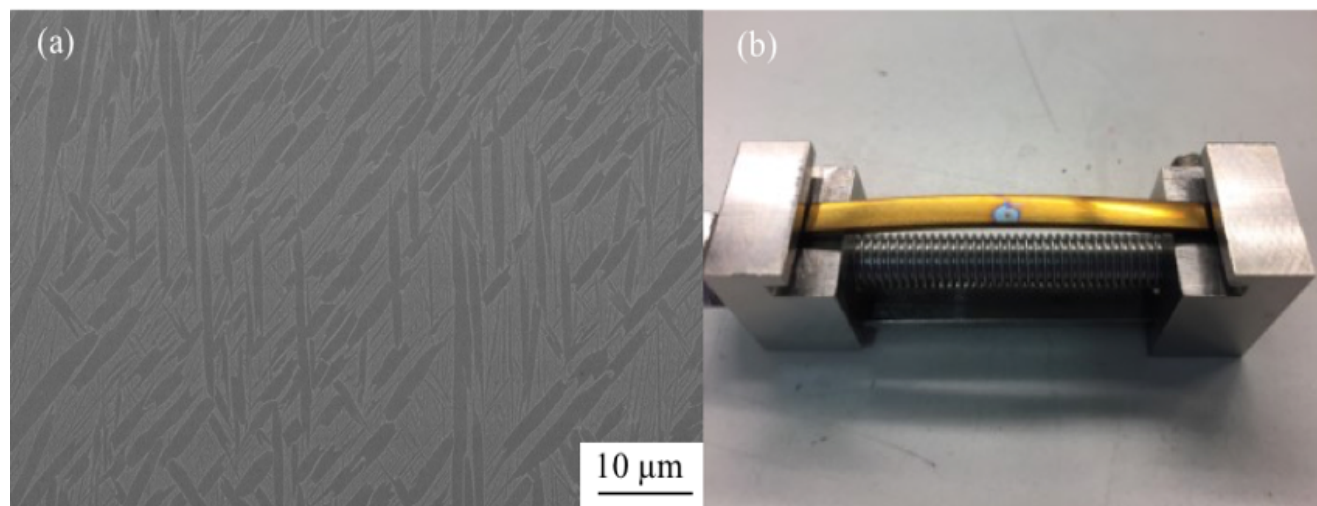
**Figure 1.** (a) Backscattered electron SEM image of as-received Ti-6246 showing the  $\alpha+\beta$  basketweave microstructure; (b) two-point bending rig containing a corroded and cracked Ti-6246 specimen.

Cuboidal Ti-6Al-2Sn-4-Zr-6Mo (wt%) samples 60mm\*3.5mm\*1.5mm in size were obtained by electrical discharge machining (EDM), grinding and hand polishing from material provided by Rolls-Royce plc. The alloy possessed a basketweave lamellar microstructure, Figure 1(a), consisting of primary  $\alpha$  laths ( $\alpha_p$ ) embedded in prior  $\beta$  grains with fine secondary  $\alpha$  ( $\alpha_s$ ) as precipitated between the  $\alpha_p$  laths. Mechanical loads were applied using a two-point bending rig designed according to ASTM standard (E290-14), as shown in Figure 1(b). The body of the bend rig was made of Ti-64 while the bolt was made of gr5 CP Ti. The maximum applied stress on the centre of the specimen was calculated using [6]:

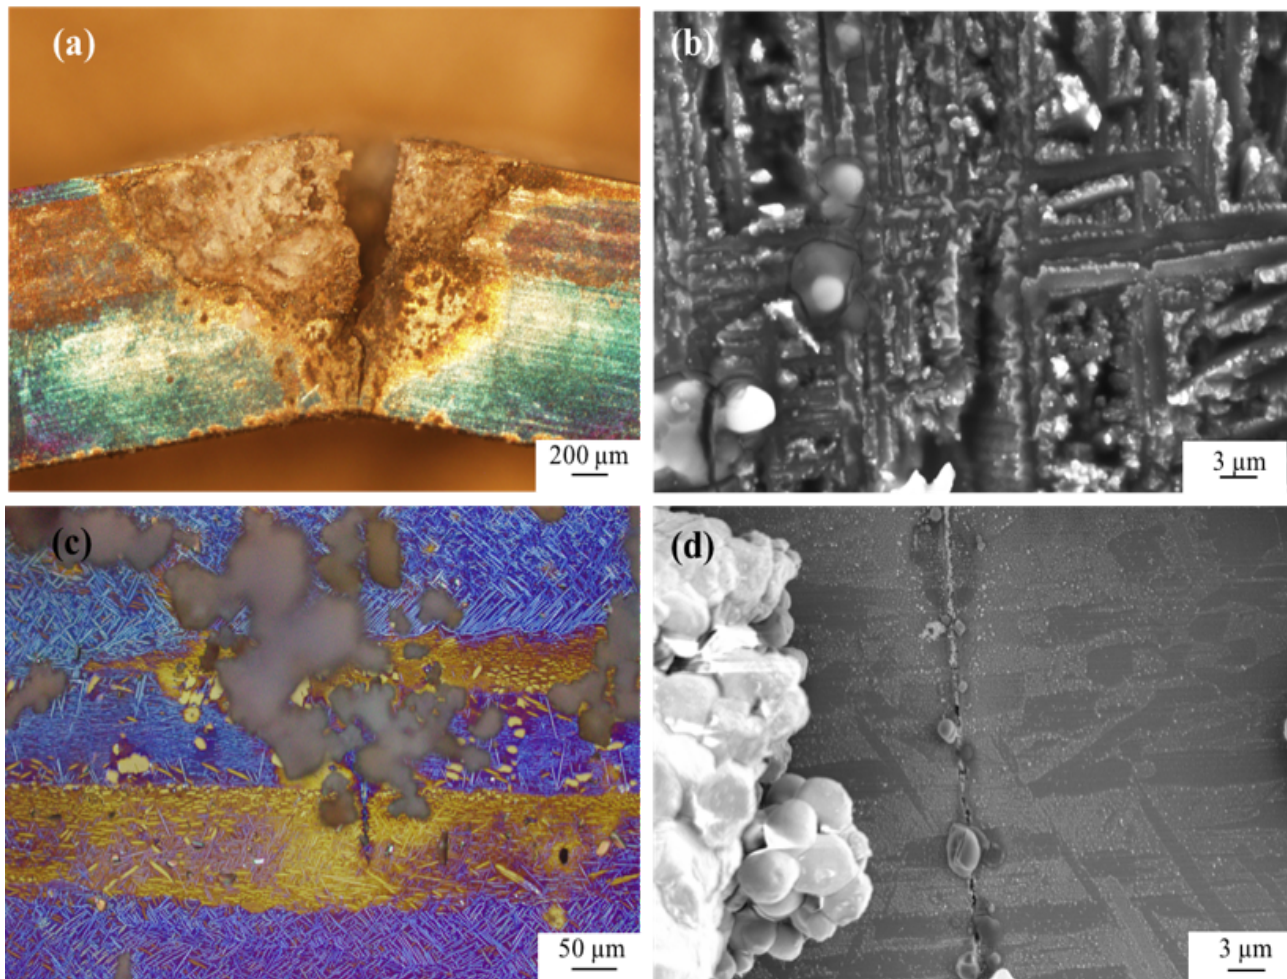
**Figure 2.** (a) Optical image of the side view showing failure of the specimen after testing at 500 °C / 700 MPa; (b) SE image showing the fracture surface covered by corrosion products after the 440 °C/600 MPa test; (c) optical image and (d) SE image revealing a small crack formed on the top surface of the specimen tested at 380 °C/500 MPa.

Table 1 summarizes the results of the 24h bending tests. Rapid failures occurred at 500°C at all stresses examined; a side view of a failed sample is shown in Figure 2(a). A thick layer of corrosion product was generated near the crack, with a blue colouration around the corroded area due to the formation of oxide. At 440 °C (below  $T_m$  of AgCl), macroscopic sample failure was not observed at 400 MPa and below, but significant cracking was still observed. The fracture surface exhibited a transgranular appearance with the deposition of corrosion products, as shown in Figure 2(b). At 380 °C, cracking was absent for stresses of 400 MPa and below, whilst cracking was observed at 500+MPa. Therefore 400 MPa can be considered to be the stress boundary condition for triggering HSSCC within 24 h. Figure 2(c) showed that a small crack initiated beneath the salt particles on the top surface of the 380 °C/500 MPa specimen. The optical image also shows the underlying microstructure, a result of preferential oxidation and corrosion of the primary  $\alpha$  laths compared to the transformed  $\beta$ ; such rapid preferential oxidation is not usually observed for these heat treatment conditions in the absence of corrodant. The secondary electron image in Figure 2(d) shows the same crack at a higher magnification; it can be observed that the crack propagated across  $\alpha_p$  laths, with the formation of nodular corrosion products.

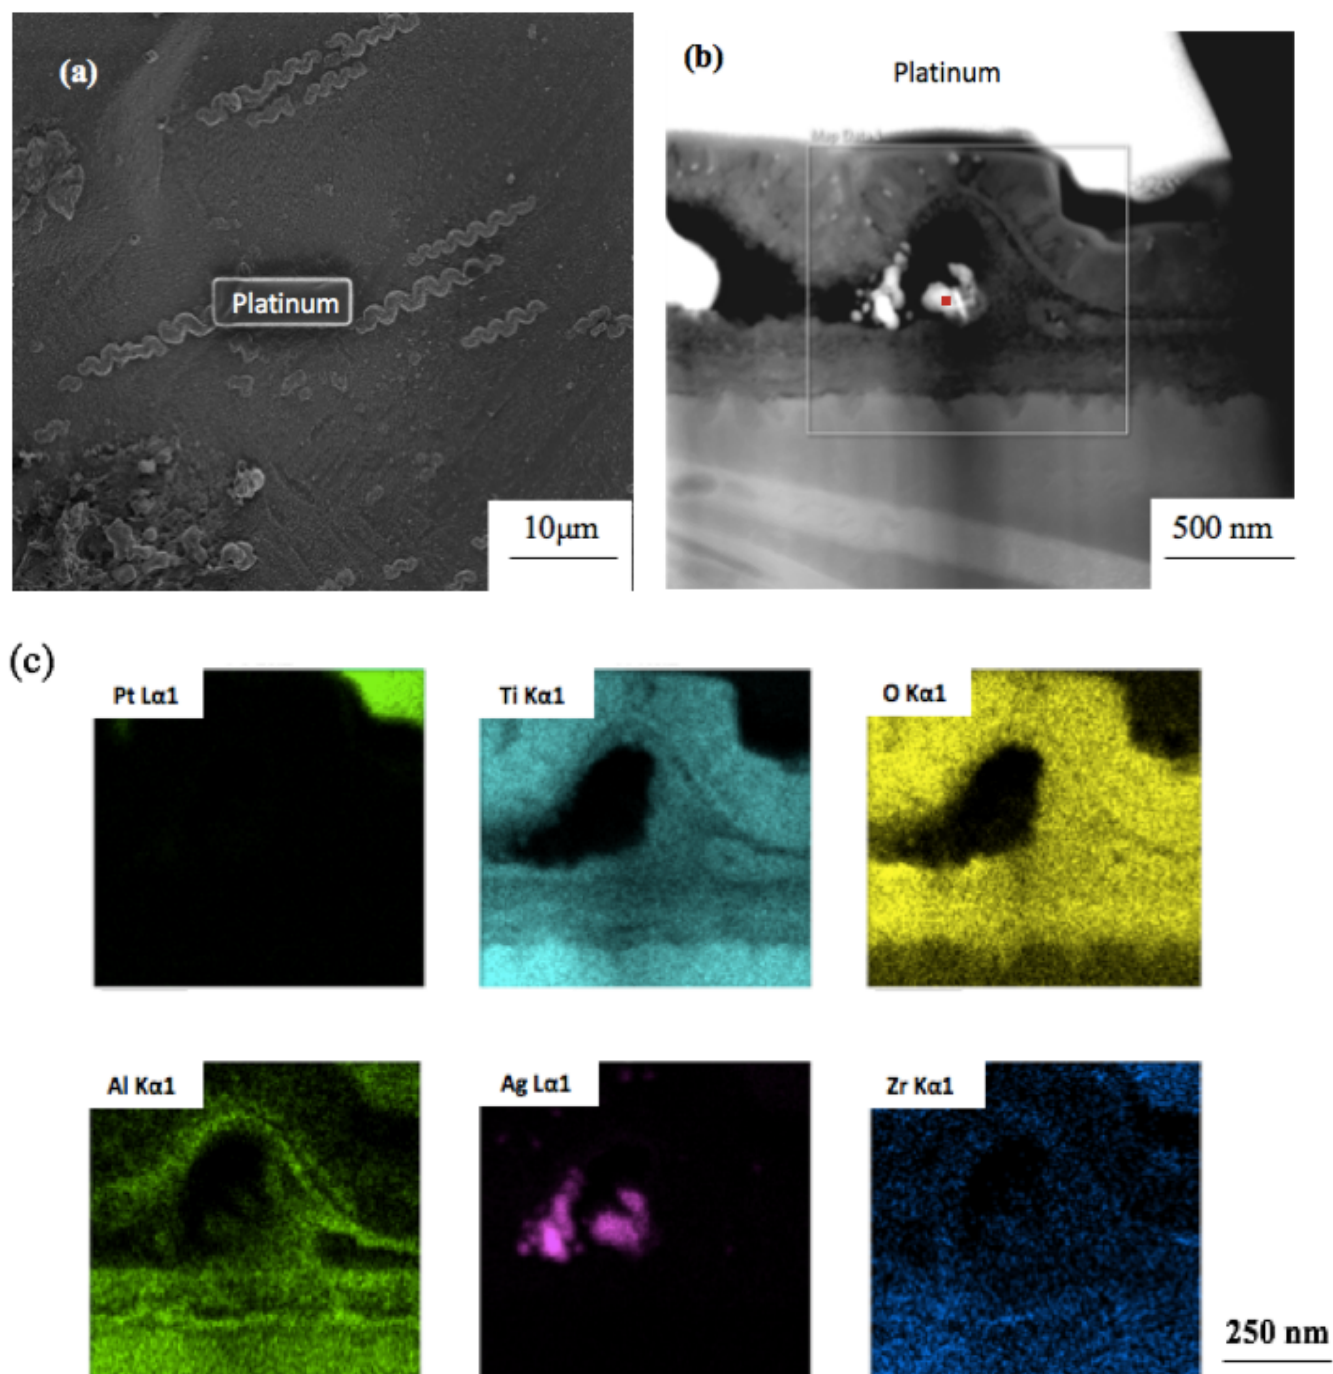
**Figure 3.** (a) Focused-ion beam (FIB) image showing a snake-like structure formed on the top surface and protected by platinum deposition, taken under the voltage of 30 kV and current of 27 pA; (b) STEM dark field image on the cross-section of the snake-like structure; (c) STEM-EDX map of the cross section showing the structure of the layers formed.

Wavy, snake-like structures were extensively observed on the top surfaces of the specimens, Figure 3(a). To investigate these, FIB milling was utilized to make a trench to expose the cross section of a snake-like structure. Figure 3(b) and (c) show that it formed on a primary  $\alpha$  lath and that the inside was hollow with some particles precipitated in the interior. These particles nearly pure Ag (>93 at%), deduced to be metallic Ag. The outer shell was about 200 nm in thickness and was close in composition to titanium dioxide. Some deposits containing Ti, Al and O were formed inside the walls of this structure. The underlying alloy was found to be oxygen-enriched near the surface of the  $\alpha$  lath, and the locally Al-enriched layers were formed above base alloy and Ag-rich region, indicating the upwards diffusion of Al.

EDX analysis on the snake-like structures suggested the occurrence of strong oxidation on certain preferred primary  $\alpha$  laths. Metallic Ag could be formed through the cathodic reaction, assuming silver ions freely diffuse from the salt coated region through the interface between oxide and base alloy. Besides, it has been found that Al and Zr are very active and able to diffuse upward to react, which conforms to the findings on previous studies [3,4]. The hollow structure might result from the expansion of Ag particles or formation of gaseous chlorides on the Ag particles. It has been reported that titanium and aluminium chlorides have relatively low boiling points and are volatile at temperatures above 200 °C [7]. Simultaneously, oxidation was greatly enhanced, stimulated by the local electrochemical reactions around the silver particles. The reasons for the wavy shapes of those structures and their formation on preferred  $\alpha$  laths can be speculated to be a consequence of the orientation and defect structures of the underlying primary  $\alpha$  laths. There is no any evidence to link these structures to crack initiation sites; the snake-like features were associated with the formation of a thicker oxide shell (about 250  $\mu\text{m}$ ) than in other areas.

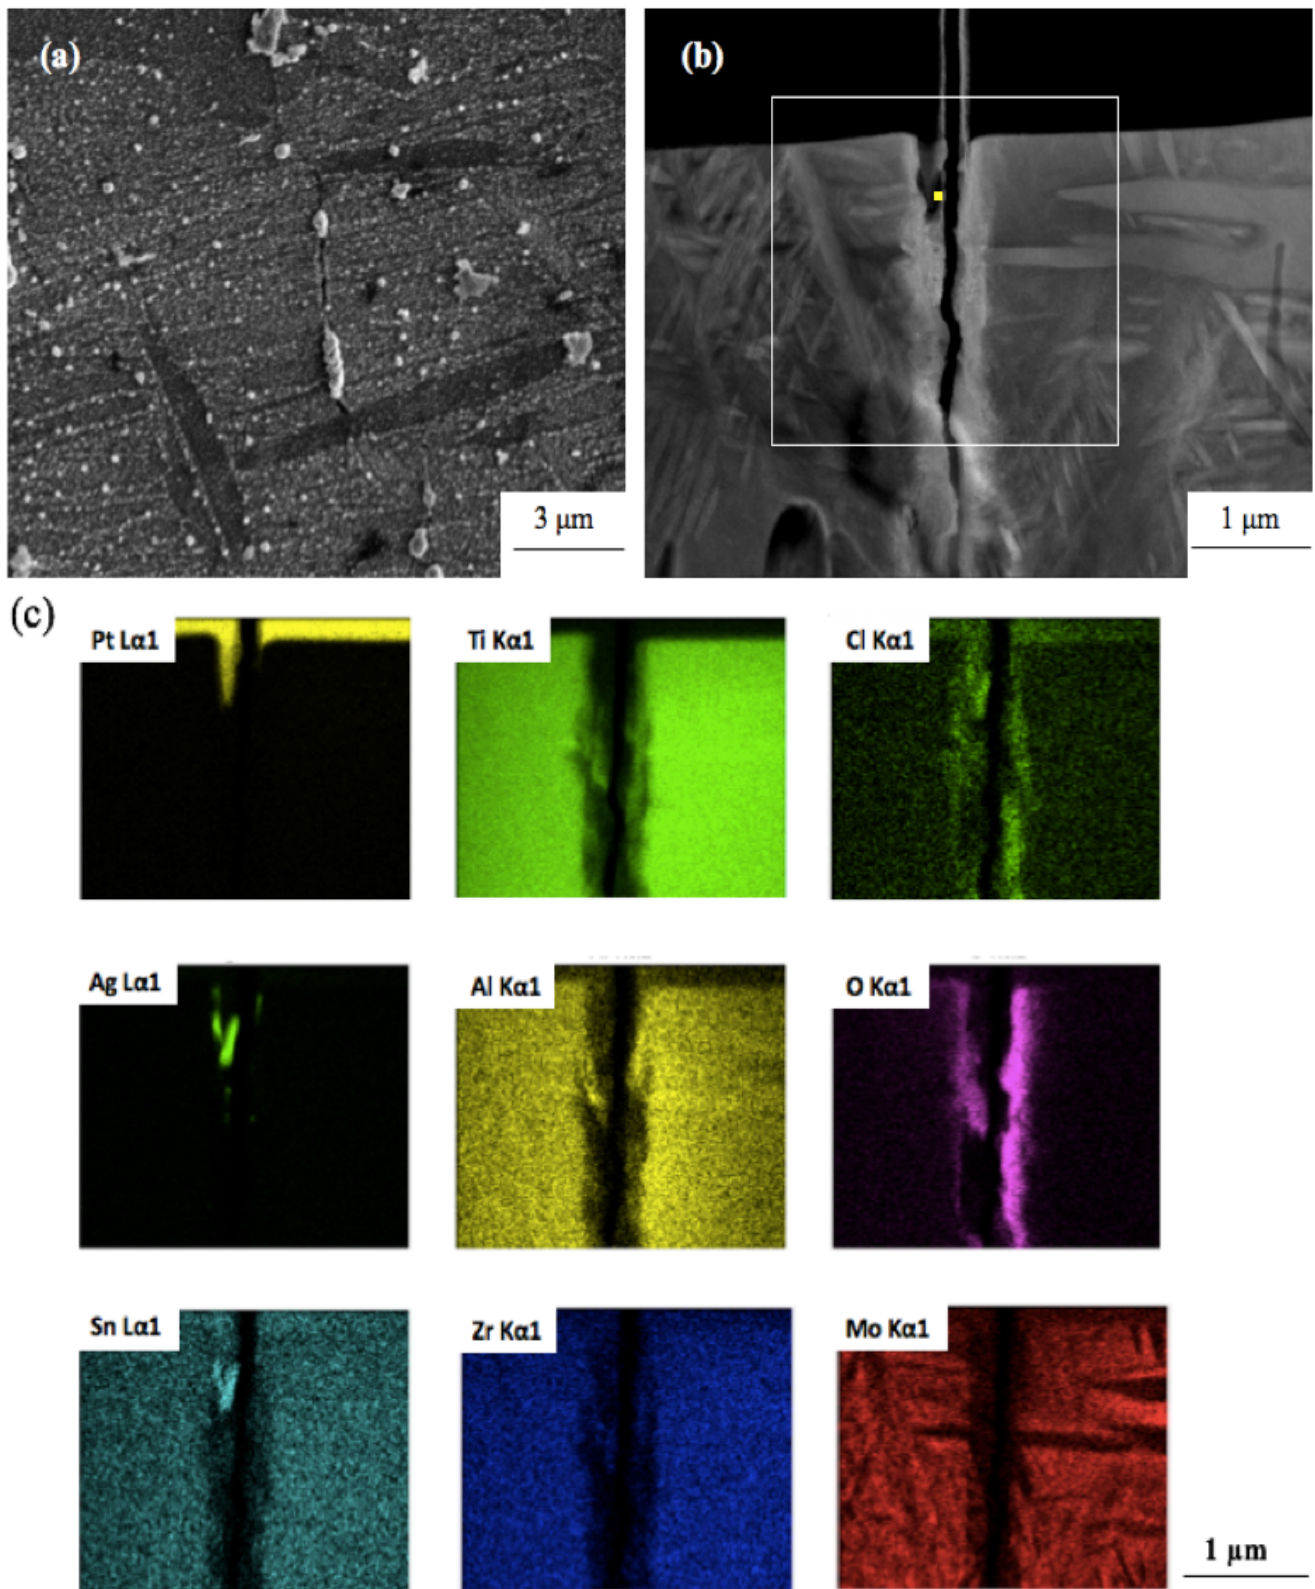
**Figure 4.** STEM bright field image (b) taken from the platinum coated region (a) containing a crack propagating from top surface down to the base alloy (the white rectangular box indicating the area analysed by STEM-EDX under camera length 20 cm, spot size 1.5 nm); (c) STEM-EDX mapping showing the distributions for different elements

A similar TEM lamella obtained from a crack was examined by STEM-EDX, Figure 4. Some platinum deposit from the preparation process can be observed within the open crack mouth. A small Ag and Sn precipitate is observed in the crack, with the crack faces consisting of a layer enriched in O (up to 45 at%) and Cl (several at%). In this region, the Al/Ti ratio was also elevated compared to the base alloy, indicating the outward diffusion of Al, which is suspected to be a preferential former of volatile metal chloride.

Figure 4 showed a TEM lamella containing a crack. Pitting was not observed in this crack initiation region, but a layer of precipitation rich in Ag (about 60 at%) was generated near the crack mouth and penetrated down. This layer also consisted of Ti, O, Al and Sn, so there could be multiple compounds formed after degradation of the original oxide film. Both Al and Sn, which are easier chloride formers than Ti and segregate to the  $\alpha$  phase, participated in the reactions. It has been reported in literature [8] that the equilibrium solid solubility of Sn in Ag is beyond 11 at%, which suggests that Sn could form a low melting point Ag-Sn eutectic in this case. There were some thin ligaments present below this precipitate layer consisting of the oxides of Ti, Al and Zr. It should be noted that trace chlorine penetrated down through the crack while Ag was only found at the crack mouth. The diffusion of chlorine along crack walls is expected to be a consequence of vapour transport (e.g. in HCl) at elevated temperatures. It has been postulated in previous work [9] that the gaseous  $\text{Cl}_2$  and HCl are likely to be released as a byproduct from reactions with moisture and attack the alloy. Also, various gaseous alloy chlorides (e.g.  $\text{TiCl}_4$ ,  $\text{AlCl}_3$ ) can be produced under this temperature range. The transgranular fracture appearance can be also linked to hydrogen embrittlement. Hence, it is expected that hydrogen embrittlement is associated with the mechanism of cracking, but the nature of the crack tip hydrogen should be explored in the future work.
