Seismic performance of brick masonry infilled frame structures with bed joint reinforcements

Abstract. This paper presents the evaluation of the seismic performance of brick infilled RC frame structures with bed joint reinforcements based on reversed cyclic lateral load tests. Three specimens of the structural model of 1/4 scale-down single-story single-bay brick infilled RC frame was prepared, which were brick infilled RC frames with and without bed joint reinforcements. Two specimens of brick infills with bed joint reinforcements were different in the spacing of bed joint rebars. The specimens were tested by applying a reversed cyclic lateral loading in-plane direction. During the tests, the crack propagation was observed at the peak and residual drifts of each loading cycle to recognize the failure mechanisms of the specimens. As the results, although the use of the bed joint reinforcements ineffective to increase the lateral strength of the overall infilled frame structure. The rebars in mortar bed joints role to sustain the lateral strength in plastic deformation, and provide the whole structure with high ductility. It seemed that the rebars in mortar bed joints confined the

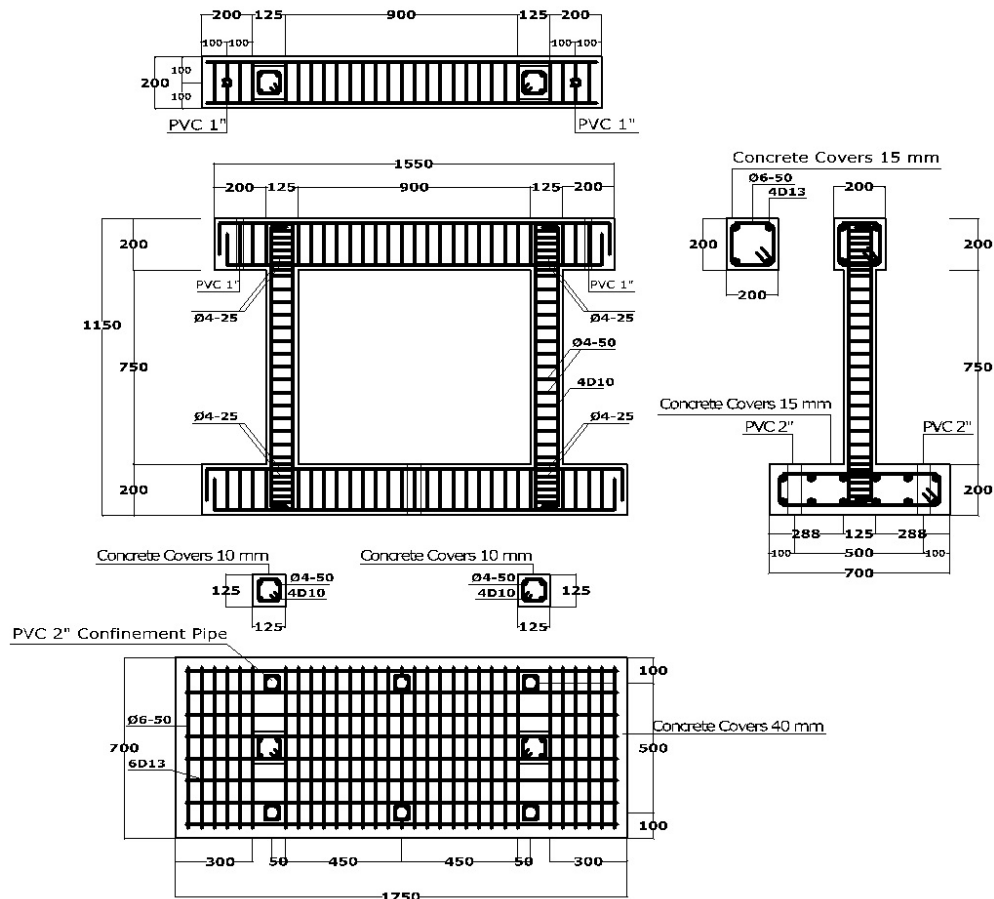
Fig. 1. Cross-section and reinforcements detail of RC frame.

In this study, three specimens of 1/4 scale-down single-story single-bay brick infilled RC frames were constructed. All specimens had the same cross-sectional dimensions and rebars arrangement, which described in Fig. 1(a). The figure shows 750 mm of the clear height of the columns with 125 mm x 125 mm of the cross-section dimensions. The longitudinal and transversal reinforcements of columns were 4D10 and $\phi 4@50$, respectively. The dimensions of the lower-beam were 700 mm wide, 200 mm deep, and 1650 mm length with 12D13 longitudinal bars and $\phi 6@50$ transverse stirrups. The dimensions of top-beam were 200 mm wide, 200 mm deep, and 1550 mm length with 4D13 longitudinal bars and $\phi 6@50$ transverse stirrups. The three specimens consisted of one brick infilled RC frame (IF-BM), and

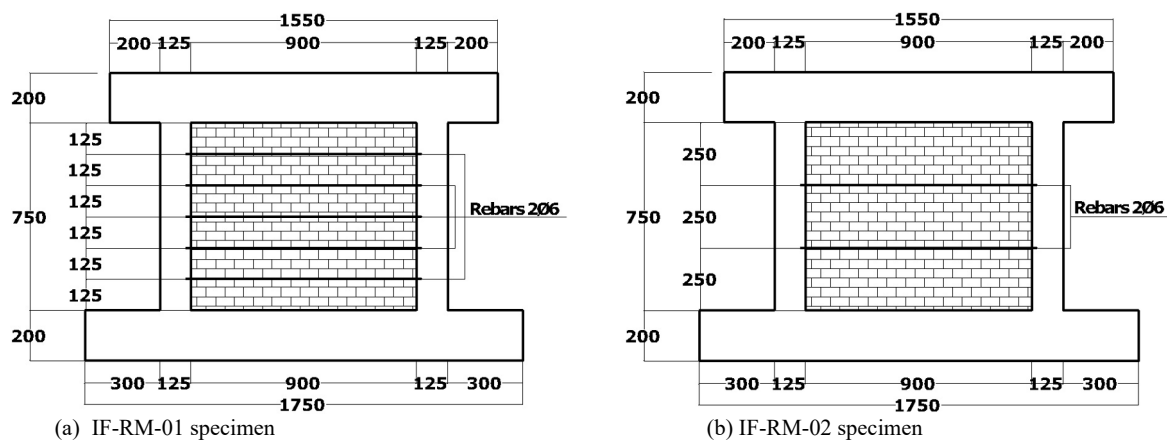
Fig. 2. Design drawing of infilled RC frames with bed joint reinforcements specimens.

two brick infilled frames with bed joint reinforcements (IF-RM-01 and IF-RM-02). On the last two specimens, horizontal reinforcements of 2Ø6 were placed in bed mortar joints with rebar spacing of 125 mm and 250 mm for the IF-RM-01 and IF-RM-02 specimens,

respectively, as shown in Figs. 2(a) and 2(b). Both ends of each rebar were embedded about 2.5 cm in boundary columns as the shear connector, which glued using a chemical epoxy adhesive.

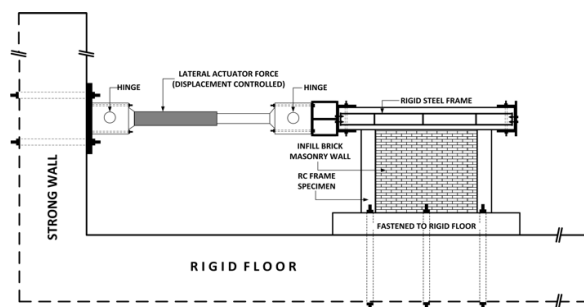
a). The test set up a view.

The prepared specimens were tested under quasi-static cyclic lateral load in which a schematic view of the test set up and instrumentation are shown in Fig. 3.

For the test set up of the specimen, at first, the specimen was placed on the rigid-floor, and then it was fastened to the rigid-floor by using six post-tensioning rods to make the specimen with a fixed support at the lower beam as shown in Fig. 3(a). A double-action lateral actuator force equipment was attached and fastened to the strong wall by using four post-tensioning rods. Two horizontal steel beams were used to restrain the top-beam of the specimen from preventing the applied force on its top-beam causes out-of-plane deformation occurs during testing. These two horizontal steel beams were connected to the actuator force, which mounted on the strong wall. The displacement transducers (LVDTs) were installed at several points to measure the deformation of the RC frame specimen, as is shown in Fig. 3(b). A displacement transducer which was placed in the middle of top-beam was used as a displacement-control point.

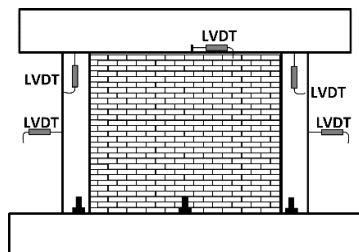
b). The position of the LVDTs

Fig. 3. Experimental test setup and instrumentation.

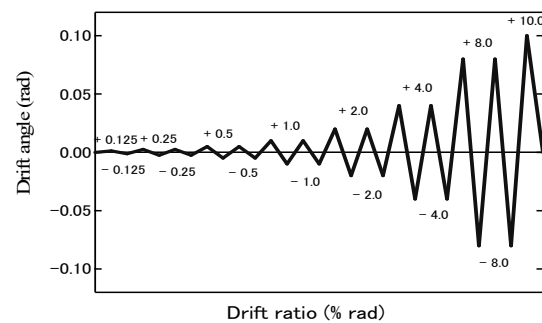
Fig. 4. Lateral loading history.

According to the FEMA 461 [13], the lateral loading program was employed to specimen with initial cycles to $R=1/800$ followed by two cycles to $R=1/400$, $R=1/200$, $R=1/100$, $R=1/50$, $R=1/25$, $R=1/12.5$ and the a final load by a pushover to $R=+1/10$ rad where R was drift angle that was a ratio of lateral displacement to column height, used for controlling the incremental loading. The lateral loading history applied to specimens is shown in Fig. 4. Incremental of the applied lateral static load and lateral deformation were monitored and recorded throughout the tests. An initial crack and its crack propagation were drawn on the RC frame and brick masonry infill in every loading cycle for identifying the failure mechanism of the specimen.

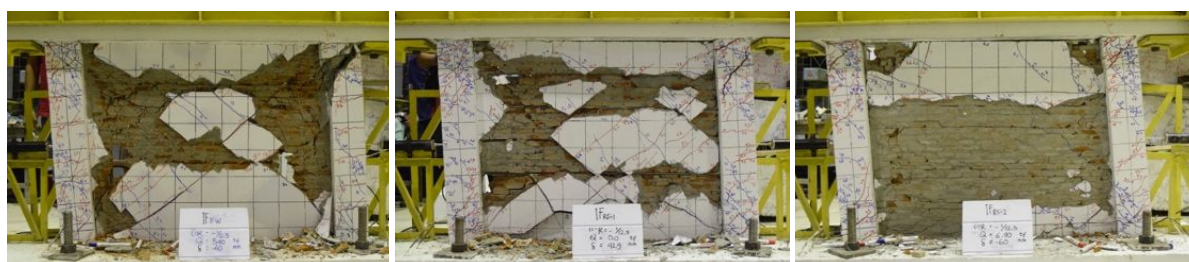
Fig. 5. The final condition of specimens a drift angle to R=1/12.5.

a) IF-BM specimen

b) IF-RM-01 specimen

c) IF-RM-02 specimen

Under cyclic lateral load on brick infilled RC frame (IF-BM) specimen, the initial flexural crack was observed at the bottom of the tensile column in the cycle 1/800 at a drift ratio of 0.13%. The flexural cracks were developed on the bottom of both columns during the cycles of drift angle 1/400. Initial shear crack on the center of brick infill occurred during the cycle 1/200 at a drift ratio of 0.47%. Further, flexural cracks in both columns grown, and shear cracks on infill widened/elongated during the cycles of 1/100. The maximum lateral strength was observed at these cycles. At the next cycles of 1/50, an initial shear crack occurred at the top of the tensile column at a drift ratio of 1.11%, the plaster mortar started to peel off, the shear cracks on the ends of tensile columns were widened, and the lateral strength was gradually degraded. Consequently, the brick infill failed in shear during the cycle 1/25 at a drift ratio of 3.65%. Moreover, the boundary column failed in shear during the cycle 1/12.5, and the brick infill failed in out of plane direction during the cycle 1/10. After the failure of column and brick infill, the lateral strength significantly dropped. The condition of the IF-BM specimen after the cycle of 1/12,5 is shown in Fig. 5(a).

the plane direction. Fig 5(b) shows the cracks of the IF-RM-01 specimen at the cycle of 1/12.5.

Initial shear crack on brick infill of IF-RM-02 specimen appeared at the first cycle of 1/800 at a drift ratio of 0.05%. Further, in this cycle, an initial flexural crack occurred on brick infill at a drift ratio of 0.12%. During the cycle 1/400, initial flexural and shear cracks were observed on the compressive column and tensile columns, respectively, at a drift ratio of 0.22%. In subsequent cycles, several shear cracks dominantly appeared in the center area of infill, and the plaster of mortar started to peel off during the cycles 1/200. However, the plaster of mortar collapsed during the cycles 1/50, and then brick infill failed in shear, the development of shear cracks on infill was slower when it was compared to brick infill without bed joint reinforcements. Further, the tensile column failed in shear during the cycles 1/12.5 at a drift ratio of 3.9%. After the shear failure of the column, the whole structure dropped its lateral strength to 67% of the peak, but the infill persisted from out of plane failure. The final condition of the IF-RM-02 specimen at drift angle R=1/12.5 is shown in Fig. 5(c).

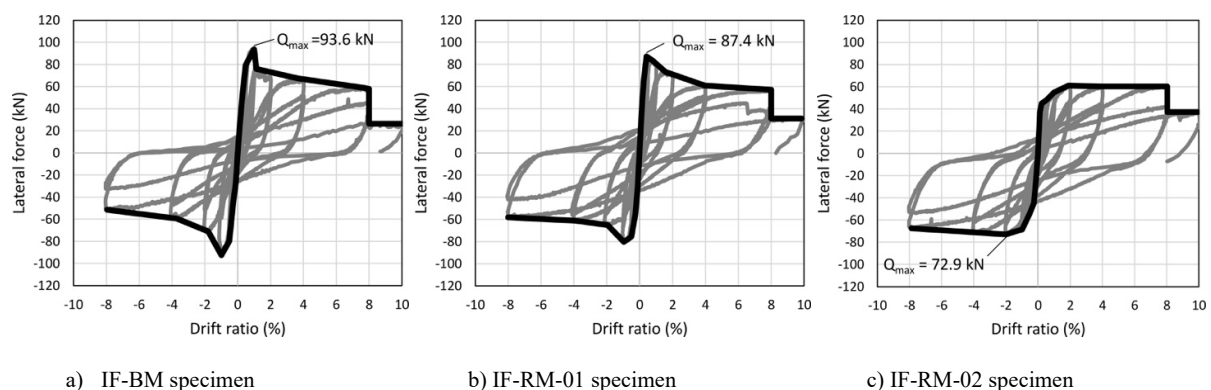
Fig. 6. Lateral force – drift ratio relationship

The seismic performance of brick infilled RC frame specimens is presented as a relationship between lateral force and drift ratio, as shown in Fig 6, comparing the seismic performance between the specimens.

The maximum lateral strength of the IF-BM specimen of 93.6 kN was observed at a 0.99% drift ratio. On the other hand, the maximum lateral strength of 87.4 kN and 72.9 kN were observed at 0.43% and 2.01% drift ratios for IF-RM-01 and OF-RM-02 specimens, respectively. In the case of IF-BM, the maximum lateral strength was reached at the elastic region, and its strength degraded soon after the peak in the plastic region, as shown in Fig. 6(a). After the shear failure of infill at a drift ratio of 4.0% and column at a drift ratio of 8%, the lateral strength of structure significantly dropped to 28.06% of peak assumed as a residual strength. However, in the case of the IF-RM-01 specimen, its envelope curve of strength was similar to that of the IF-BM specimen, its residual strength was 31.16% of the peak, as shown in Fig. 6(b). A distinctive envelope curve of strength was identified on IF-RM-02 specimen when it was compared to that of IF-BM and IF-RM-01 specimens. The maximum lateral strength of IF-RM-02 was detected in the plastic region at a large drift ratio, as described in Table 2, and then it was maintained to a drift ratio of 8%, as shown in Fig. 6(c). The residual seismic capacity of IF-RM-02 specimen was 50.94% in which it can prevent the structure from collapsing in large deformation. It seemed that the rebars in mortar bed joints role to sustain the lateral strength in plastic deformation and provide the
