# Assessment of Damage Detection in Composite Structures Using 3D Vibrometry

**Abstract.** Carbon fibre reinforced polymers (CFRP) have been used significantly more in recent years due to their increased specific strength over aluminium structures. One major area in which their use has grown is the aerospace industry where many now use CFRP in their construction. One major problem with CFRP's is their low resistance to impacts. Structural health monitoring (SHM) aims to continually monitor a structure throughout its entire life and can allow aircraft owners to identify impact damage as it occurs. This means that it can be repaired prior to growth, saving weight with the repair and the time that aircraft is grounded. Two areas of SHM being researched are Acoustic Emission (AE) monitoring and Acousto-Ultrasonics (AU) both based on an understanding of the propagation of ultrasonic waves. 3D Scanning laser vibrometry was used to monitor the propagation of AU waves with the aim of gaining a better understanding their interaction with delamination in carbon fibre reinforced polymers. Three frequencies were excited with a PZT transducer and the received signal analysed by a cross correla

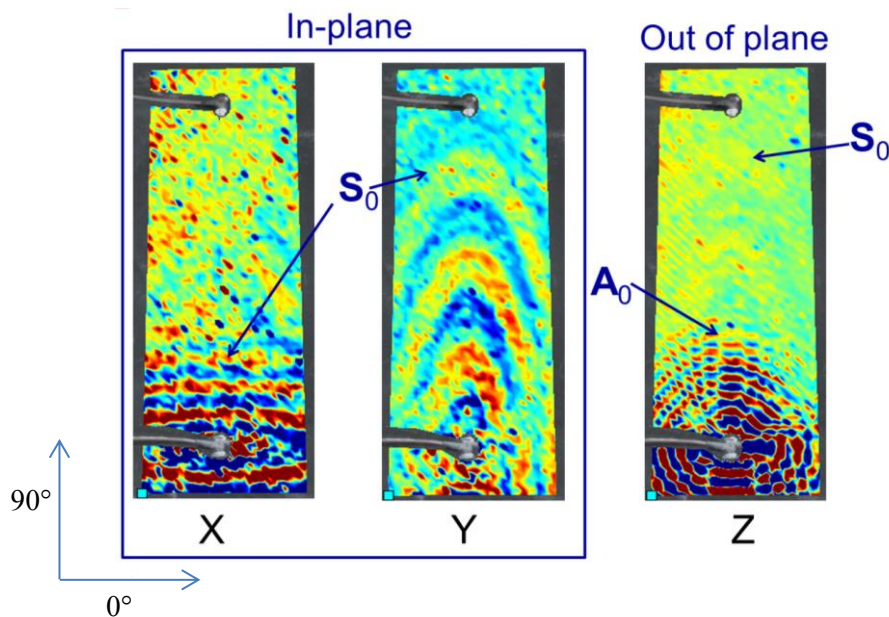
Figure 3 – 100 kHz wave in each individual axis

The initial vibrometry pre impact scans show the wave propagating through the structure with the  $S_0$  propagation elliptically at  $0^\circ$  and  $90^\circ$ . The  $A_0$  mode can also be seen to be propagating cylindrically at a much slower rate than the  $S_0$  mode [5]. It was also apparent that the in plane (X and Y) plots were only observing the propagation of the  $S_0$  mode whereas the out of plane Z axis was detecting both, but predominantly  $A_0$ . Examples of these various modes can be seen in Figure 3 where some of the 100 kHz scan plots can be seen.

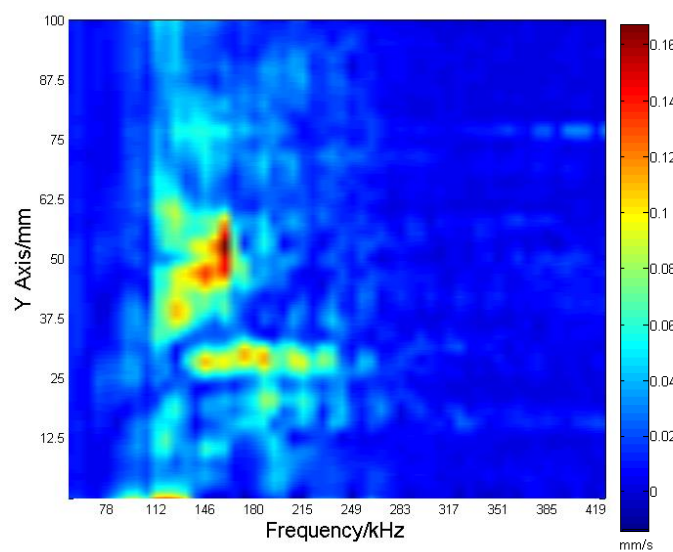
**Figure 7** – 3D matrix FFT

The 3D matrix FFT plot can be seen in Figure 7. This plot shows a range of FFT results at different frequencies for a cross section of x at the point of impact. It identifies a peak at 160 kHz, meaning that this frequency has the most interaction with the delamination. This should also mean that this frequency should yield the greatest change in cross correlation.
