## The Effects of Corrosion, Fatigue, and Corrosion-fatigue of Multilayer Coated Polyesters for Flexible Electronics Applications

# The Effects of Corrosion, Fatigue, and Corrosion-fatigue of Multilayer Coated Polyesters for Flexible Electronics Applications

**Keywords** ITO/Ag-alloy/ITO; Polymer substrates; PET; Agglomeration

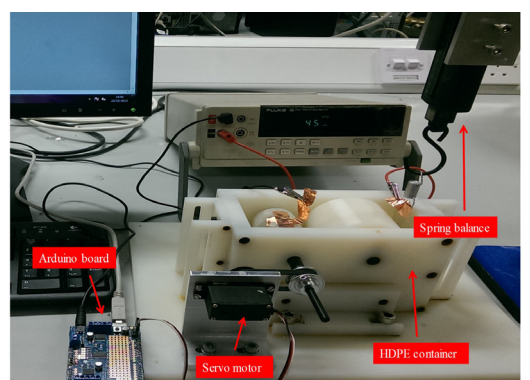
Corrosion-fatigue experiments were performed using a custom-built cyclic uniaxial bending apparatus based on that used by Bejituat *et al.* [19]. A schematic diagram and the setup of this apparatus is shown in Figure 1. The sample was wrapped over a mandrel made from chlorinated polyvinyl chloride (c-PVC) on one end and it was fixed to a spring balance at the other end. The copper conductive tape was used at each end of the sample to allow optimized electrical contact for resistance measurements. A large c-PVC mandrel ( $R \gg r$ ) supported the sample in the horizontal position and prevented sagging of the sample. A servomotor was utilized to rotate the mandrel with the reciprocating rotary motion controlled by a board driven using the Arduino software. The tests were run at a fixed reciprocating frequency of 2 Hz. Each test was carried out for 115200 cycles. The response of the film in terms of the electrical resistance was monitored *in situ* using the multimeter (Fluke 45).

Figure 1: Photograph and schematic diagram of the custom-built bending fatigue apparatus.

A high-density polyethylene (HDPE) container was filled with 0.3 M of the NaCl solution for the corrosion-fatigue test. Before and after testing, the samples were washed with distilled water and dried using compressed air. The data obtained through this test are the number of cycles to failure with the corresponding electrical resistance changes. Note that the ITO/Ag-alloy/ITO surface is placed under tension. According to the mandrel radius  $r$  of 12.5 mm, sample strips of approximately 202 mm in length and 10 mm wide were cut from the sputtered sheets. The bending tensile stain,  $\varepsilon$ , from this mandrel was calculated to be 0.5% using the equa-

periment was performed in 0.3 M NaCl since the time to corrode ITO/Ag-alloy/ITO is adequate to allow meaningful observations to be made. Using data from the bending tests, a mandrel diameter of 25 mm, which is equivalent to a tensile strain of 0.5%, was selected for the fatigue tests.

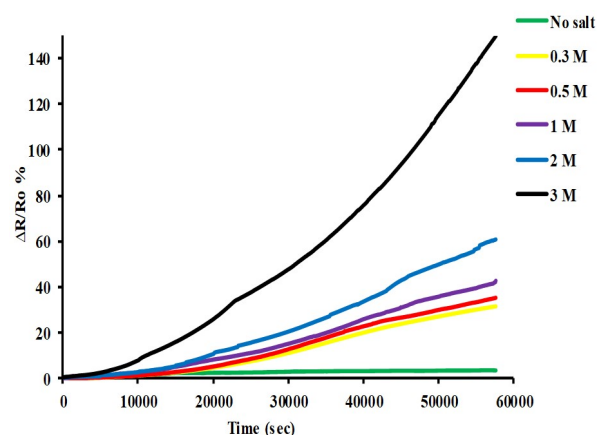
Figure 2 shows the normalized change in electrical resistance over time for the ITO/Ag-alloy/ITO films along with the as-received films immersed in different concentrations of NaCl. In general, the results obtained from this investigation indicate that, when the ITO/Ag-alloy/ITO film is exposed to NaCl, a loss of the electrical function of the film over time will be caused by agglomeration of Ag. In particular, for the samples in the 0.3- and 0.5-M solutions, the percent increase in the electrical resistance is still close to zero

Figure 2: Normalized electrical resistance versus time for the ITO/Ag-alloy/ITO film during immersion in different NaCl concentration solutions.

until around 15000 s and then an increase is noticed. After 57600 s of immersion, the change in the electrical resistance was 31.4% for 0.3 M and 35.2% for 0.5 M, as shown in [Figure 3](#). For samples immersed in 2 M NaCl, a higher increase in the electrical resistance was observed, indicating faster corrosion of the ITO/Ag/ITO films as compared to the samples immersed in the lower NaCl concentrations. After 57600 s, a ~60.7% resistance increase is observed ([Figure 3](#)). The electrical resistance trace of ITO/Ag-alloy/ITO when exposed to 3 M NaCl shows that a higher concentration of NaCl makes an ITO/Ag/ITO coating susceptible to a more rapid corrosion process. After 57600 s of experimental testing, the increase in the electrical resistance is observed to be

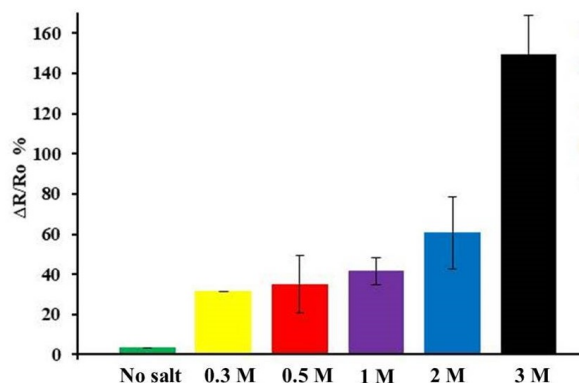
**Figure 3:** The effect of various concentrations on normalized electrical resistance of ITO/Ag-alloy/ITO film after 57600 s.

~149.5% ([Figure 3](#)). We anticipate that, if the experiment is conducted for a significantly longer period, the ITO/Ag-alloy/ITO film would experience total corrosion leading to a catastrophic electrical conductivity decrease.

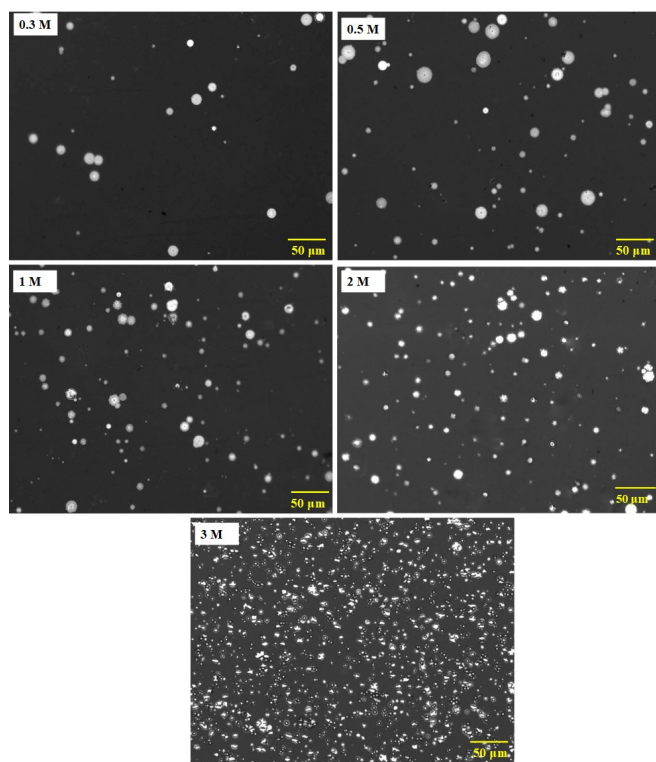
**Figure 4:** CLSM images of the surfaces of ITO/Ag-alloy/ITO immersed in NaCl of various concentrations for 57600 s.

[Figure 4](#) displays the progressive morphological degradation for ITO/Ag/ITO immersed in NaCl of various concentrations for a total of 57600 s. The samples immersed in 0.3 M were degraded, showing a number of white spots. The samples that were immersed in 0.5, 1, 2, and 3 M exhibited less degradation, although they exhibited a number of white spots in places. The samples immersed in 3 M were more degraded in comparison to the samples immersed in 0.3, 0.5, 1, and 2 M of the solutions, and a high number of corrosion spots was observed covering almost the whole surface of the sample. These observations agree with results in term of the electrical resistance changes over time obtained for all concentrations.

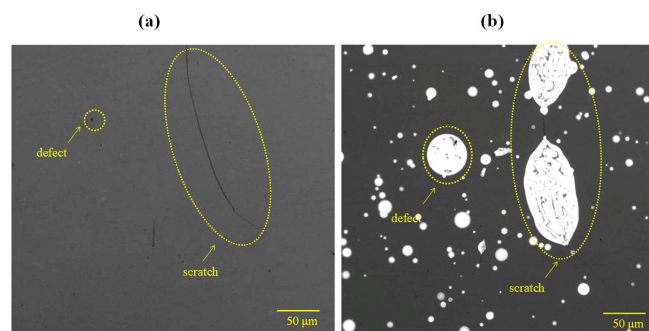
**Figure 5:** CLSM images showing the coating defects and scratches on the ITO/Ag-alloy/ITO surfaces before (a) and after (b) immersion in 0.5 M for 57600 s.

The corrosion mechanisms have been studied by Koike *et al.* [15], who suggested that the chloride ions ( $\text{Cl}^-$ ) attacked the ITO surface, passed through the top ITO layer, and reached the Ag layer. Then, the Ag atoms aggregate around the chlorine atoms to form the white clusters. Besides that, in our work, the pre-existing defects and scratches on the surface resulting from the deposition process and from handling were found to serve as nucleation points of the corrosion products (or Ag agglomerations) which appeared as white areas on the CLSM image in [Figure 5](#). Defects and scratches in the layer are believed to facilitate the movement of  $\text{Cl}^-$  to reach the Ag layer and enhance the agglomeration

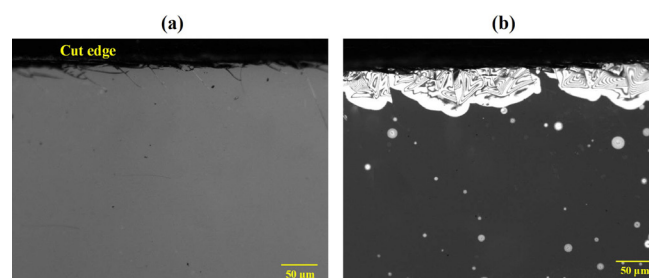
**Figure 6:** CLSM images showing the edge defects initiated upon cutting of ITO/Ag-alloy/ITO before (a) and after (b) immersion in 0.5 M for 57600 s.

Apart from  $\text{Cl}^-$  penetration through permeable defects or scratches on the coating, the  $\text{Cl}^-$  ions could also penetrate through small cracks formed at the edges after sample cutting, as shown in Figure 6. This implies that, during cutting of specimens or fabricating of patterned electrodes in the photolithography process, care must be taken to enhance edge resolution and fidelity and to avoid edge-generated

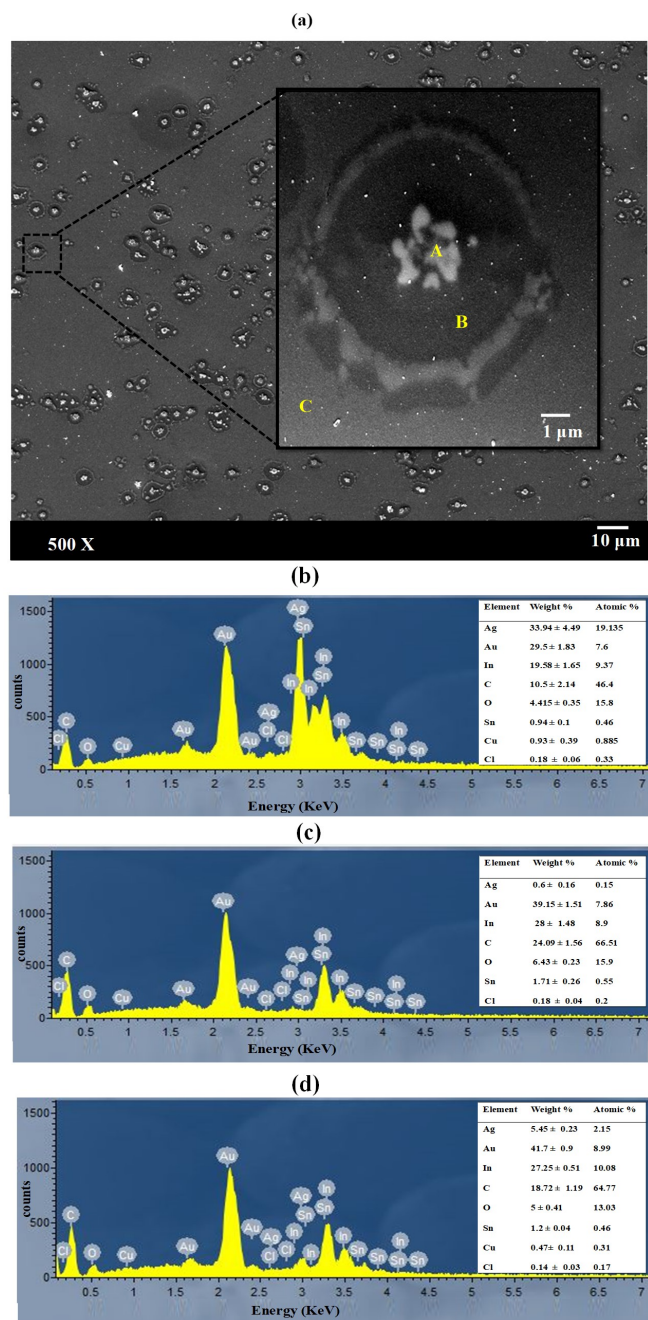
**Figure 7:** (a) SEM micrograph of the ITO/Ag-alloy/ITO surface immersed in the 3-M NaCl solution for 57600 seconds. (b–d) EDS spectra obtained from regions A (b), B (c), and C (d) indicated in panel (a). Inset is the table showing the percentage of each component in the film.

The samples immersed in 3 M NaCl were also investigated using EDS to clarify the corrosion product elements for the ITO/Ag-alloy/ITO film. EDS spot-scan analysis of surface failures and elemental mapping analysis are shown in Figures 7 and 8. The cluster of bright particles in the center of the image in region A is Ag-rich and slightly depleted in In and Sn. Along the circular edge of area in region B, there are periodic agglomerations that are rich in Ag, but still exhibiting higher concentrations of In and Sn. In all areas of the sample, no removal of In and Sn was detectable, i.e., the Sn/In ratio of the ITO film at region A is  $\sim 0.044$ , which is similar to that in the unaffected area (region C), suggesting that both top and bottom ITO layers have not been removed. Eight other damage spots have been examined and yielded similar results. The high carbon content is most likely due to the PET substrate.

A tiny amount of Cu was also found in regions A and C and is most likely due to the Ag alloy constituent. The Cu content in region A is  $0.93 \pm 0.39$  wt%, which is higher than that in other regions. Cho and Lee [21] investigated the role of Cu additions in the Ag alloy deposited between layers of indium zinc oxide and found that Cu did not improve the stability of the Ag-alloy layer but did improve thermal stability.

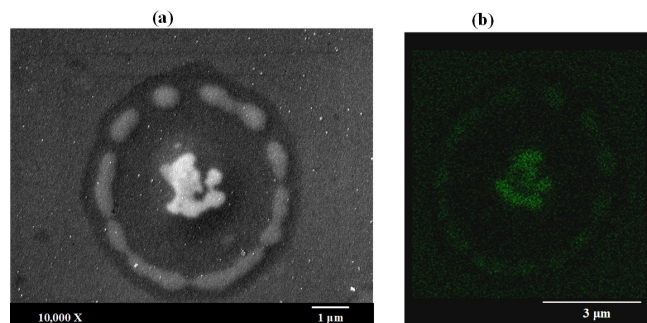
**Figure 8:** (a) SEM micrograph of the ITO/Ag-alloy/ITO surface after 57600 s submerged in the 3-M NaCl solution. (b) EDS mapping image of Ag.

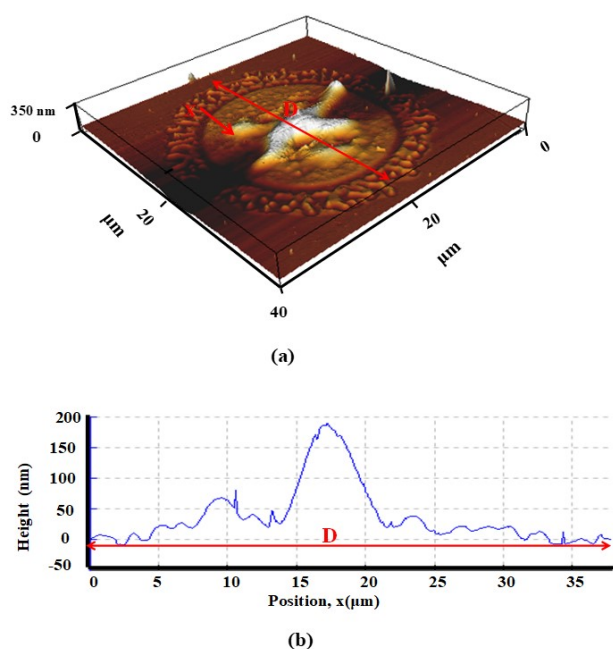
The samples immersed in 0.3 and 3 M NaCl for 57600 s were investigated using AFM to characterize the corrosion spot topography of the ITO/Ag-alloy/ITO film. As the three-dimensional AFM micrographs in Figure 9(a) demonstrate, the damage area for a sample immersed in the 0.3-M solution consists primarily of circular blisters that appear to form folds in the top ITO layer, indicating interlayer delamination. The Ag layer was clustered, and its clustering, or agglomeration, was clearly seen all over the damaged area, even though the agglomeration of the Ag film is thick at the center and the height of the agglomeration at the center area is about 175 nm, as the cross-sectional AFM micrograph shows in Figure 9(b). This indicates that the Ag agglomerations appear to be mobile once they are formed. However, when a sample is exposed to the 3-M solution, most of Ag

**Figure 9:** (a) Three-dimensional AFM image of the damage area and (b) a corresponding extracted height profile scanned across the profile line for the ITO/Ag-alloy/ITO film sample submerged in the 0.3-M NaCl solution for 57600 s. A red line and a red arrow in panel (a) indicate the positions of the extracted profile and the x direction.

has agglomerated at the center point of the circle with the height of around 80 nm with some parts appearing along the circumference with a height almost equal to 15 nm [Figure 9(b)].

Furthermore, it is observed from Figures 9(b) and 10(b) that the spot size decreases significantly with increasing the solution concentration; the spots with approximately 37 and 9  $\mu\text{m}$  in diameter were observed for 0.3 and 3 M, respectively. This is because the diluted solutions can not be sustained, allowing the growth into the spot region to continue, whereas thicker solutions allow a deeper attack in the small spot region.

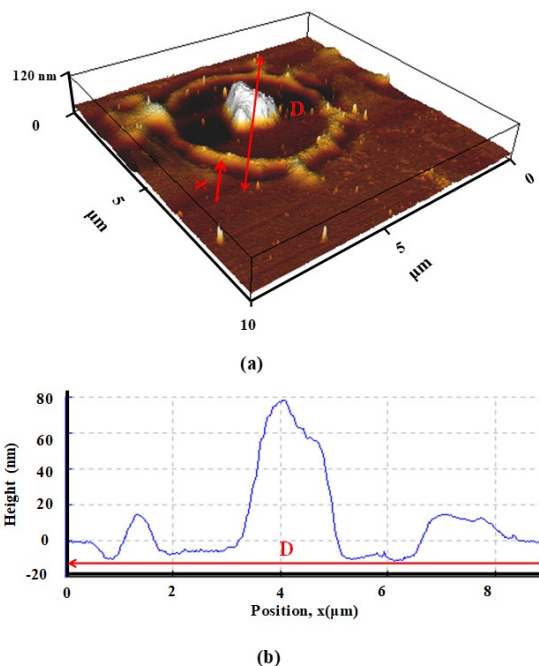
**Figure 10:** Same as Figure 9, but the sample was immersed in the 3-M NaCl solution.

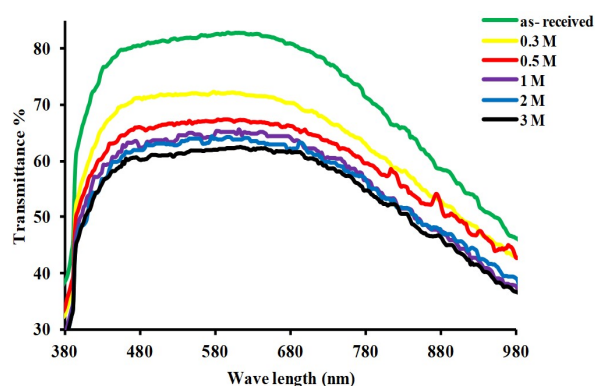
Figure 11 exhibits the transmittance curves of ITO/Ag-alloy/ITO films immersed in various concentrations of NaCl for 57600 s. For comparison, the transmittance of the as-received ITO/Ag-alloy/ITO thin film is also presented. As a general trend, the transmittance of the ITO/Ag-alloy/ITO films after being submerged in the NaCl solutions was compared to that measured for the as-received specimen. In particular, the transmittance of ITO/Ag-alloy/ITO significantly decreased after being immersed in 3 M NaCl. This is likely due to the existence of several corrosion spots (Ag agglomeration) on the surface which cause surface roughening and an increase in the scattering of the incident light [9]. Similar observations have also been reported by Sahu *et al.* [22] on Ag films exposed to 200°C for 30 min. They attributed the decrease in transmittance of the Ag film to the agglomeration of Ag and consequently to the enhanced scattering of the light. These results are also consistent with

**Figure 11:** The effect of various concentrations on optical transmittances of the flexible ITO/Ag-alloy/ITO film after 57600 s.

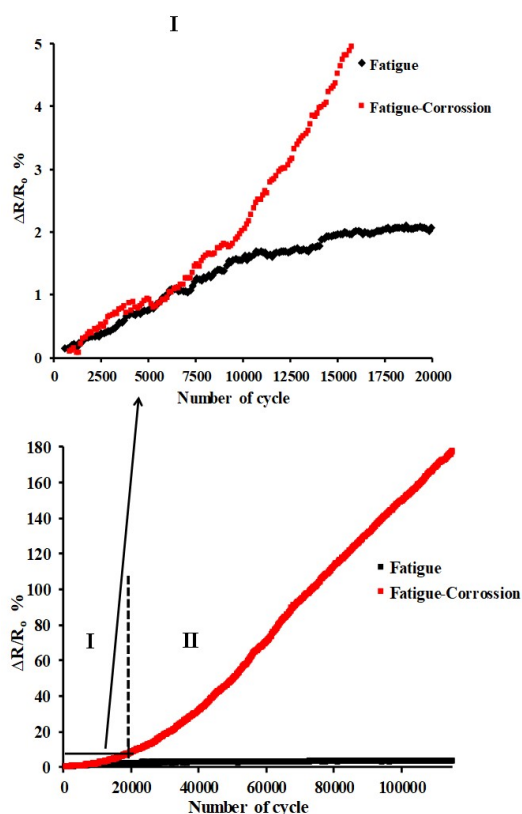
**Figure 12:** Normalized electrical resistance versus the number of cycles of ITO/Ag-alloy/ITO under bending fatigue and bending fatigue-corrosion conditions. The upper inset represents the enlarged result up to 2000 cycles, which clearly reflects the initial increase of the electrical resistance.

Figure 12 shows the percentage increase in the electrical resistance as a function of the number of cycles under fatigue and fatigue-corrosion. The mechanism of bending fatigue appears to be similar to that observed in our previous work for the twisting fatigue test [24], and the observed increase in the electrical resistance can be split into two distinct regions. In the first region (region I), the increment in the normalized electrical resistance is associated with the dimensional change of the compliant substrate until an equilibrium size is attained [25]. In the second region (region II), the gradually increasing resistance is likely to be due to cracking of the ITO/Ag-alloy/ITO film.

The mechanism of corrosion-fatigue in region I is similar to the fatigue-only case. However, in region II, the high rate of the electrical resistance increase was observed (Figure 12). For example, at the same applied strain of 0.5% and 115200 cycles, the sample under fatigue-corrosion exhibited an increase of the resistance of ~177%, which is significantly higher than that of ~3.4% for the sample under fatigue only.

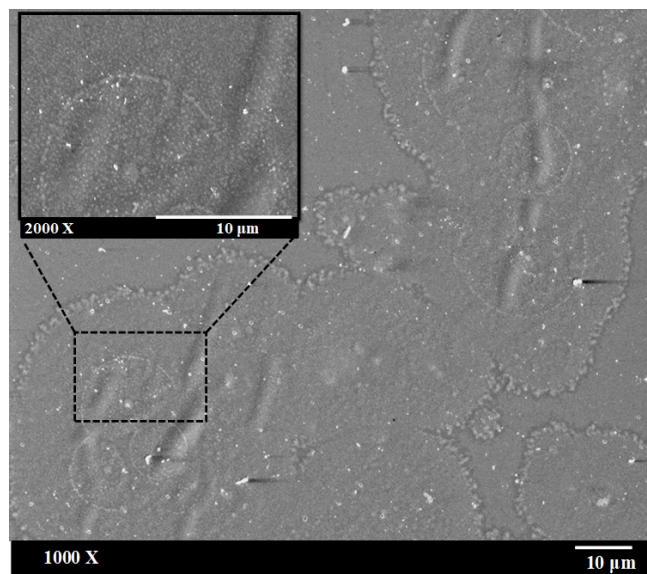
**Figure 13:** SEM image with an enlarged image of the surface of the ITO/Ag-alloy/ITO film after the fatigue-corrosion test for 115200 cycles.

Cracking was not observed on the surface of the samples after fatigue. However, some submicron cracks may have probably formed on the ITO/Ag-alloy/ITO films and were associated with a slight increase of the electrical resistance with increasing the number of cycles. Then, upon load removal, strain recovery in the polymer results in the closure of the cracks and leads them to be not visible [27], in a similar manner to that in the twisting fatigue test at low angles. Figure 13 presents an SEM image of the ITO/Ag-alloy/ITO samples after corrosion-fatigue. No crack was visible, possibly because of the same reason as mentioned above in the fatigue-only case. Ag agglomeration is observed to spread inside the circular spot.

At the area where circular-blisters exists, damages such as wrinkles or buckling features were observed. This is because the externally applied mechanical stress which induces stress in the thin film combined with mechanical energy (through surface tension and capillary forces provided by the solution) can cause buckling [28].
