# Development of a hurricane-resistant roof-to-wall connection using high-performance fiber composites

DEVELOPMENT OF A HURRICANE-RESISTANT ROOF-TO-WALL  
CONNECTION USING HIGH-PERFORMANCE FIBER COMPOSITES

A thesis submitted in partial fulfillment of the  
requirements for the degree of

CIVIL ENGINEERING

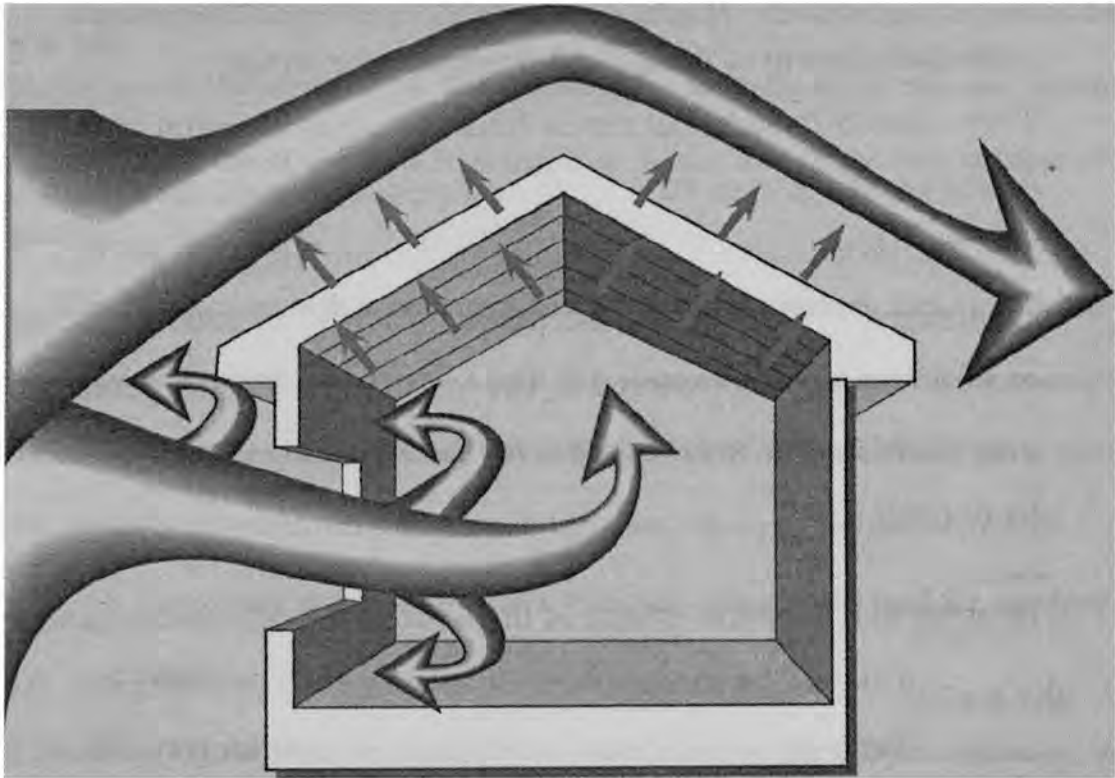
**Figure 1.1 – A schematic representation of forces acting on the roof during a high wind event (FEMA 1992)**

After Hurricane Andrew, a report was prepared by the Federal Emergency Management Agency (FEMA 1992). The main purpose of the report was to identify the failure modes, improper construction practices and recommended changes in construction. The report stated that the most tragic failures of all site-built structures were observed in one or two story wood-frame houses. The main reason for these failures was stated as wind forces due to negative wind pressure accompanied with internal pressure from breach of envelope (see Figure 1.1). Absence or inappropriate use of connections that would transfer loads between different components of the structure was considered as one of the primary reasons for failure.

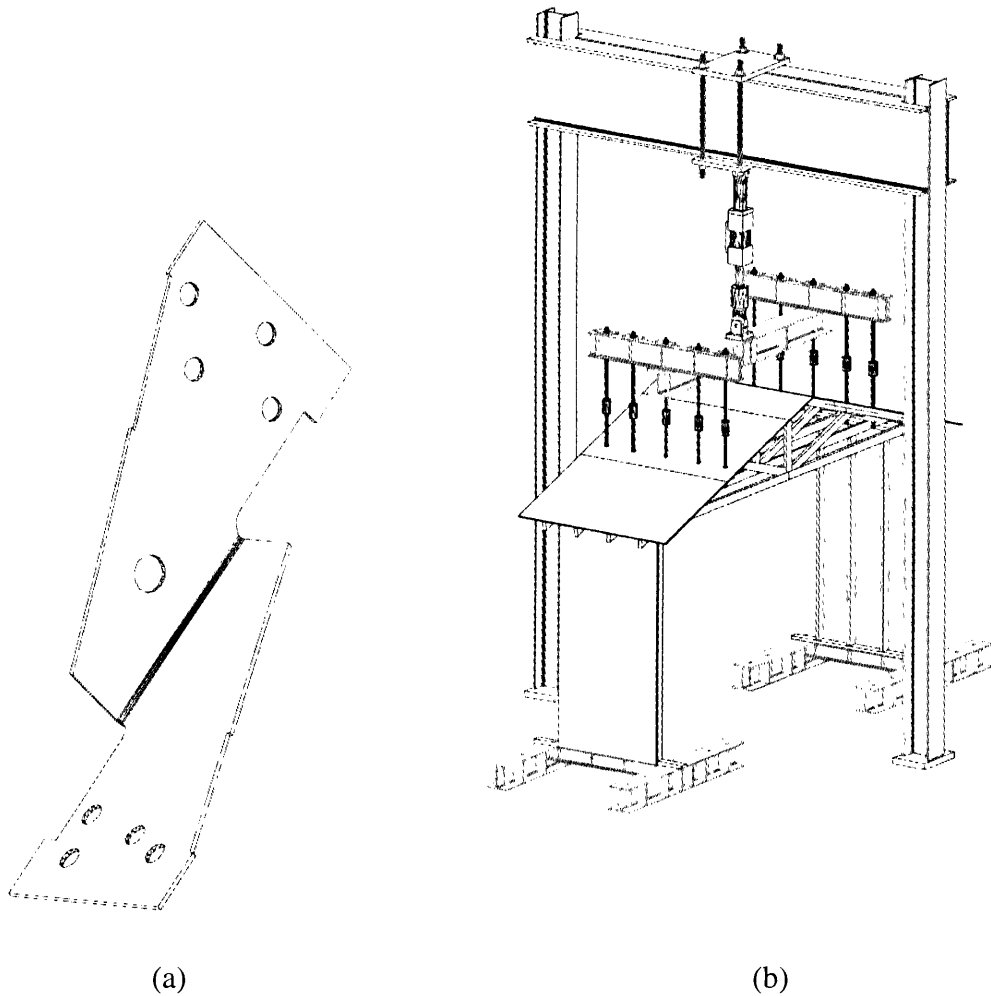
**Figure 2.1 – (a) Hurricane clip tested by NIST, (b) Application of monotonic uplift load to the full-scale specimen (NISTIR 6938 by Riley and Sadek, 2003)**

The National Institute of Standards and Technology (NIST) conducted a comprehensive study on the roof-to-wall connections using full-scale wood-frame structures (NISTIR 6938 by Riley and Sadek, 2003). The NIST reported that while wood-frame buildings are satisfactory when only gravity loads are imposed, they perform poorly under earthquake and hurricane-induced loads. They stressed that there are not enough studies for assessing the in-place performance of roof-to-wall connections, which is a key factor in the overall building performance. The specimens tested consisted of two 4-ft-long by 8-ft-1.25-in.-high shear walls that supported four roof trusses with 16-ft spans. Two different types of roof-to-wall connections were tested, namely, toe-nailed connections and hurricane clips (Figure 2.1a). These connections were tested under monotonic uplift loading, monotonic lateral loading, combined uplift and lateral loading, and cyclic lateral loading. While applying the loads, one vertical actuator and one lateral actuator were used, as needed. The monotonic uplift load was distributed using a spreader steel beam connected to nominal 2x8 in. lumbers under the sheathing using steel rods

(Figure 2.1b). The displacement rate used for the monotonic uplift load was 0.25 in./min. The instrumentation for the full-scale specimens consisted of 46 linear variable differential transformers (LVDTs) and 10 load cells located on rods which transfer the load from the actuator to the roof (Figure 2.2).

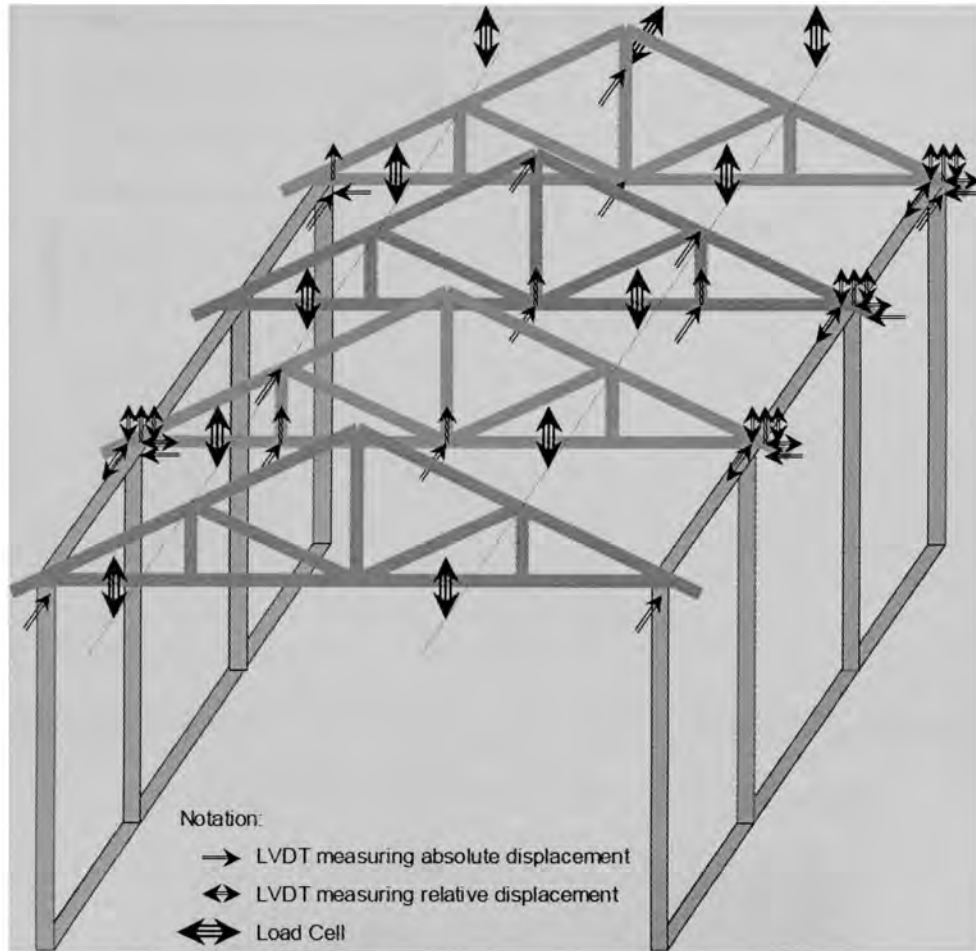
**Figure 2.2 –Schematic representation of instrumentation (NISTIR 6938 by Riley and Sadek, 2003)**

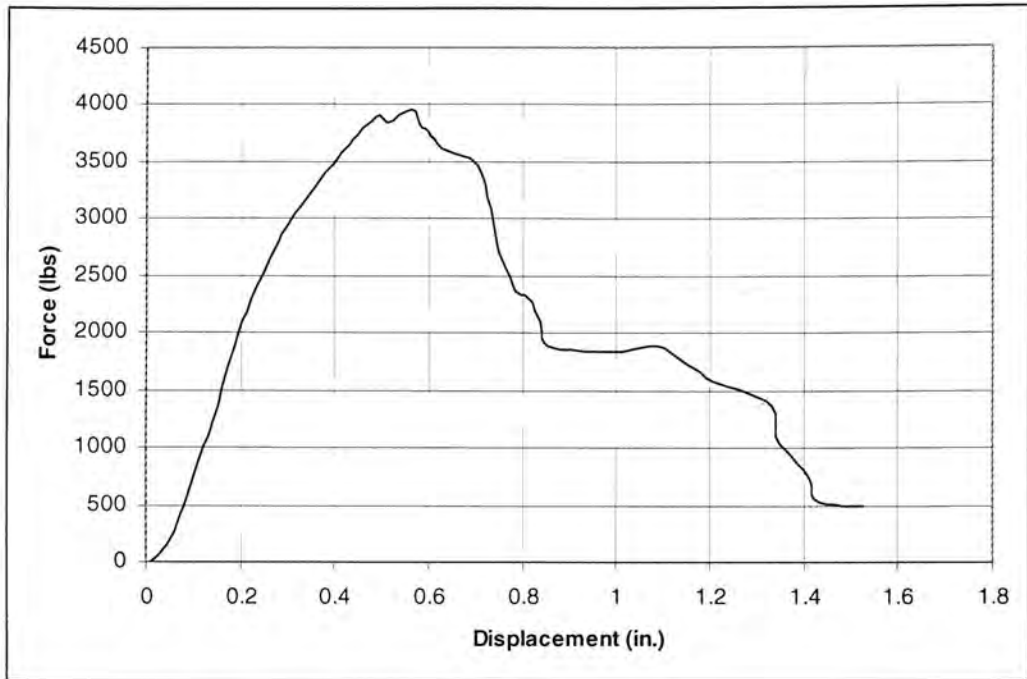
**Figure 2.3 – Structural response of toe-nailed connections to monotonic uplift load**

**(Drawn after NISTIR 6938 by Riley and Sadek, 2003)**

The toe-nailed connection, which consisted of three 16d common nails driven at 45° to the bottom chord through the top plate of the wall, failed at a load of 3,940 lbs (Figure 2.3). The mode of failure was identified as withdrawal of nails from the top plate following separation of the bottom wood fibers of the truss bottom chord (Figure 2.4)

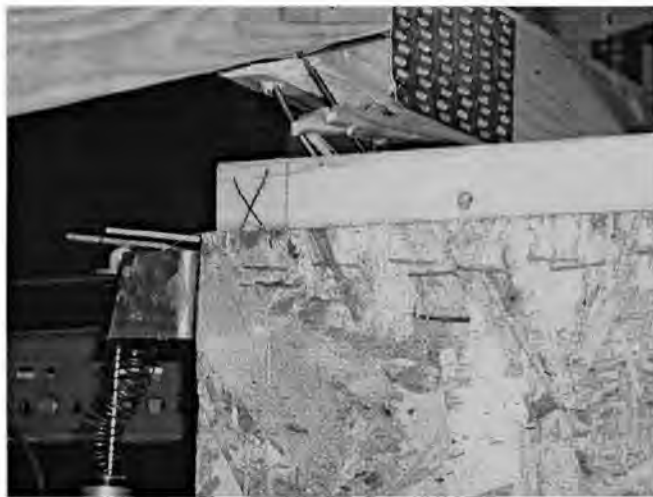
**Figure 2.4 –Failed toe-nailed connection NISTIR 6938 by Riley and Sadek, 2003)**

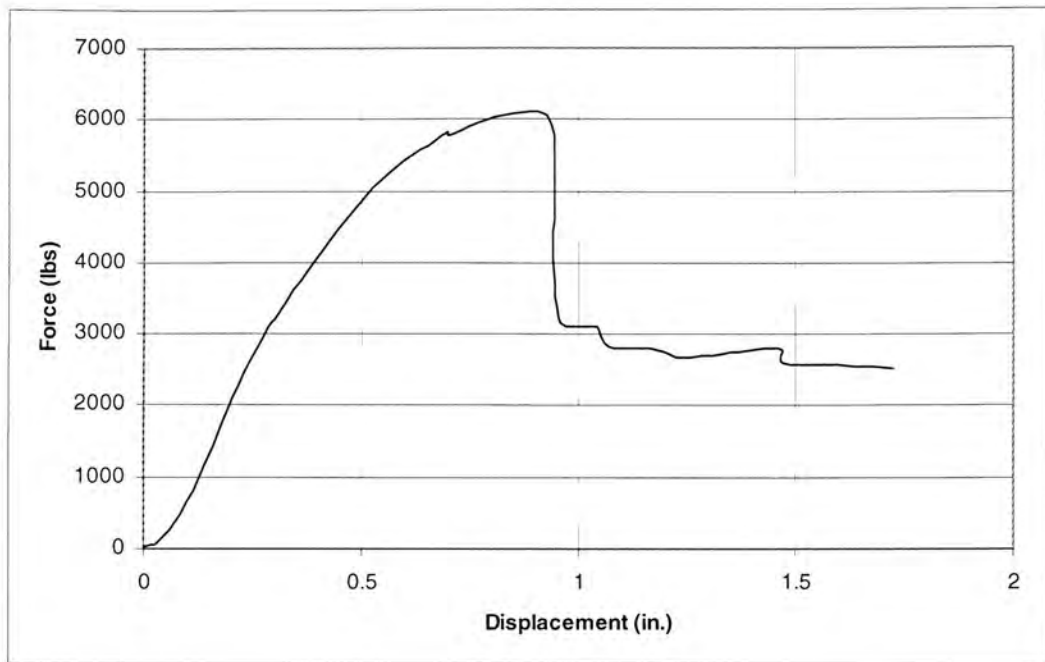
**Figure 2.5 – Structural response of hurricane clips to monotonic uplift load, (Drawn after NISTIR 6938 by Riley and Sadek, 2003)**

The specimen with hurricane clips reached a peak load of 6,070 lbs (Figure 2.5), and the connection failed as the roof truss separated from the lower top plate of the wall, with hurricane clips remaining attached to the upper top plate (Figure 2.6)

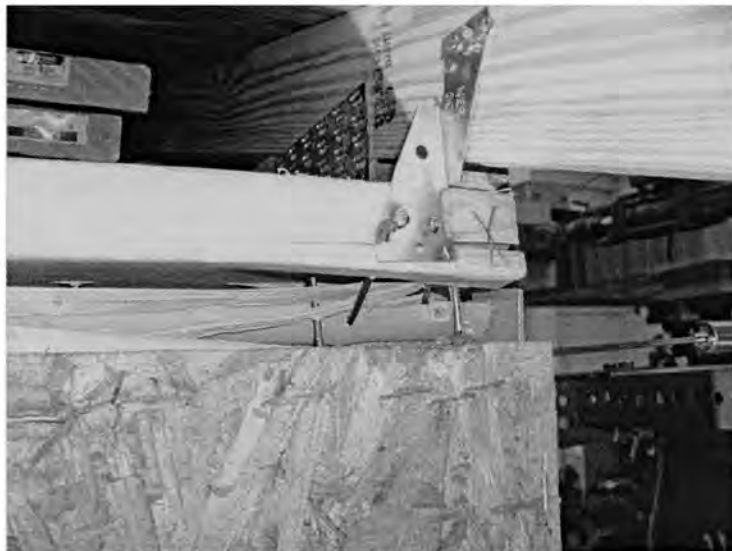
**Figure 2.6 –Failed hurricane clip connection (NISTIR 6938 by Riley and Sadek, 2003)**

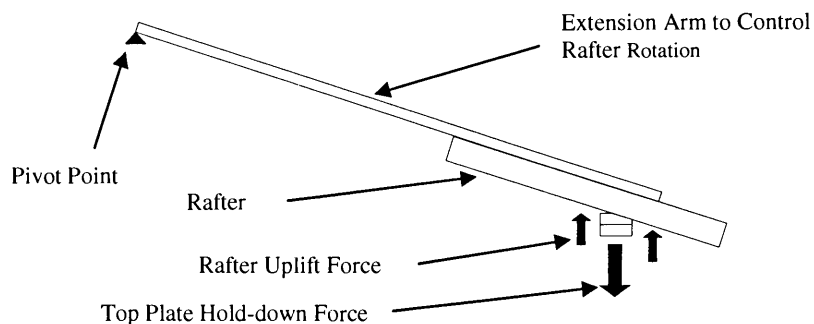
**Figure 2.7 – Roof-to-wall connection testing setup (Reed et al. 1997)**

Reed et al. (1997) conducted a research focusing on the capacity of roof-to-wall connections in wood-frame structures. Identifying that the connection of rafter to top plate is vital in maintaining the integrity of the structure, they tested various commercially available metal straps and alternative connectors such as adhesives. The main goal of the study was to test the connection in a way that can reflect its in-situ response. Therefore, specimens consisting of 12 in. long Southern Yellow Pine (SYP) top plates were connected to the 14 in. long rafters. The rafters were either SYP or Spruce Pine Fir (SPF) with a grade of #2 or better. The rafters were notched and connected to the top plates with a rafter slope of 3:12. The load was applied onto the rafter on both sides of the top plate using a hydraulic jack (Figure 2.7). An aluminum section, as long as a typical rafter, was used to prevent rotation of the 14 in. long rafter piece. The tested connections included toe nails, small hurricane straps, large hurricane straps, epoxy, epoxy with large wood blocks and their combinations.

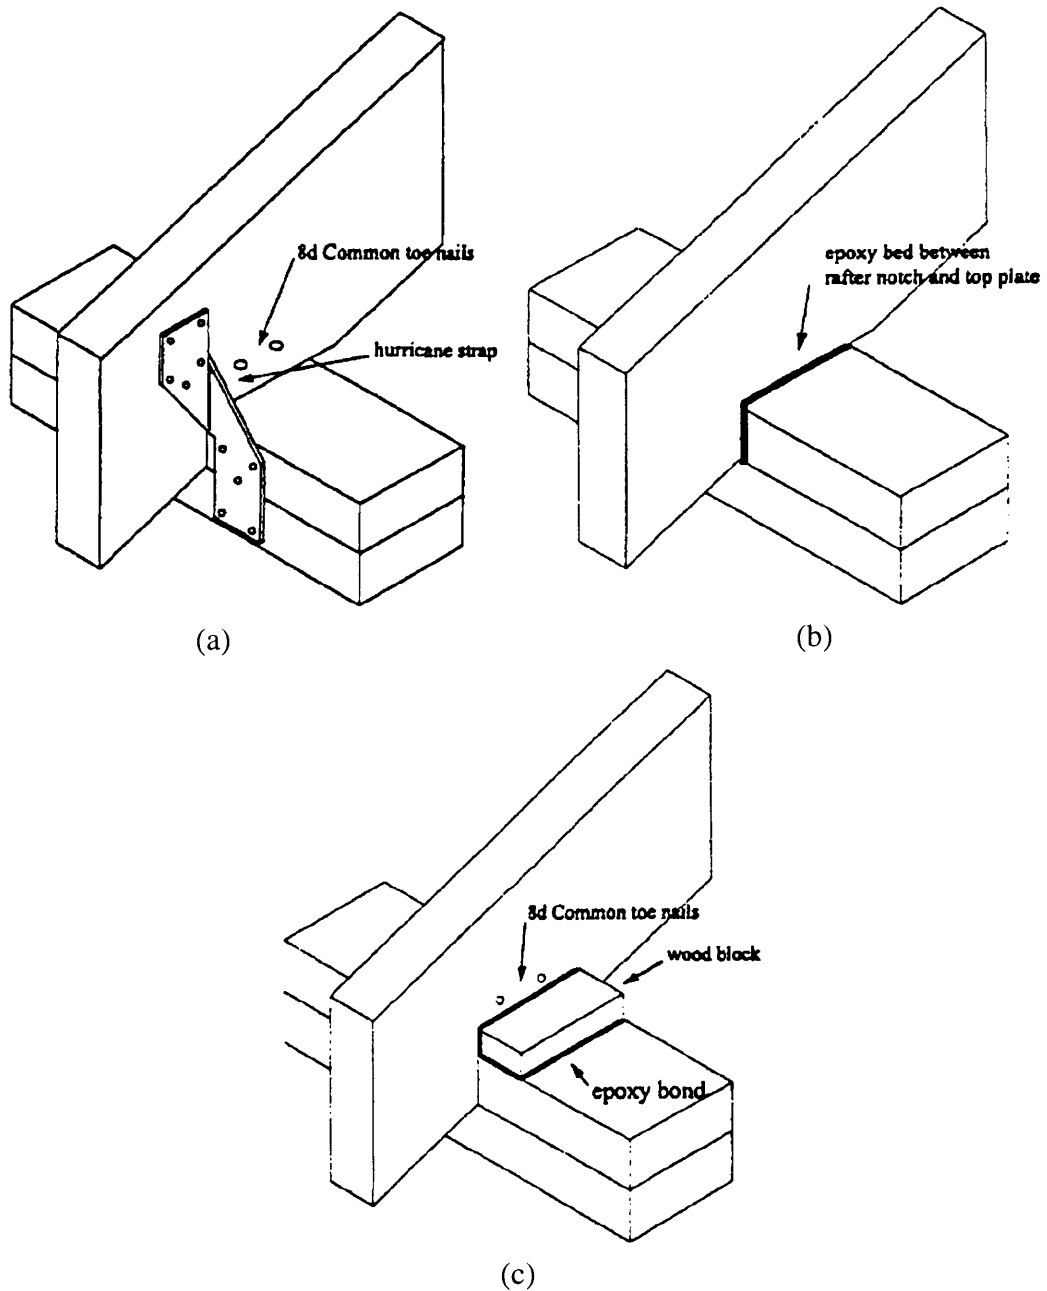
**Figure 2.8 – Connections tested by Reed et al. (1997) (a) Hurricane clips, (b) Epoxy, and (c) Epoxy with wooden blocks**

<sup>b</sup> Small strap was an 18-gauge galvanized steel strap with five short 8d nails into the rafter and five 8d nails into the top plate. The strap had a 90° bend and connected the top plate to the rafter. The nailing pattern prohibited nailing between the two top plates. (Figure 2.8a)

<sup>e</sup> Two-part, hand mixed epoxy paste applied as shown in Figure 2.8b

- <sup>f</sup> Small blocks, approximately 1.5 in. x 3.5 in. of either SPF or SYP wood installed as shown in Figure 2.8c
- <sup>g</sup> Large blocks, approximately 3.5 in. x 3.5 in. of pressure treated SYP wood installed as shown in Figure 2.8 c
- <sup>h</sup> Two part acrylic adhesive applied through diffuser nozzle, as shown in Fig 2.8b
- <sup>i</sup> An acrylic adhesive bead was applied on either side of the rafter along the top plate
- <sup>j</sup> Foaming polyurethane adhesive product applied using air pressure gun to foam large fillets between rafter and top plate

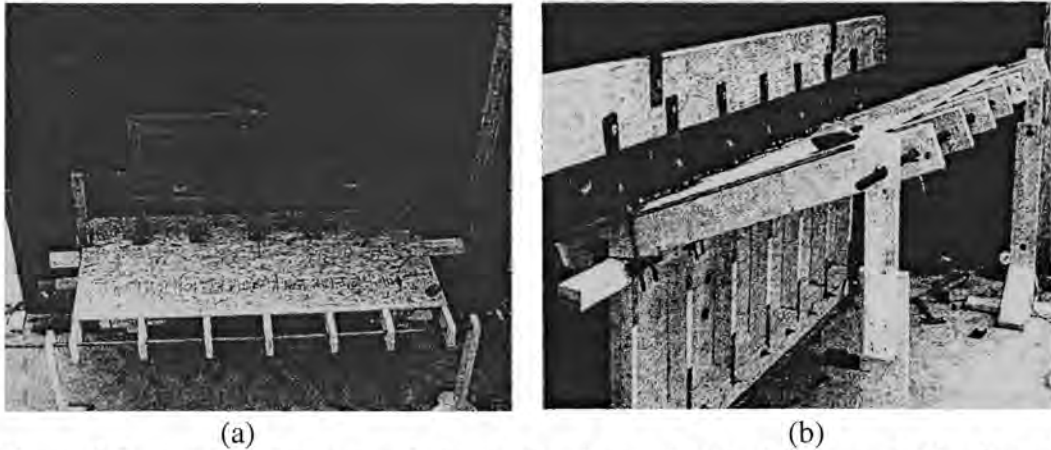
**Figure 2.9 – (a) Specimen consisting of 7 rafters, (b) Load tree used (Reed et al.**

**1997)**

Reed et al. (1997) also investigated the uplift capacity of some of the above connectors in a continuous system, where by the effect of sheathing and subfascia members were also evaluated. A system consisting of 7 rafters (Figure 2.9a) and a loading tree (Figure 2.9b) was constructed for the load testing.

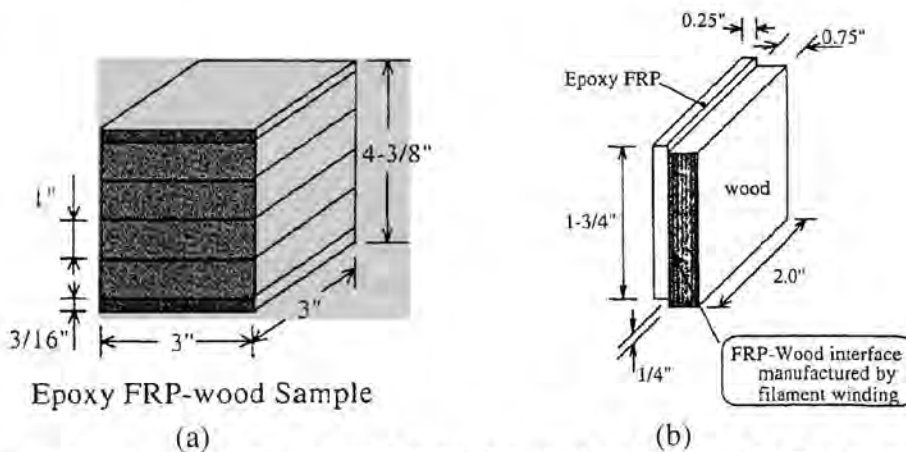
**Figure 2.10 – (a) Modified ASTM D 2559 test, (b) Modified ASTM D 905 test**

**(Davalos et al. 2000)**

ASTM D 2559 test procedure (Figure 2.10a) was followed, while for the shear strength test a modified ASTM D 905 test procedure (Figure 2.10b) was adopted. The HMR coupling agent was shown to improve the performance of epoxy FRP-wood bond subjected to cyclic wetting and drying. However, the RF agent did not provide satisfactory results. In the block shear tests, it was observed that the HMR coupling agent performed better than RF. The failure generally occurred on the wood surface when HMR was used, but the percentage of wood failure was lower with RF.

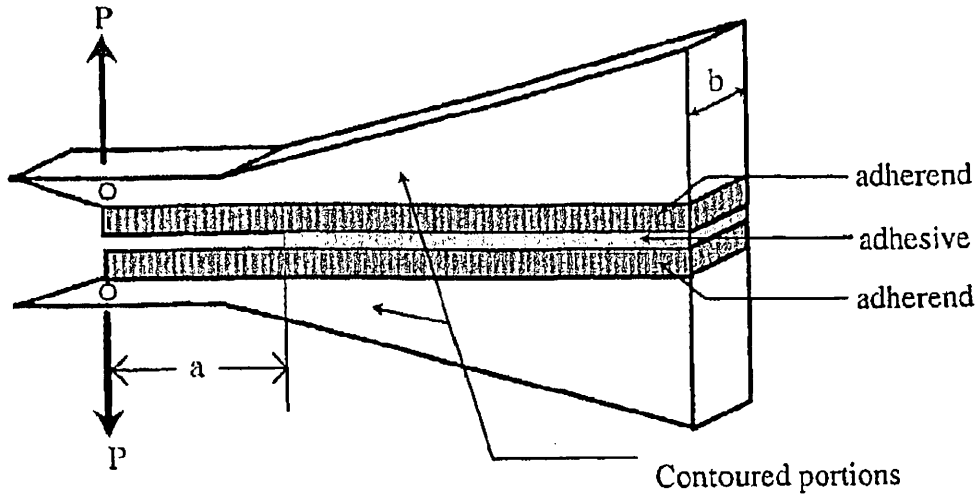
**Figure 2.11 – The contoured double-cantilevered beam specimen (Davalos et al. 2000)**

In the second part of their study, Davalos et al. (2000) investigated the Mode I fracture of FRP-wood bond interface using a contoured double-cantilevered beam specimen (Figure 2.11). The goal was to establish a fracture toughness data to predict whether delamination of FRP will occur in actual service conditions. It was again shown that HMR performed much better than RF as a coupling agent with higher strength and lower coefficient of variation values in dry conditions. Under wet conditions, the difference in specimens tested with HMR and RF became more apparent.

Jia and Davalos (2004) conducted a study to understand the effect of load ratio on Mode-I fatigue fracture of FRP-wood bonded interfaces. For this study, they used the contoured double cantilevered beam specimen show in Figure 2.11. The adherents used in this study were red maple wood and pultruded Phenolic FRP laminate. The FRP-wood interface was bonded using RF. After processing the results of the experiments, the following three equations were developed by modifying Paris Law:

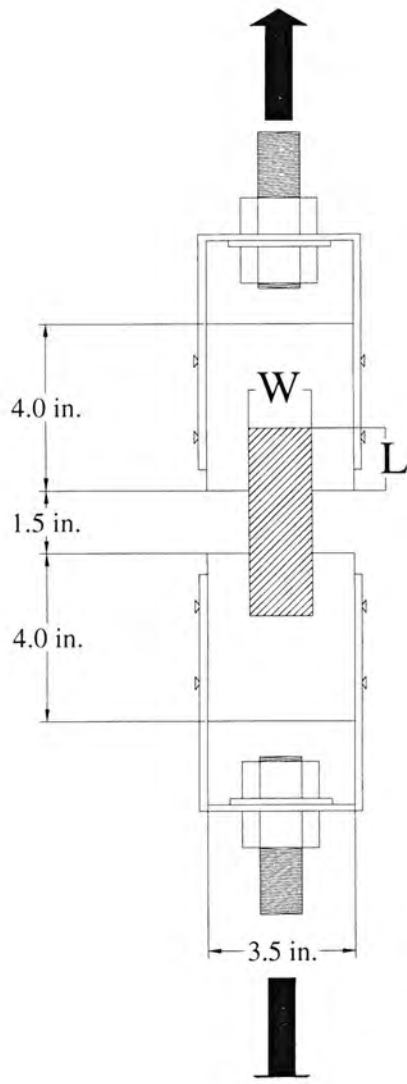
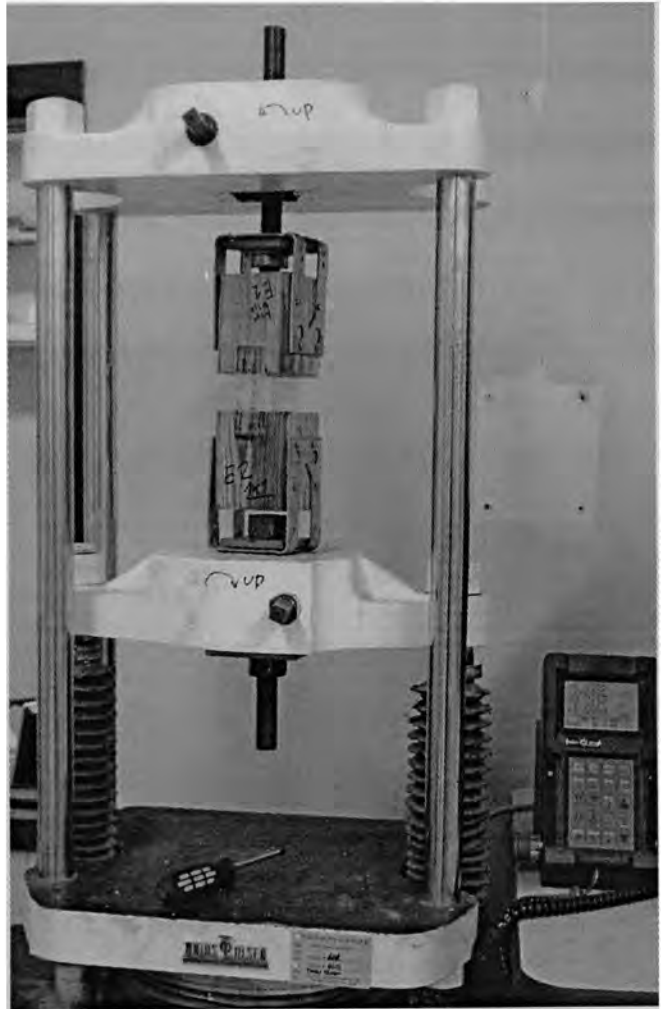
(a)

(b)

**Figure 3.1 – (a) Schematic representation of direct shear test setup, (b) Specimen placed at universal testing machine**

The specimens were then connected to a U-shaped metal attachment using screws on top and bottom. Later, the assembly was attached to a universal testing machine using bolts from the top and bottom side through a hole drilled at the center of the metal attachments (Figure 3.1).

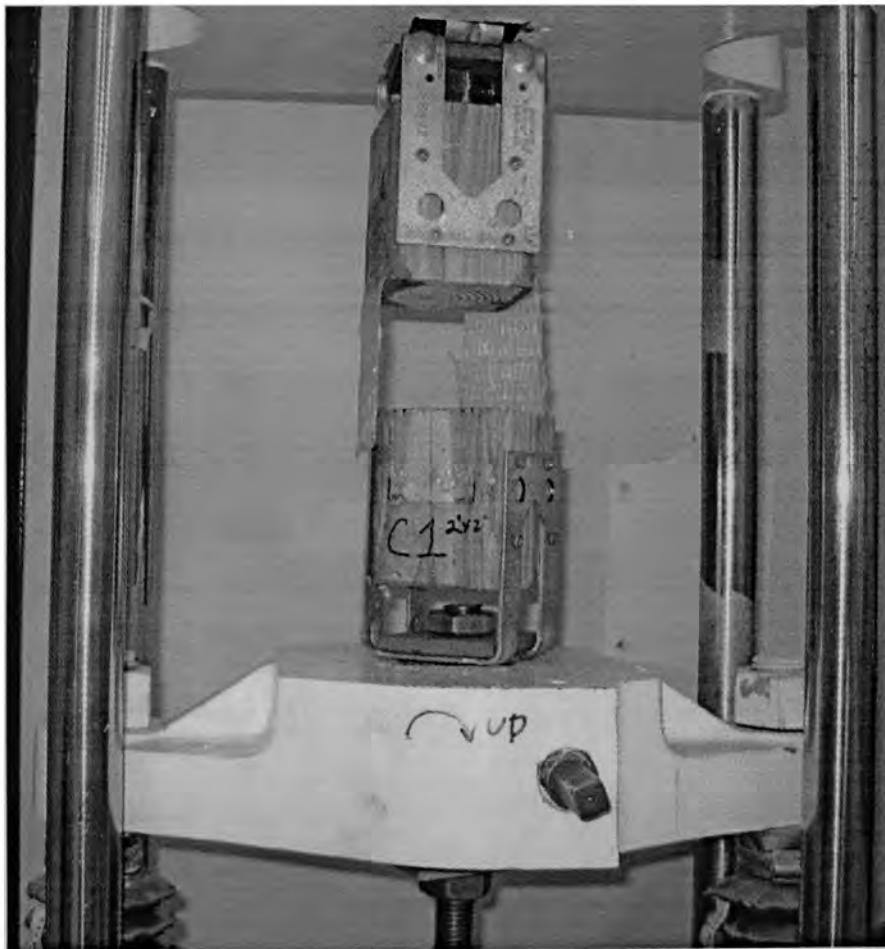
**Figure 3.2 – Failure of direct shear specimen**

All of the specimens failed due to debonding of FRP placed on wood blocks. When failed specimens were investigated, it was seen that the plane of failure was usually the interface between wood and FRP. Very little separation of fibers from the

wood was observed (Figures 3.2 and 3.3). In configurations A and B, which have larger bond areas, the delamination stage could be identified visually and the progressive shearing of FRP from wood could be observed. Following the beginning of debonding, specimens were able to sustain significant portion of their ultimate loads before completely failing. However, in configurations C, D and E the failure was very sudden and there was no indication of failure before the peak load was reached.

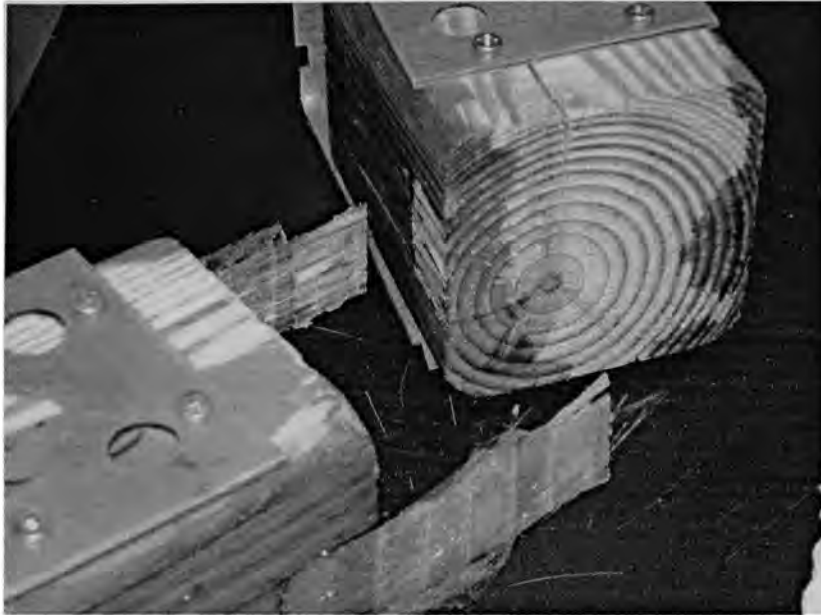
**Figure 3.3 – Typical failure of direct shear specimen**

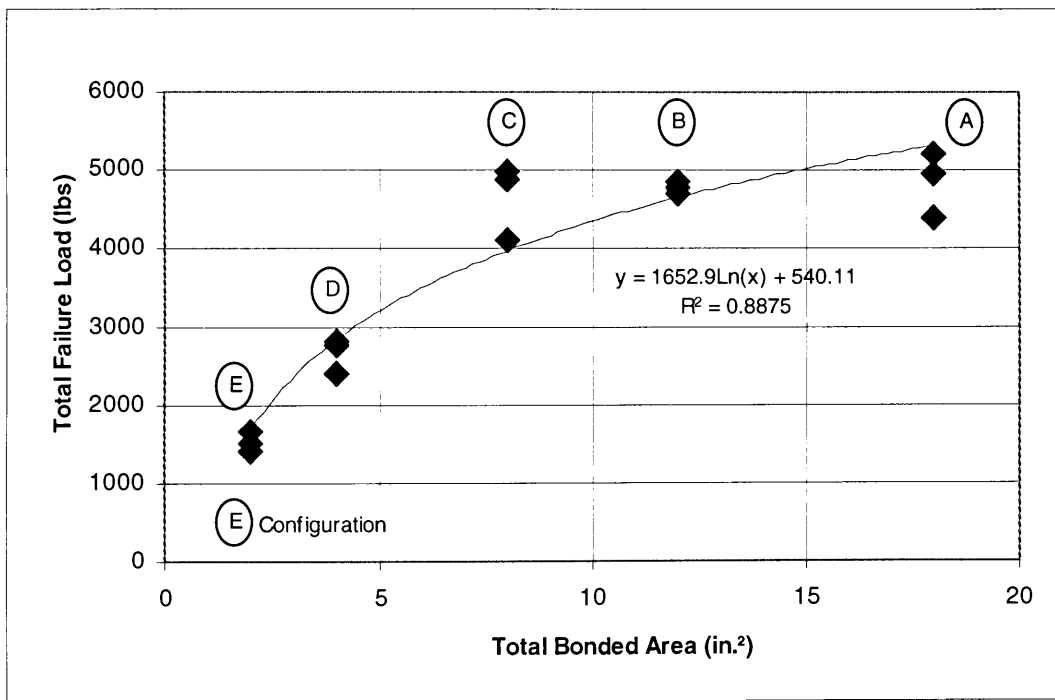
**Figure 3.4 – Total failure load vs. bonded area**

Figure 3.4 shows the effect of total bonded area on the failure load. The total bonded area represents the two sides of each block. It can clearly be seen that beyond a threshold of approximately 9 in<sup>2</sup>, no further increase in the failure load can be achieved by increasing the bonded area. For this data set, a trend line with an R<sup>2</sup> value of 0.8875 was found, as

$$y = 1652.9 \ln(x) + 540.11 \quad (\text{Equation 3.1})$$

where y is the total load and x is the bonded area.

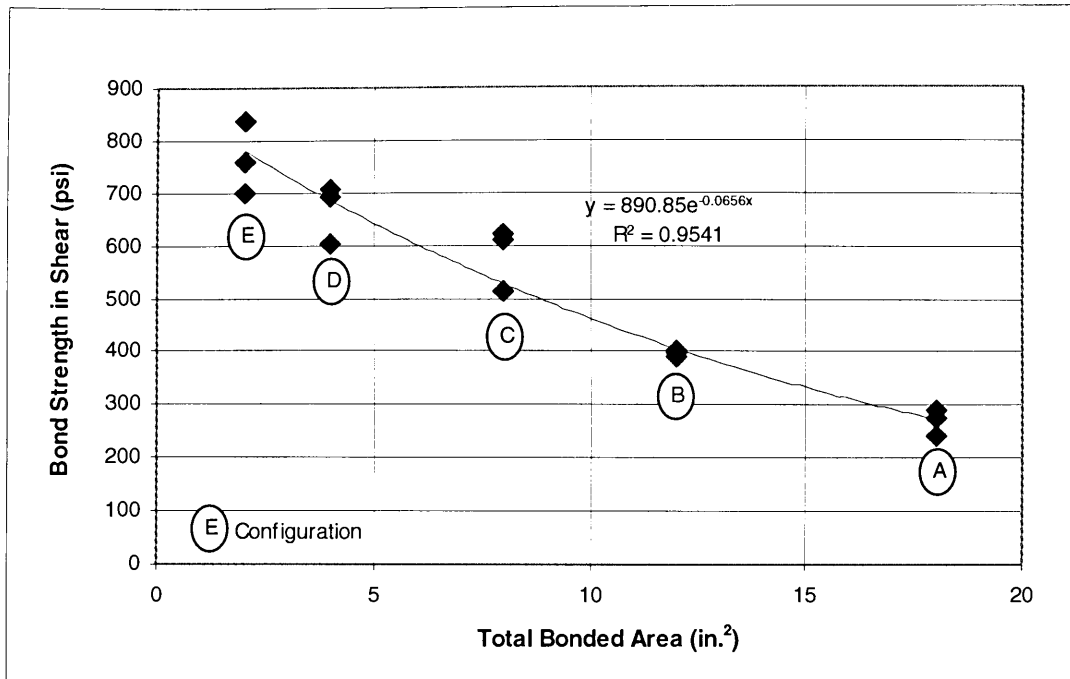
**Figure 3.5 – Bond strength in shear vs. bonded area**

Figure 3.5 shows the Mode II bond strength versus total bonded area. A trend line with an R<sup>2</sup> value of 0.954 was found as

$$y = 890.85 e^{-0.0656x} \quad (\text{Equation 3.2})$$

where y is the bond strength in shear and x is the bonded area.

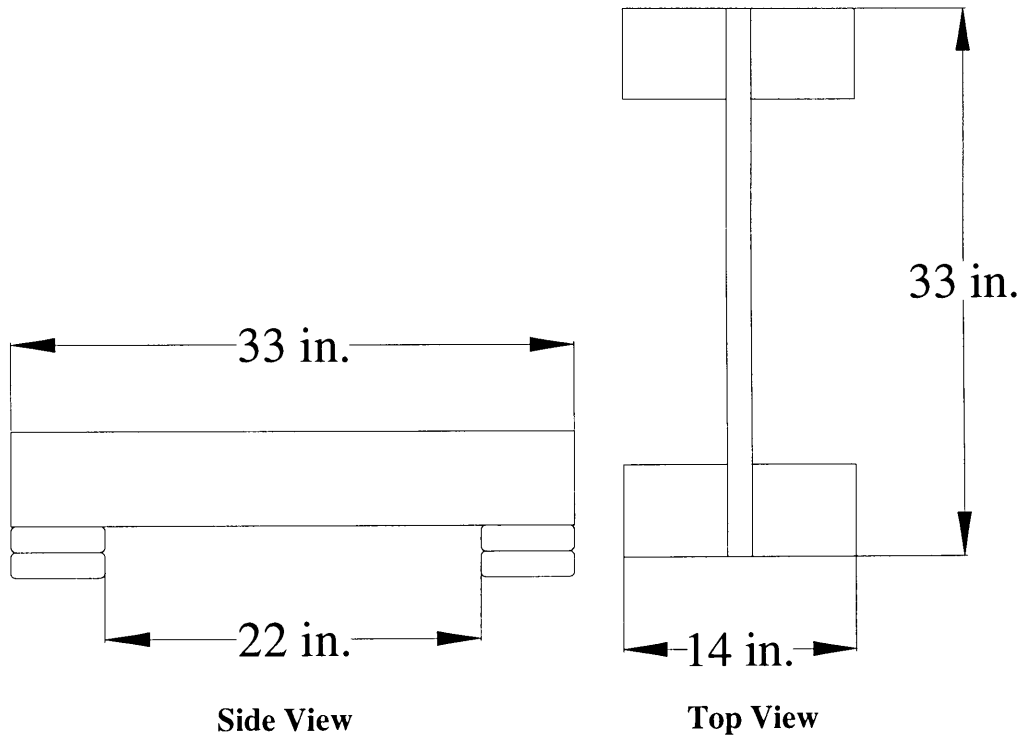
**Figure 3.6 – Top and side views of test specimen**

For testing of the FRP roof-to-wall connections, ASTM D 1761 standard was used, as followed by most of the hurricane clip manufacturers. The specimens consisted of two 14 in. long double top plates and a 33 in. long joist, all built using 2 x 6 in. dimensional lumber with a grade No 2 quality. Type of the lumber used in the first two stages of development was spruce-pine-fire (SPF). In the last stage, southern yellow pine (SYP) was also used in some of the specimens for comparison. Figure 3.6 shows the schematics of test specimen. While preparing the specimens, the double plates were first placed on the ground at a clear spacing of 22 in. The joist was then placed at the center of

the top plates. Subsequently, the FRP was attached at two ends of the joist using two-part epoxy according to the manufacturer's specifications. The specimens were allowed to cure for at least one week prior to testing. Four types of FRP were used, including unidirectional carbon FRP (CFRP), bidirectional CFRP, unidirectional glass FRP (GFRP) and bidirectional GFRP.

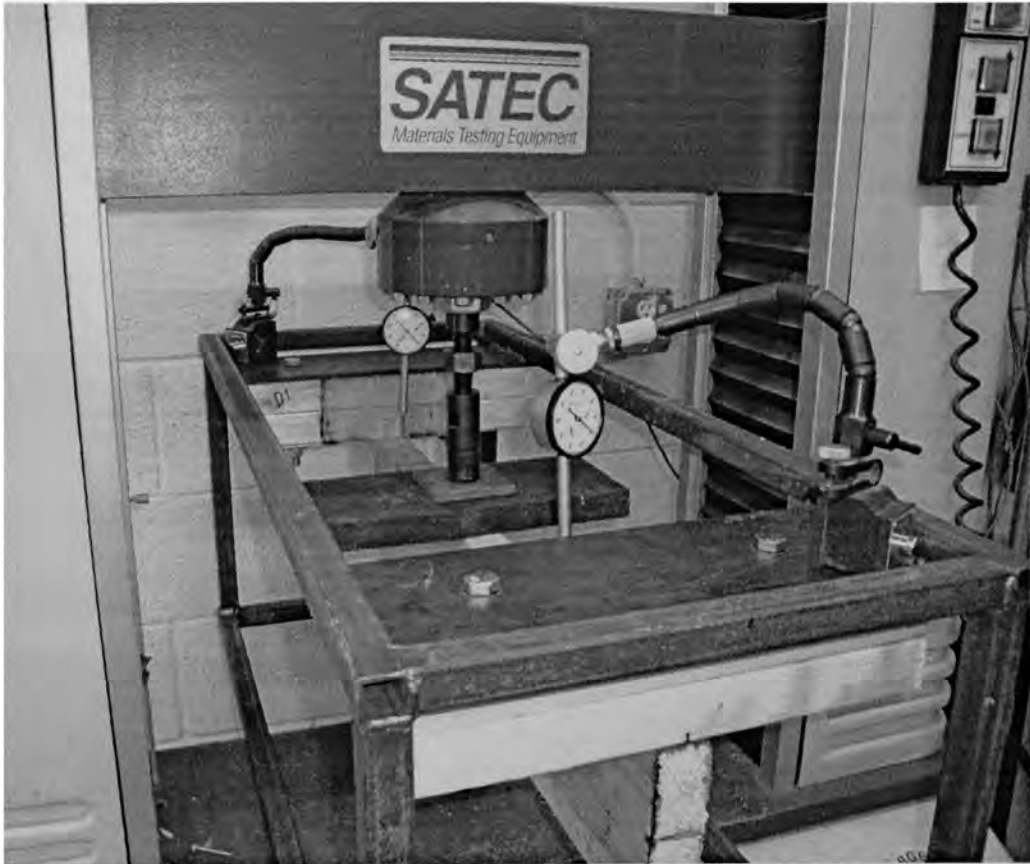
**Figure 3.7 – A typical specimen before testing**

For testing, the specimens were assembled upside down on a steel frame, as shown in Figure 3.7. The specimens were connected to the frame using either four bolts or clamps at the corners of the double top plates. The load was applied at the center on the bottom of the joist, using a universal testing machine at a displacement rate of 0.035 in./min. A 5 in. long rubber was placed under the crosshead to avoid crushing of the wood under the loading point.

Two dial gages were placed at the two ends of the joist at 1.5 in. spacing from the top plates. The load at 1/8 in. deflection, which is a criteria used by the hurricane clip manufacturers, was measured at these points.

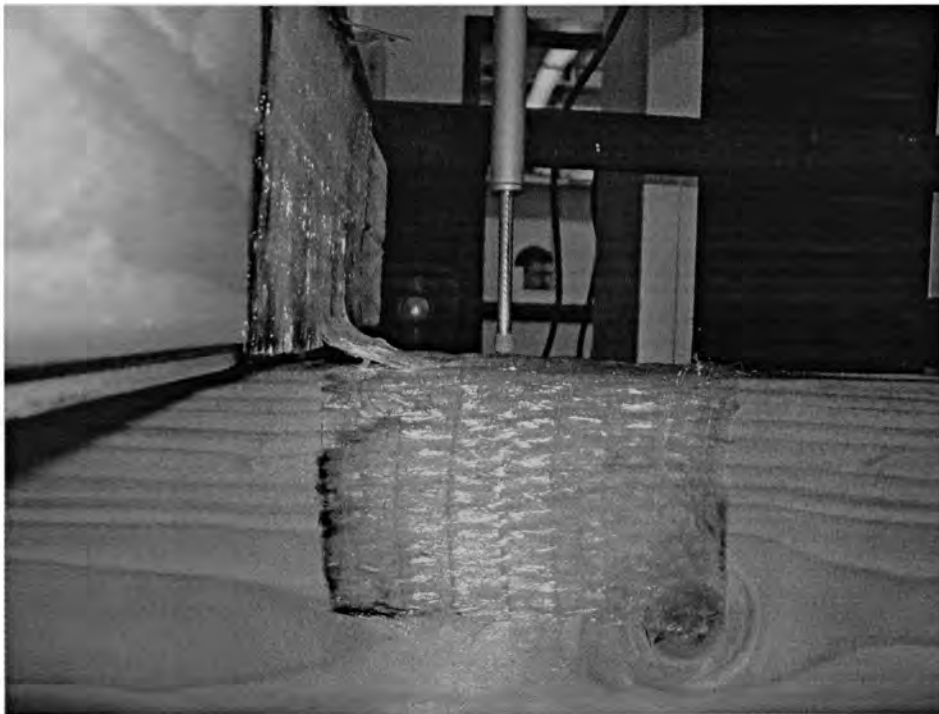
**Figure 3.9 – Failure of FRP tie Configuration I**

observed at 1,120 lbs before the 1/8 in. deflection limit was reached. Since there is one connection at each end of the joist, the load per connection was 560 lbs. The failure mode of the connection, as shown in Figure 3.9, was peeling (Mode I) and rupture of FRP at the edges of the joist.

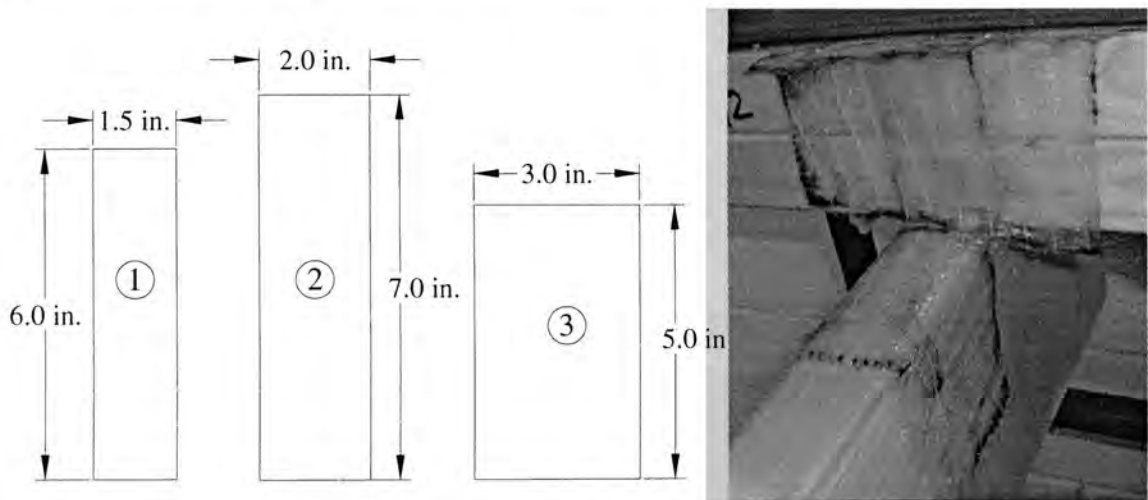
**Figure 3.10 – Schematics and application of FRP tie Configuration II**

Configuration II was very similar to Configuration I in terms of the load transfer mechanism. Three pieces of FRP were cut and applied to the connection point, as shown in Figure 3.10. The first piece, 1.5 in. x 6 in., was placed as an angle on top the plate and the joist. The second piece, 2 in. x 7 in., was placed on the joist. The third piece, 3 in. x 5 in., was attached onto the top plate. The total failure load was 1,280 lbs, or 640 lbs per connection, and it occurred before 1/8 in. deflection was reached. The failure mode of the specimen, as shown in Figure 3.11, was by rupture of FRP in the first piece.

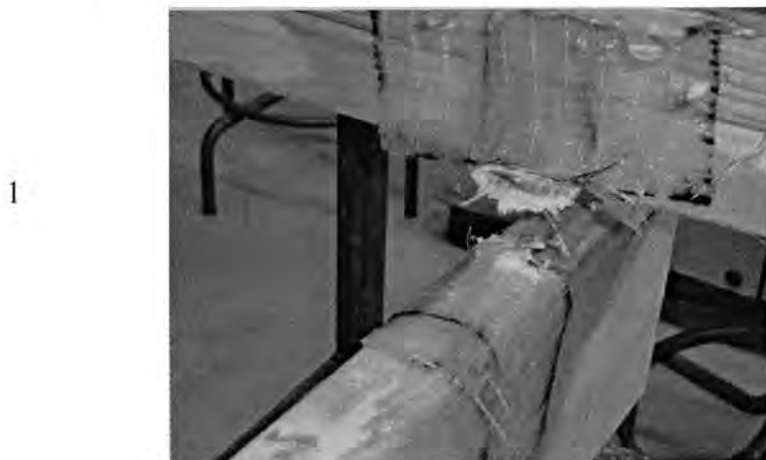
**Figure 3.11 – Failure of FRP tie Configuration II**

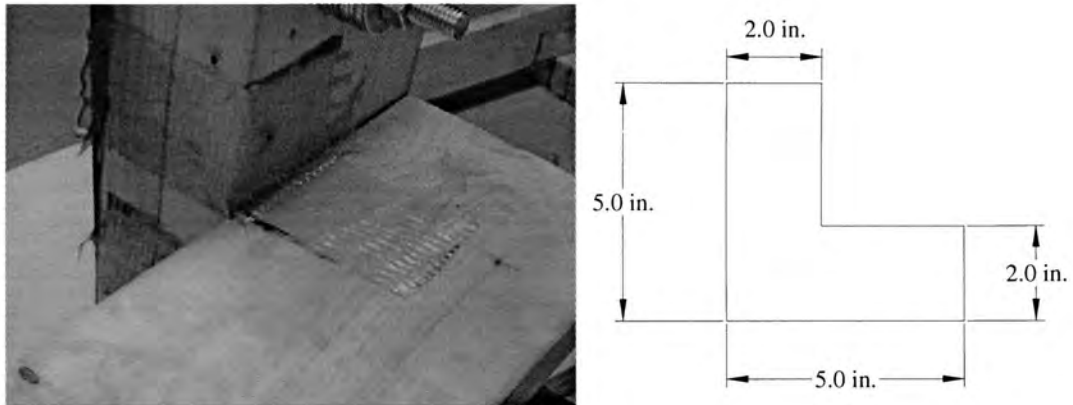
**Figure 3.12 – Schematics and application of FRP tie Configuration III**

Configuration III included L-shaped FRP pieces, as shown in Figure 3.12. Two independent ties were used at each end of the joist. The failure was observed at a total load of 3,100 lbs or 1,550 lbs per connection, as FRP ruptured along its weak direction and peeled off from the top plate (Figure 3.13). Again, the 1/8 in. deflection was not reached before the failure.

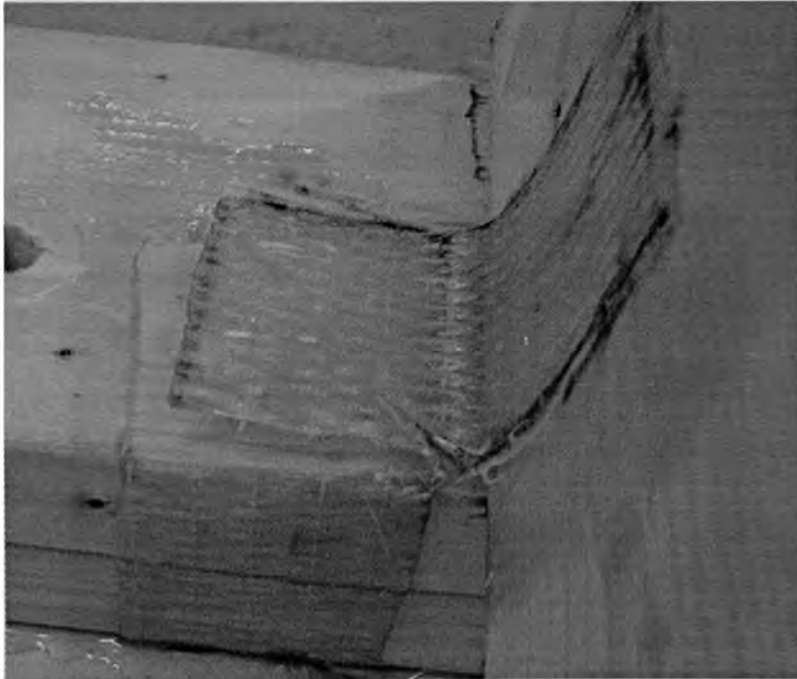
**Figure 3.13 – Failure of FRP tie Configuration III**

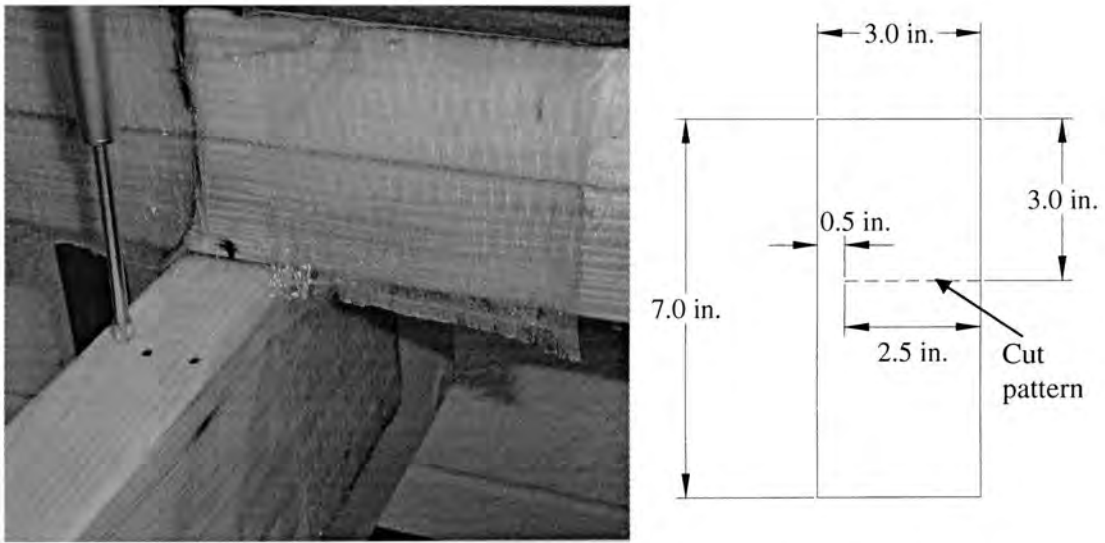
Configuration IV consisted of a 3 in. x 7 in. rectangular piece of FRP, as shown in Figure 3.14. The piece was cut along the dashed line, and placed such that the 3 in. portion will be on the top plate. The load transfer from the double top plate to the joist was achieved through the 1/2 in. wide FRP section. The failure was observed at a total load of 3,190 lbs or 1,595 lbs per connection, as FRP ruptured before the 1/8 in. deflection was reached (Figure 3.15).

**Figure 3.14 – Schematics and application of FRP tie Configuration IV**

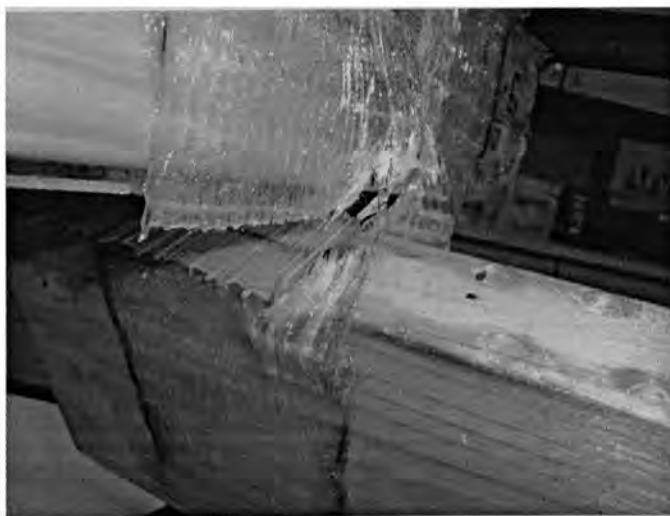
**Figure 3.15 – Failure of FRP tie Configuration IV**

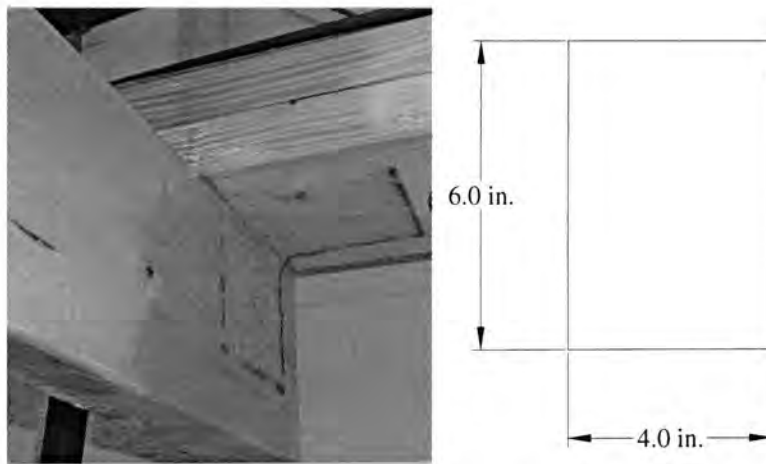
Configuration V consisted of a 4 in. x 6 in. rectangular piece of FRP applied such that half of the FRP will be on the top plate and the other half on the joist, as shown in Figure 3.16. These pieces were placed on each side at ends of joist as an angle, making 4 FRP pieces per specimen. The failure of this connection occurred at 5,560 lbs, or 2,780 lbs per connection, before the 1/8 in. deflection limit was reached. The mode of failure was identified as peeling off of FRP placed on the top plates as shown in Figure 3.17. It was observed that significant amount of wood fibers peeled as the FRP detached from the top plate.

**Figure 3.16 – Schematics and application of FRP tie Configuration V**

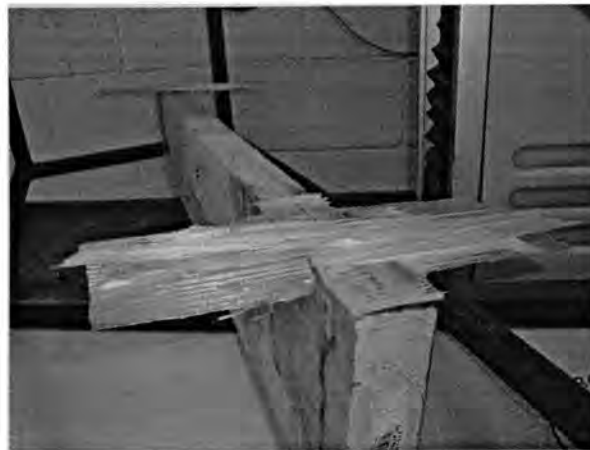
**Figure 3.17 – Failure of FRP tie Configuration V**

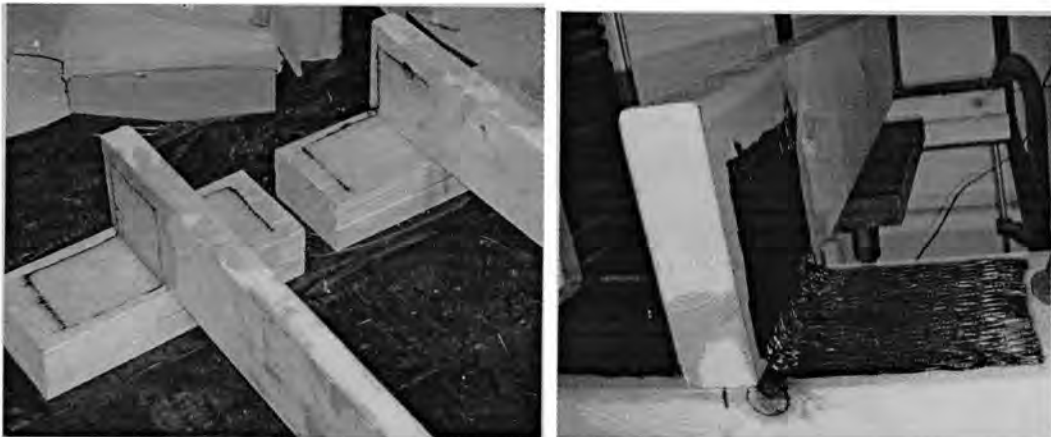
Configuration A was developed by enlarging the contact area of FRP that was used in Configuration V of Stage I. The top plates were connected to the joist using four 4 in. x 9 in. FRP pieces. Each FRP piece was placed, such that half will be on the top plate and the other half on the joist. The specimens prepared by GFRP and CFRP are shown in Figure 3.18. It was seen that modes of failures were very similar for glass and carbon. In all specimens, the FRP peeled off from the top plate came while detaching wood fibers (Figure 3.19). It was observed that ultimate load for carbon FRP was approximately 20% higher than that of glass FRP. Also, the separation of wood fibers from the top plate was more obvious in CFRP ties.

**Figure 3.18 – Configuration A with GFRP (left) and CFRP (right) before testing**
